Environmental Drainage Maintenance Research Programme

Catchment-wide Assessment 2024

IFI/2025/1-4755

Inland Fisheries Ireland & the Office of Public Works

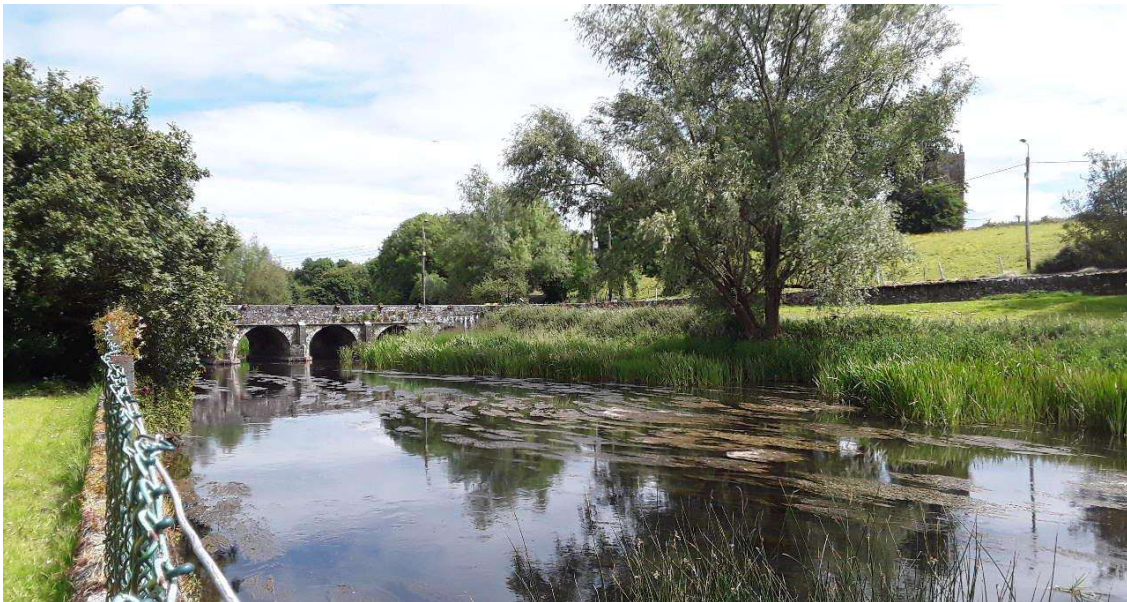
Two sites in the surveyed area scored Bad status for hydromorphology and both were on the main channel of the Maigue, both in urban areas in Bruree (Figure 3.3) and Croom (Figure 3.4). At Bruree, the site covers an area with a very large weir and a waterfall (see Figure 4.7 middle & right). Overall, it achieved a score of just 4. The channel was over-widened extensively to accommodate the positioning of the weir historically. The land is managed locally as far as the bank top as an amenity area. However, due to such management, it is evident that there are problems with large amounts of invasive and disturbance species, including Giant Hogweed, developing in the area. Both banks are reinforced to varying degrees along their length. The channel has a significant impoundment due to the presence of the weir, which affects the score for channel vegetation negatively. The substrate condition was not visible due to the impoundment and applying the survey methodology, it was assigned a moderate score.

Figure 3.3 Impounded area upstream of the weir at Bruree (C1 Maigue Outfall).

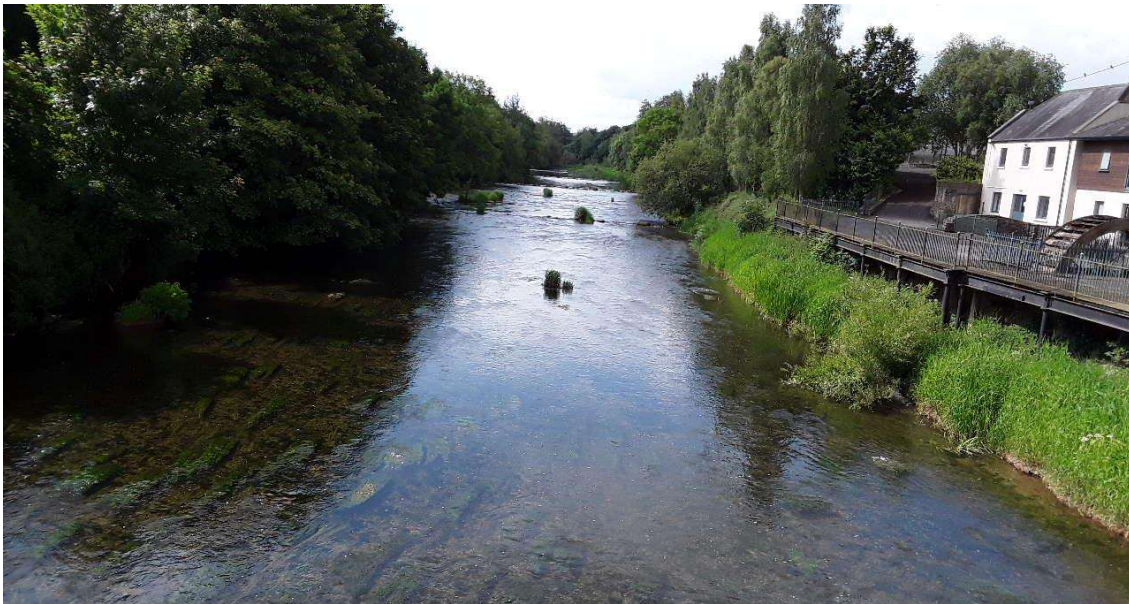
The site at Croom (C1 Maigue Outfall) also scored Bad for similar reasons. Although there was no weir present at the site surveyed, the channel is extensively over-widened with two large weirs present upstream. There are a series of small, stepped structures upstream

between the survey site and the main weir. The extensive over-widening has left very shallow flows in places and allows excessive homogenous vegetation to thrive. Reinforcement along both banks and the lack of floodplain connectivity contributes to the Bad score.

Figure 3.4 The River Maigne (C1 Maigne Outfall) at Croom.

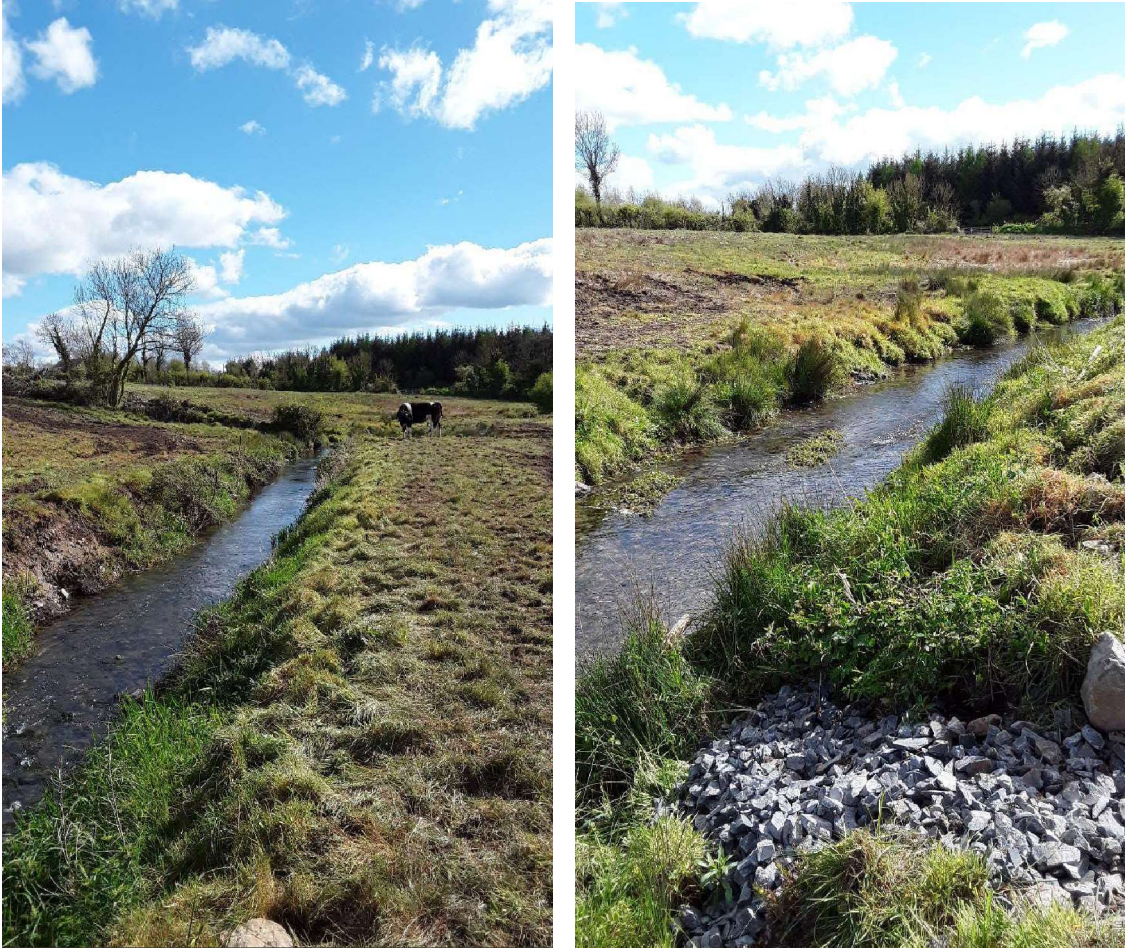
One site surveyed in the upper catchment area was on the Mahore river (C1/25/23, stream order 2) outside the village of Emly (Figure 3.5). The channel was assigned an overall score of 9, in the middle of the range for Poor status. A number of factors contributed to the low score, with the key one being the lack of riparian cover and fencing. The channel is over-widened from historical drainage. It is not over-deepened and has no fence for the majority of the stretch, leaving it accessible to livestock. It is heavily poached from both banks and cattle freely access the instream area. Due to the lack of riparian cover and a buffer strip, algae was excessive on the day of the survey and hence the channel vegetation attribute scored badly.

The substrate condition scored poorly with an excessive amount of fine sediment within the wetted area. The bank structure and stability as well as the bank vegetation scored bad for both banks, due to the heavy poaching and patches of bare ground evident along the stretch. Instream vegetation indicated the channel was over-widened with shallow flows in places. Improved management of this stretch which include halting livestock access to the channel would easily improve the RHAT score in numerous attributes.

Figure 3.5 The Mahore River (C1/25/23) is heavily poached with unstable banks, large patches of closely cropped or bare ground and an absence of riparian cover. Vegetation is colonising the wetted area instream (right) demonstrating evidence the channel is over-widened.

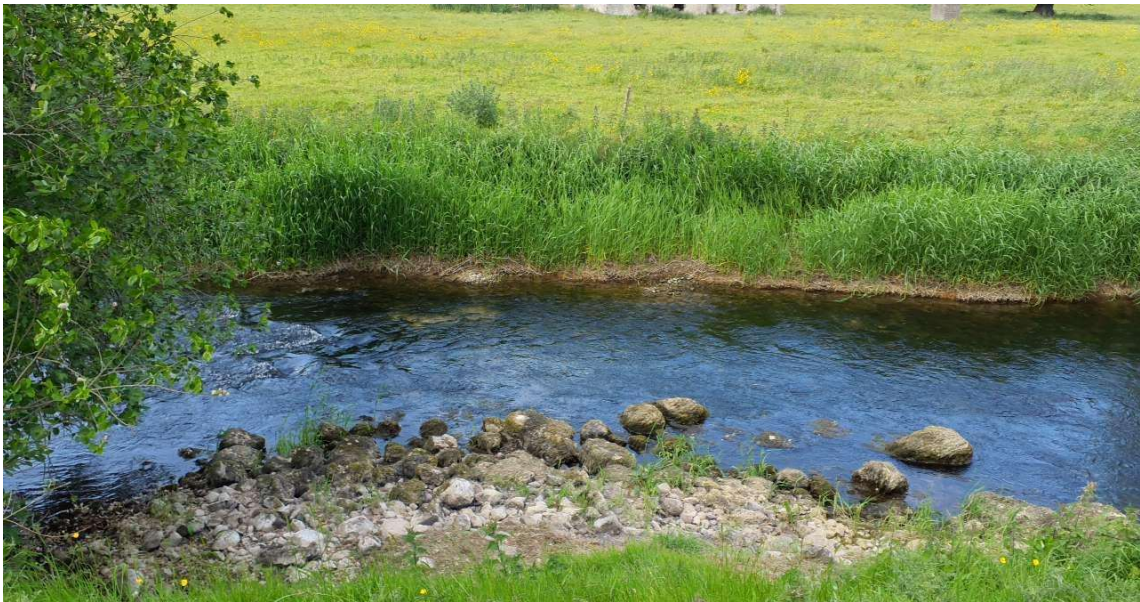
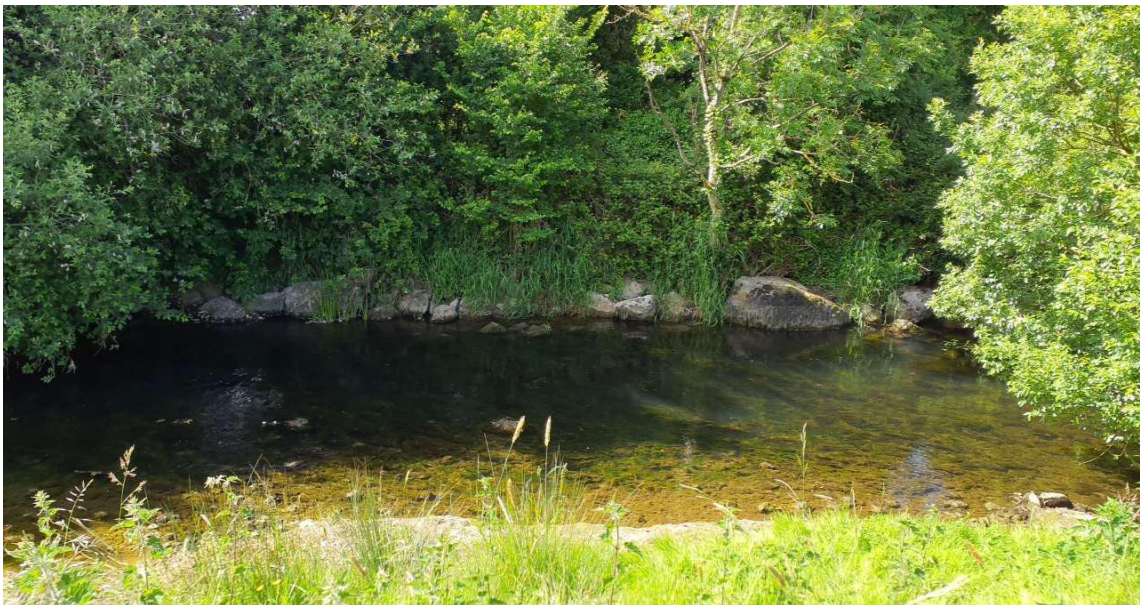
A higher order river (stream order 5), which also scored Poor status at one site, was the Camoge River (C1/25) outside Meanus (Figure 3.6). It scored 9.5 overall, also keeping it in the mid-range of the Poor scores. The site was significantly over-widened and over-deepened with reinforcement to varying degrees along both banks, with rip-rap particularly evident along the right hand bank. Instream works were completed along this stretch of river between 2008 and 2010. A series of deflectors made of stone are evident instream, and they have not naturalised since being installed. There is also an intermediate weir recorded in the channel at this site. The deflectors do improve the flows in some parts of the river where it is over-widened but the artificial alterations to the channel form are quite evident throughout the stretch. The channel suffers with a lack of riparian shading as the riparian cover is mostly simple grasses and nettles. Along with the over-widening this has created an environment for

algae to thrive and it out-competes other instream vegetation types. Correspondingly the channel vegetation scored bad for this site. There is a large amount of silt on substrate throughout the reach so that attribute scored poorly.

Figure 3.6 Site on the Camoge River (C1/25). Artificial deflectors have not naturalised since installation (top). Bank reinforcement evident on over-widened channel and algae is dominant in the instream area (bottom).

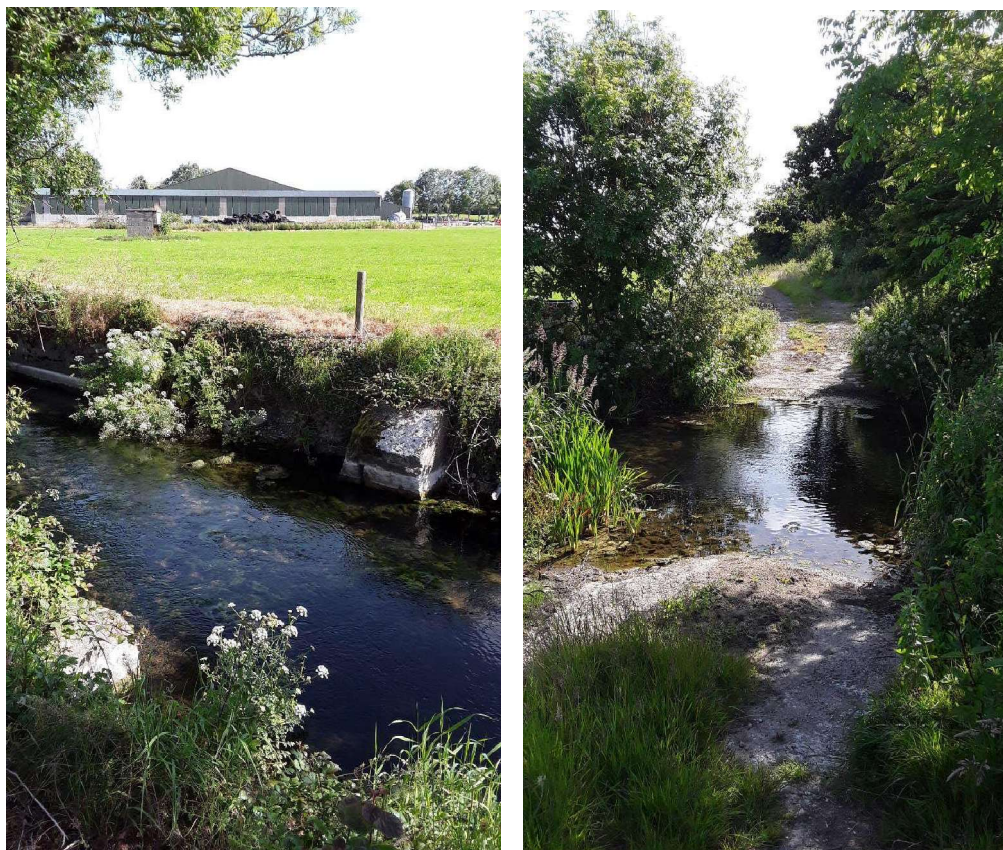
Figure 3.7 The River Clonshire (C1/17) showing minor reinforcement as well as management to the bank top (left). Ford on the Clonshire (right) showing very low water levels due to over-widening as well as algal growth.

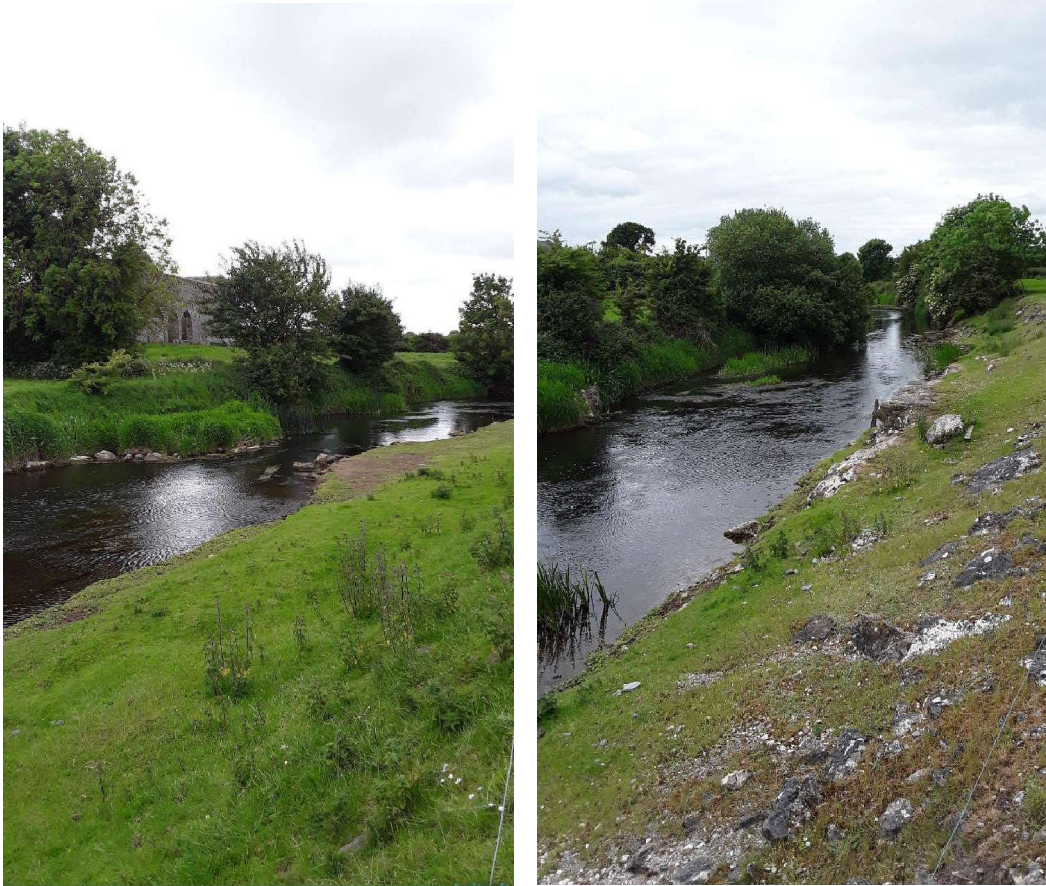
A site with a mid-range moderate score was on the River Camoge (C1/25) at Monaster (Figure 3.8) with a score of 15. The extensive grazing by livestock and free access to the channel meant that this site was downgraded on the right-hand bank. Removing such unhindered access would improve the scores in various RHAT attributes. The channel is significantly over-widened and over-deepened from drainage works. There is evidence of previous instream works done along the stretch with sets of stone deflectors and large pools downstream. Most of the stone deflectors have not naturalised since installation. Channel form and flow is improved by the deflectors but flows and depths are still limited in parts, leaving this attribute with a moderate score. Algal growth in the wide shallow sections is extensive and it out-competes other flora along the stretch. In parts, vegetation is narrowing the over-widened channel. The bank structure/stability along with the bank vegetation score poorly for the right-hand bank due to the over-grazing. The left-hand bank scores moderately for vegetation as it is fenced and has some complex patches of shading. Fencing both banks would allow vegetation recovery both in the riparian zone as well as the instream wetted area.

Figure 3.8 Survey site on the River Camoge (C1/25) showing instream deflectors (left), grazing to the bank top and vegetation narrowing the channel (right).

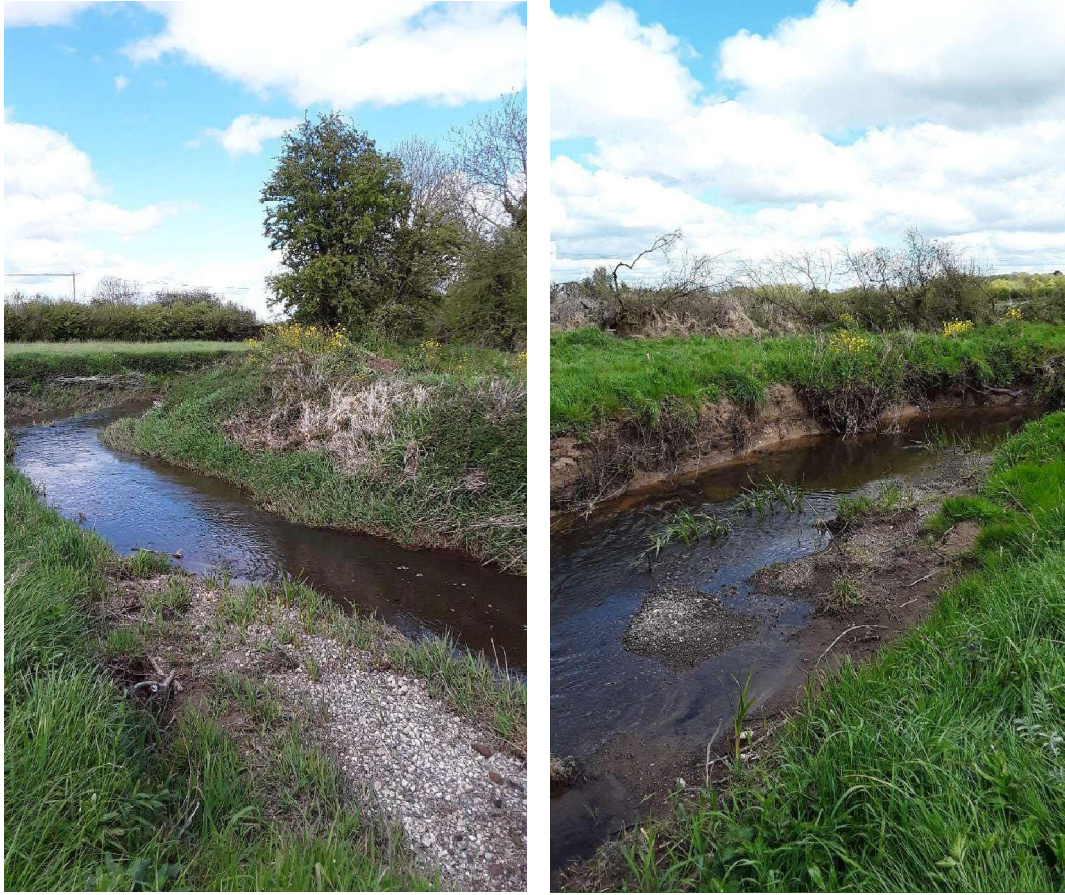
In contrast to the previous two examples, the site on the River Drumcomoge outside Knocklong (C1/25, a tributary of the Camoge River) scores a lot higher, near the threshold of Good with a score of 18 (Figure 3.9). To achieve a good status for hydromorphology, the score would need to be improved by 1.5 overall. This channel was recently subjected to drainage maintenance by the OPW which encompassed good implementation of the 10-steps protocol. The channel scores good for channel form and flow types, channel vegetation as well as substrate condition. There are a variety of bedforms in the instream area including berms and mid-channel islands providing good heterogeneity in flows and depths. Some are established and vegetated whereas others are pioneer berms or islands in the process of establishing their form. The channel was over-widened and over-deepened and now it is trying to narrow its base width in line with its discharge through deposition of sediment and subsequent establishment of vegetation.

Figure 3.9 Drumcomoge River (C1/25) with established gravel bedforms and pioneer vegetation.

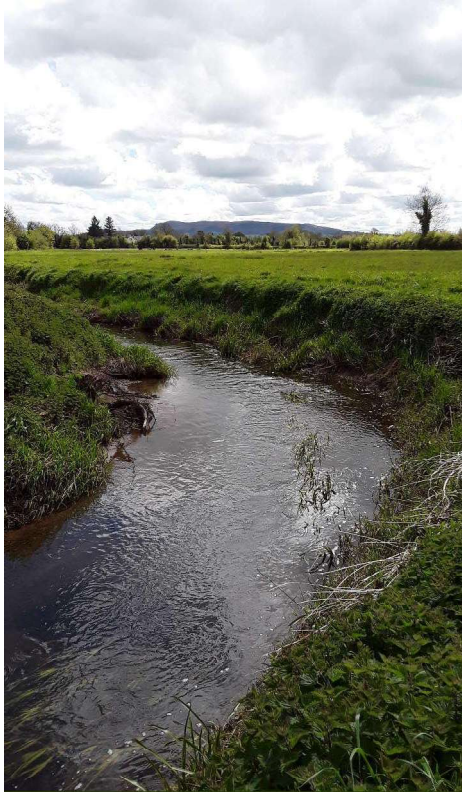
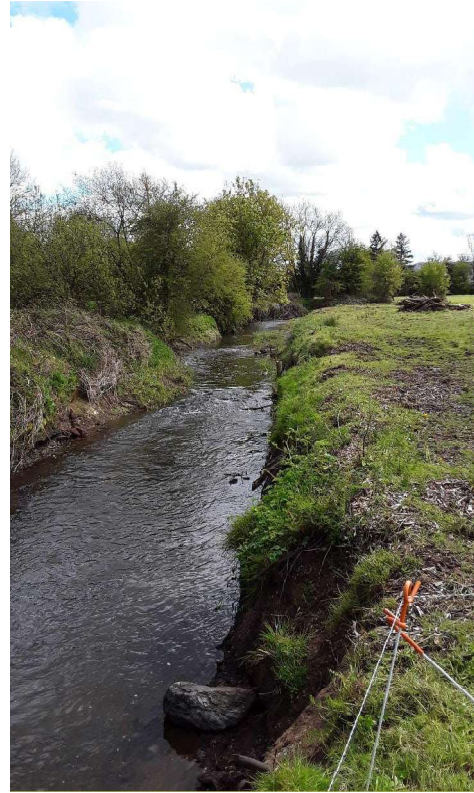
For both banks, bank structure and stability scores moderate – some sections are slumping and falling into the channel in places this is as a result of poor land management. . the left-hand bank is grazed to the bank top and there are only uniform grasses, so there is a lack of riparian shading and heterogeneity (Figure 3.10). With changes to land management and the management of the banks and riparian vegetation, the hydromorphology score could improve to good status.

Figure 3.10 Grazing to the bank top and an absence of riparian canopy cover on the Drumcomoge River (C1/25).

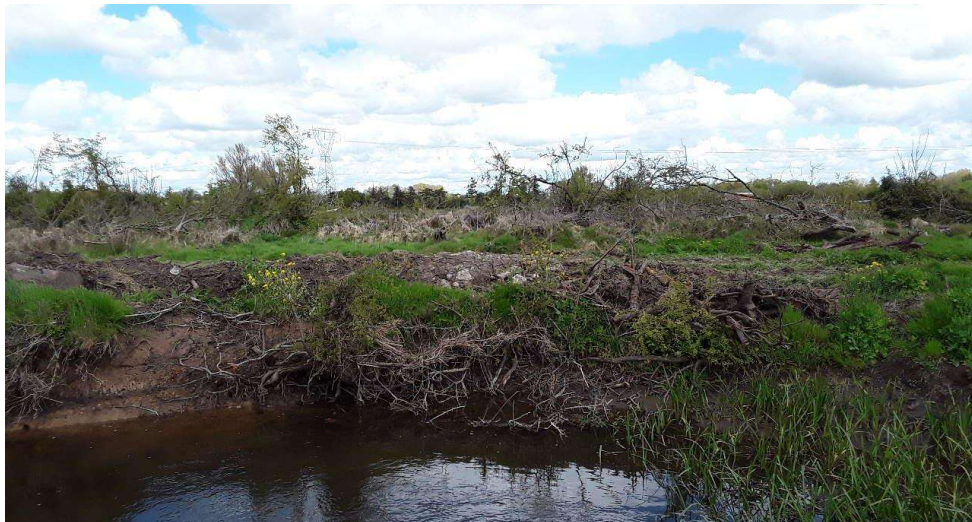
Figure 3.11 Poor land management where a small soil embankment was installed on the Drumcomoge River (C1/25) recently.

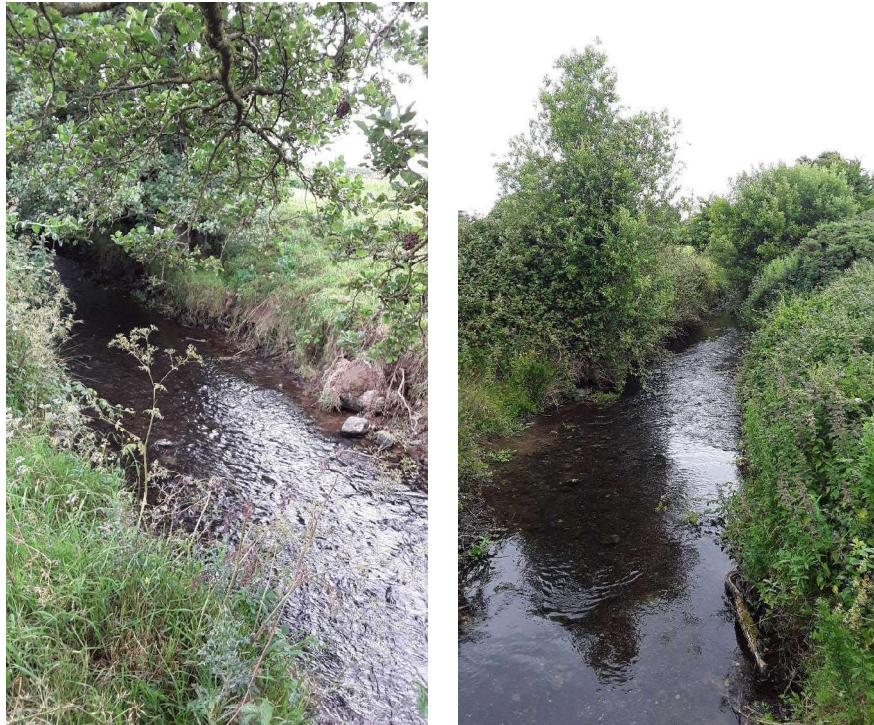
This site on the Flemingstown stream (C1/34/12, stream order 3) is located on the upper reaches of the Maigne system near Ardpatrik (Figure 3.12). Overall, the site scored Good status with a score of 19.5, meaning it is just within the range for Good status. The river is over-deepened and over-widened at this location due to historic drainage works but there is extensive recovery from re-sectioning evident throughout the stretch walked. The instream vegetation and substrate condition attributes both scored well. There is a nice mixture of coarse bedload with little fine sediment deposited, which would be expected for a channel in the upper reaches of the catchment. The channel has good riparian canopy cover and this also limits livestock access to the river, with only minor poaching evident in spots. The extensive canopy along the stretch contributes positively to the score for bank structure and stability. The stretch scored moderately for channel form and flow types. There is a homogenous channel shape due to the over-widening and over-deepening which in turn creates homogenous flows through the stretch. More diversity in flows and forms would be expected in an unmanaged channel of this type.

Figure 3.12 Good substrate condition, vegetation and riparian cover on the Flemingstown stream (C1/34/12). The channel trapezoidal-shaped channel has a limited range of depths and flows.

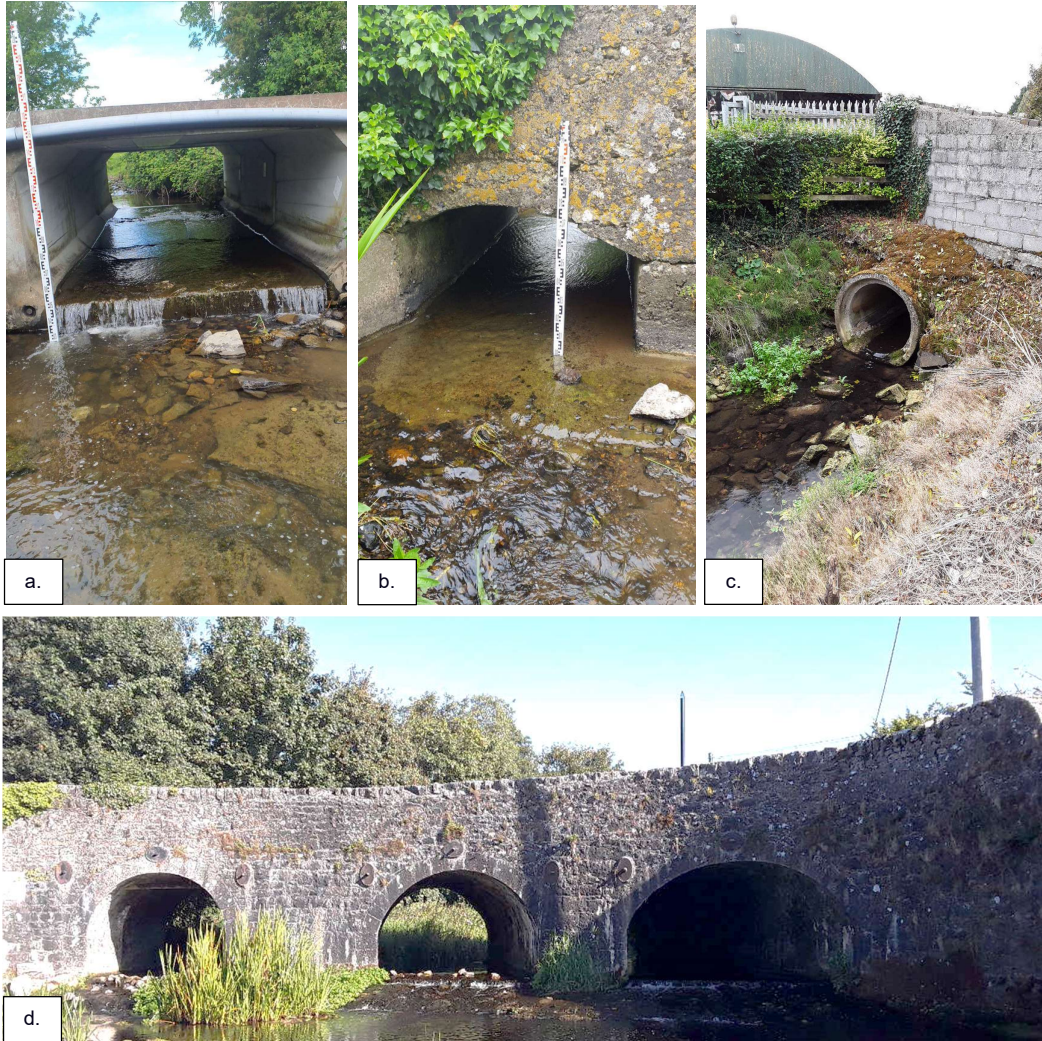
Notable steps/drops off these structures are visible in Figure 4.2 with the drop heights varying between 0.1–0.68 metres. These obstacles situated at the foot of such structures present a jump barrier to fish movement longitudinally within the channel, and especially during lower flows. These elevated bridge apron/culverts often have shallow depths of water (0.01–0.20 metres) flowing over the floor of the structure which presents a possible swim barrier to migratory fish species. For context, depths of 0.15 metres or less present a swim barrier to fish, with the required swim depth varying according to the species in question.

Figure 4.2 Examples of barriers classified as culvert / bridge apron. (a. 24_9_3; b. 24_9_6; c. 24_1688_46a; d. 24_795_76).

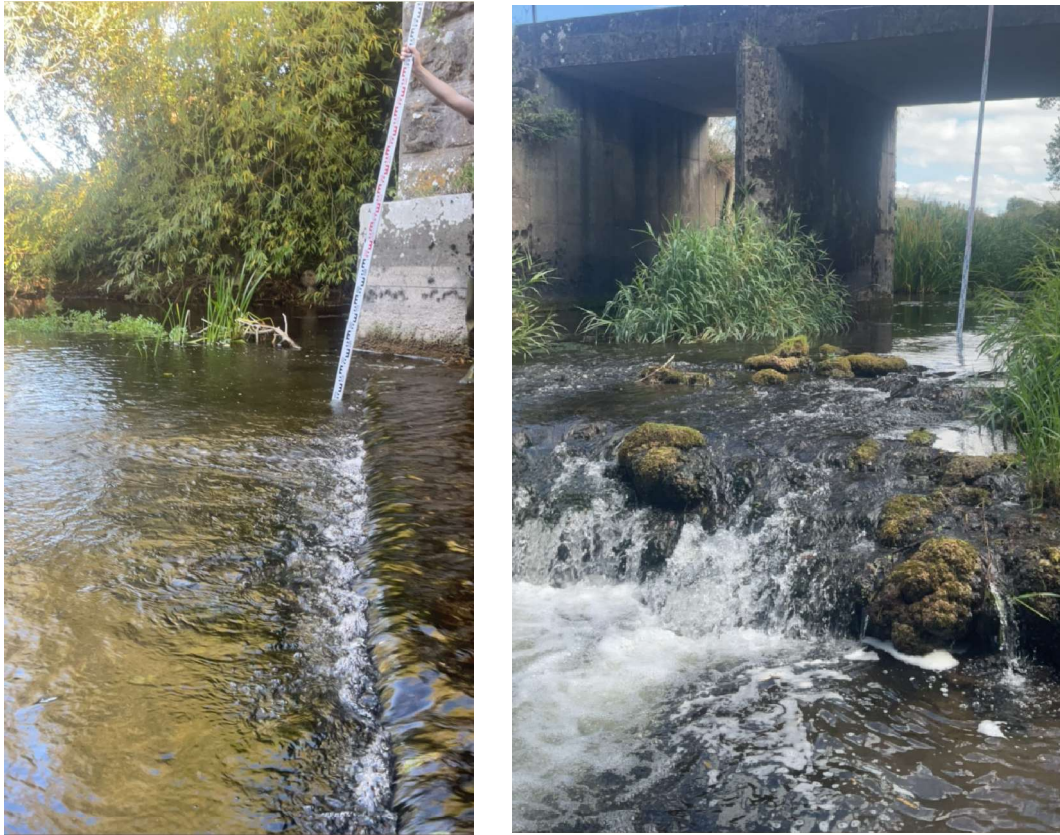
All of the bridges display similar characteristics which consists of a shallow bridge apron with a drop (Figure 4.3).

Figure 4.3 Problematic bridge aprons identified on the main stem of the Camoge (C1/25) (left: 24_711_42; right: 24_711_46).

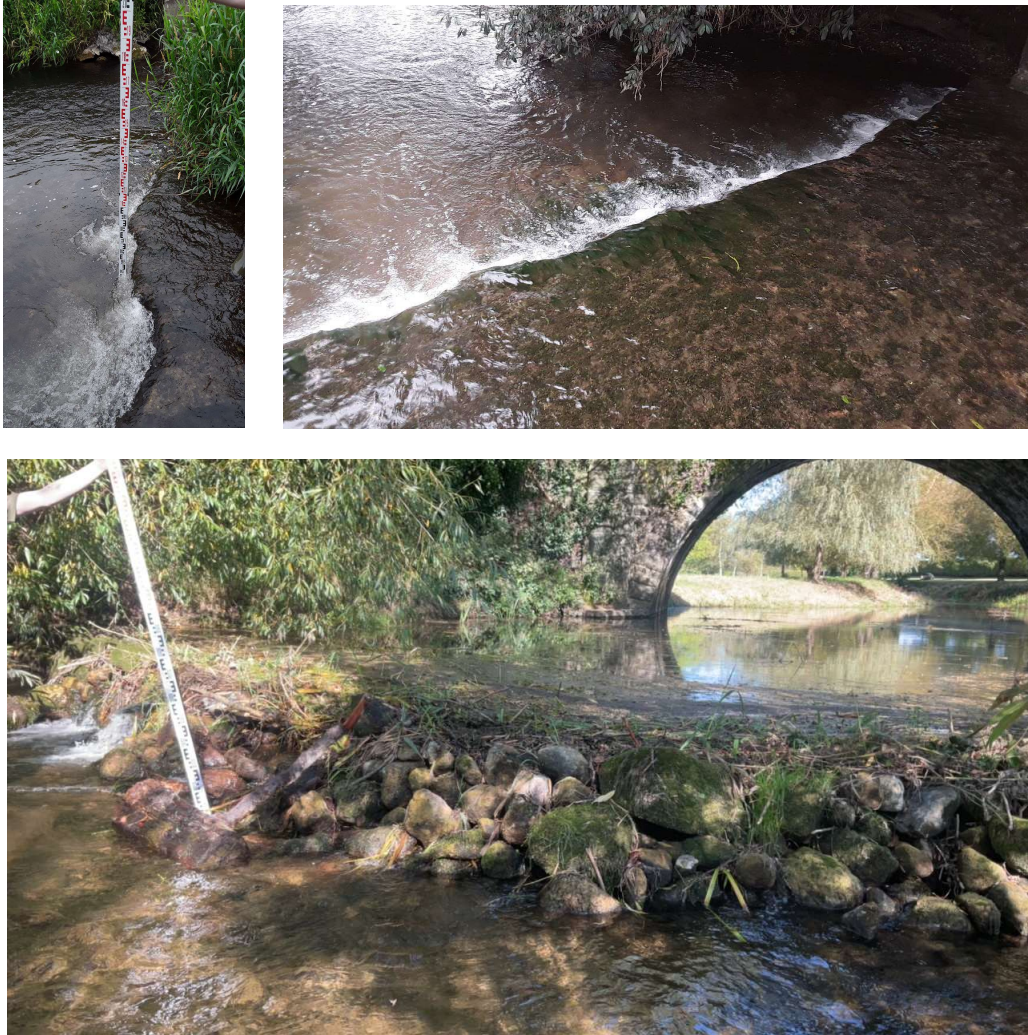
Five barriers deemed to impede fish passage were located on the Morningstar, of which four were categorised as culvert/bridge apron. The other was a stone weir constructed in the lower reaches of the channel approximately 650 metres upstream from the confluence of the main Mague channel (Figure 4.4).

Figure 4.4 Top: Shallow bridge aprons posing both a jump and swim barrier to migratory species present on the Morningstar (C1/31) within 200m of each other (left: 24_792_26; right: 24_792_19). Bottom: stone weir present in the lower reaches of the channel.

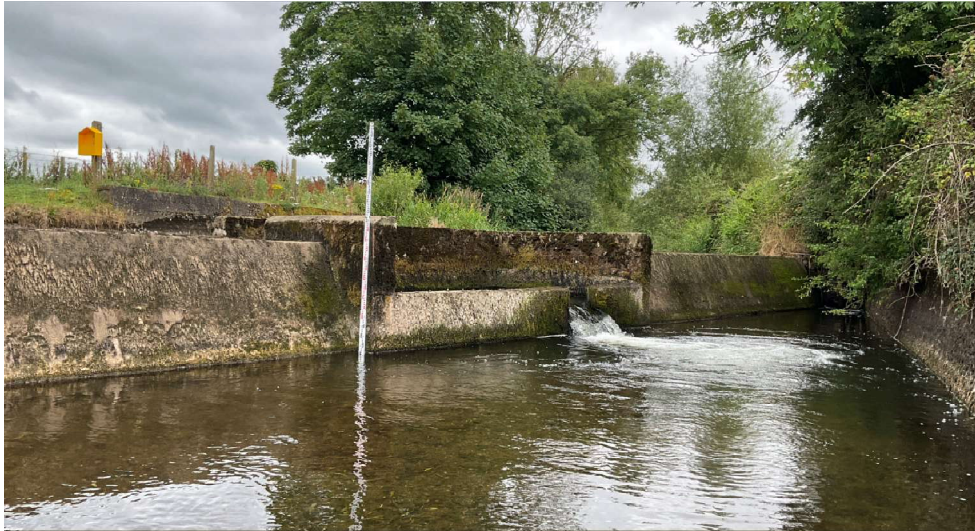
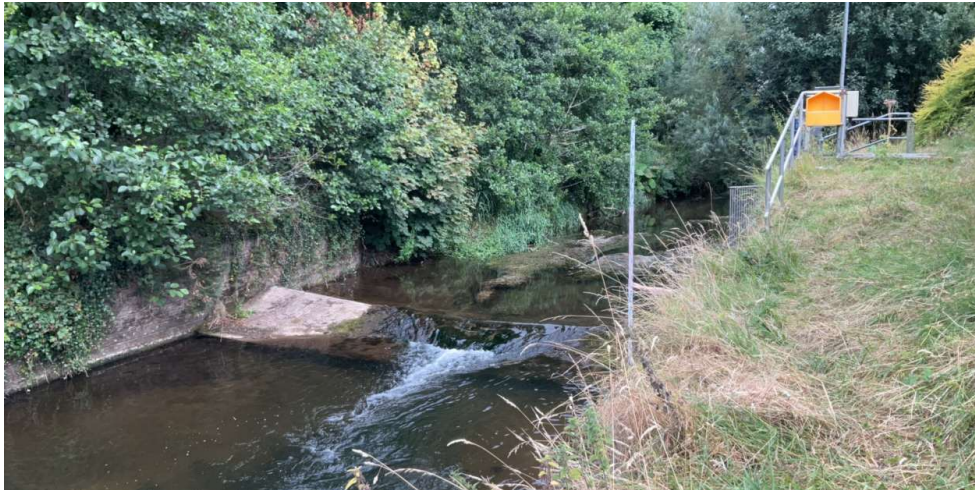
On the Loobagh, four barriers were identified, of which two are classified as culvert/bridge aprons and two as weirs. One of the weir structures is an OPW owned Sediment Trap (ST12) and the other is a gauging station (Figure 4.5). The weirs identified on the Loobagh are at a much smaller scale than those on the main channel.

Figure 4.5 Weirs identified on the main stem of the Loobagh (C1/34). (Top: Sediment Trap [ST12]; Bottom: Gauging Station (24_729_24)).

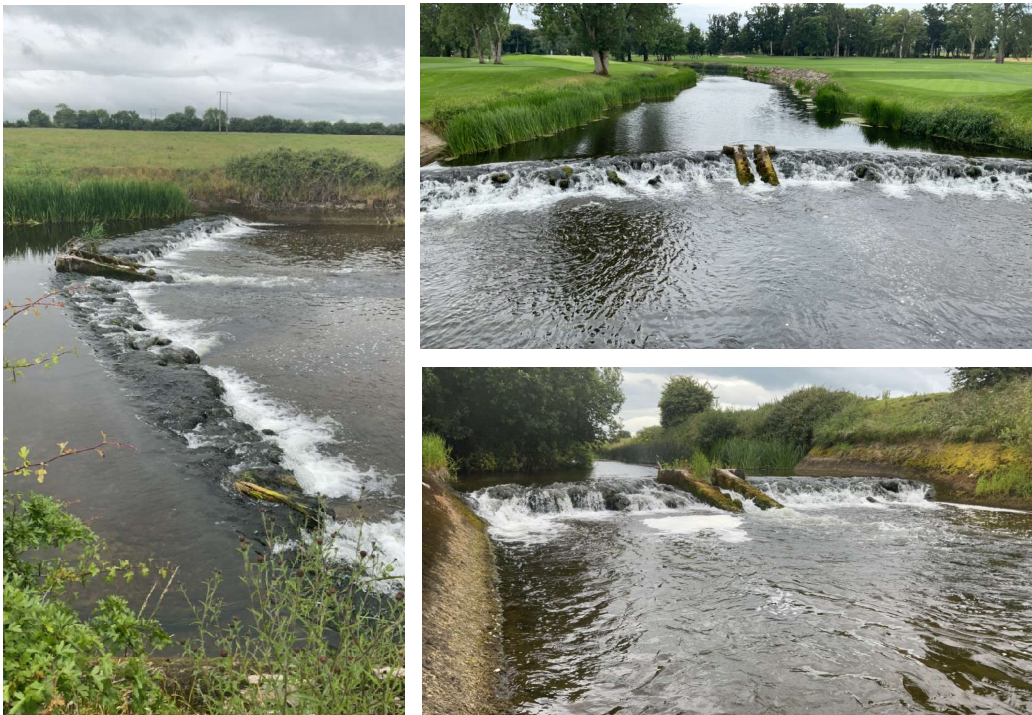
Figure 4.6 Examples of structures present on the main stem of the Maigue River, all displaying similar characteristics.

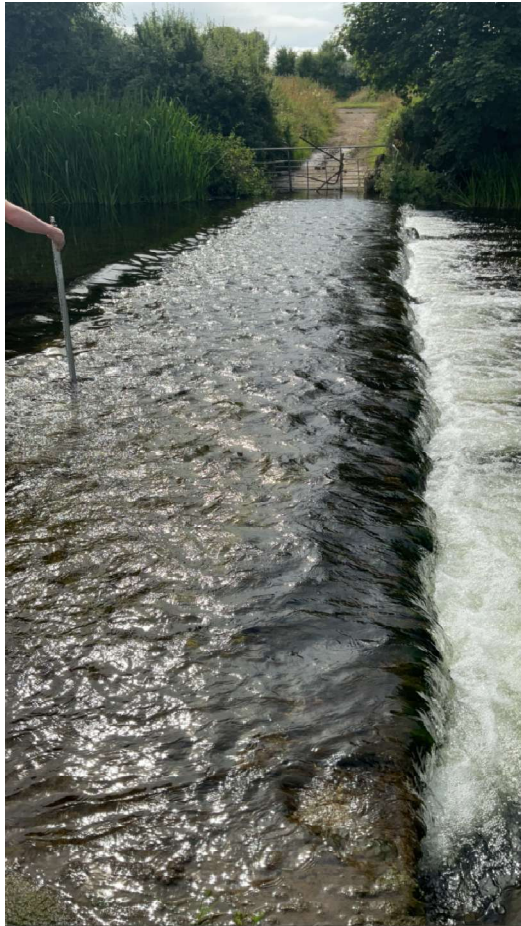
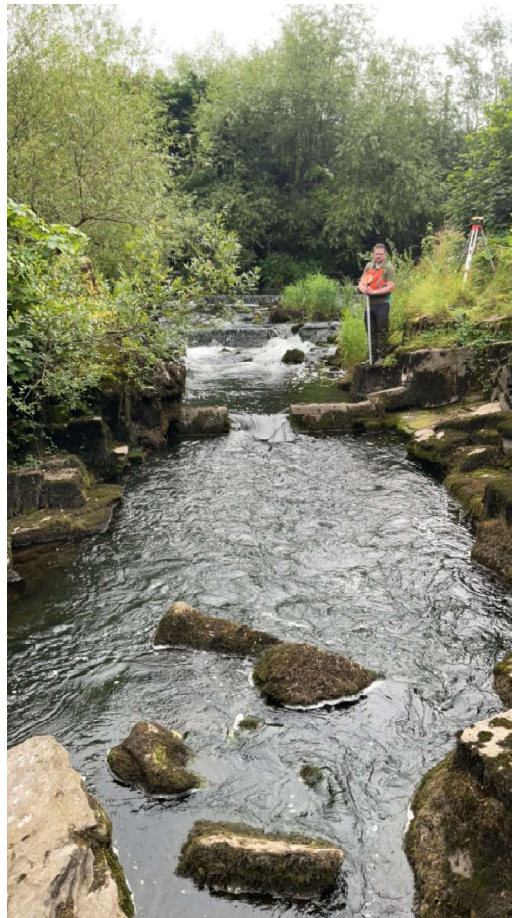
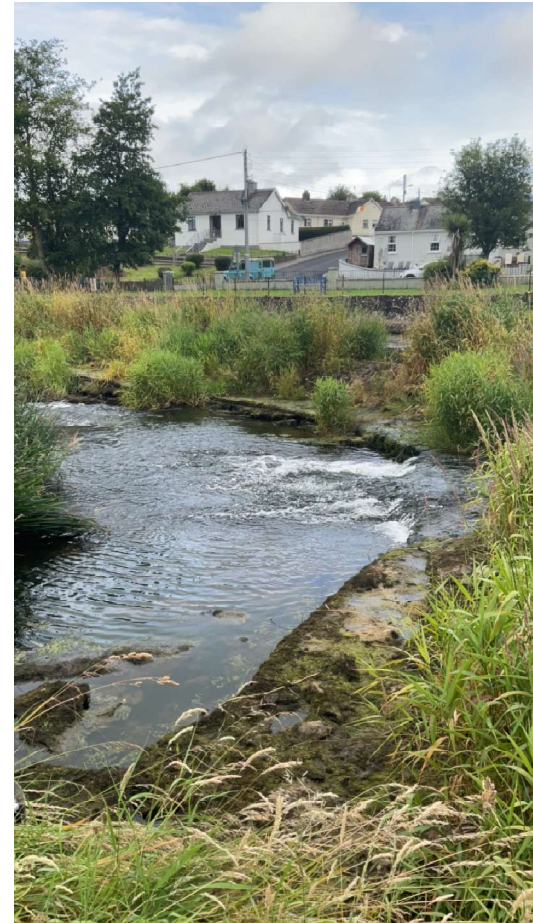
Figure 4.7 Examples of large structures on the main stem which were surveyed using the SNIFFER methodology (Left: Ford 24_216_7; Middle: Waterfall 24_191_36; Right: Weir 24_191_31).

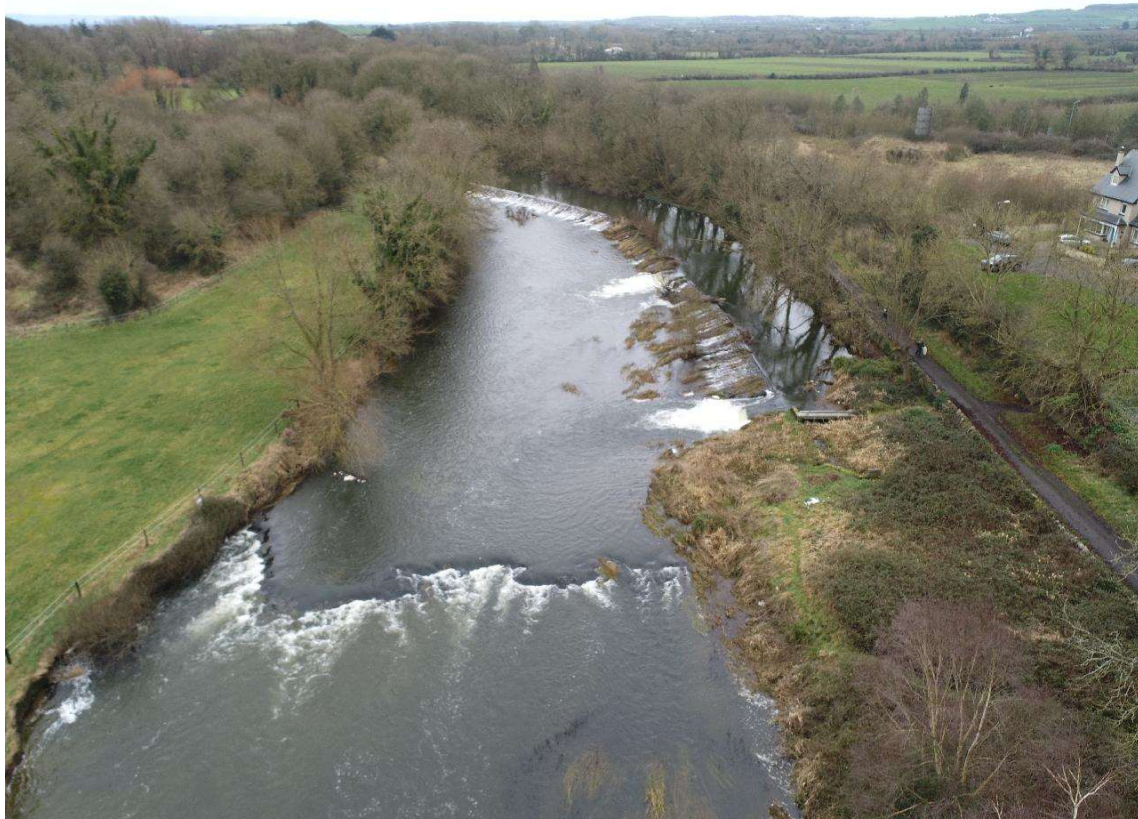
Of the variety of structures surveyed on the main stem of the Mague, hydraulic head height ranges from 0.31-2.16 metres. The structure with the largest head height was the waterfall in Bruree (Figure 4.7) followed by the large weir located upstream of Croom (Figure 4.8). The majority of structures surveyed fell into the bracket of 0.5-0.9 metres which is representative of 12 weirs on the main stem. All structures present similar characteristics of a weir with a relatively low hydraulic head and a single fish pass in the centre. Weirs present on the main channel varied in width from 12-123 metres. The structure displaying a crest width of 123 metres was located upstream of Croom (Figure 4.8).

Figure 4.8 Drone imagery of the weir upstream of Croom. The weir has a crest width of 123 metres and a head height of 1.1 metres.
