Aerial & fish stock survey of the River Crana catchment, Co. Donegal

September 2018

IFI/2018/1-4438

Inland Fisheries Ireland Research & Development preliminary report

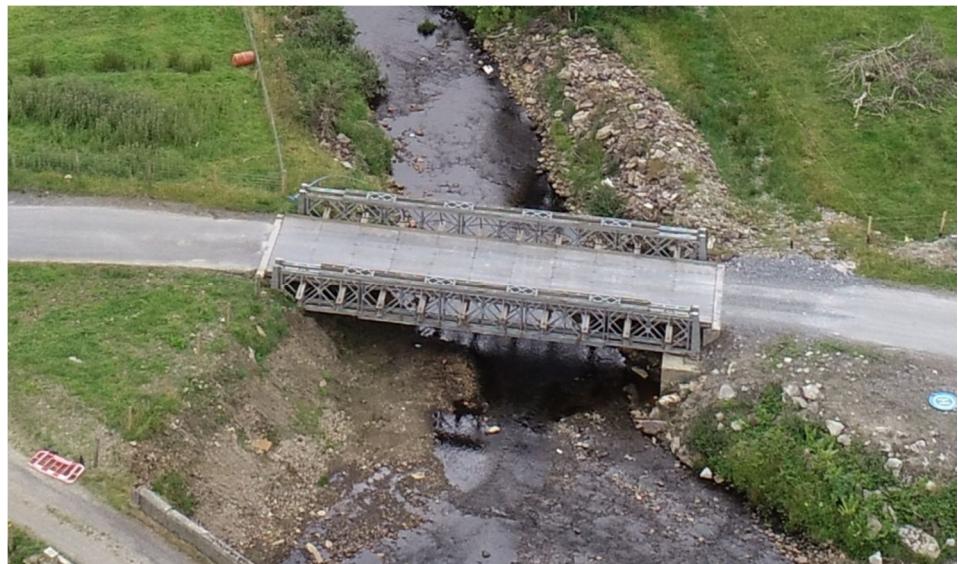
Figure 4 Twin Sisters bridge showing bank works (CR1).

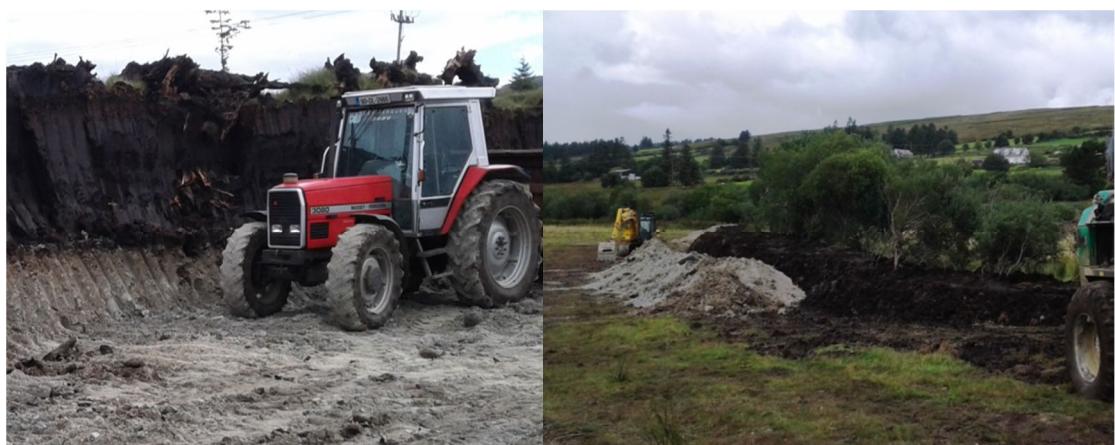
Figure 5 Installation of levee with locally sourced materials along LHB at CR18–CR23.

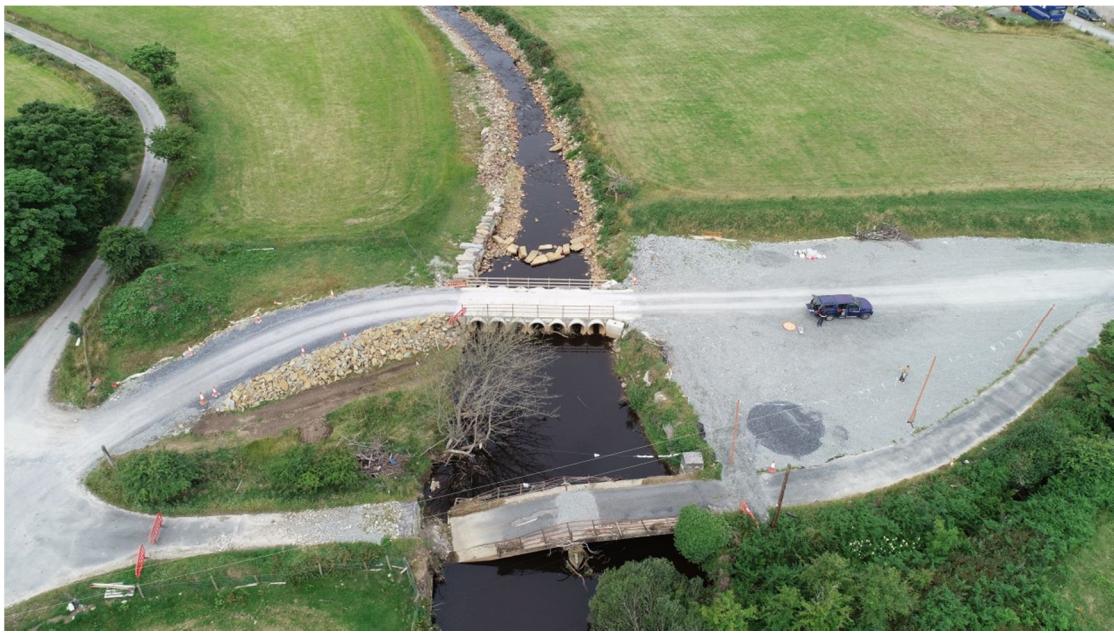
Figure 7 Temporary pipe-culverted bridge and boulder footbridge installed as adjacent bridge collapsed in flood (CR 170) with remedial bank stabilisation works present downstream (CR170-175).

The Crana (mid) appears to be in a good physical state to support salmonid stocks. Channel substrate composition and land use adjacent to the river channel is similar to the Crana (upper). However, tree-lined banks and exposed bedrock were present in extended sections of this river segment (Table 2). Some localised bank reinforcement works have been undertaken within this river segment with more extensive such works evident directly upstream and in the vicinity of the Owenboy confluence (Table 4; Figure 6, Figure 7 and Figure 8). Installation of fencing along exposed areas of the riparian zone is recommended to encourage its natural development and consequently aid long-term bank stability. In addition, fish passage should be assessed at CR144 (Figure 9) and CR 170 (Figure 7).

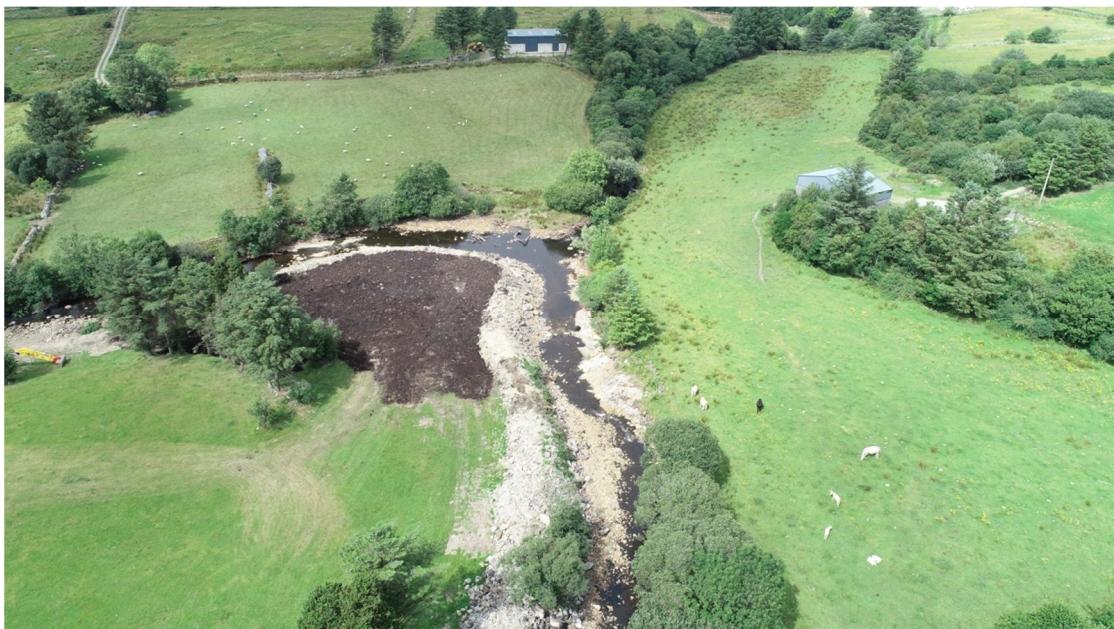
Figure 8 Extensive bank reinforcement works on LHB at confluence with Owenboy (CR239-242)

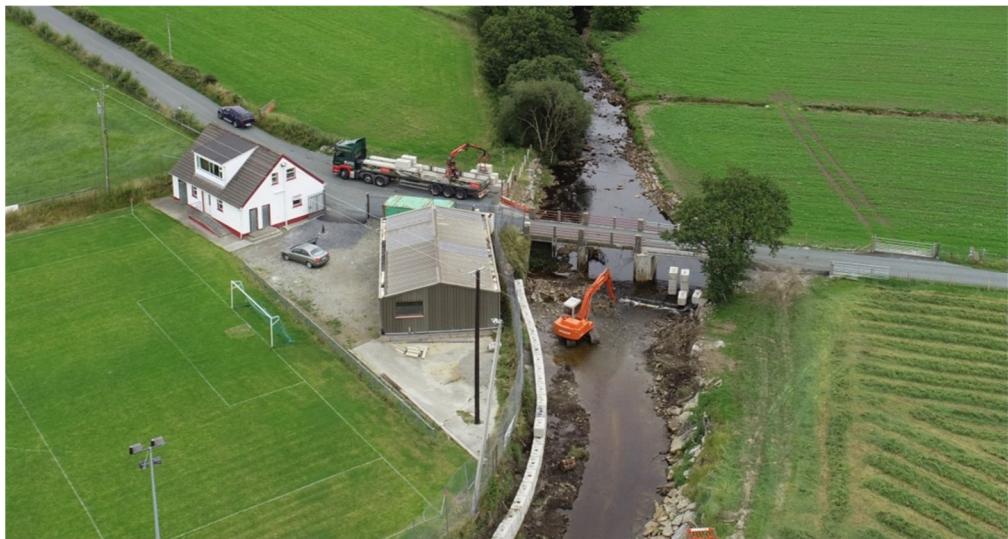
Figure 9 Extensive rock armour installed by soccer pitch (CR144).

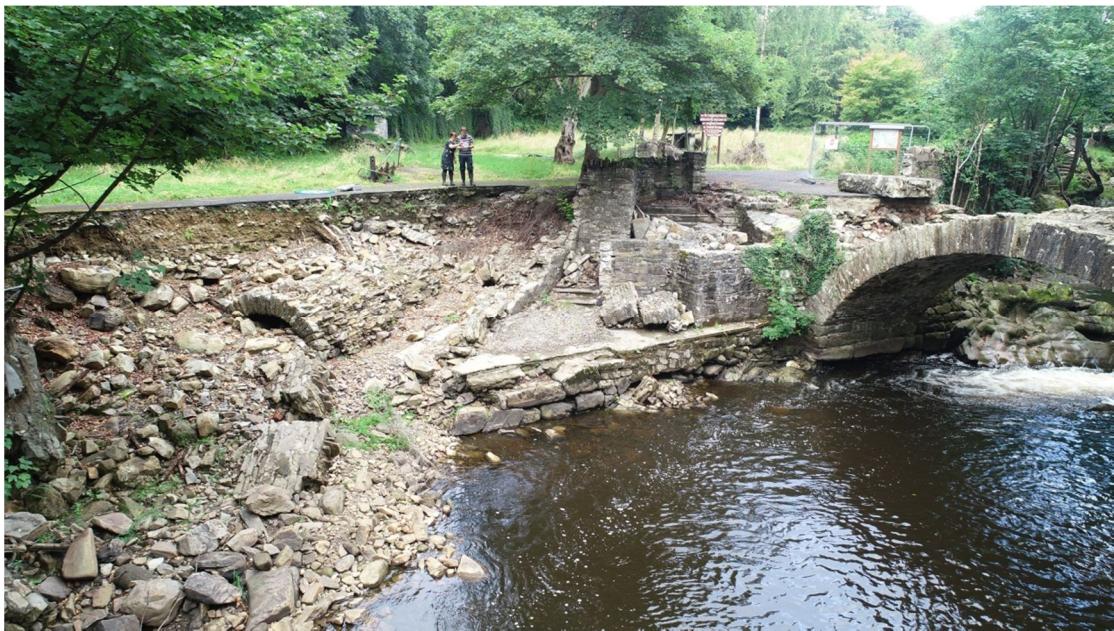
Figure 11 Structural damage in Swan Park area of Buncrana Town.

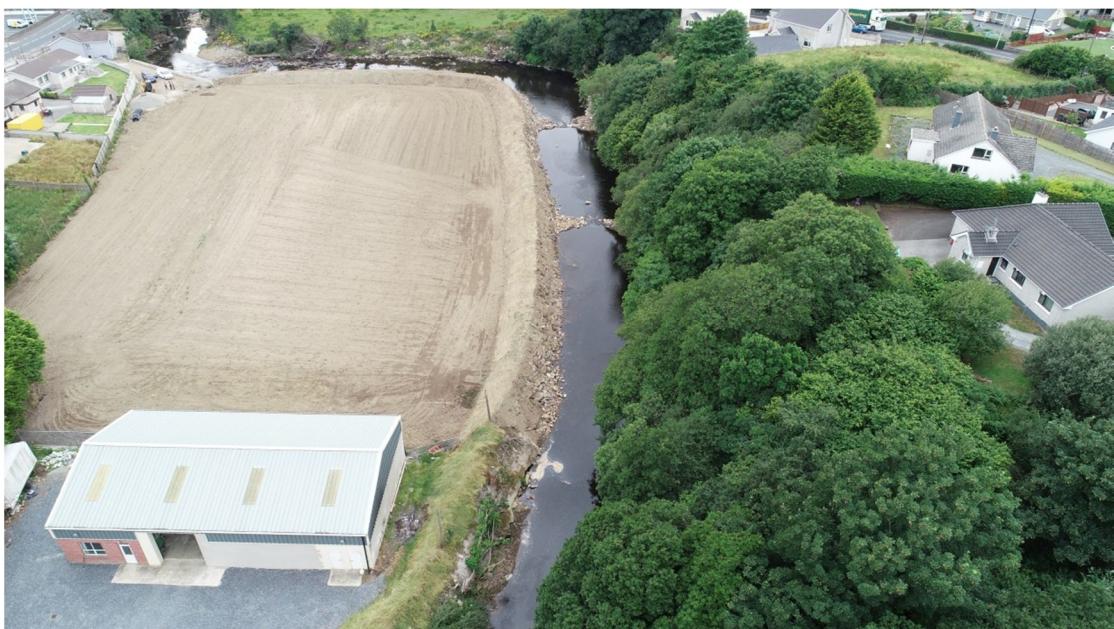
Figure 12 Earthen levee along channel at GAA pitch (CR353–CR359).

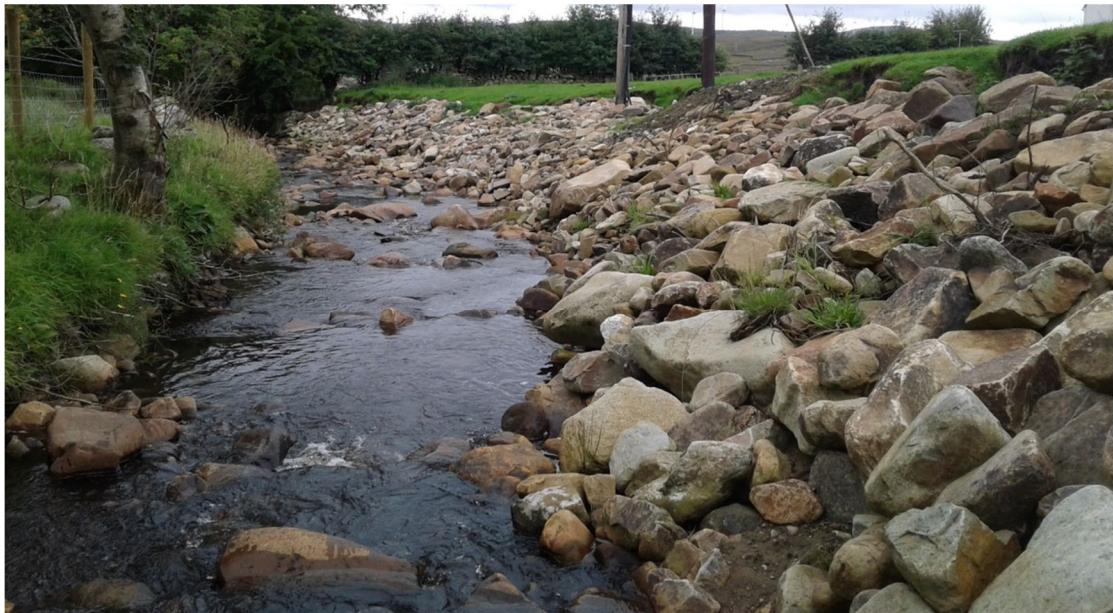
Figure 14 Boulder rock armour installed in the lower portion of the Glashagh (at GL21).

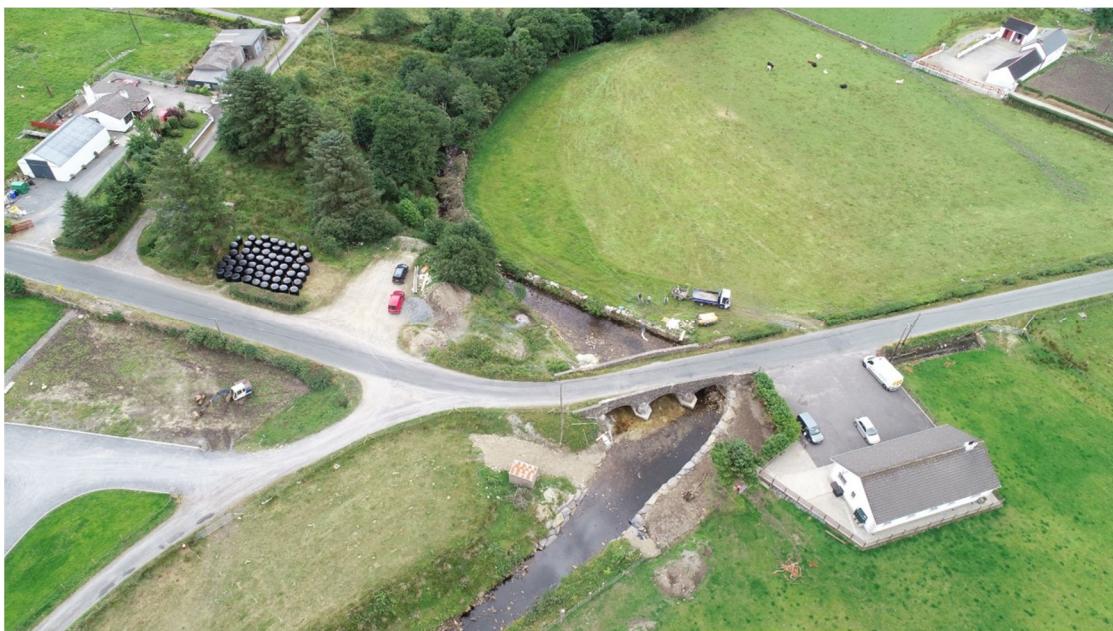
Figure 15 Rock armour installed at bridge in lower portion of the Glashagh (GL29).

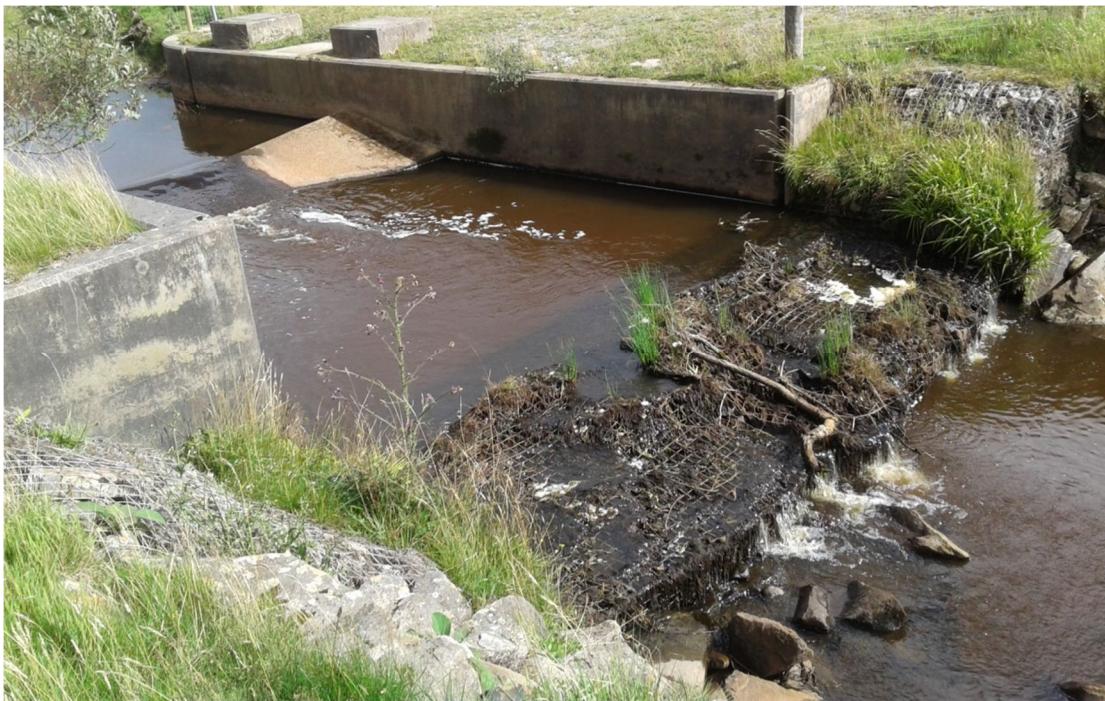
Figure 17 Potential fish passage impediment on Camowen (CM44).

Measures	Observations	Image Reference
Measures implemented by landowners in response to the flooding	None observed	
Recommended measures	Assess fish passage	CM44

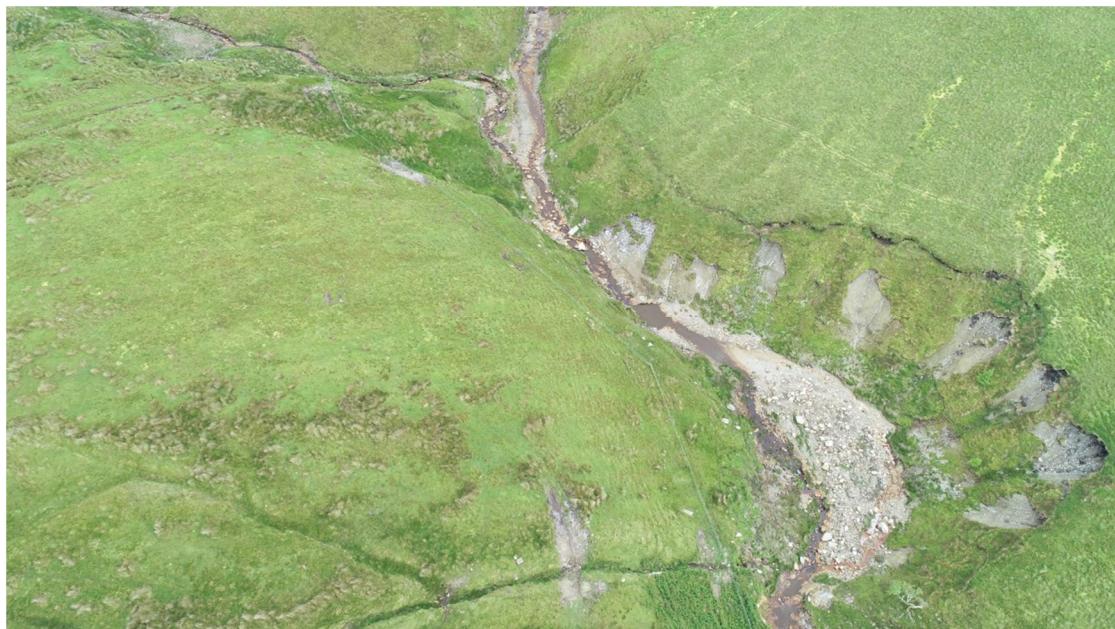
Figure 19 Bank subsidence in upper portion of Meenatomish surveyed (MT1–MT4).

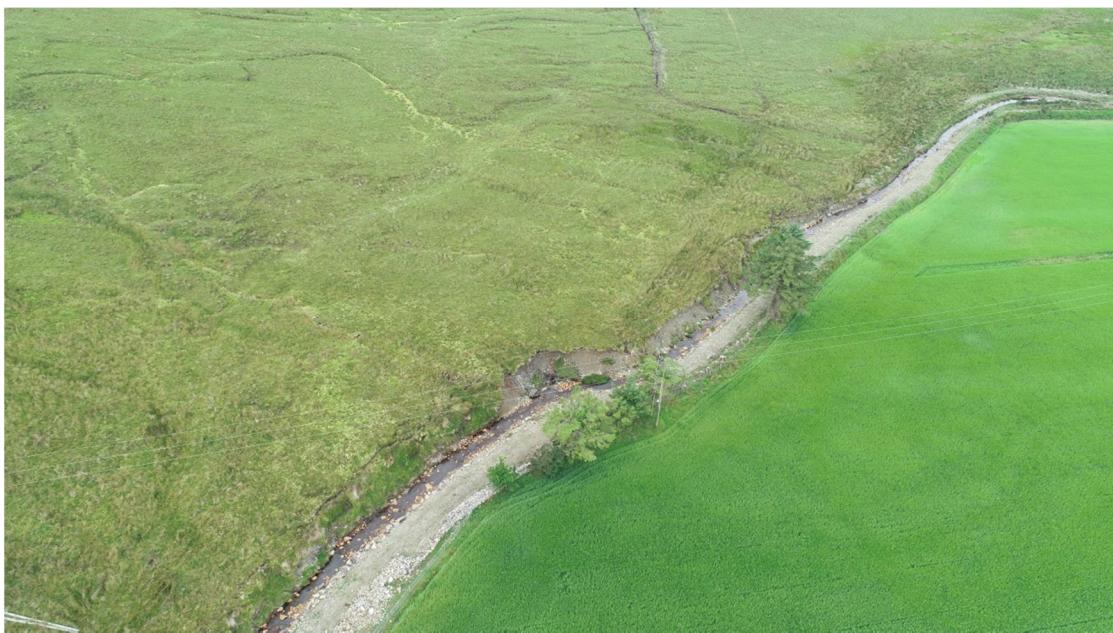
Figure 20 Bank reinforcement works along RHB of lower portion of Meenatomish (MT15–MT22).
