# Environmental River Enhancement Programme

## Annual Report 2021

IFI/2022/1-4586

### **Environmental River Enhancement Programme**

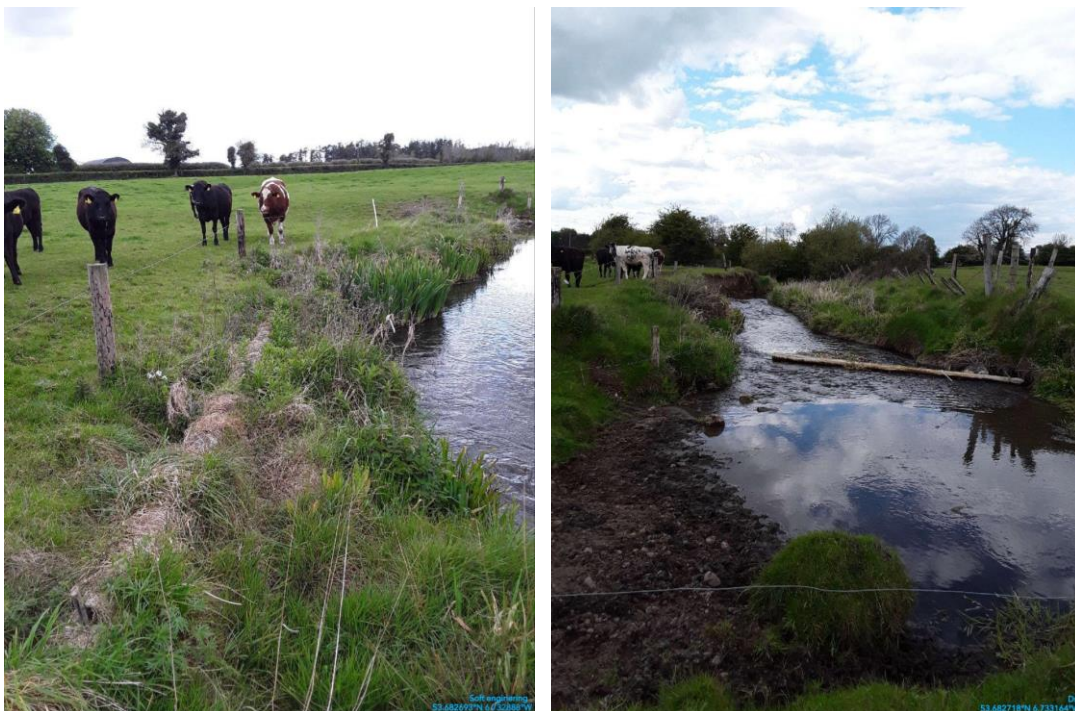
The first example is a site on a small tributary (C1/8/5) off the main Blackwater channel, upstream of the Boyne confluence (Figure 2.16). On the day of the survey, it was classed as Moderate. Good channel form and flows were present, with berm development and soft engineered banks in places along with some diversity in marginal instream vegetation. However this was negated by a high level of algal growth due to nutrient input, poaching by cattle de-stabilising the banks, excessive silt in the channel and minimal vegetation in the riparian corridor.

**Figure 2.16 Example of soft engineering (left) and poaching (right) on channel C1/8/5 (Moderate status).**

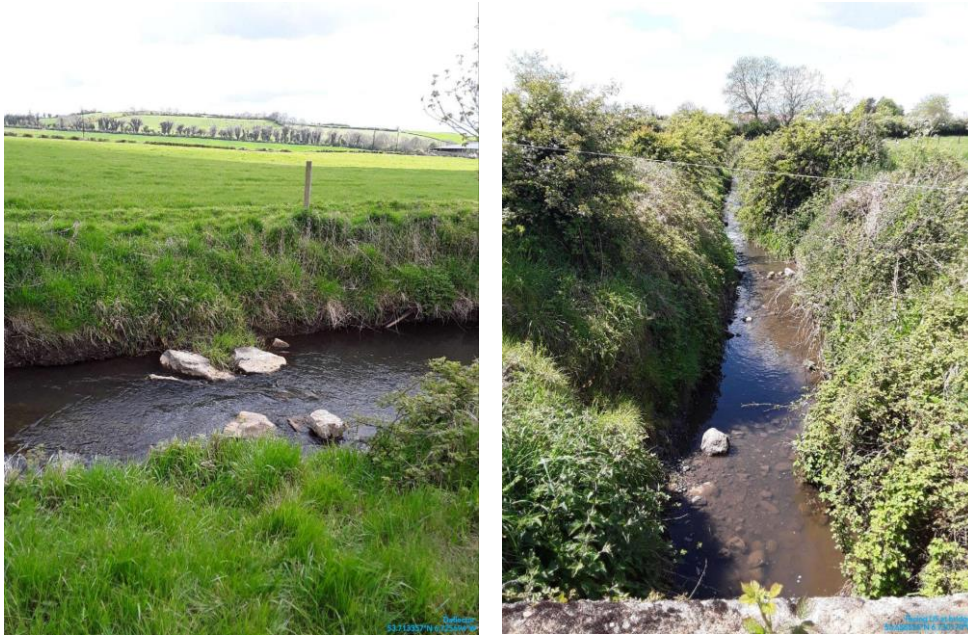
The next site is on another straightened tributary (C1/8/1) discharging into the main Blackwater (Figure 2.17, right). The site has been extensively over-deepened, resulting in minimal variation in channel velocities and depths. The substrate is good in places for the river type but there is excessive silt on it. The banks are now re-naturalising, and simple native vegetation is in succession. There is no floodplain connectivity due to the re-sectioning. Overall the site was classified as Poor.

**Figure 2.17 Artificial deflectors (left) creating good flows in a straightened part of the river channel C1/8/5 (Good status). Picture shows excessive silt on substrate (right), extensive over-deepening of the channel and simple native bank vegetation colonising the banks in channel C1/8/1 (Poor status).**

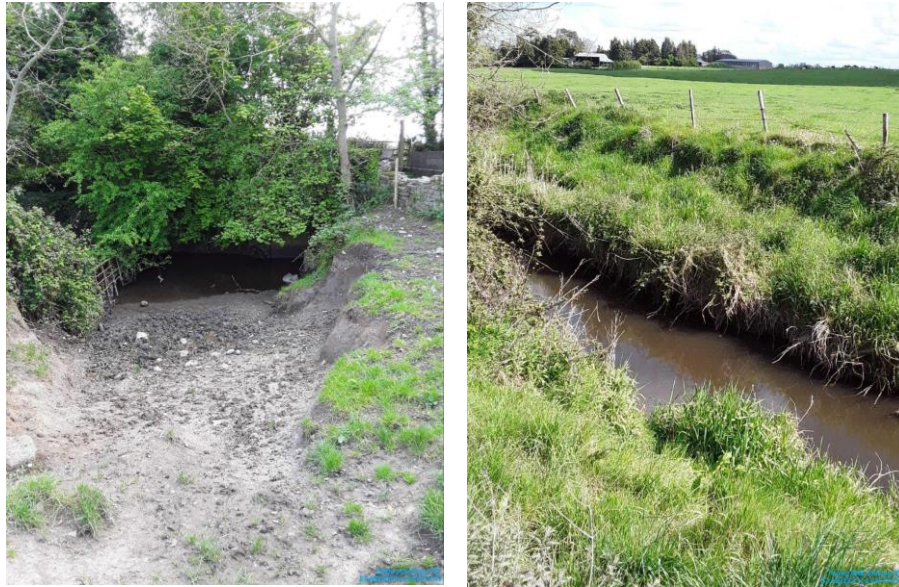
Another site which displayed issues with hydromorphology was on a larger tributary within the scheme (C1/8/9) which fared Poor. The banks have been excessively over-deepened at this location resulting in a lack of connectivity between the channel and floodplain. There was poaching at various points along the reach, and the scale of these cattle drinkers was quite extensive (Figure 2.18). The flows in this channel were not perceptible, and the substrate not visible due to the high levels of turbidity in the water. Overall, there was a good range of riparian cover, although this is not immediately visible in the photos below.

**Figure 2.18 Cattle poaching and high turbidity within the channel C1/8/9 (Poor status).**

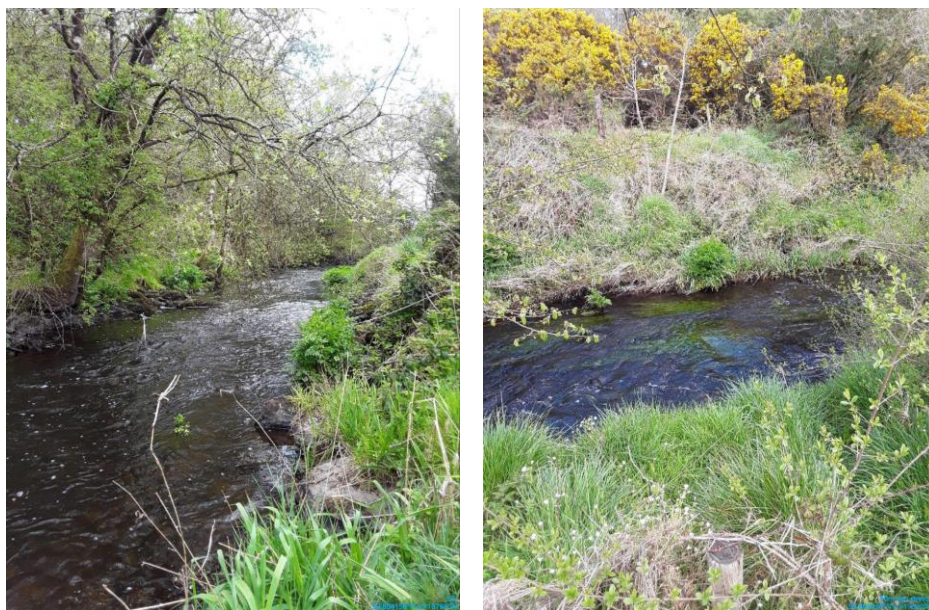
On the main stem of the Barora River (C1/8/10), just upstream of the Moynalty confluence, the site was surveyed and yielded an overall Good result despite the extensive over-deepening and over-widening (Figure 2.19). The historic re-sectioning has renaturalised along the bank profiles and the site has good riparian habitat and cover. There was diversity in velocities and depths, with a variety of instream vegetation and woody habitat present. The substrate is also free from siltation and favourable for fish. This is supported by the electrofishing results at the site, with a wide variety of species recorded, of various age classes.

**Figure 2.19 Riffle habitat and riparian cover, instream vegetation on channel C1/8/10 (Good status).**

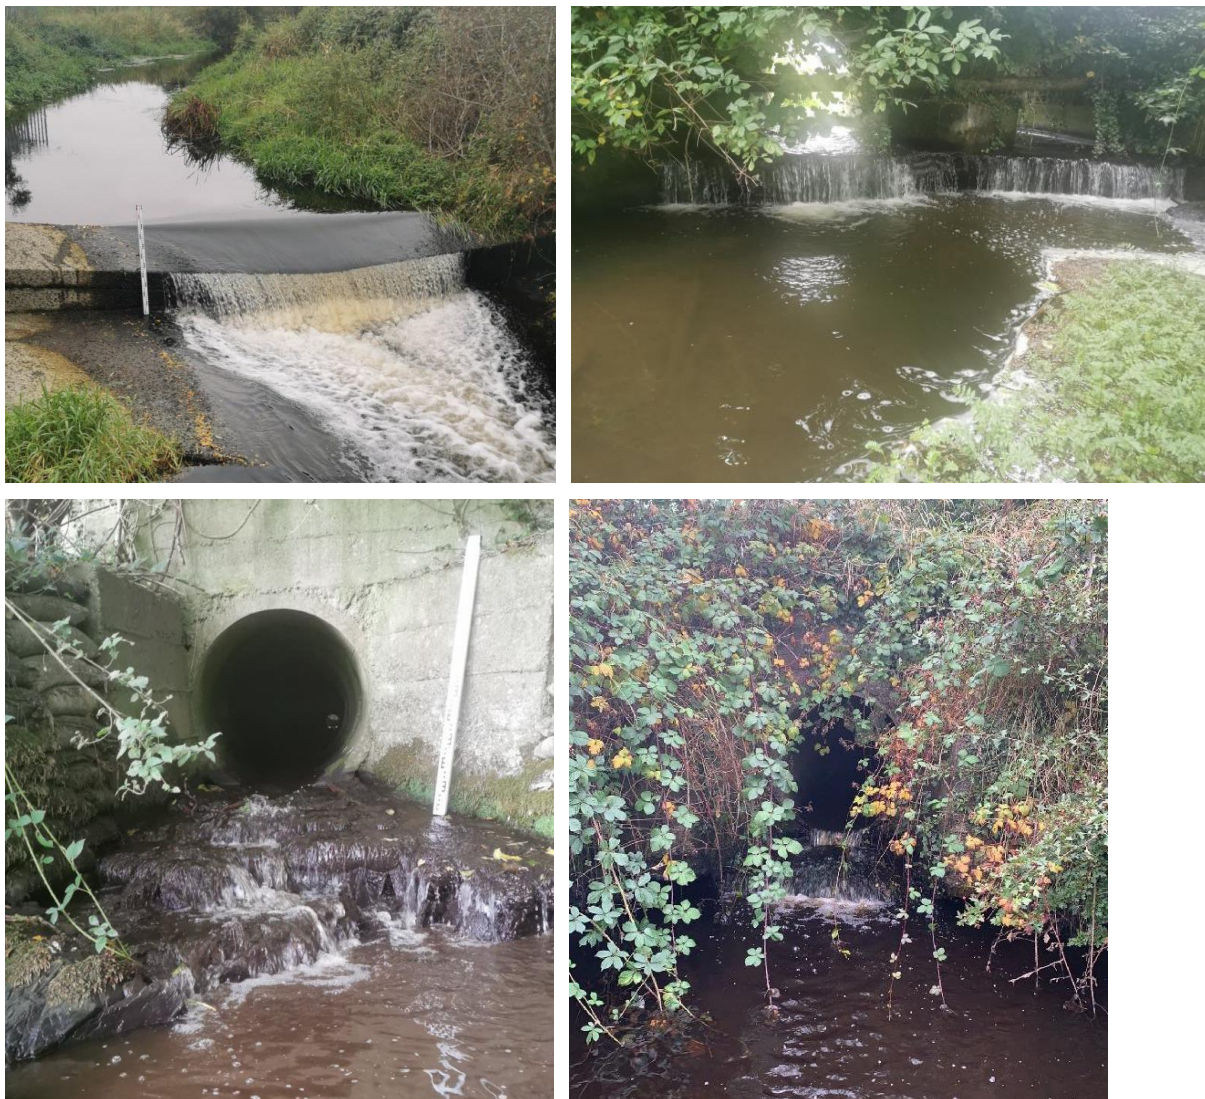
**Figure 2.21 Small gauging weir (top left, C1/8/10); two-eye bridge with drop (top right, C1/8/15); culvert with apron and drop (bottom left, C1/8/16); perched culvert (bottom right, C1/8/19).**

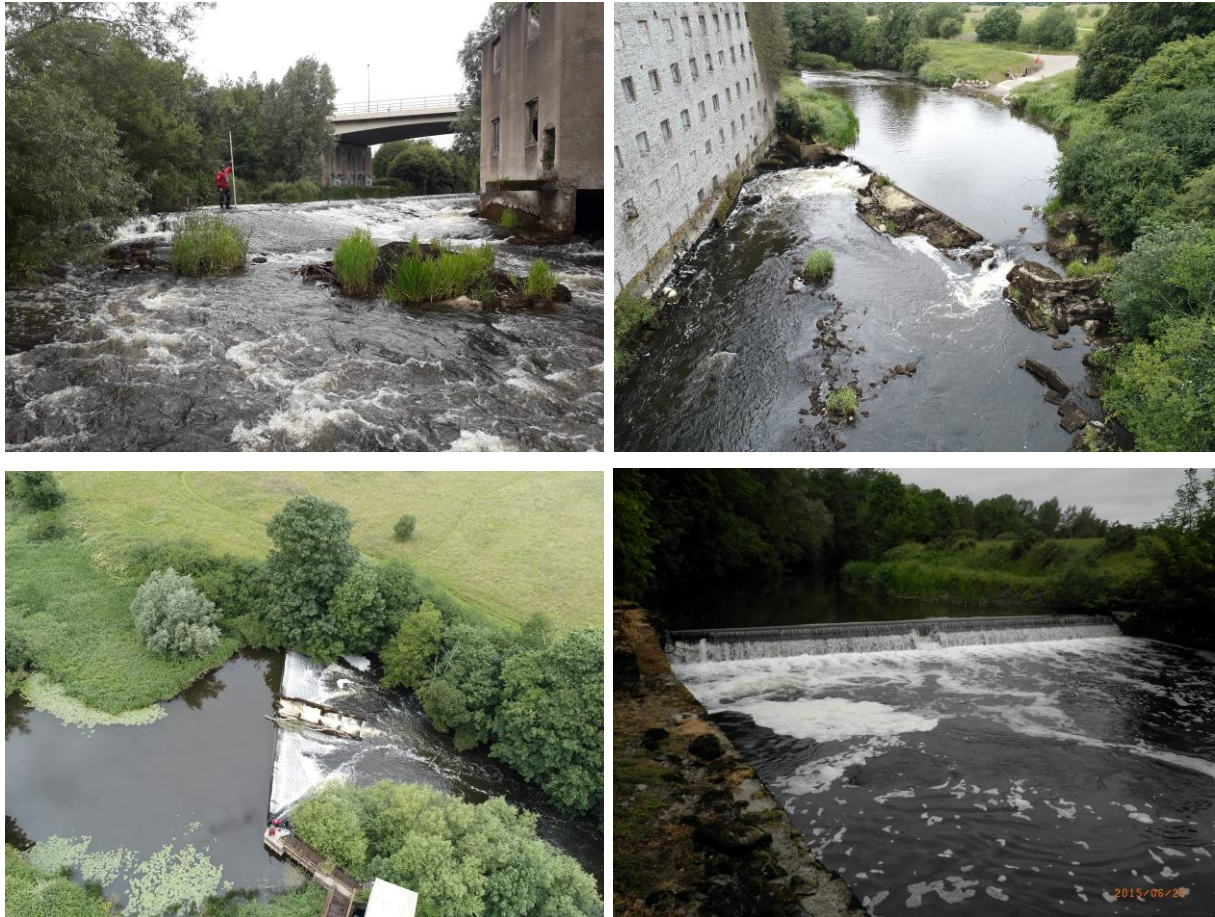
(SNIFFER, 2010) in 2015. At the time of the survey the hydraulic head was 0.96m and there were two transversals – the vertical drop and a central fish pass. The height of the weir is the main issue for upstream fish passage. The additional lip on the crest of the structure compounds that problem. On the day of the survey it was a High Impact Partial Barrier for adult salmon and trout, and a Complete Barrier to all other species, save for eels.

**Figure 2.23 The four lowest weirs on the Blackwater: Eliot's Saw Mill (top left); Spicer's Mill (top right); Balmoral weir (bottom left); and Martry weir (bottom right).**

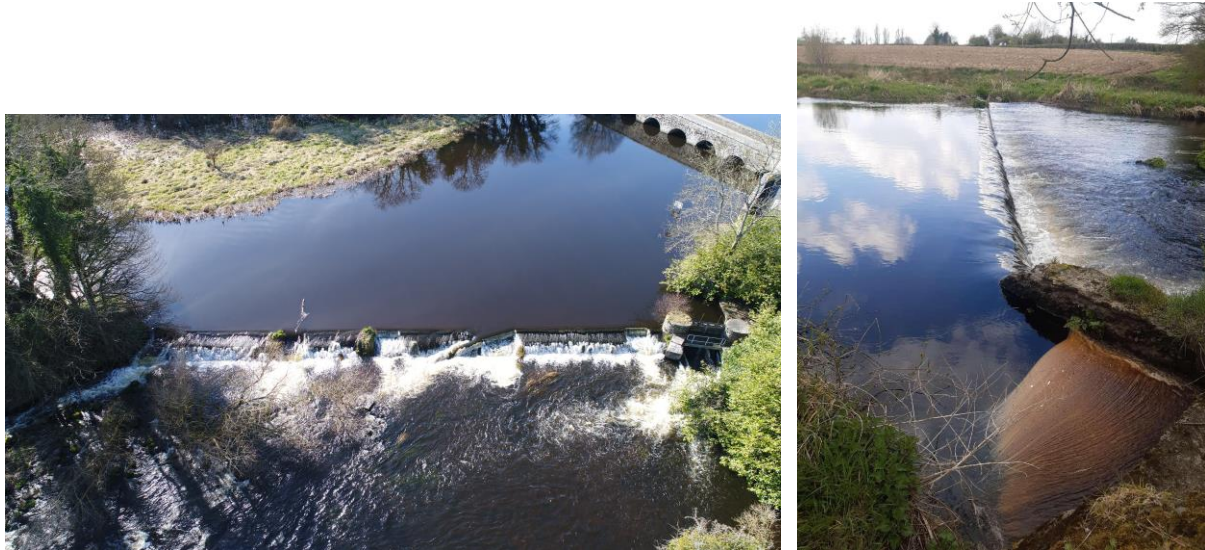
of these eel weirs existed (or still do) between this location and Lough Ramor. Four transversals were recorded during the barrier survey – 3 sloping faces and a fish pass. The weir height is just over 1 metre which given the shallow water depth on the face, is a challenging height for upstream passage. Moreover there is a lip on the crest of the weir further impeding passage. The fish pass is sloped with a high angle, making this transversal a difficult option. The weir was deemed a High Impact Partial Barrier for adult and juvenile salmon, trout, cyprinids, and lamprey. It was considered a Low Impact Partial Barrier for juvenile eel.

**Figure 2.24 Headfort weir with a sloping face and central sloped fish pass (left) and abstraction weir at Clavens bridge (right).**

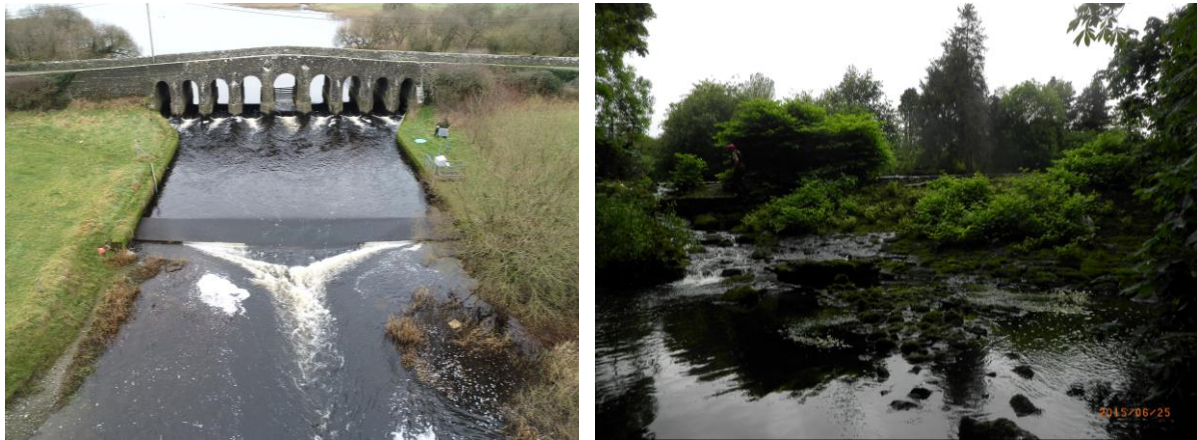
**Figure 2.25 The nine-eye bridge at Stramatt with gauging weir downstream (left). Note Lough Ramor in the background. Virginia weir (right). Note the person in the left of frame for scale, demonstrating the extreme hydraulic head height.**

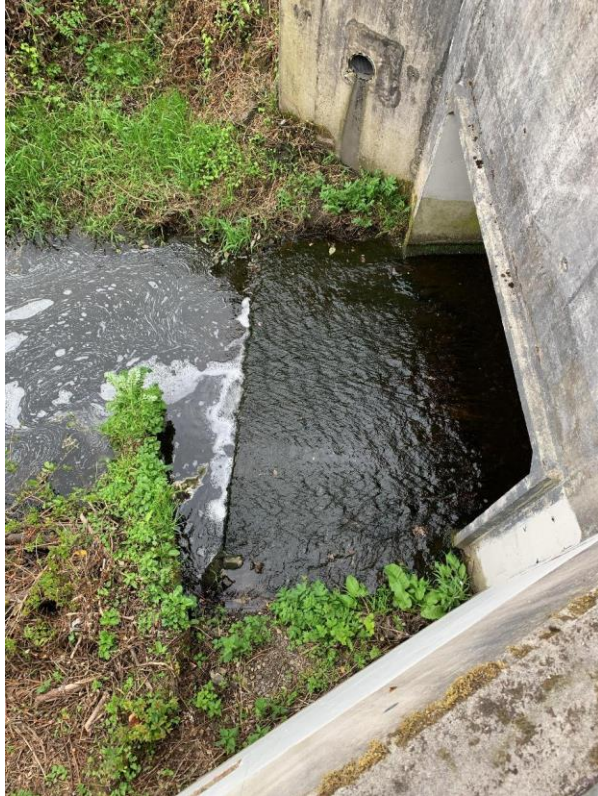
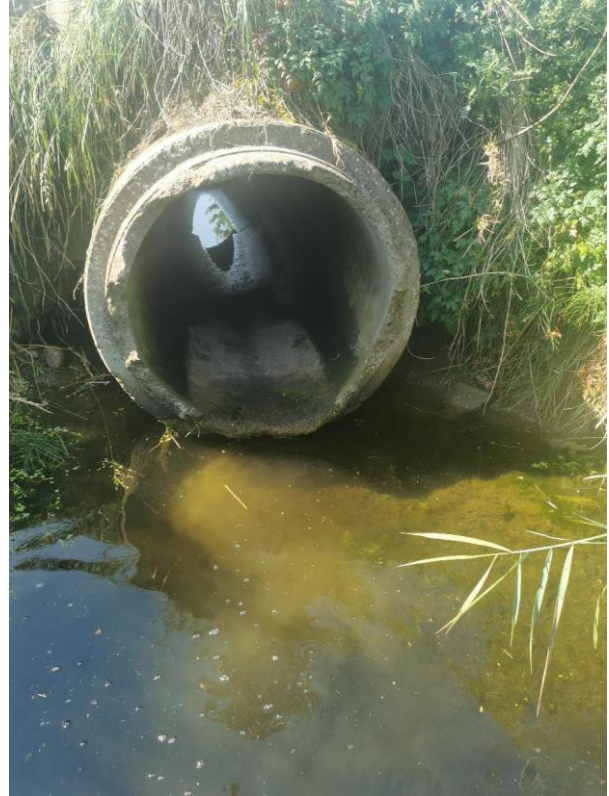
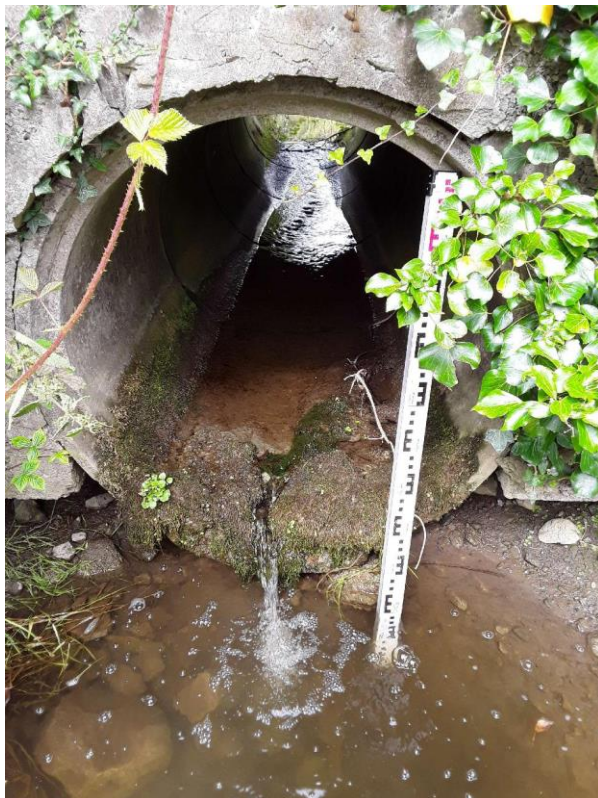
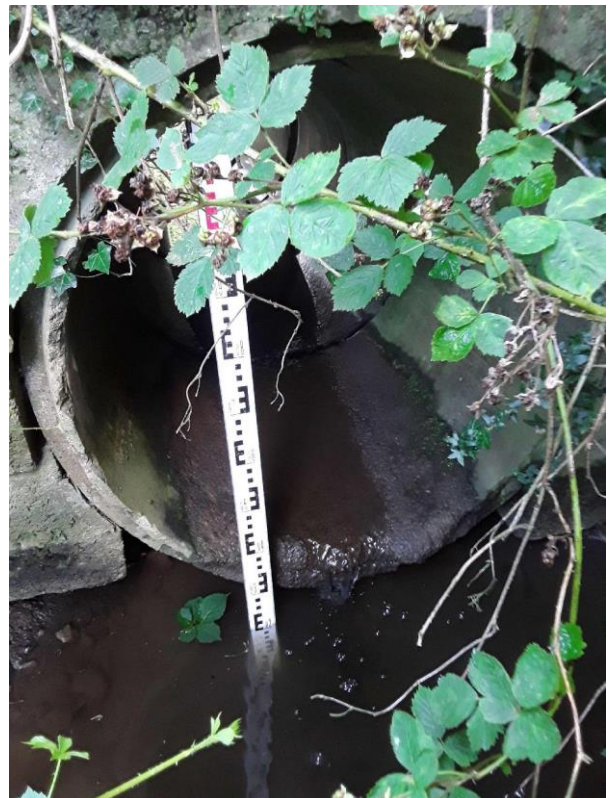
**Figure 3.2 Examples of barriers on the Broadmeadow & Ward scheme. Bridge apron with drop, and perched culvert (top, C1/6). Two perched culverts (bottom, C2/10).**

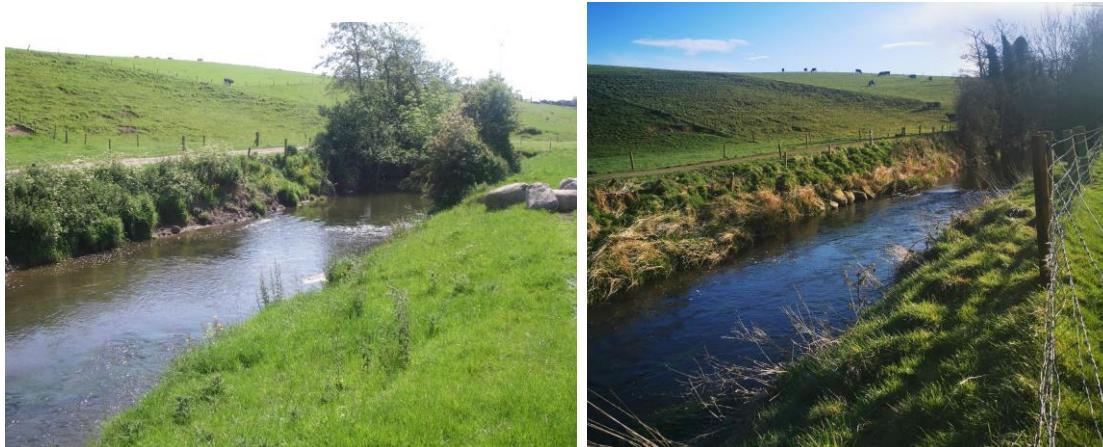
**Figure 4.3** Photograph taken on the left-hand bank looking from T0 upstream to T30 (left, 2009 and right, 2022) where the vortex weir was constructed.

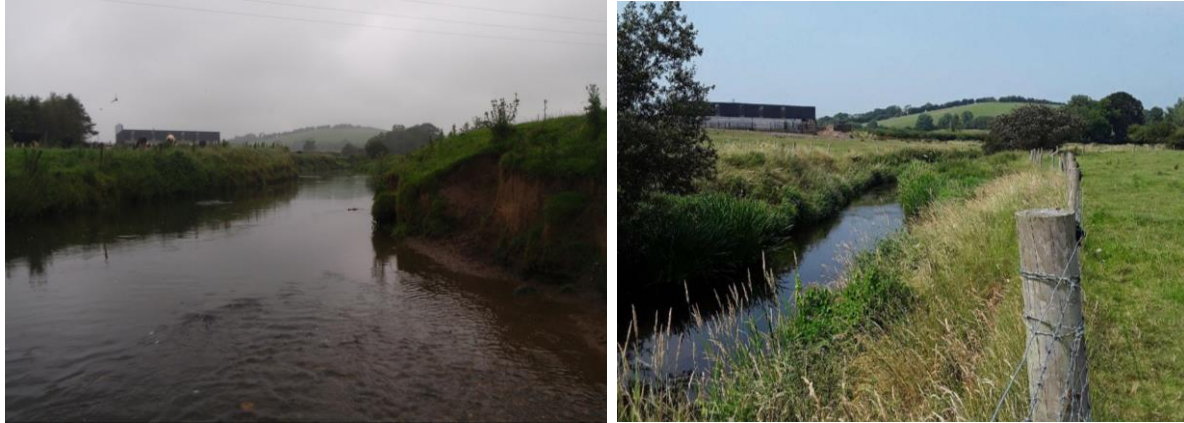
**Figure 4.8** Photo taken in the channel in 2009 (left). Photo taken from left bank top of the same stretch of channel in 2021 (right). Both images are facing upstream.

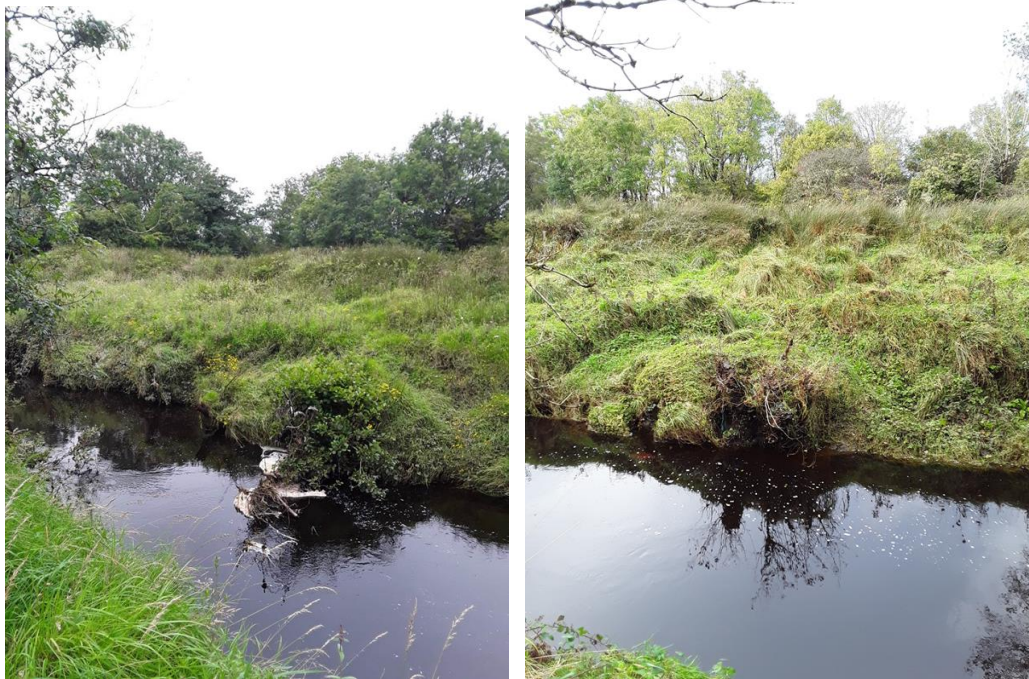
During the follow up walkover in 2021, identified work sites from 2020 were photographed post works to show the extent of works undertaken. Blockage / tree removal from the instream sections of the river was recommended if currently impeding on flood conveyance, and if items had the potential to impact flows before the next maintenance cycle. In Figure 5.2, it can be seen that low impact methods were used to remove this obstruction from the left-hand bank (LHB). This tree stump remains intact and continues to stabilise the bank. Similar work at a larger scale is evident in Figure 5.3 below.

**Figure 5.2 Example of an obstruction removed from the channel (left, 2020 & right, 2021).**

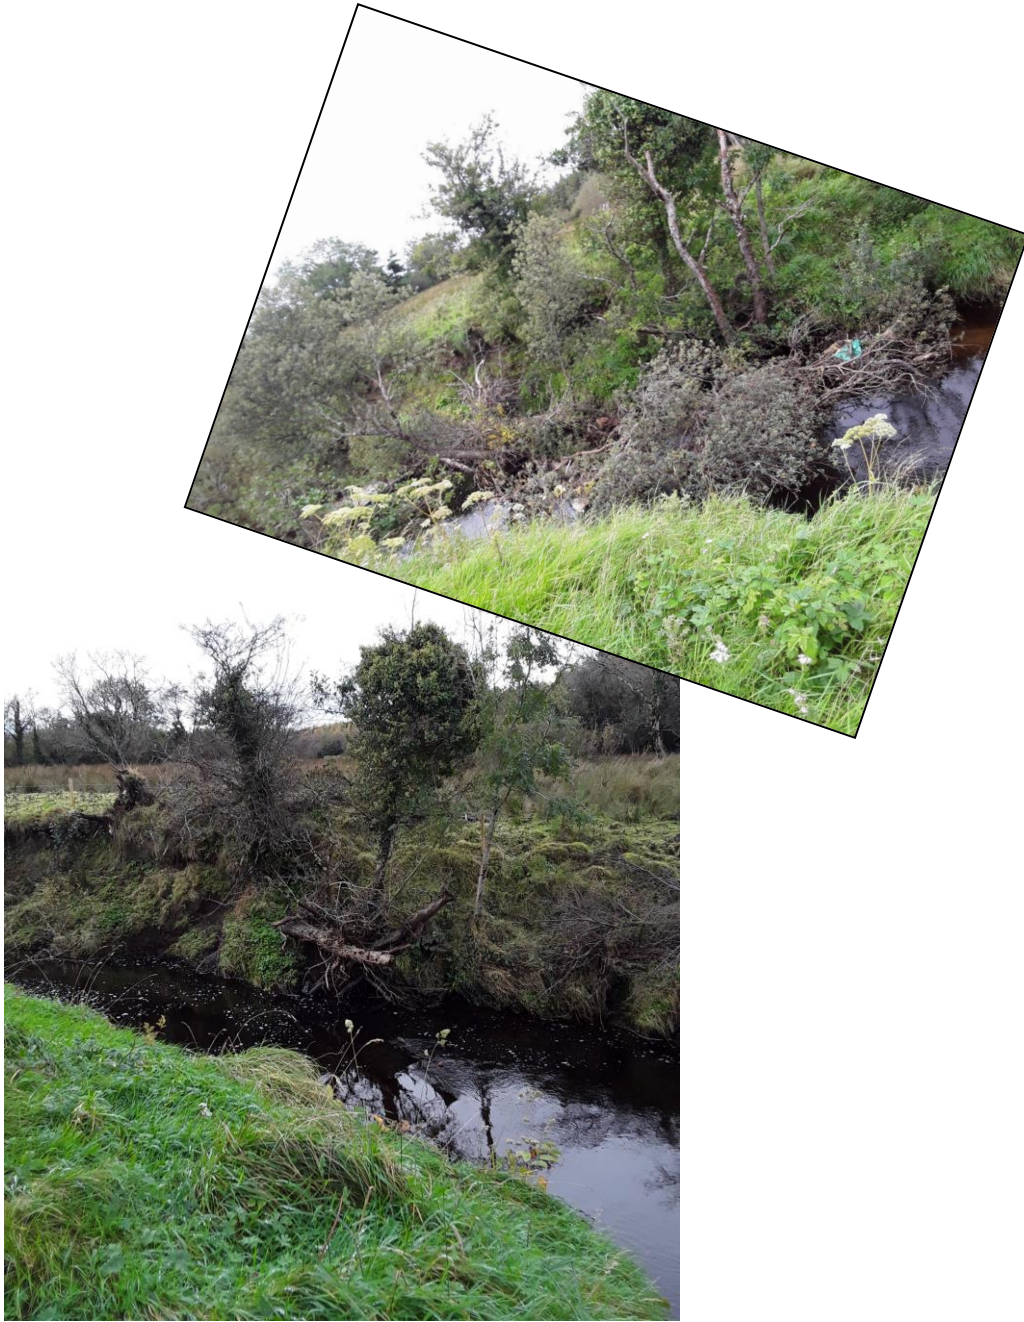
**Figure 5.3 Example of effective but not destructive debris dam removal (top, 2020 & bottom, 2021).**

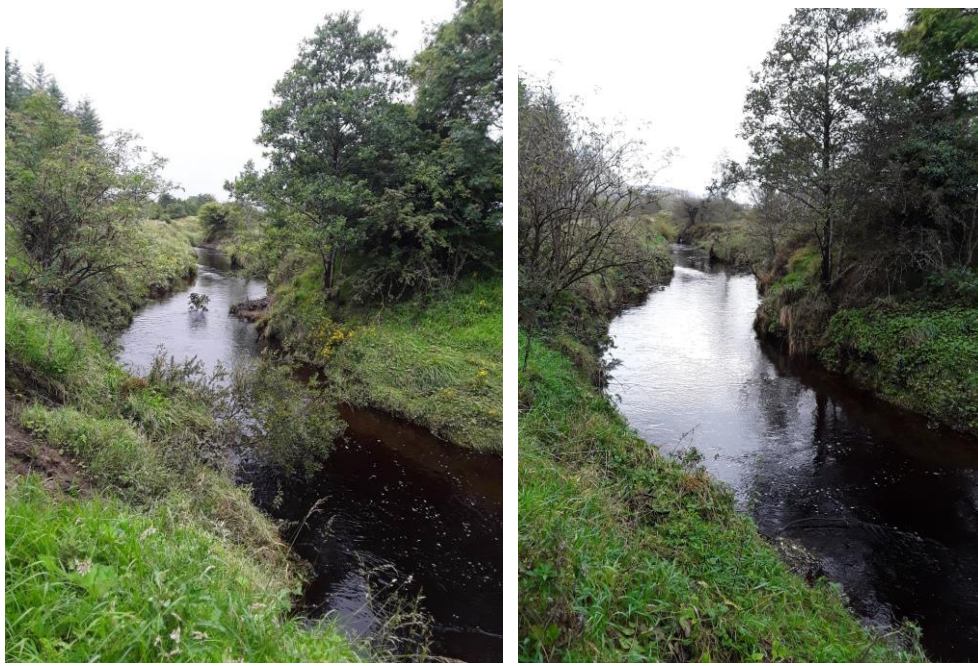
**Figure 5.4 Example of the removal of minor and potential blockages (left, 2020 & right, 2021).**

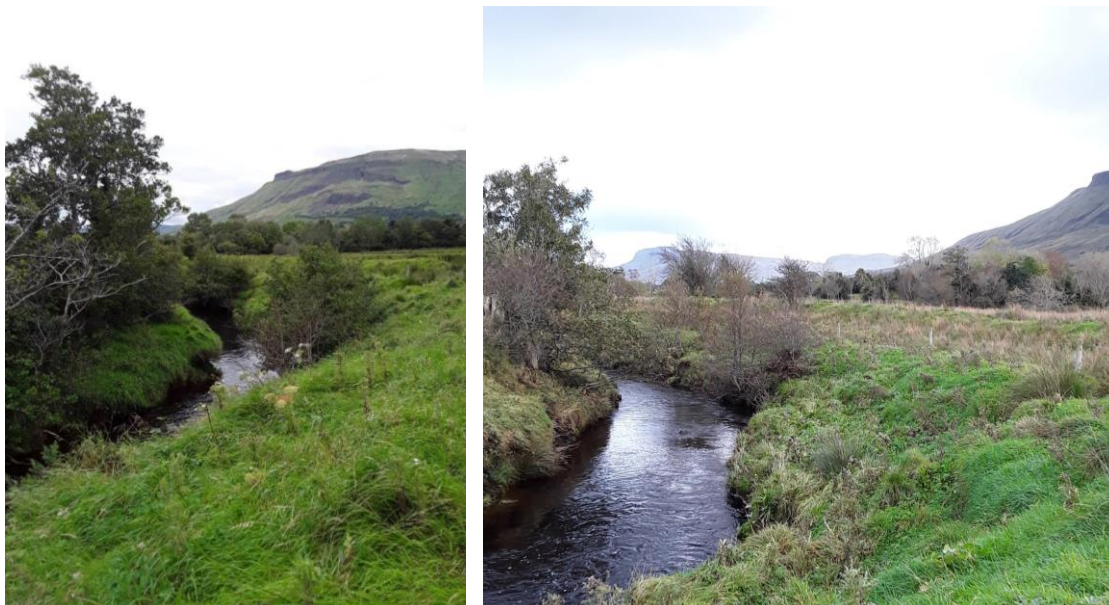
**Figure 5.5 Example of a site where guidance was given to leave this section untouched (left, 2020 & right 2021).**

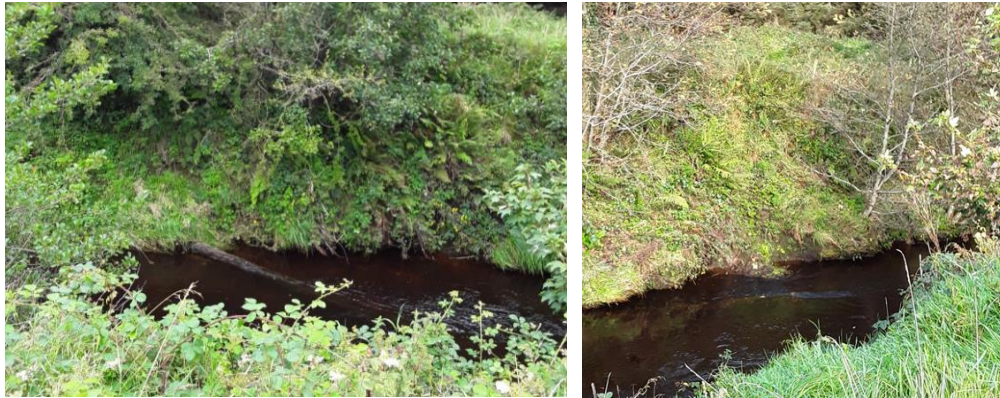
**Figure 5.6 Logs retained in the channel (left, 2020 & right, 2021).**

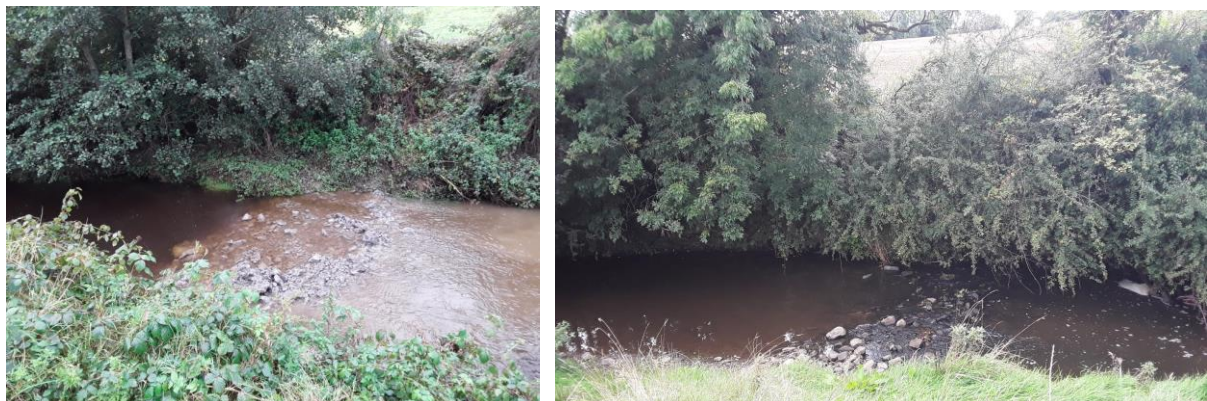
**Figure 5.10 Left photo was taken post-works in 2019, and right photo was taken during a follow up walkover in 2021. It is evident that the pool and riffle remained intact.**

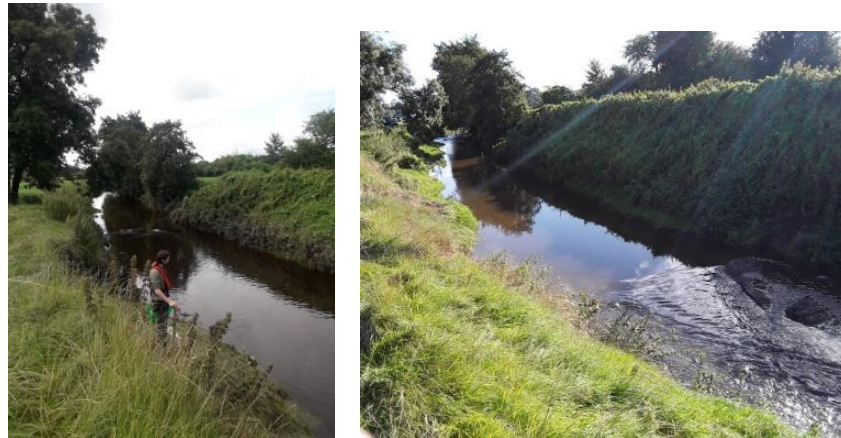
**Figure 5.11** Left photo was taken pre-works showing a uniform glide and the photo on the right taken post-works. Changes in flows are evident following the introduction of paired deflectors which were created using the material from within the channel.

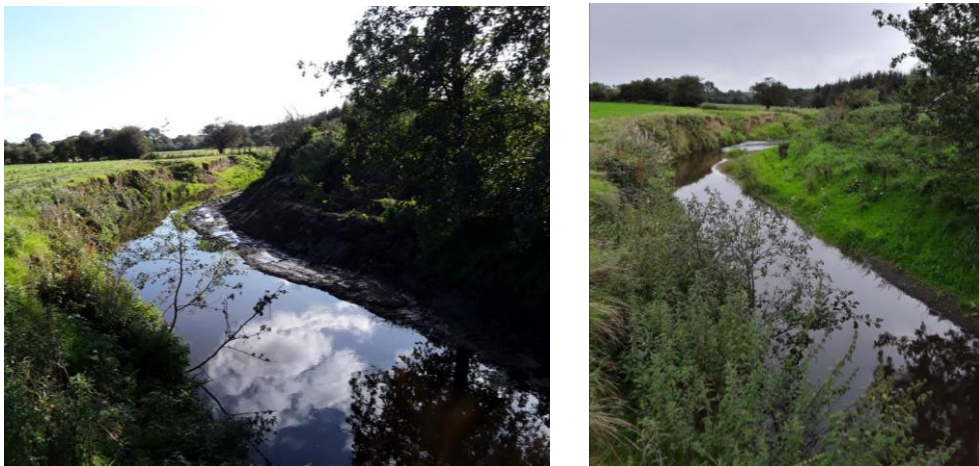
**Figure 5.12** Left photo was taken post works of a berm topped during the works and the follow up photo on the right was taken in 2021.
