Environmental River Enhancement Programme

Annual Report 2015

**Inland Fisheries Ireland & the Office of Public Works
Environmental River Enhancement Programme**

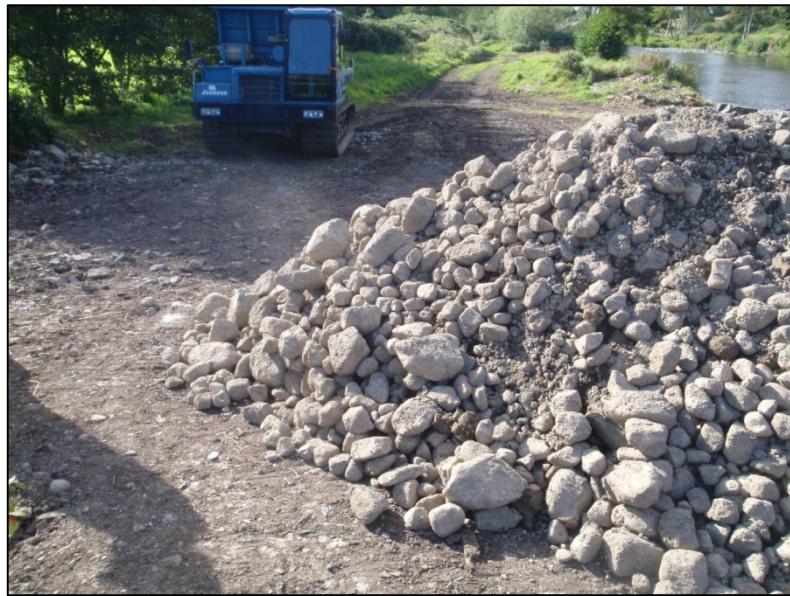
Figure 2.2. Delivery of incorrect 'spawning gravels' (note the size range of the stone).

One issue that came to light during 2015 was that when OPW changed quarries there wasn't always a follow up with the quality and type of material being supplied by the new quarry. This, coupled with new drivers, led to incorrect gravel material being used for gravel spawning beds on the Kells Blackwater works. Incorrect gravel material was also supplied to the Boyne main channel works (Figure 2.2) but this was identified on-site and was not used.

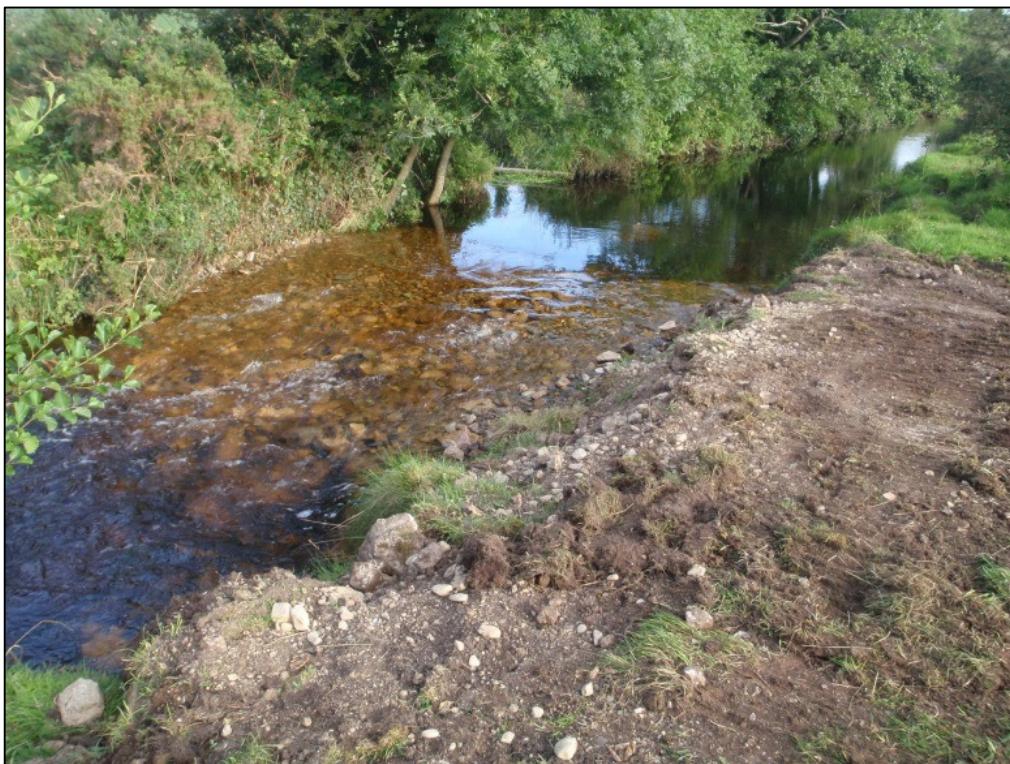
Figure 2.3. Addition of a gravel shoal in the Abbey River (C1).

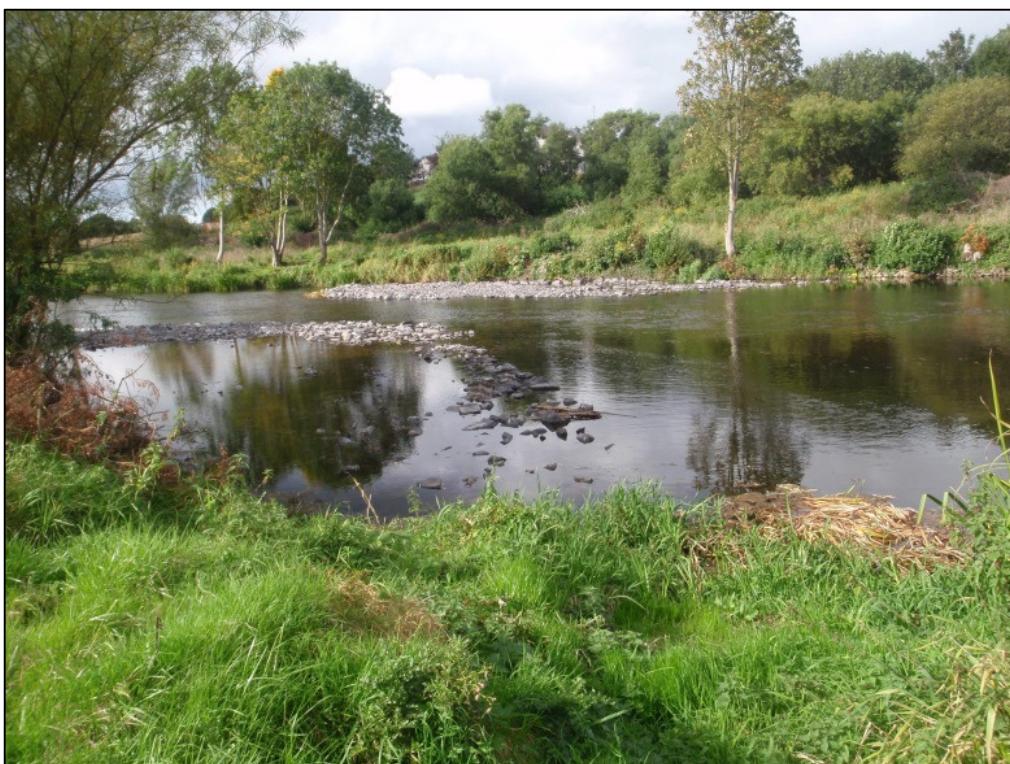
Figure 2.4. Paired deflector on the Boyne main channel (C1).

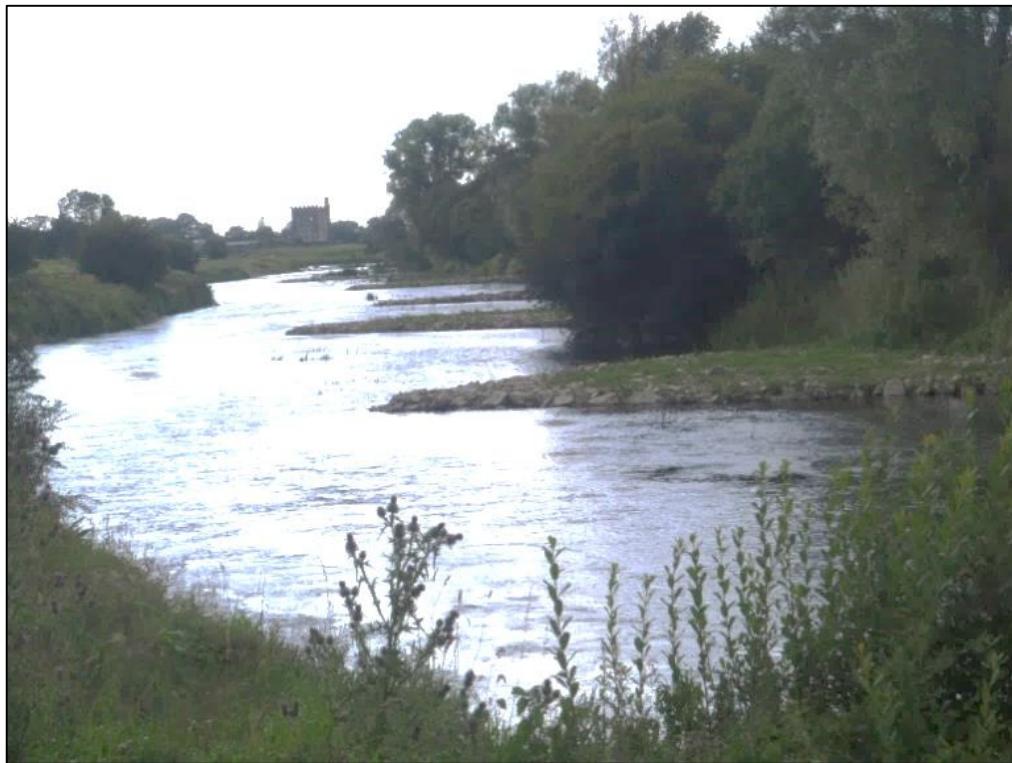
Figure 2.5. Series of single deflectors around a bend, Boyne main channel (C1)

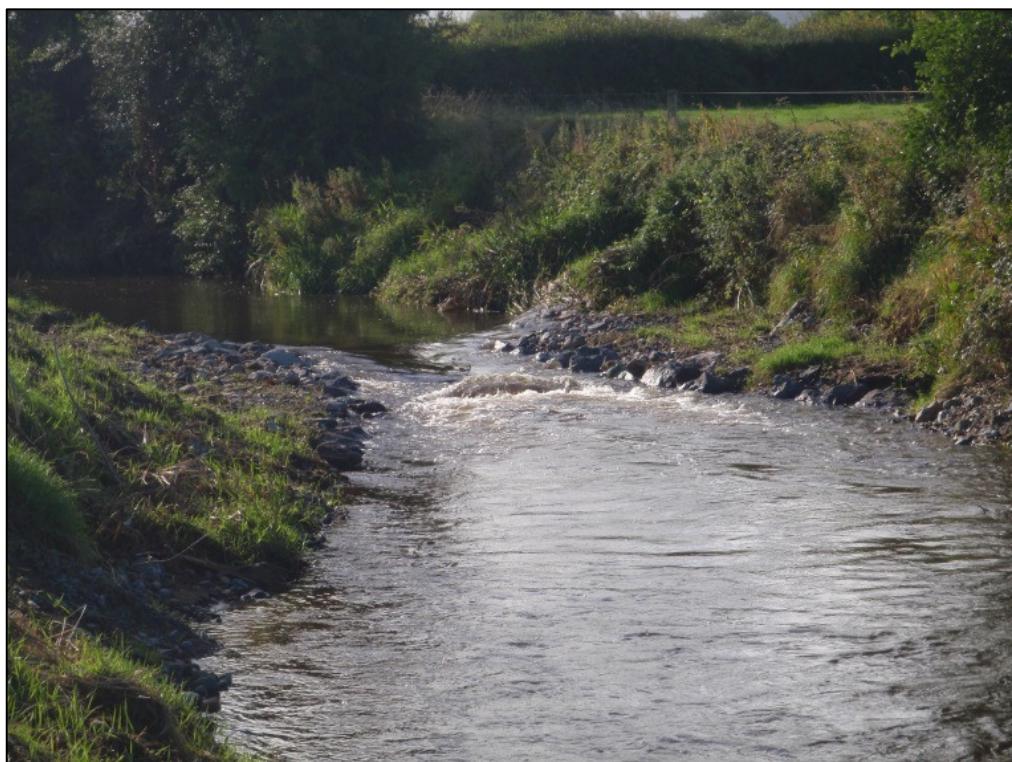
Figure 2.6. Paired deflector, pool and gravel shoal unit, Loobagh River (Maigue C1/34)

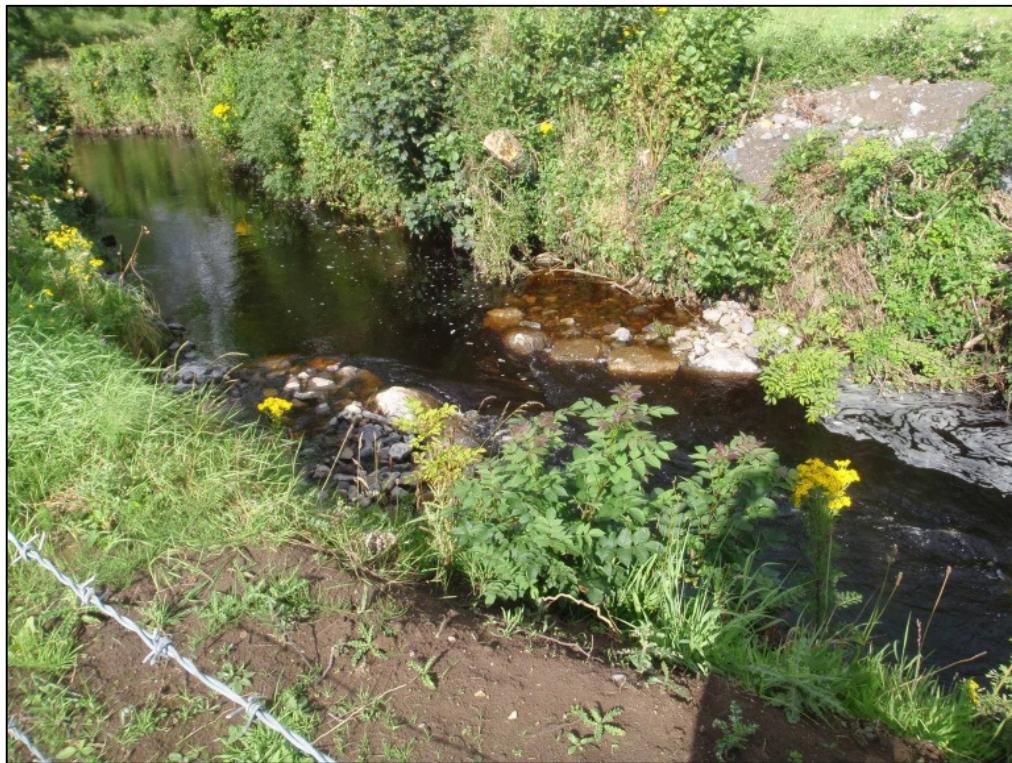
Figure 2.7. Straide River (Moy C1/23), paired deflector and pool.

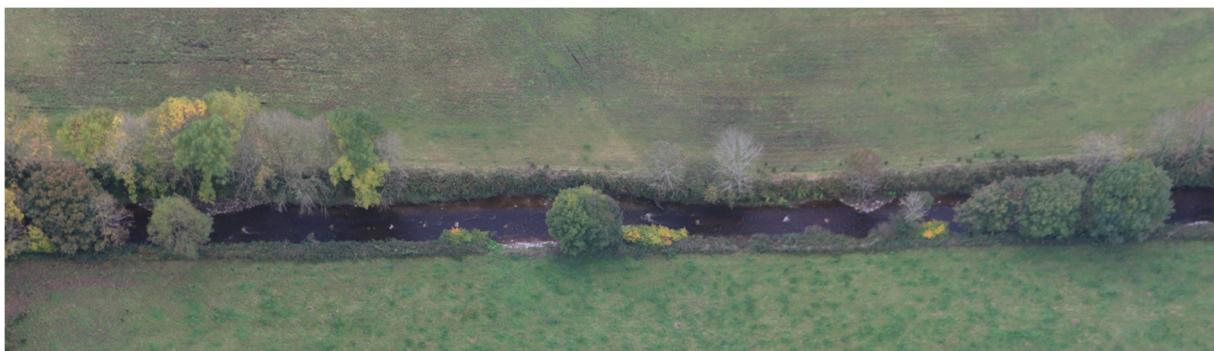
Figure 4.8. Aerial view of the River Maine experimental post works October 2009 (note alternating deflectors and random boulders).

The experimental section is downstream from the bridge at Tullig (Figure 4.7 and 4.8), was chosen, as it is representative of the River Maine. The Maine in this area is composed of shallow riffle-glide sections with high bed load mobility. The control site, downstream of Fairfield Bridge is very similar to the experimental sites comprising of shallow riffle-glide sections, although at a smaller base width.

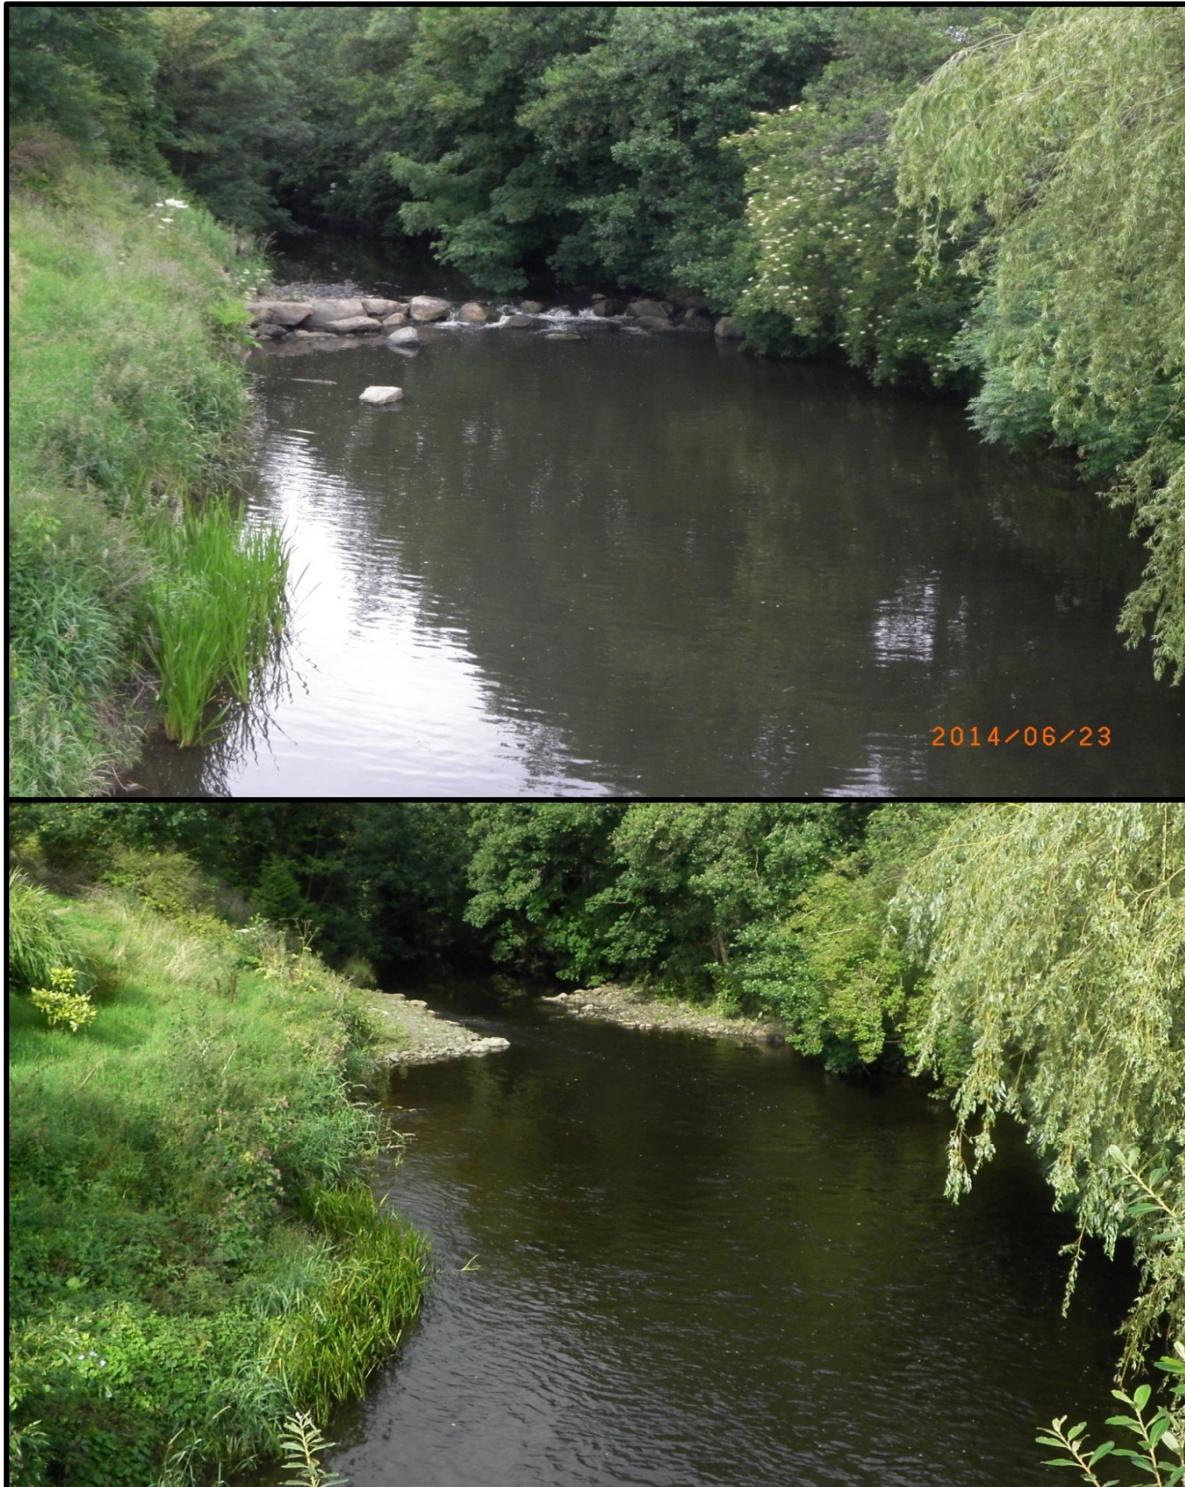
Figure 4.12. Capital works on the Monaghan Blackwater upstream of Miltown Bridge pre (Top -2014) and post (Bottom - 2015) works.

In 2014, it was decided to undertake capital works to improve trout fishing in the Milltown Bridge area. As part of these works, the horseshoe weir upstream of Milltown Bridge was replaced with paired deflector (Figure 4.12). This was done to return the river to a more natural state, by removing the ponding effect of the weir.

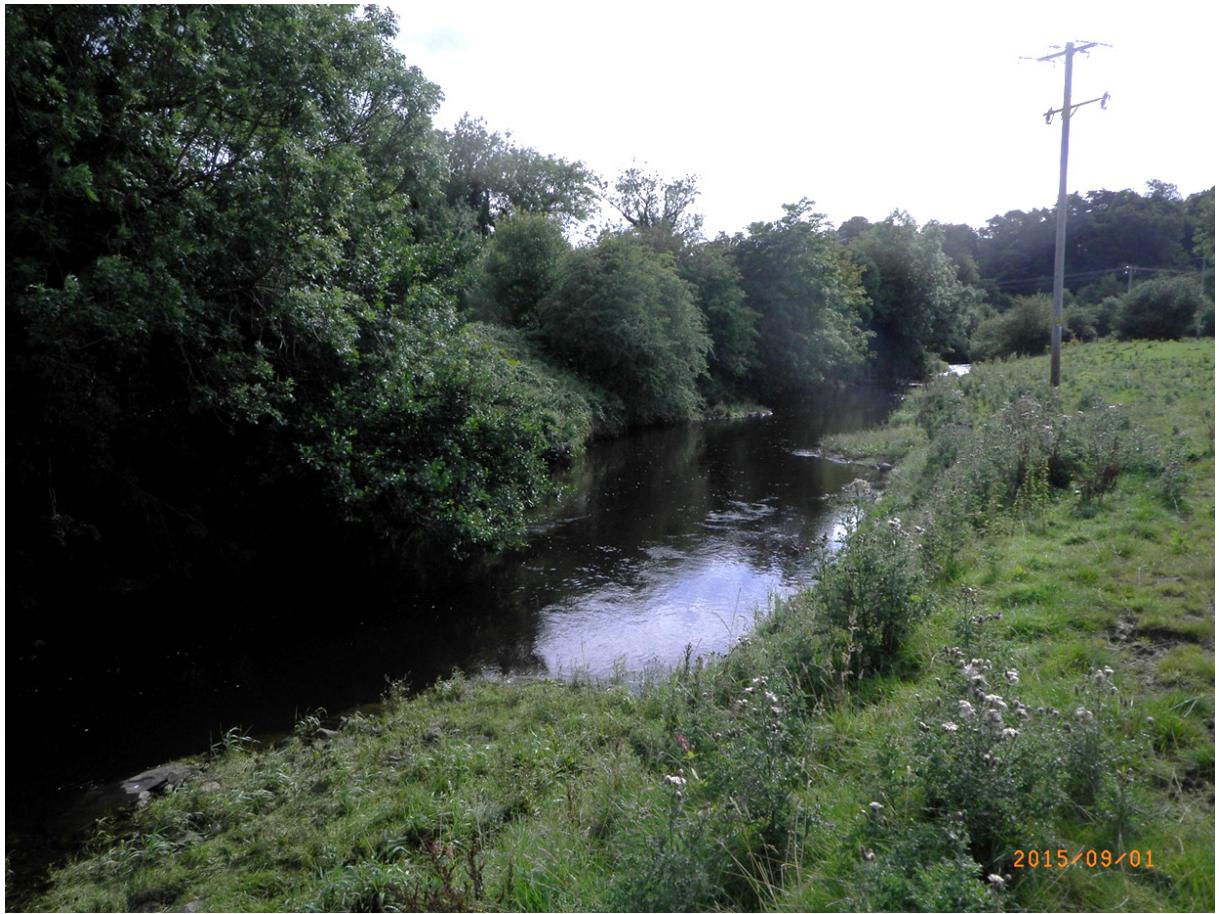
Figure 4.17. Alternating deflectors constructed downstream of Milltown Bridge as part of the Capital works programme 2014.

The trout numbers increased from 1.0 to 48.5 No/100m² between 2013 and 2015. The removal of the weir upstream of Milltown Bridge has significantly reduced the pike population and increased the trout population utilising this site. Creating more available trout habitat, these works should increase the trout population in this area in the medium to long term. This section is also a large trout habitat with fish >40cm recorded each sampling year, apart from 2013. Four trout >40cm were recorded in the 2015 survey. Capital works downstream of Milltown Bridge will allow anglers to access this resource and intercept trout overspill from the site upstream (Figure 4.17).

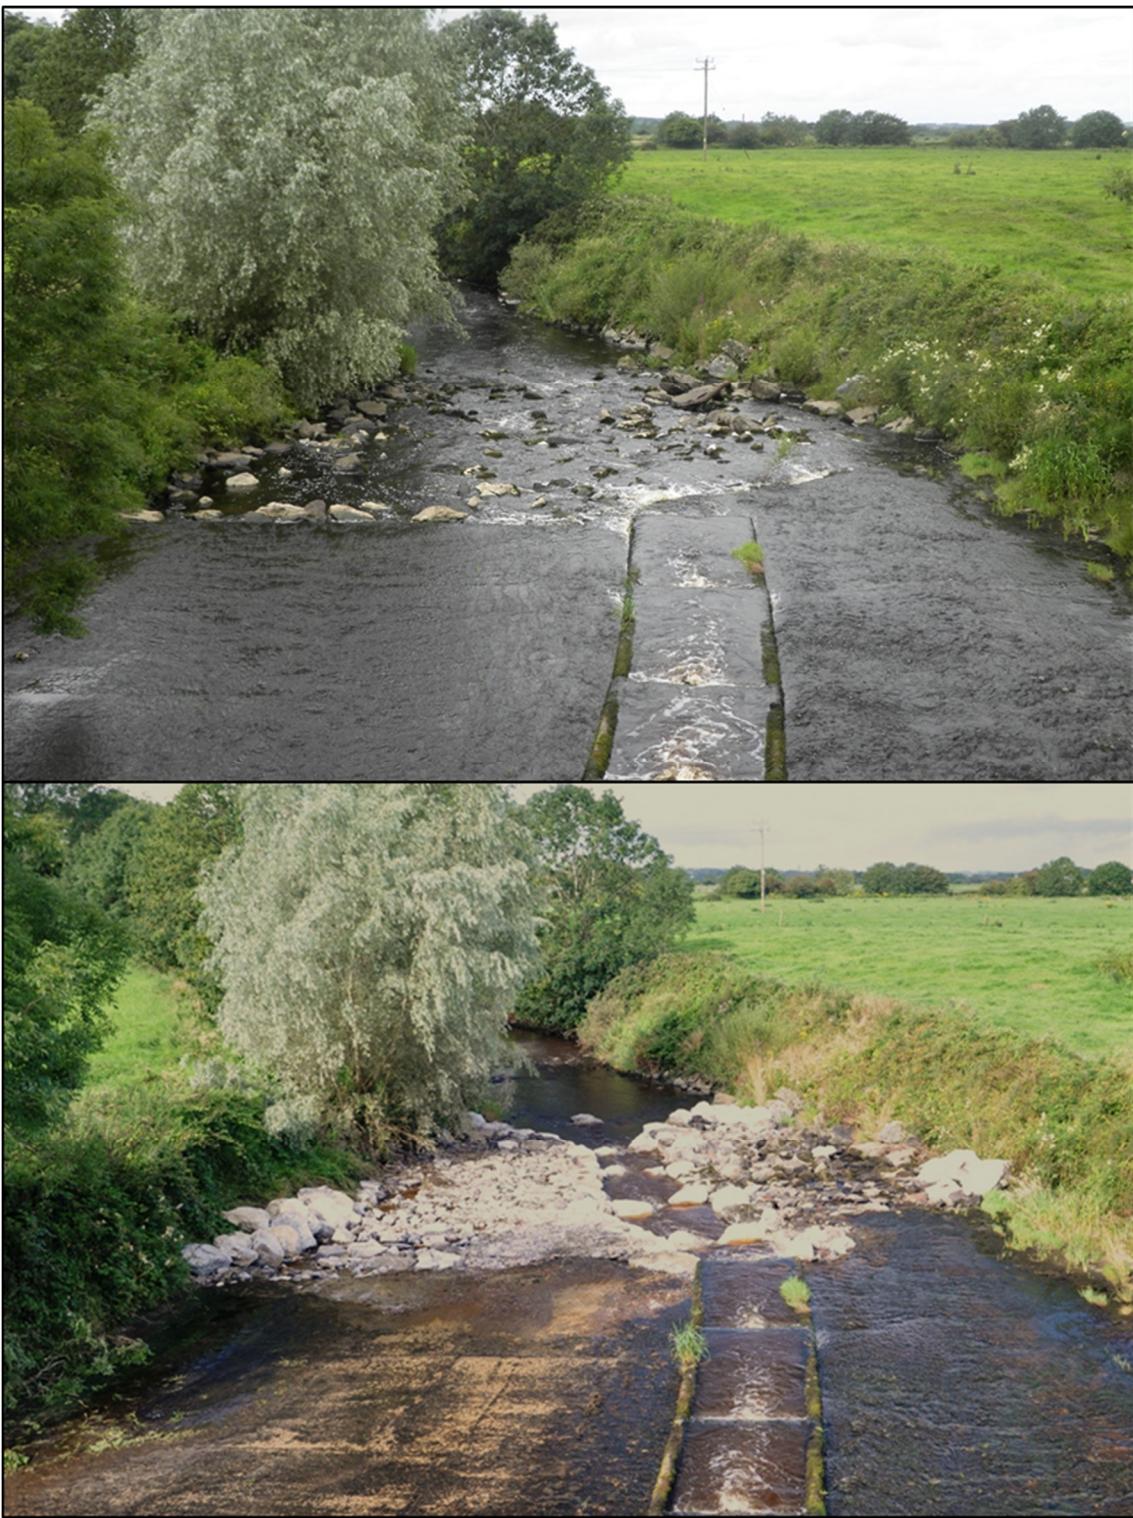
Figure 5.3. 2015 remediation works at Ahavoher Bridge on the Galey River (Feale CDS), Pre (top) and Post (Bottom) works.

Seventeen WFD III assessments have been undertaken in OPW catchments to date (Figure 5.2, Table 5.2). These represent structures that IFI has recognised as being problematic to fish passage. Ahavoher Bridge on the Galey River (Feale CDS) was identified as an issue to fish passage due to a damaged fish pass. This problem was addressed in 2015 as a Capital Works measure and a follow up surveys will be initiated in 2016 (Figure 5.3).

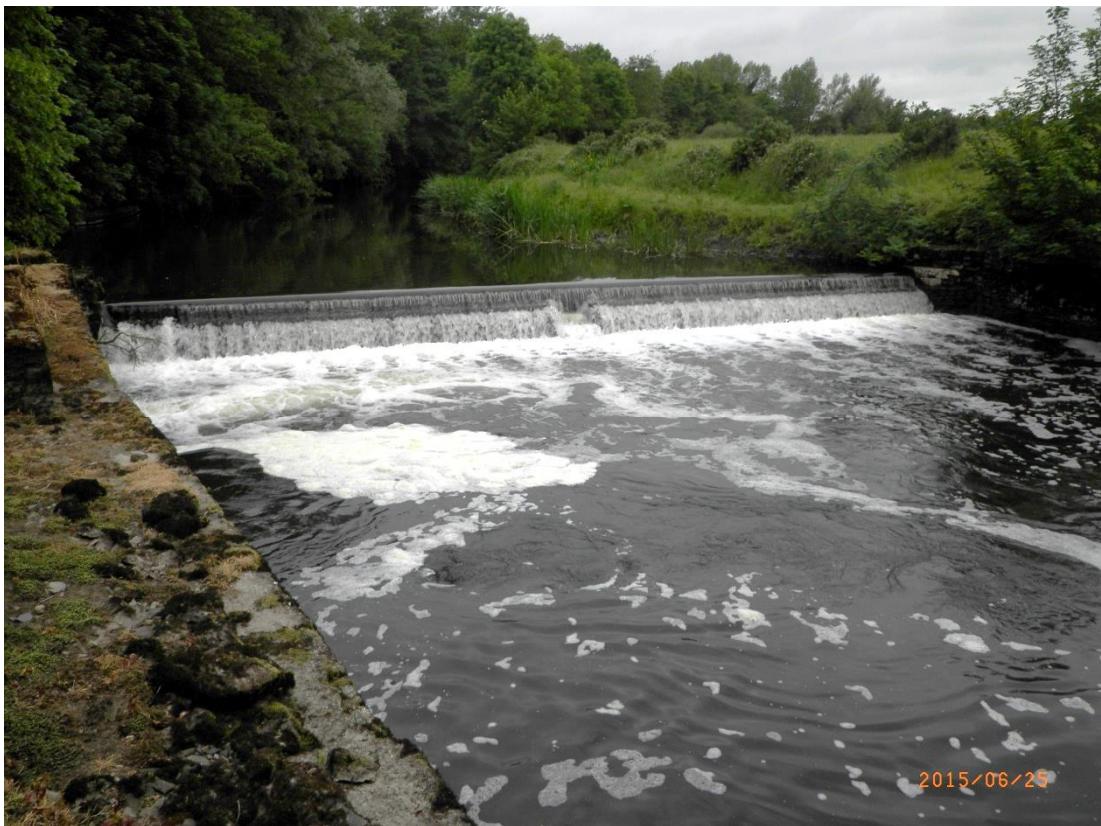
Figure 5.4. Martry Mill on the Kells Blackwater (Boyne CDS) a structure highlighted for mitigation (rock ramp). This is a high impact barrier to adult salmon and a complete barrier to lamprey.

Structures, which are in the process of mitigation or highlighted for a WFD III assessment are Martry Mill on the Kells Blackwater (Figure 5.4), the weir upstream of Ballycathall Brige on the Kilcrow River (Killimore CDS) and structures on the main stems of the Boyne, Feale and Deel Catchments.
