ENVIRONMENTAL RIVER ENHANCMENT PROGRAMME

Annual Report 2008

Environmental River Enhancement Programme (EREP)

A report commissioned by the Office of Public Works (Drainage Division / Environment Section) and prepared by the Central Fisheries Board.

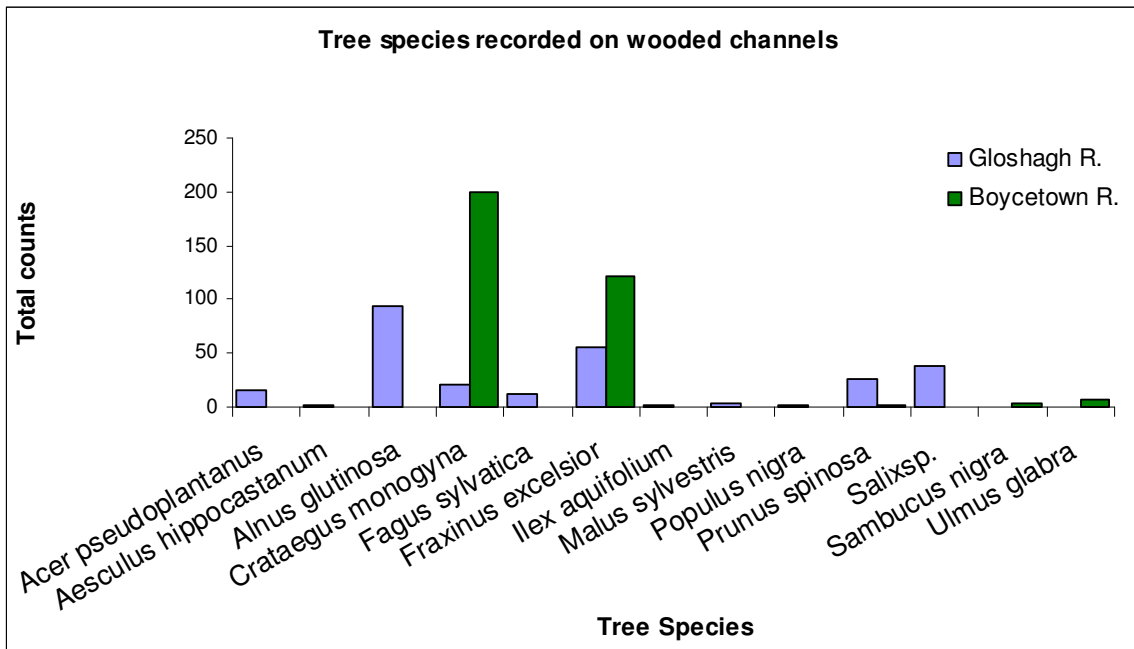
Figure 3. Total counts of tree species recorded on the Boycetown and the Glosagh rivers.

- 17 tree species were recorded along river corridors examined in 2008 (Figure 3). Hawthorn (*Crataegus monogyna*), Ash (*Fraxinus excelsior*) and Alder (*Alnus glutinosa*) predominated with lesser numbers of species that are typical of river banks such as Willow (*Salix sp*), Blackthorn (*Prunus spinosa*) and Wych elm (*Ulmus glabra*). The species mix and degree of dominance differed substantially between the Gloshagh and the Boycetown channels (Figure 3).

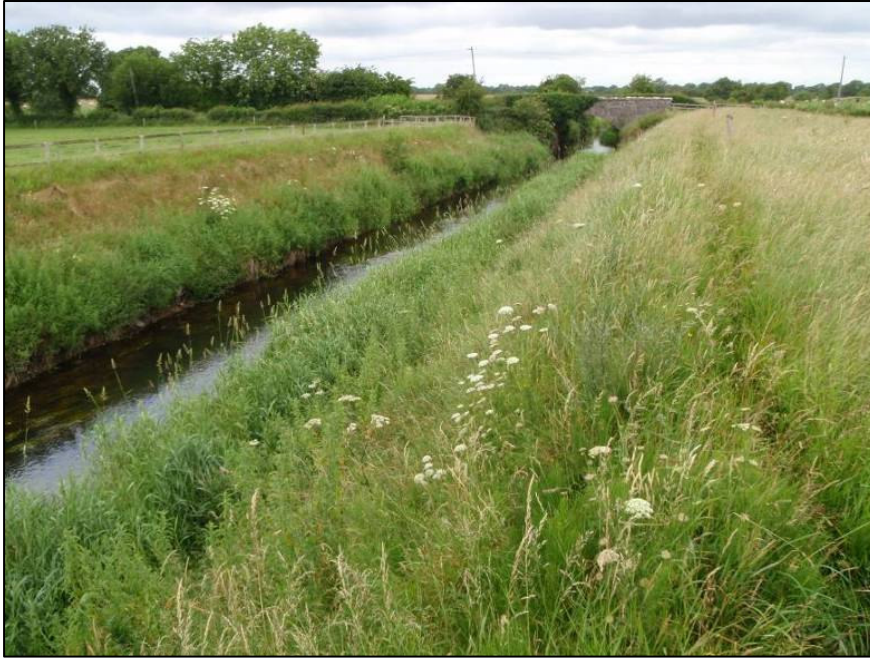
Plate 5. Dry meadow grassland dominated by tall grasses and umbellifers.

Dry meadows: ‘dry meadows are now rare in Ireland’ (Fossitt, 2000). Most have been improved for agriculture and are now mainly limited to grassy roadside verges, the margins of tilled fields, railway embankments, churchyards and cemeteries. This vegetation type is best represented on the Boycetown open site 2 (Plate 5).

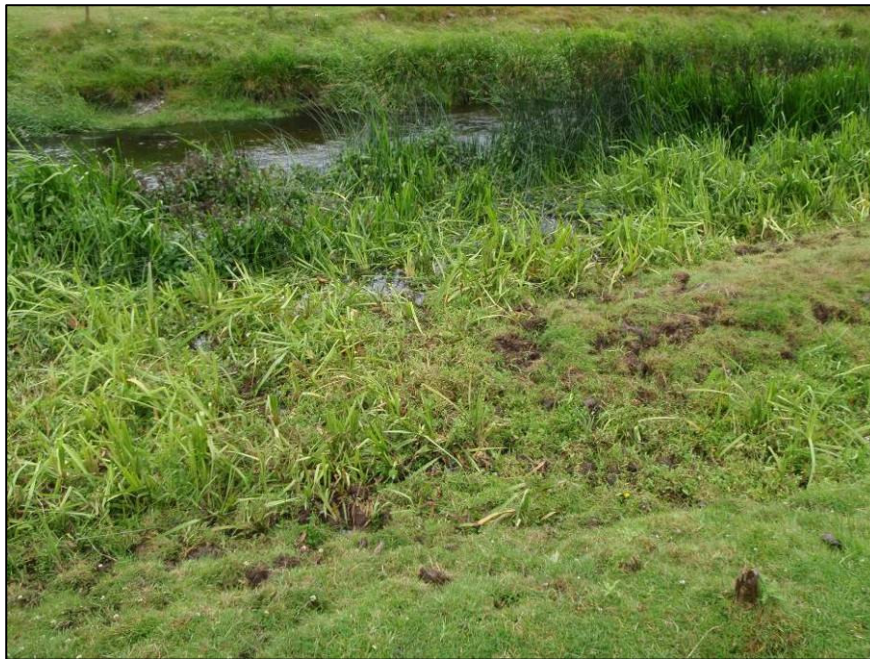
Plate 6. Unfenced site on the Robe subject to grazing/poaching.

Fencing was also identified as a major factor impacting on status of riparian plant communities (Plate 6). Some fenced sites where instream berms had developed tended to be dominated by marginal plants and other species typical of damp sites. For example on the Owenavorrhagh and some locations on the Glosghagh open sites and Morningstar, Reed Canary Grass (*Phalaris arundinacea*), Water Mint (*Mentha aquatica*), Greater Willow Herb (*Epilobium hirsutum*), Common Nettle (*Urtica dioica*), and Thistle species (*Cirsium* sp.) dominated.

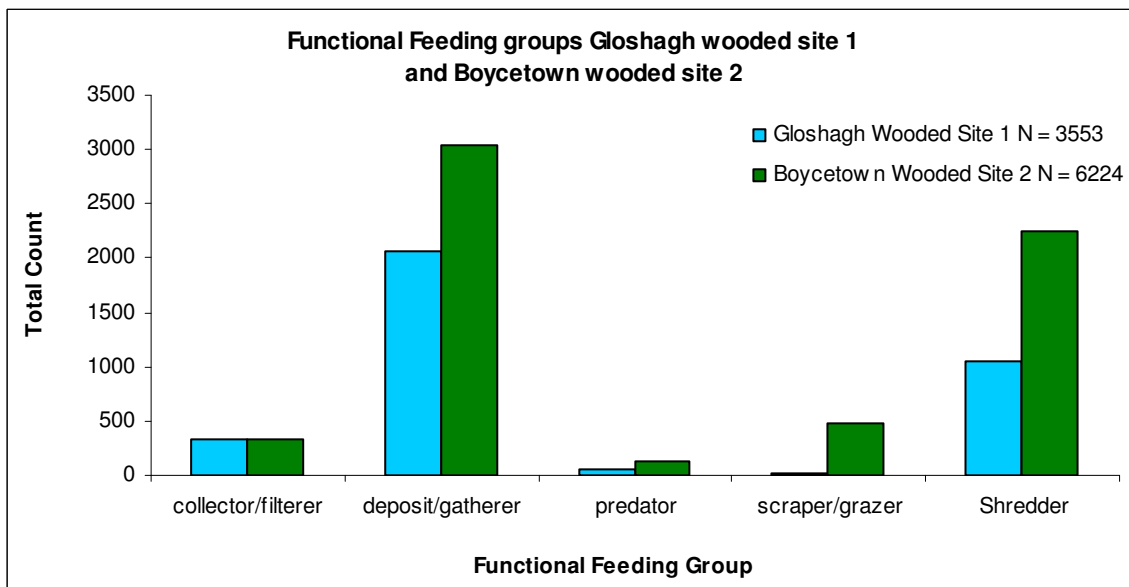
Figure 5. Comparison of functional feeding groups between wooded sites on the Boycetown and the Gloshagh channels.

Comparison of the wooded sites on the Boycetown and Gloshagh channels identified that the Boycetown river was the more productive channel, supporting a higher density of macroinvertebrates (Figure 5). The sample sites on the two channels were very similar in terms of functional feeding groups (Figure 5).

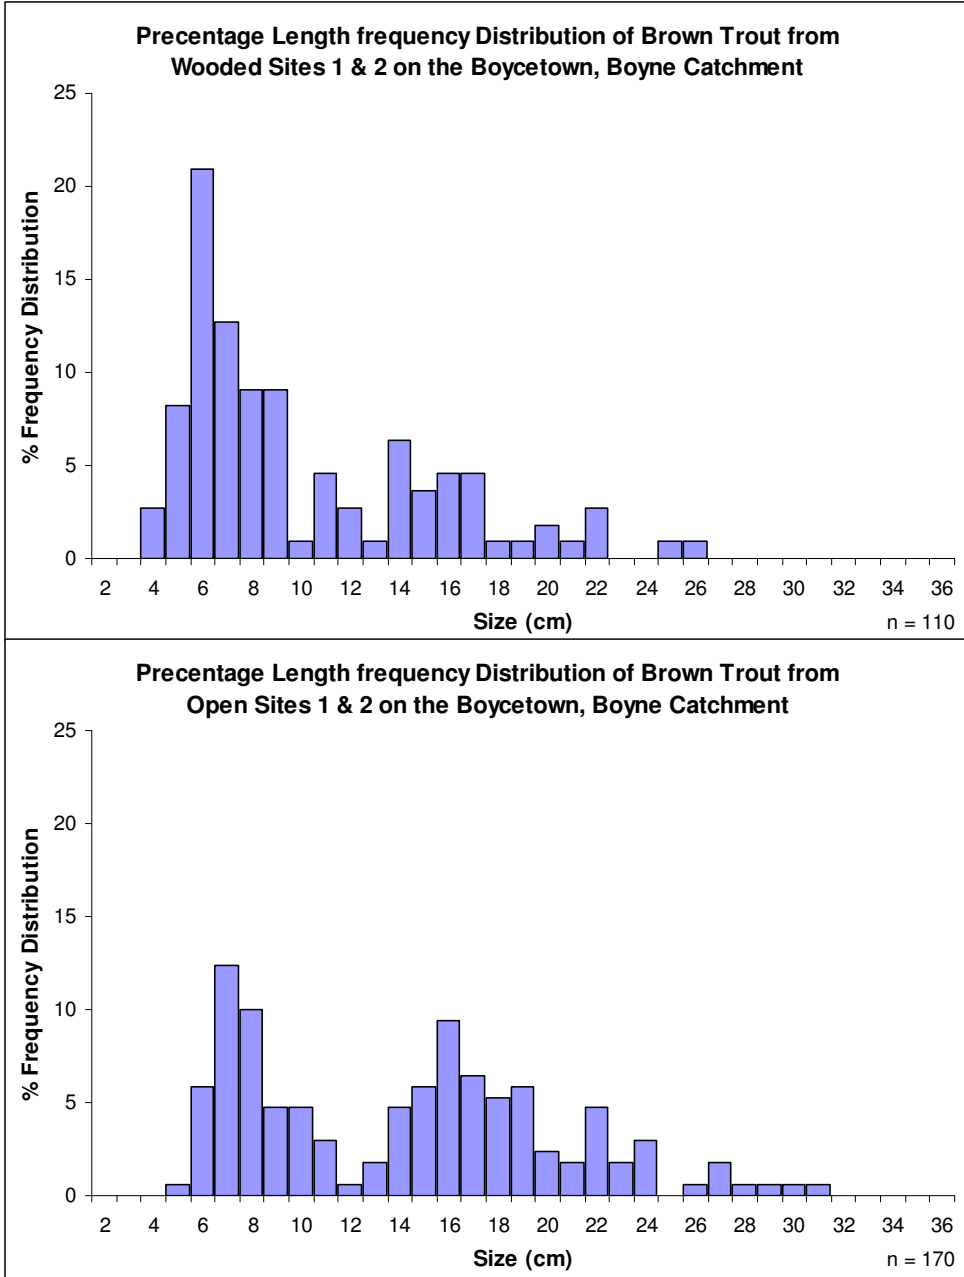
Figure 7. Showing the percentage length frequency distribution of brown trout from the wooded and open sites on the Boycetown River, Boyne Catchment 2008

of the population structure (or length frequency distribution) of the trout population indicated substantial differences, with more small trout (5 – 8 cm) recorded within the shaded sites and a greater number of 1+ and of older trout in the open site (Figure 7).

Statistical analysis of the length frequency distribution for the two trout populations, the wooded and open sites, indicated they were significantly different (Kolmogorov-Smirnoff, $p < 0.05$). This difference in the trout population structure is most probably generated by the greater water depths and instream habitat complexity found at open sites. In turn, this complexity is considered to be related to the presence of riparian and marginal plant cover.

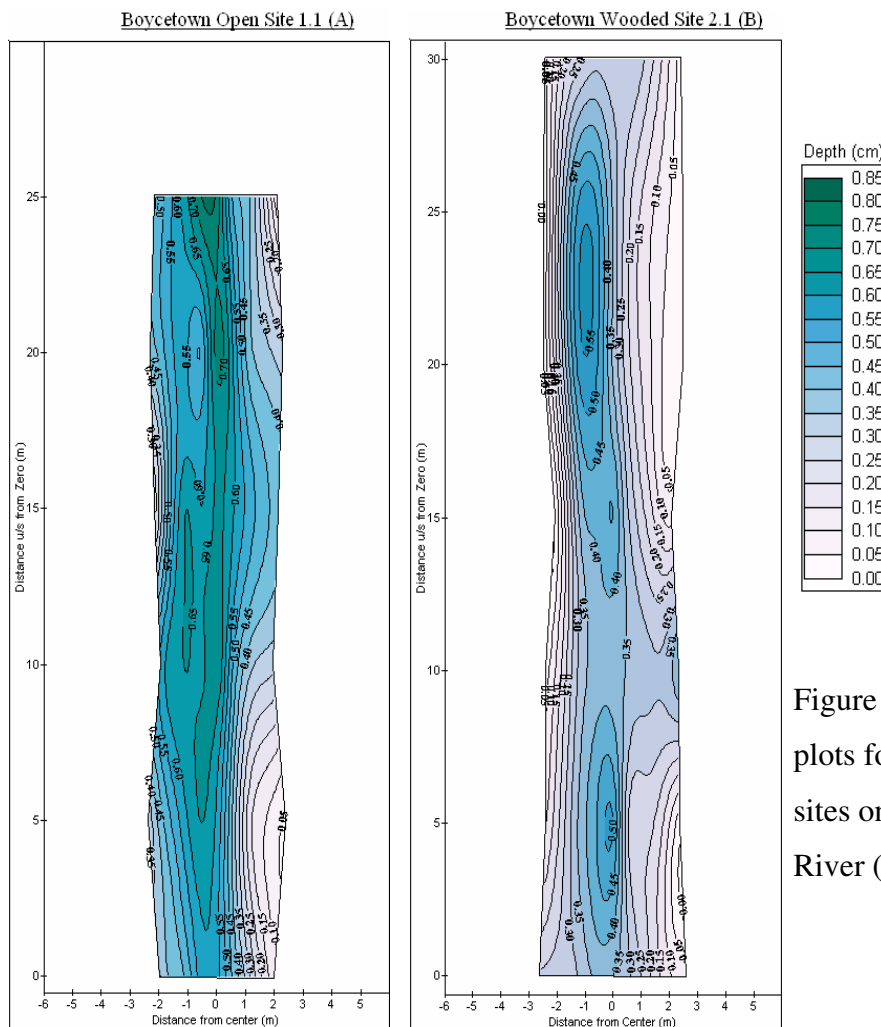
Figure 10. Depth contour plots for open and wooded sites on the Boycetown River (Boyne Trib. C1/15).

These depths when displayed using a contour plot (Figure 10) give an indication of how depth and channel width varies through the river sections.

The depth and width variations across two sites from the Boycetown River (Figure 10) show substantial differences in depth/width profiles between the open and, wooded sites, the wooded site being wider and shallower than the open site. Differences in depth and width between the open and wooded sites on the Boycetown can be partly explained by the bankslope and aquatic vegetation that grows in the open sites. The bankslope vegetation binds the physical fabric of the bank and reduces or prevents erosion. This offsets a widening of the wetted width that can occur in shaded sections of channels. In

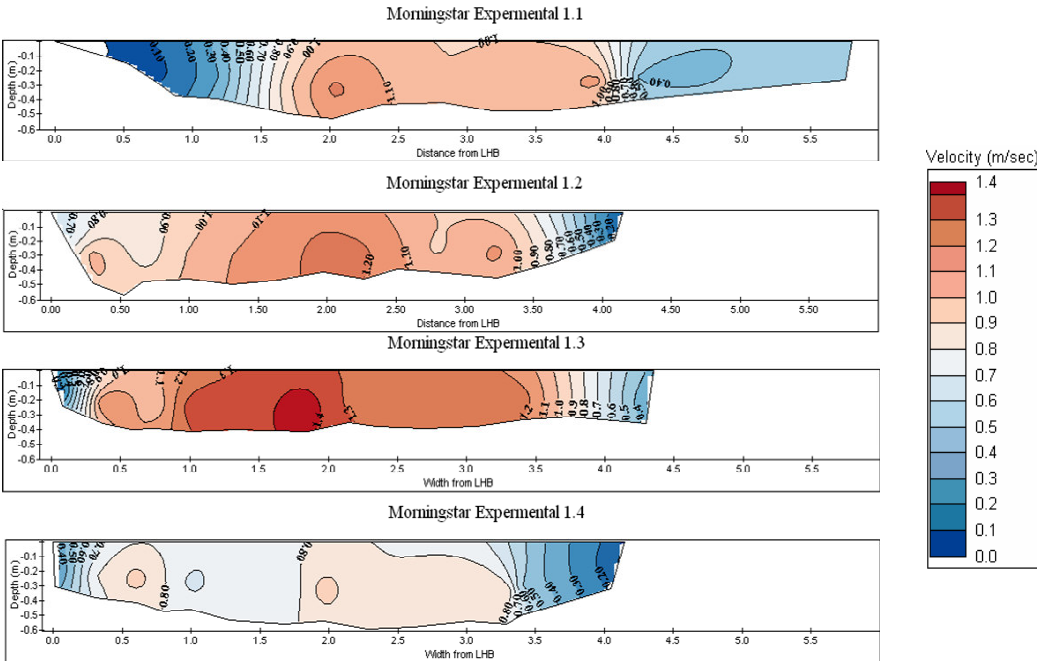
Figure 11. Shows contour plots of depth velocity profiles taken from the Morningstar River, (Zero is from the waters edge on the left hand bank (LHB)). 1.1 is at the site, 1.2 is at 20m, 1.3 is at 40m and 1.4 is at 60m upstream.

Velocity (V) measurements are presented as contour plots (Figure 11). These plots show channel cross sectional velocities at a number of representative locations at each site. A study on a pre-enhancement stretch from the Morningstar River (Figure 11) demonstrated the application of this graphical method. The plots show how width, depth and velocity can change over very short lengths of channel. In the future these contour plots will be used to graphically show the effect of works – both capital enhancement and enhanced maintenance on channel form, dimensions and velocity.

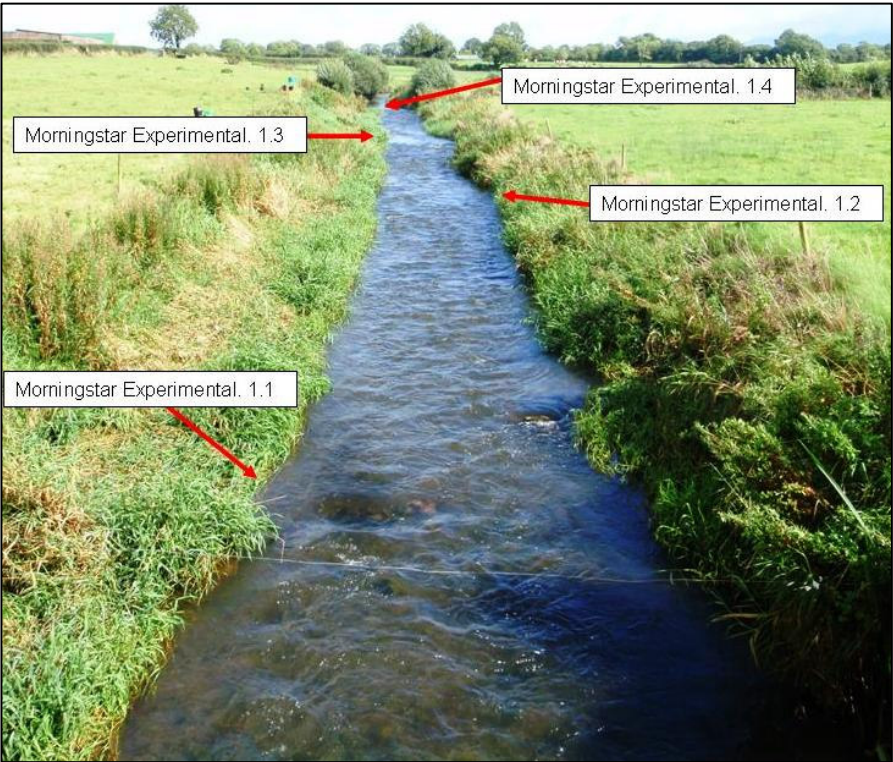
Plate 10. The Morningstar experimental section (Maigue Catchment) monitored pre-works in the EREP programme.

A typical riffle/glide sequence from a drained OPW channel is shown in Plate 10. Morningstar experiment 1.3 is taken through a riffle while Morningstar experiment 1.4 is taken through a deep glide. In an undrained, channel Morningstar Experiment 1.4 should be a pool in the riffle/glide/pool sequence. However in this case it is a deep glide with corresponding high velocities. The Morningstar experimental site is shown in Plate 10, giving the location of each of the velocity cross sections in Figure 11. The image gives a good indication of the riffle/glide sequence found in drained channels and the corresponding lack of pools. In the EREP enhancement plan for this site, three vortex stone weirs with associated pools and gravel shoals, will be constructed.

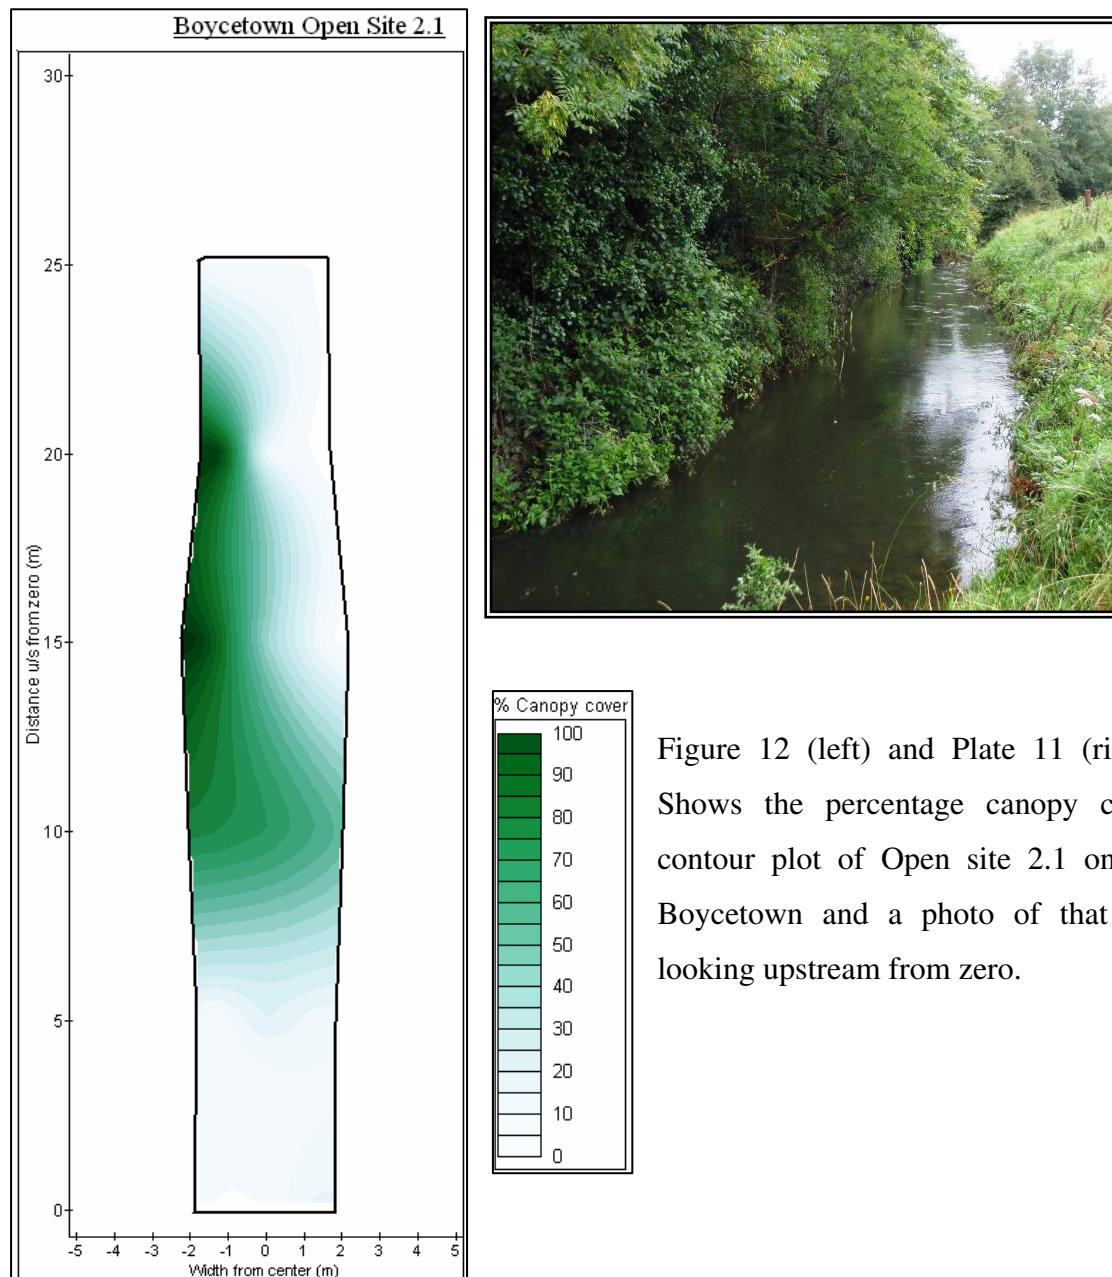
The image and contour plot in Figure 12 shows an open site on the R. Boycetown that has an average of 21% canopy cover, which can be defined as sparse cover using Table 8.

Figure 12 (left) and Plate 11 (right). Shows the percentage canopy cover contour plot of Open site 2.1 on the Boycetown and a photo of that site looking upstream from zero.

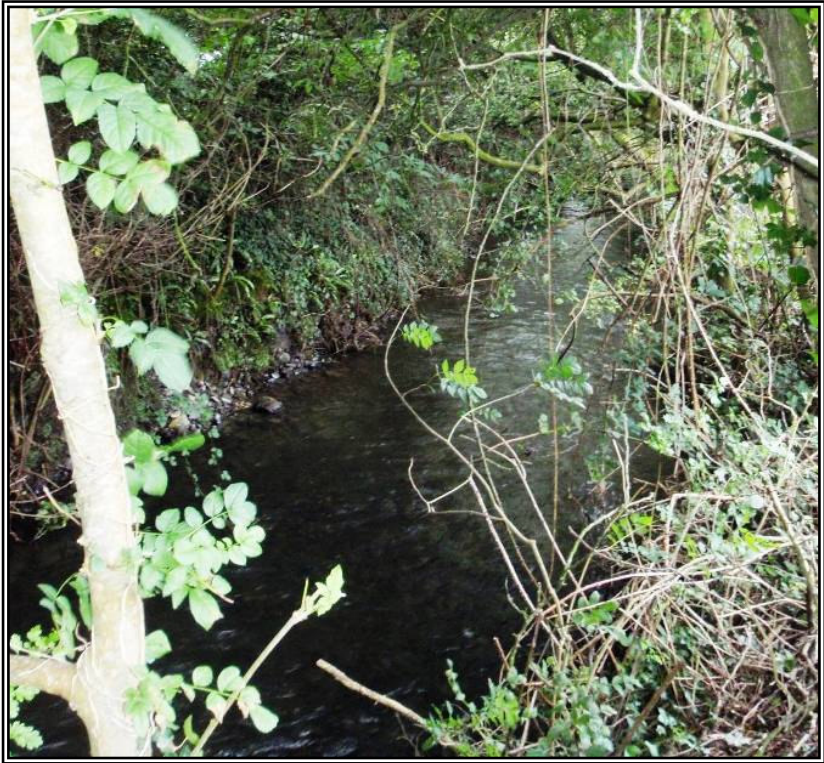
Plate 12. A wooded site on the Boycetown River. This site has on average 81% canopy cover giving it a rating of dense canopy as from Table 8.

The dense shading seen at the wooded site in Plate 12 prohibits the growth of most aquatic/marginal plants and enables the growth of shade tolerant plants such as ferns and ivy. The absence of bankslope vegetation, in turn leads to the erosion seen at the waters edge in wooded sites.

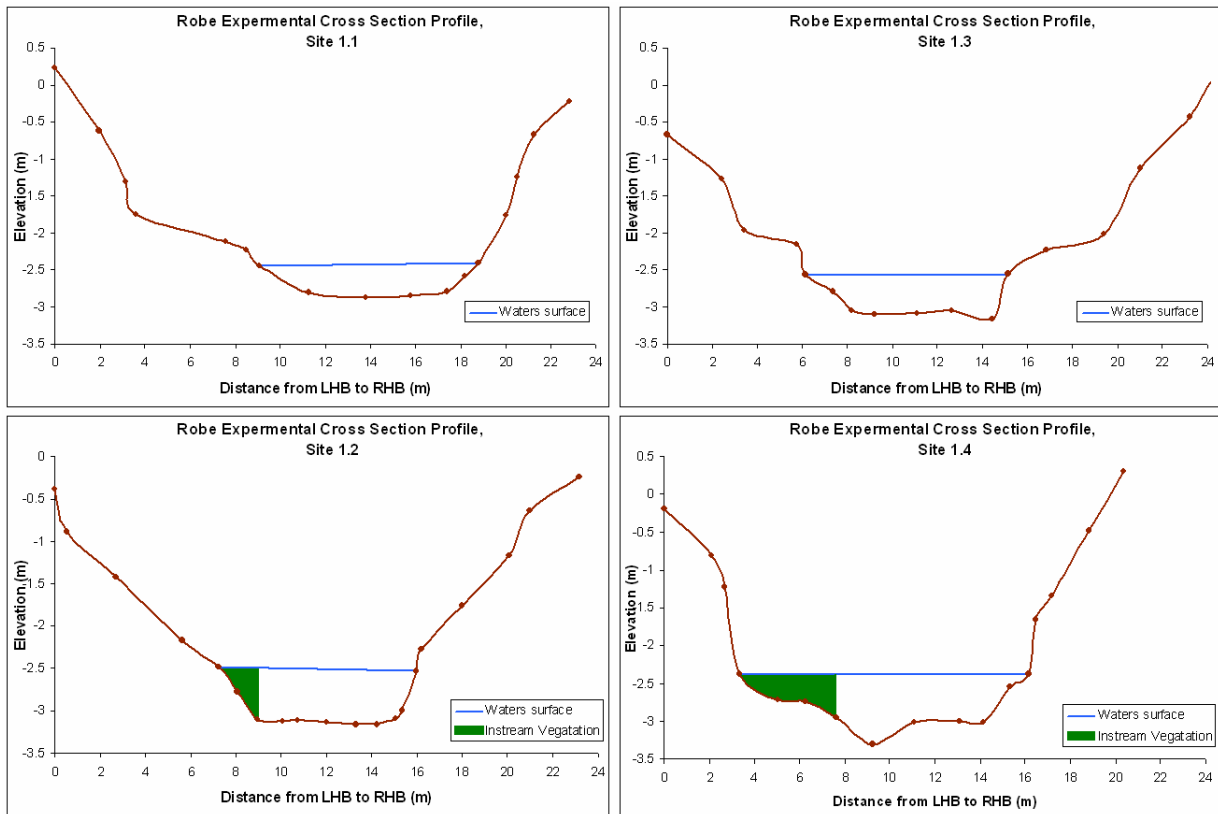
Figure 13 Cross-sectional profiles of four cross sections before enhancement works taken on the Robe River (CM 4)

The surveyed cross sections as given in Figure 13 are extremely useful to quantify the difference in bank, bed and water height pre- and post- enhancement and maintenance. It is also gives the ability to accurately map and possibly quantify the aquatic vegetation in the river channel. In the future channel cross sectional profiles will be used in berm management projects, allowing for berms to be measured pre and post works and as they redevelop over subsequent years. For these projects, integrating channel cross sections with plant surveys and velocity profiles will show the physical and biological process which combine to reform maintained berms. This integration will enable an assessment of both hydromorphological change and biological change.

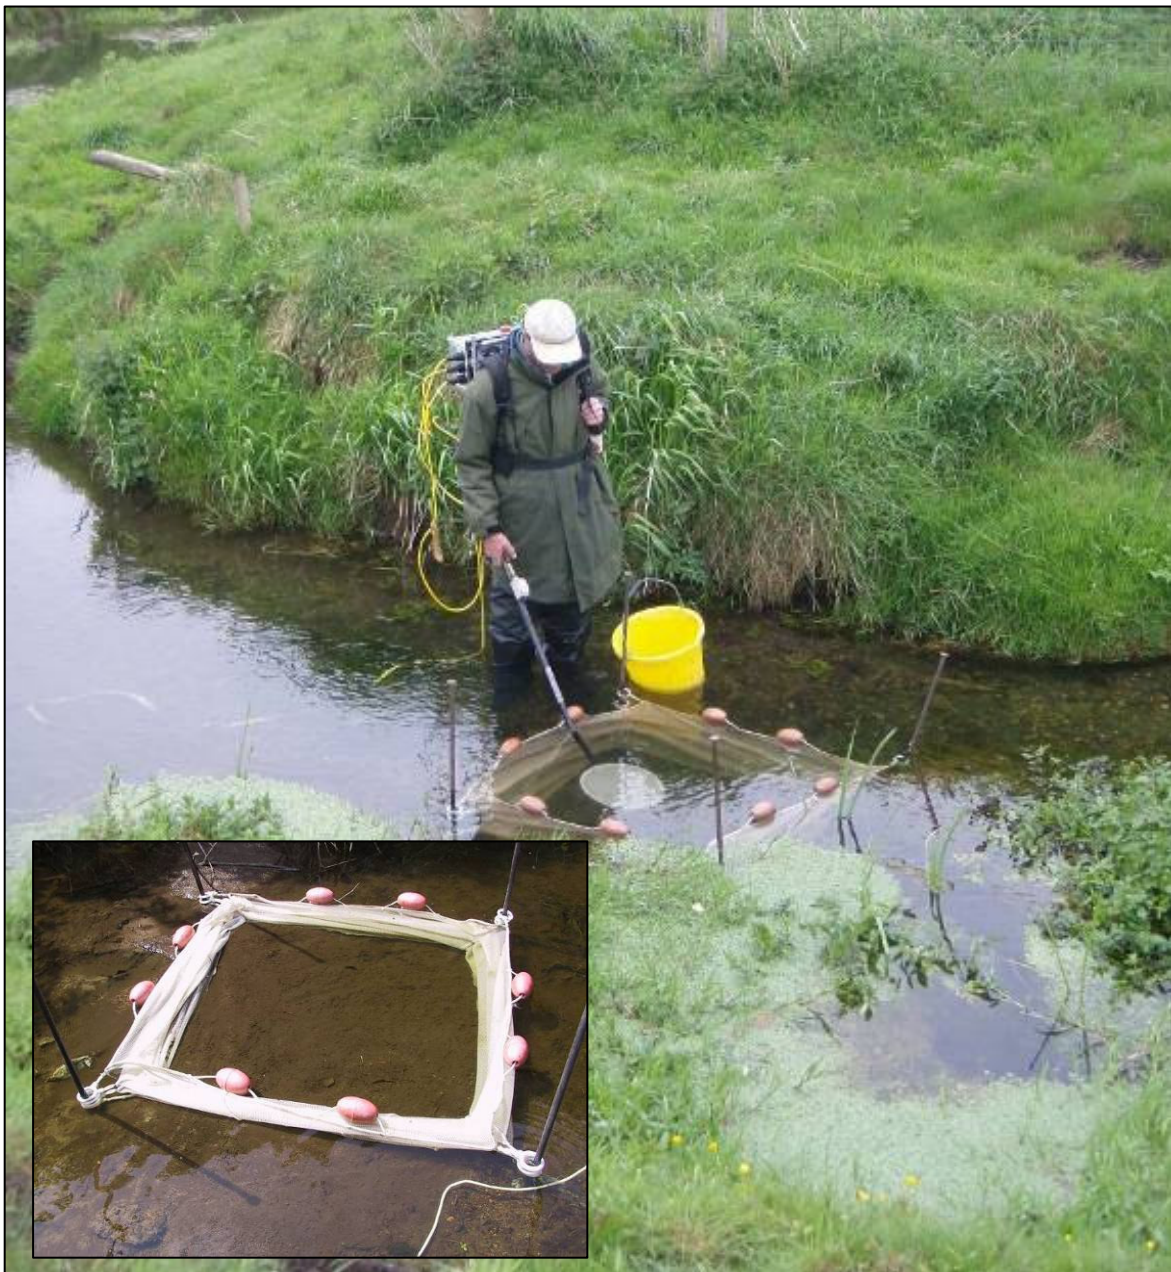
Plate 13. Electro-fishing 1m² enclosure on C1/32, Stonyford, May 2008.

The survey in 2008 re-fished the set of 17 replicates (Plate 13). Density values remained low (Figure 15), relative to the 2007 pre-maintenance condition. However, a larger overall number was recorded and the population structure indicated a definite trend of

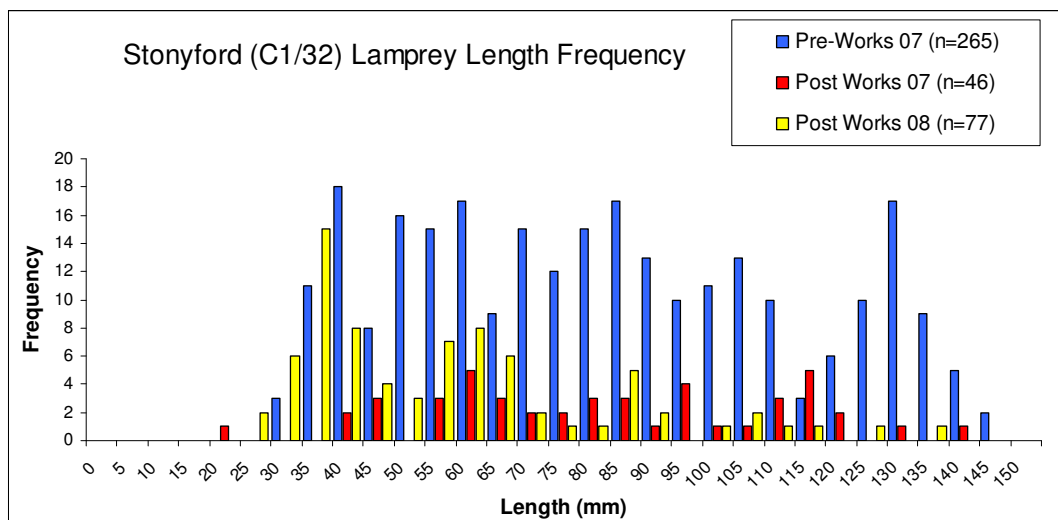
Figure 16. Lamprey length frequency distribution for C1/32, Stonyford, 2007 & 2008.

recolonisation by younger age groups or size-classes. There was a predominance of small ammocoetes, with two modal peaks in the 35mm-40mm and 55mm-65mm range (Figure 16). This pattern of colonisation was also observed in newly-excavated sites on the R. Nore in Kilkenny (King, Hanna and Wightman, 2008).

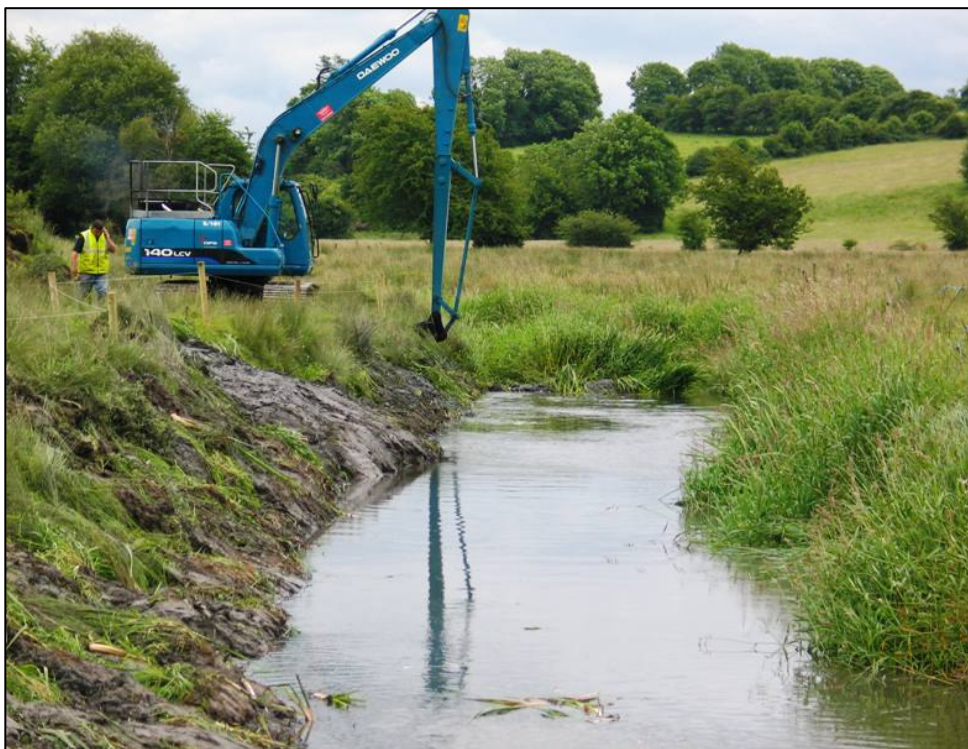
Plate 14. C50-1 (R. Glore) Survey site during maintenance June 2007.

The summer 2007 survey on the R. Glor initially indicated no impact of maintenance on the resident crayfish population, in the immediate post-works stage. However, by that autumn a substantial decline in numbers was evident. A repeat of the summer survey in 2008 indicated a further substantial decline in crayfish numbers.

It is considered that the decline is related to loss of habitat rather than actual mortalities of crayfish. The maintenance work was carried out in line with the environmental guidelines adopted by OPW, with retention of the full marginal and bankslope vegetation on the non-working bank, retention of tree cover and appropriate spoil management (Plate 14). Loss of instream habitat and of cover on the working bank is considered to be likely causes of the crayfish decline. These issues are addressed to some degree in a series of mitigations developed in a recently-published Ecological Impact Assessment (EcIA) study (King, Lordan and Wightman, 2009).

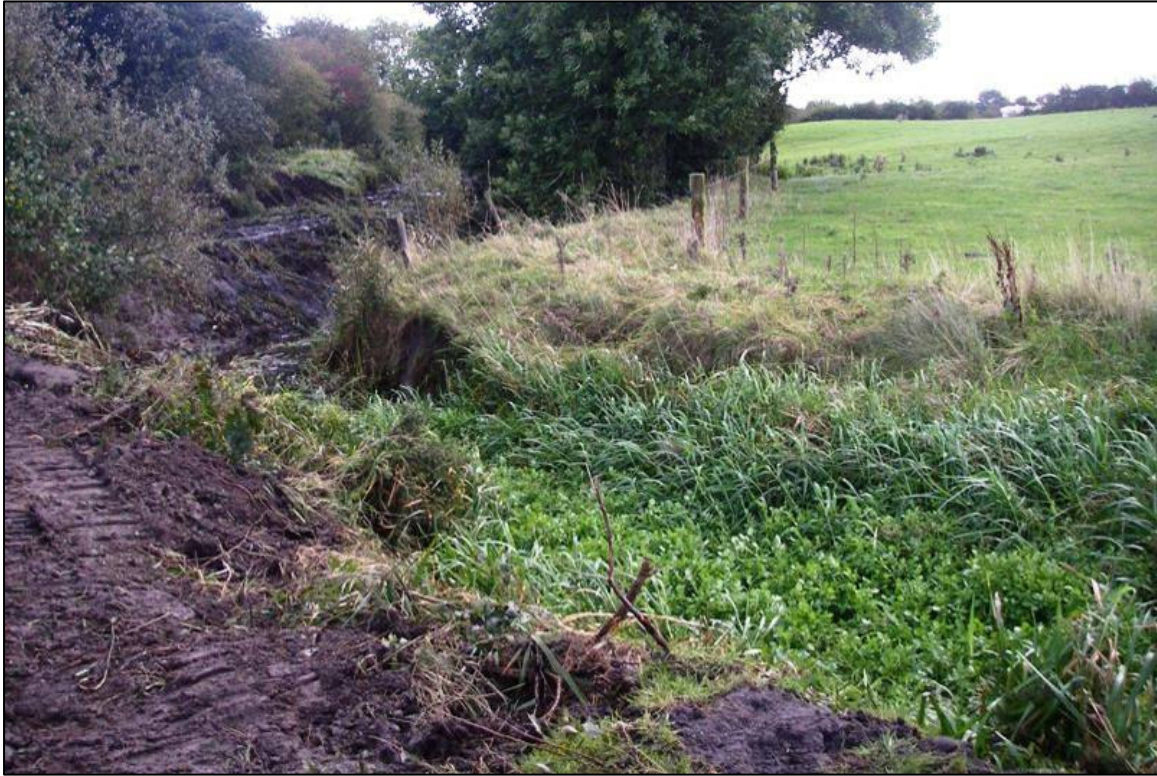
Plate 15. C40-2 (L. Ennel Tributary) Survey site during maintenance October 2008.

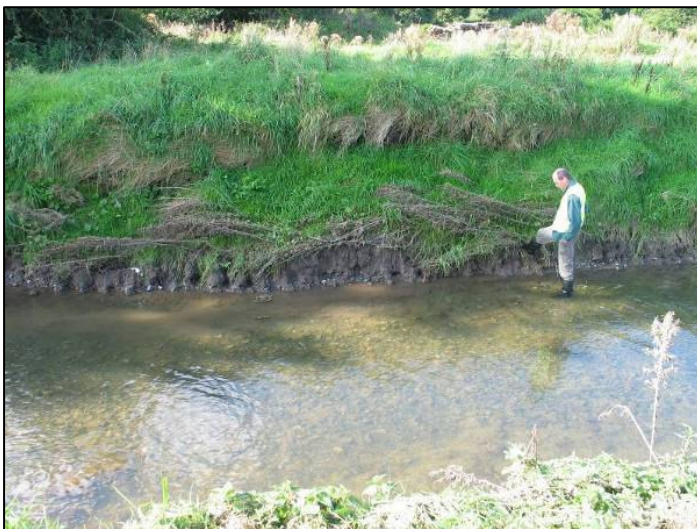
Plate 16. Machine bucket cutting into the non working bank.

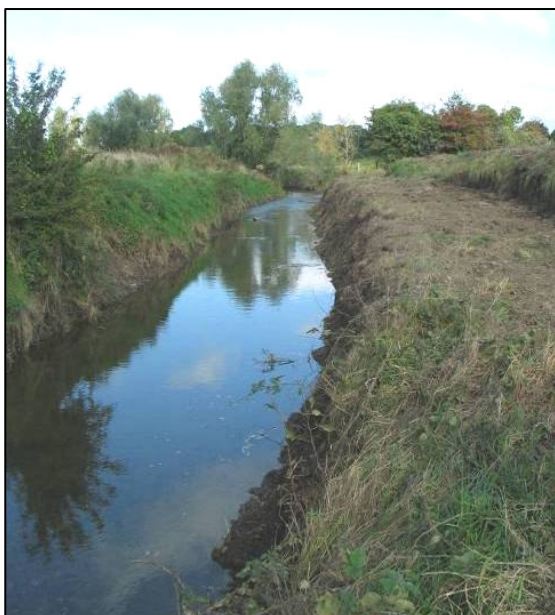
Plate 17. Both the bank slope and bank full cleared of vegetation

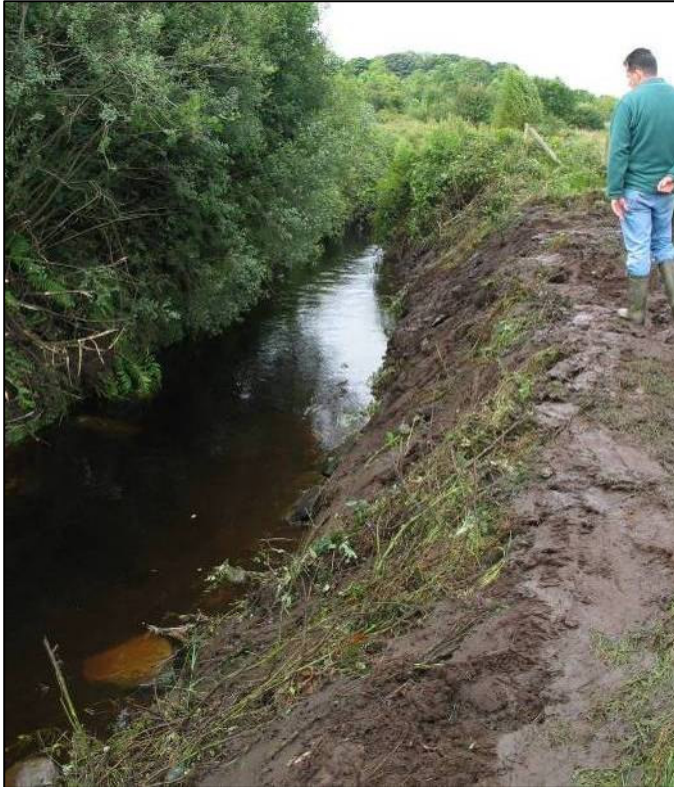
Plate 18. Excessive removal of all bank side vegetation from working side.

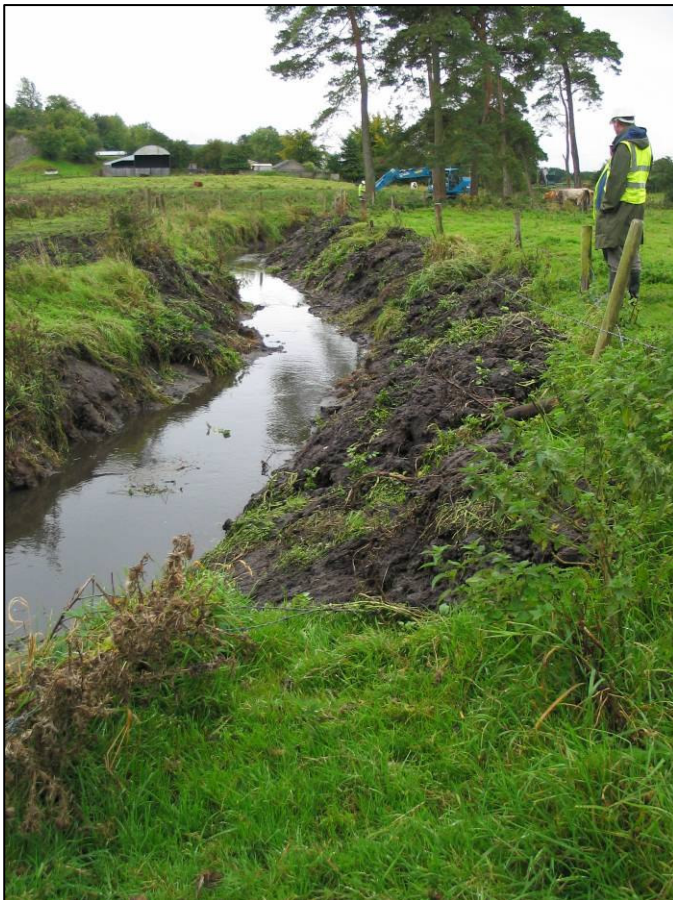
Plate 19. Excavated material deposited on the bank slope and damage also caused to the non working bank.

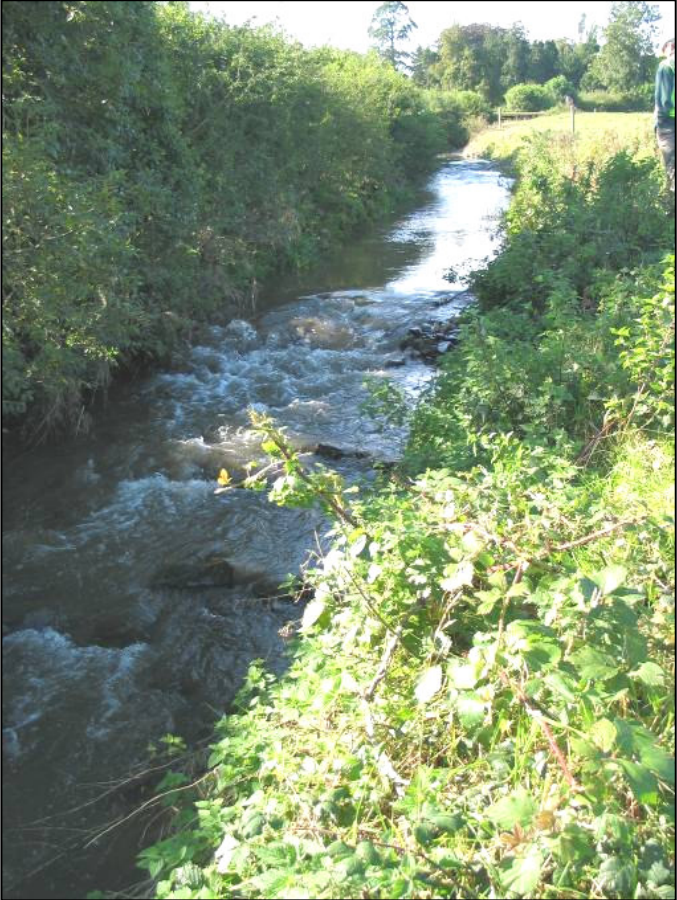
Plate 20. Instream potential identified and works successfully implemented, involving reprofiling of long section.

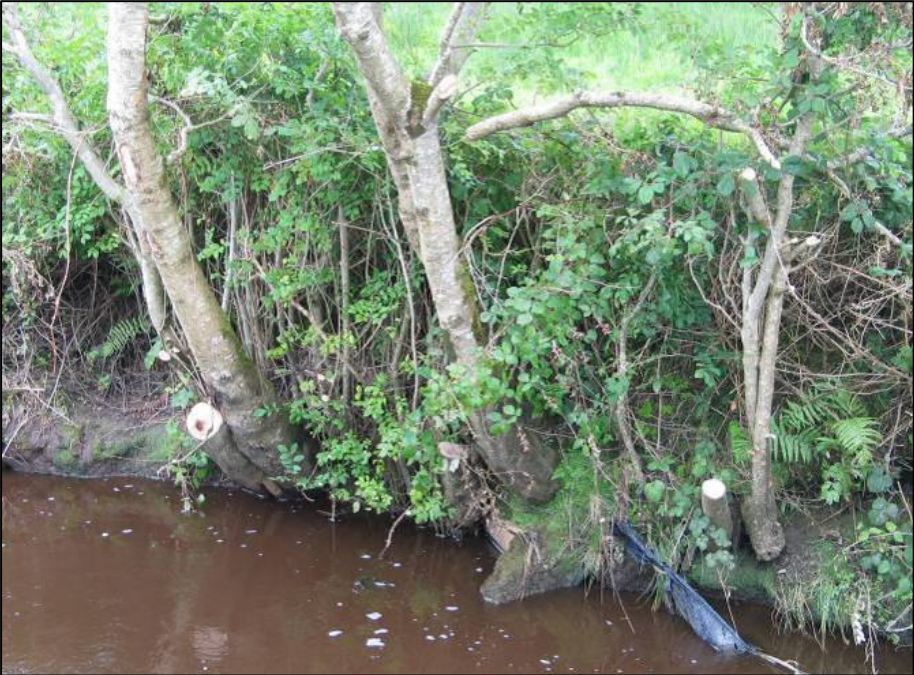
Plate 21. Trees and tree branches removed with chainsaw, effect is less damaging to the trees and visually more environmental friendly.
