ENVIRONMENTAL RIVER ENHANCEMENT PROGRAMME

ANNUAL REPORT 2009

A report commissioned by the Office of Public Works (Drainage Division – Environment Section) and prepared by the Central Fisheries Board.

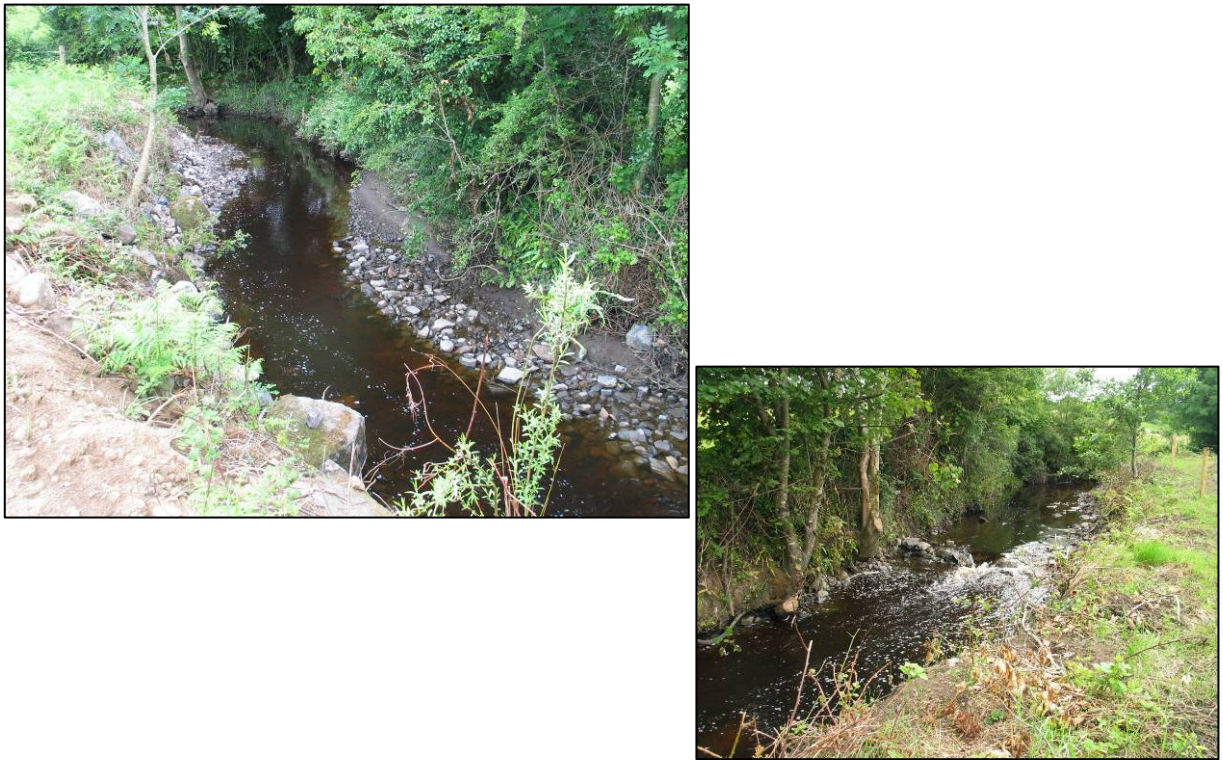
Plate 3.1. Examples of instream works carried out during Enhanced Maintenance on the Little R. Top left photo: series of alternating deflectors and digging out of a thalweg. Bottom right photo: creation of a weir and associated pool area downstream.

An example of the type of works that can be achieved, while only using available on-site materials is clearly evident on the Little R. (C1/23/3, Moy CDS) (Plate 3.1). A wide range of enhanced maintenance techniques were successfully applied here. The positive impact on the whole river corridor, post works, should be evident throughout this river over the coming years.

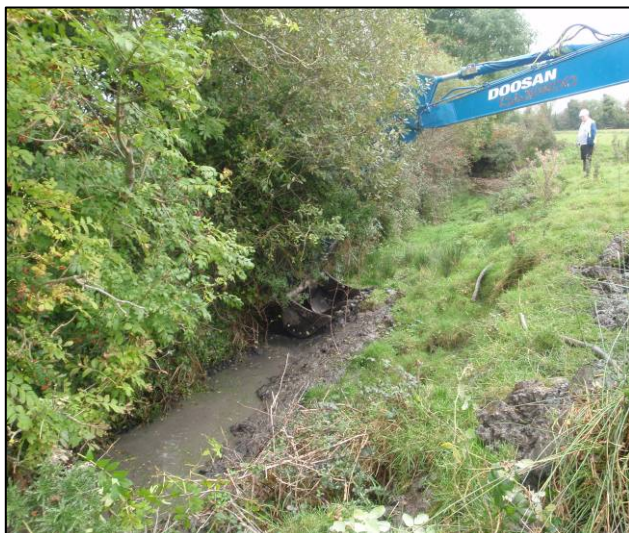
Plate 3.2. Machine bucket too big for channel it is working in.

- Difficulties arose in relation to the size of machine buckets being used in small channels ($< 3\text{m}$). In this situation it is not unusual for both banks to be scraped and damaged while the bucket attempts to clean out the channel itself (Plate 3.2). The EREP team is of the view that, in many such cases, the buckets are too large for the channels in question and that, in general, a ‘one-size-fits-all’ approach seems to apply. This is reasonable as a general ‘business’ model but in the context of implementing environmental strategies it is considered that this issue needs to be addressed. Without being addressed, audits of performance will continue to identify shortcomings in regard to management of bank slope and marginal areas as well as the handling of instream issues in

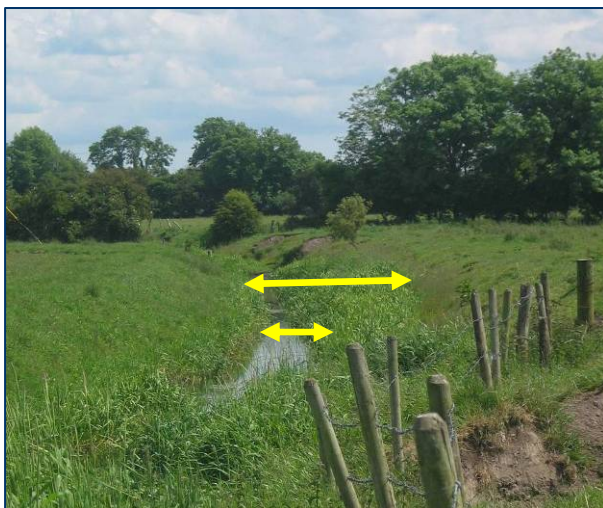
Plate 3.3. Design base width compared to desired base width.

interactions with the bed and banks. The diminished condition, in terms of hydromorphology, is further reflected in reduced biodiversity. Re-achieving design base width will also lead to steeper bank slopes and reduced capacity for the bank slope area to accommodate spoil removed from the channel. An additional concern of fisheries is that the achievement of increased base width comes at the bottom of the cross section. This part of the cross-section is most critical ecologically. In contrast, it is the least critical for flooding as this area is first to drown out for any increase in stage and will be completely drowned out in bankfull flows.

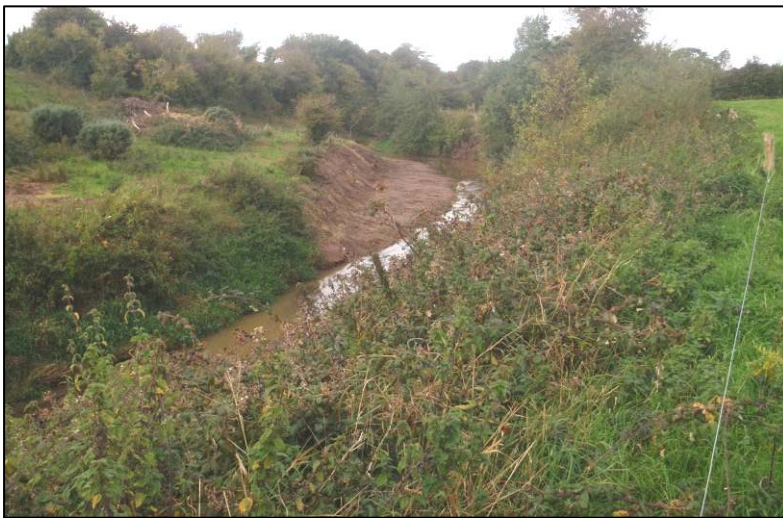
Plate 3.4. Example of berm management.

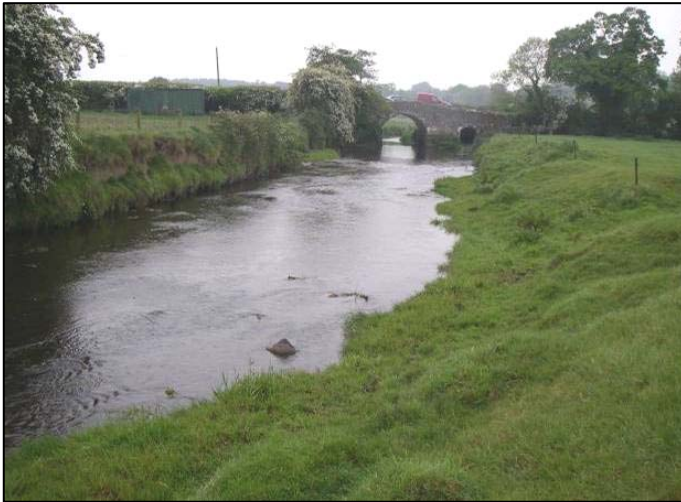
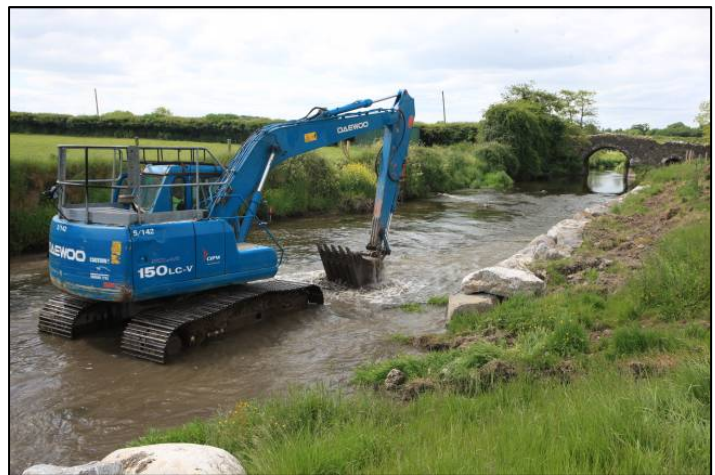
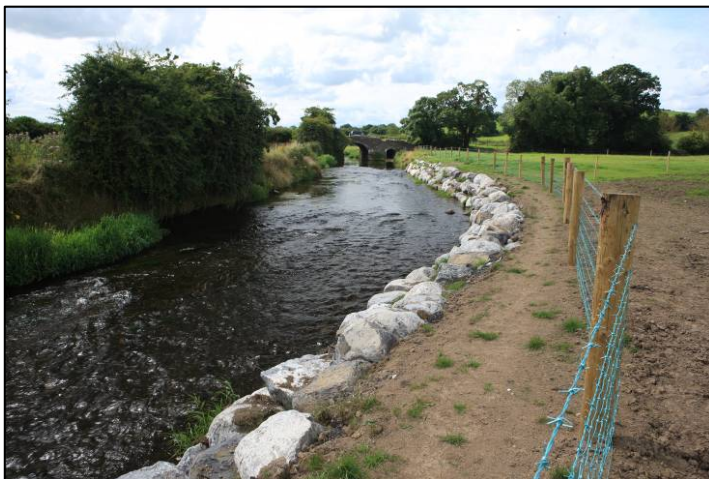
Figure 4.2. Stages of capital works on the River Dee, pre-works (A), during works (B) and post works (C).

A - River Dee pre-works, 2008.

B - River Dee during works, 2009.

C - River Dee post works, 2009.

In the majority of cases draft enhancement plans were fully implemented, although there were a small number of occasions where amendments were necessary. The changes made were generally minor. Some sections were shortened or extended. In the case of the R. Dee the addition of gravels was not necessary after all, as sufficient amounts of existing gravels were exposed within the channel during works. All changes to draft work programmes are subsequently identified and listed on a capital works completion form and the draft enhancement plan is updated.

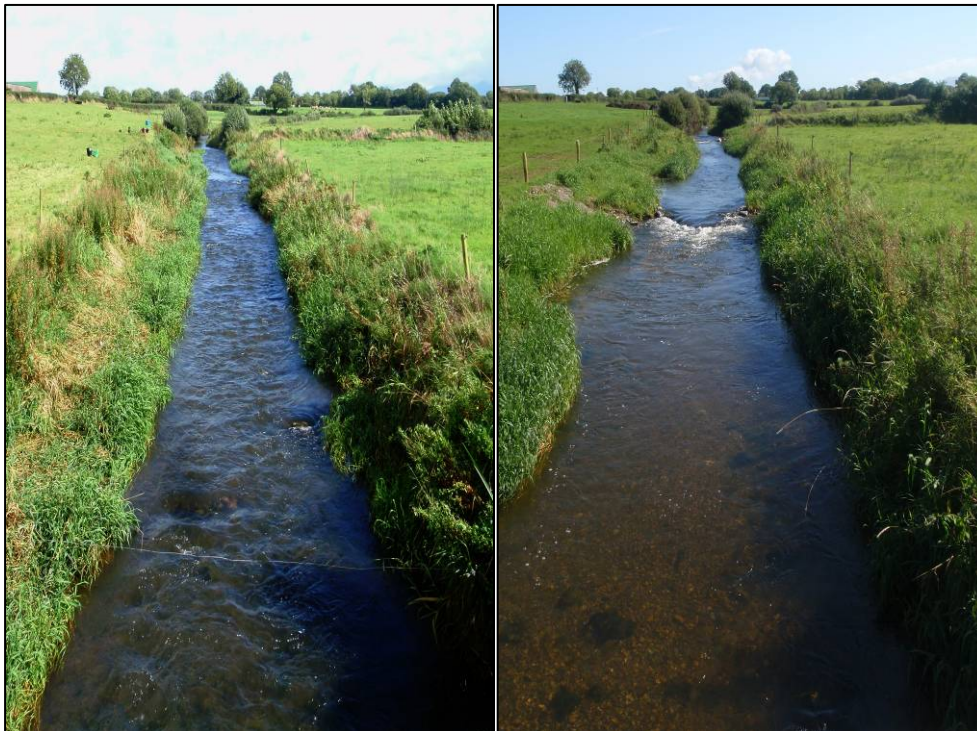
Plates 5.1. The Morningstar experimental site pre-works (Left) and post works (Right) looking upstream.

A capital works plan for the Morningstar was submitted to the OPW in 2008. However, heavy rainfall in 2008 delayed its start. Works on this site were initiated and completed in 2009 with gravel shoals, vortex weirs, rubble mats, rip rap and thalweg all constructed through the 1.23 km long site. Pre-works a 130m experimental site was selected within this works zone as a location to be monitored (Plate 5.1). Cross sectional, depth- and longitudinal profiles were also measured before and after works.

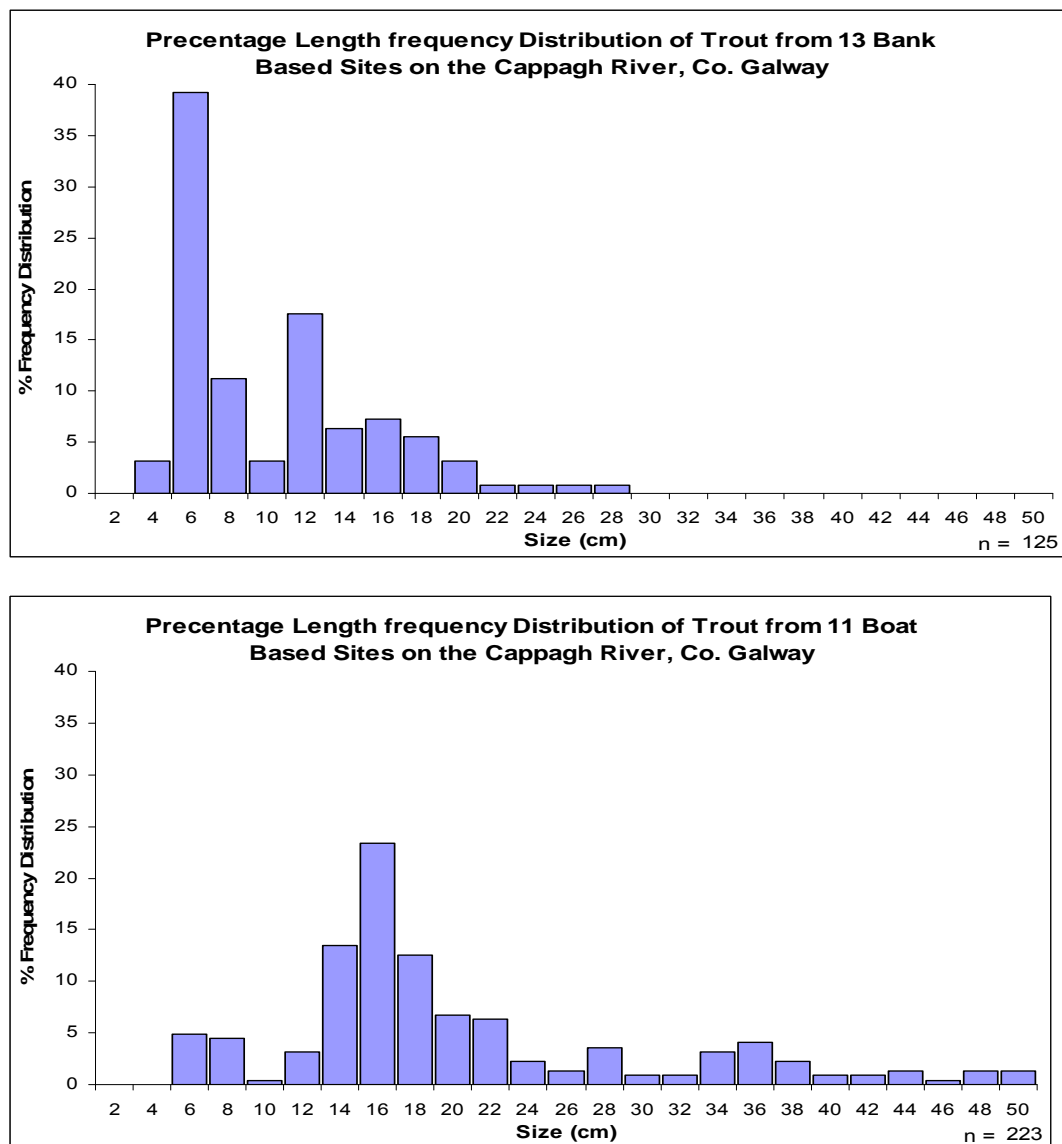
Figure 5.3. Showing the percentage length frequency distribution of trout sampled from the boat and bank based surveys of the Cappagh River, 2009.

This separation of trout age classes into different habitat types shows how the fish utilise different parts of the river as they grow. Trout spawn in shallow riffle areas with gravel beds, the 0+ juveniles spend their first year of life in this type of habitat. During their second year they move to the shallow glides and pools of the river. As >1+ the trout require deeper sections of the river and may even run to lakes on the catchments to continue growing only returning to the shallow sections of their native river to spawn.

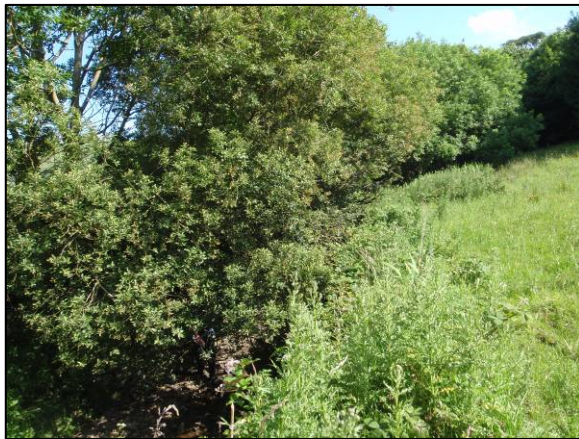
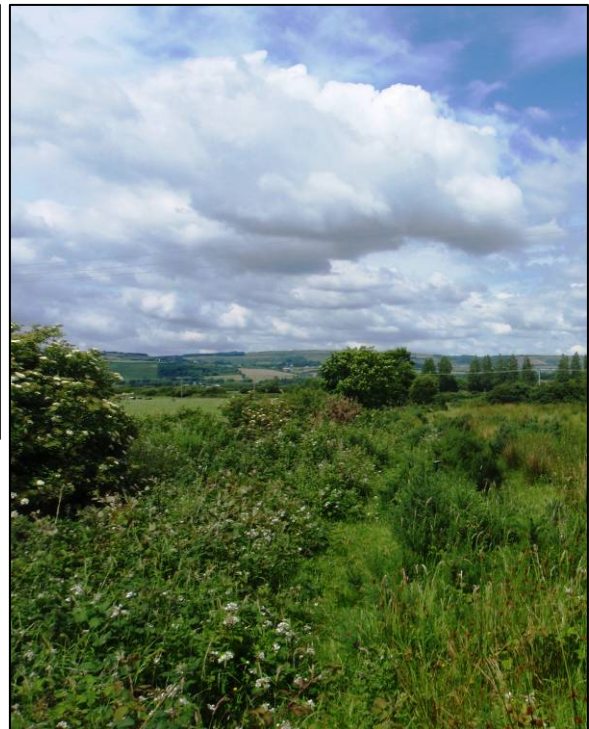
Plates 5.5. Showing undrained (Left) and drained sites (Right) on the Dirtoge stream (C1/34), Co. Kerry.

The fish survey in the drained site had five 30m replicates, while the undrained site had three 30m replicates. This was due to difficult fishing conditions in the undrained site.

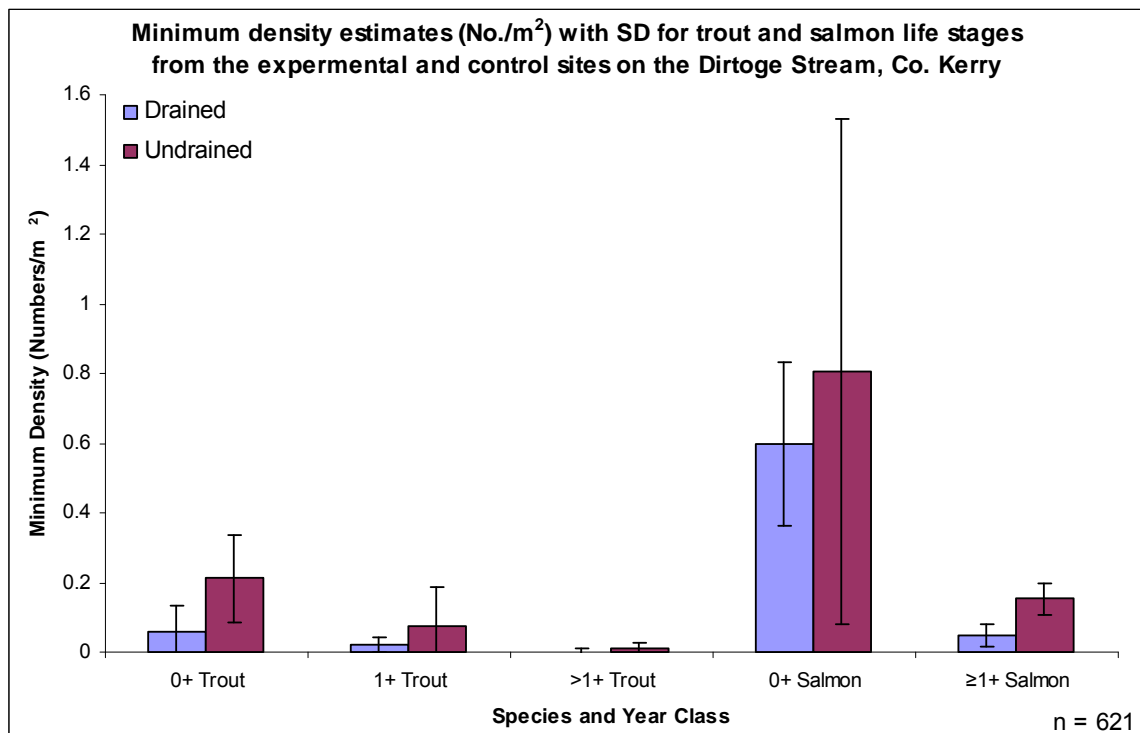
Figure 5.9. Minimum density estimates for trout and salmon (No. /m²) at different life stages with relevant standard deviations, for the drained and undrained sections on the DIRTAGE Stream (C1/34), Maine Catchment, Co. Kerry

No statistical difference in age or size distributions were found when comparing the trout and salmon populations from the drained and undrained sites. However, greater numbers of salmon and trout were present in the undrained section. Loss of suitable habitat type, post drainage, in the drained section may be responsible for its reduced salmonid numbers.

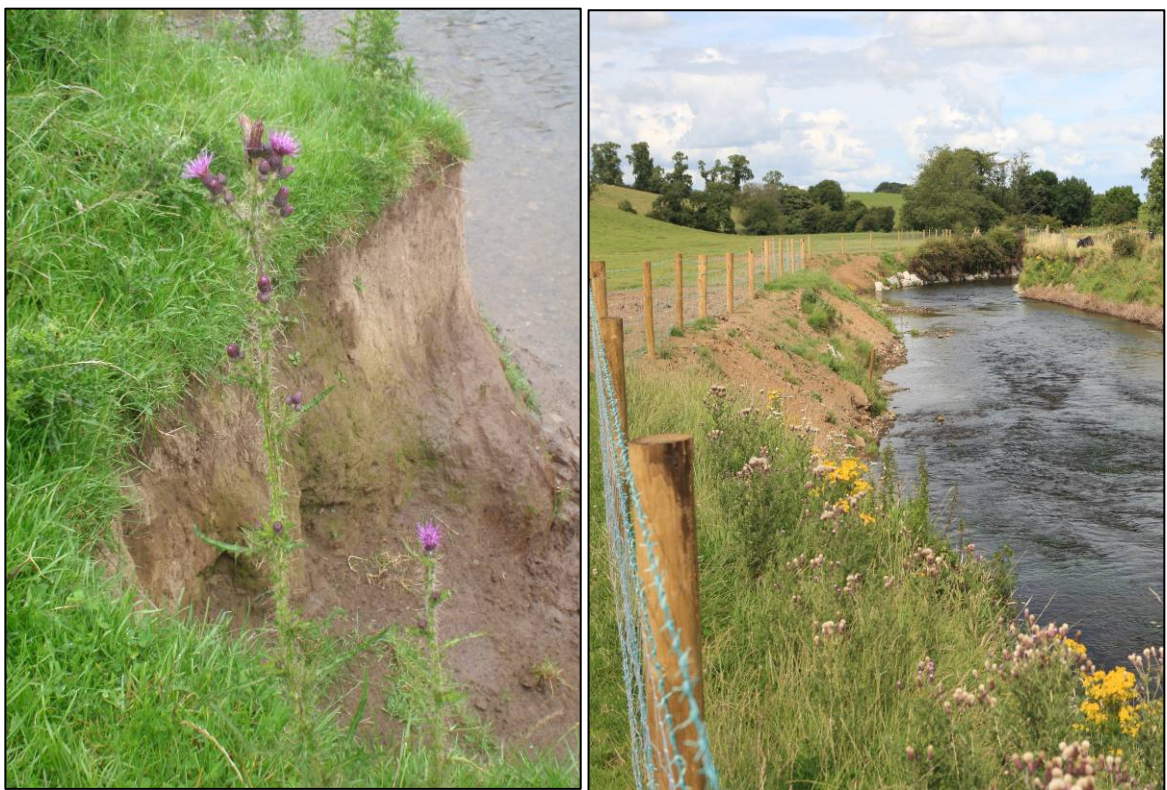
Plate 5.6: River banks on the River Dee pre and immediately post works.

The observed change in the experimental section is likely due to a combination of fencing and the creation of new, reprofiled bank slopes that were initially bare (Plate 5.6). The new fencing allowed plants to establish without being grazed/trampled by livestock. Previously, large parts of the banks were heavily eroded and under pressure from livestock. This kept the banks bare in places. Plants associated with early colonisation such as Rape Seed (*Brassica napus*) and other meadow species have now established with greater frequency on the river banks. These plant species are occurring alongside the flora that already existed in areas not subject to works.

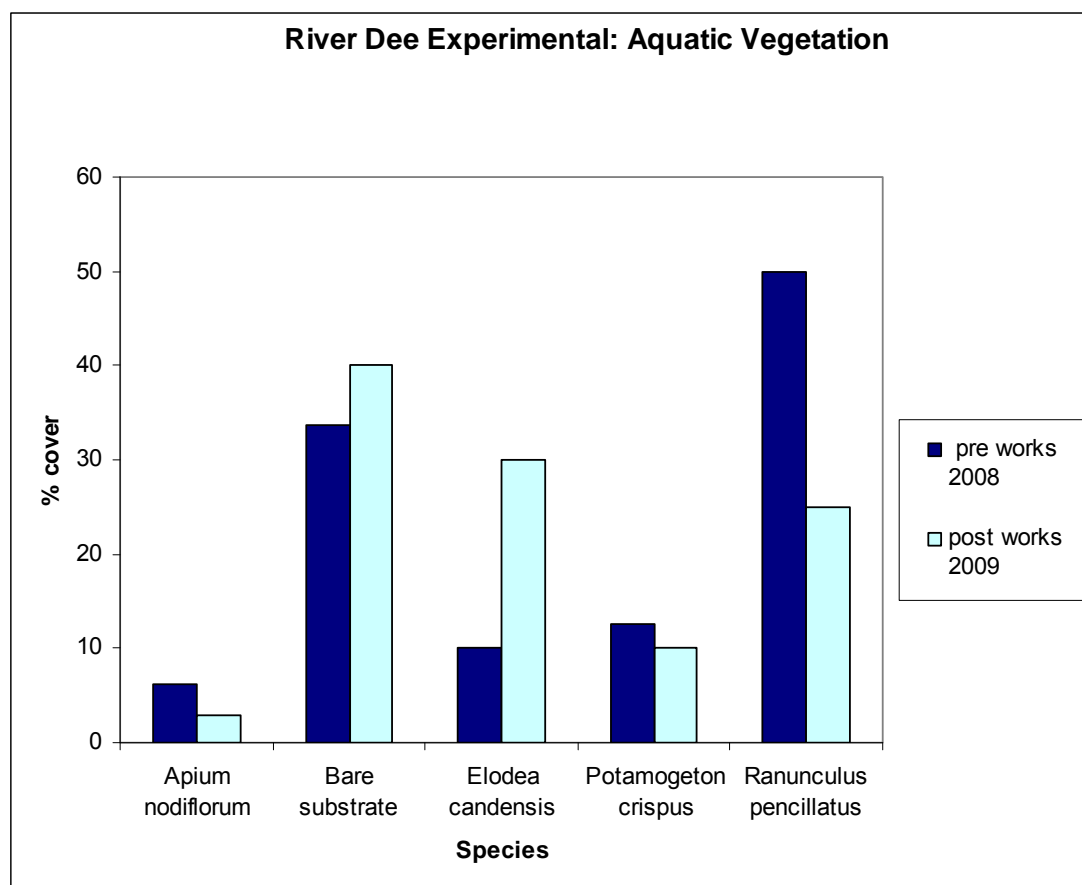
Figure 5.11: Percentage cover of channel bed pre and post works for aquatic vegetation and areas of bare substratum

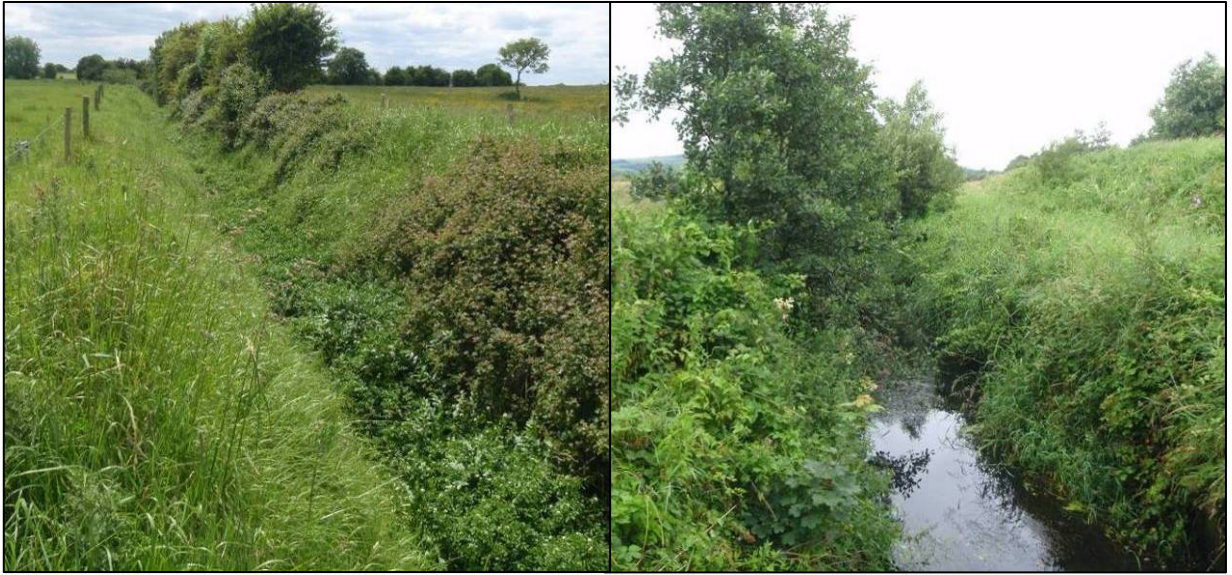
Plate 5.7: Drains on the Morningstar (left) and Blanket Nook scheme (right) with riparian vegetation characterised by semi/improved grassland, scrub/woodland and intermediate types.

The riparian vegetation was often transitional in nature with intermediate types frequently present (Plate 5.7). This is a product of their management regime. The drains are not subject to the same intensity of management as the surrounding landscape which accounts for their transitional nature. Nevertheless, they are maintained regularly enough by the OPW to reset the successional process, whereby the pattern of colonisation and competition is repeated.

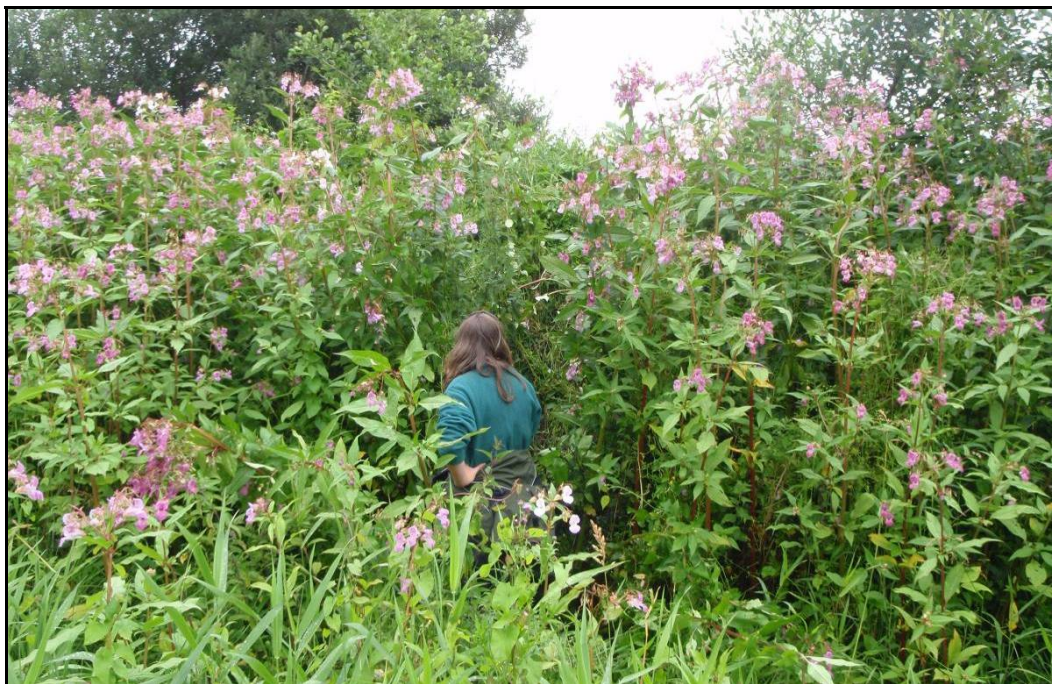
Plate 5.8: Himalayan balsam forming extensive patches over an OPW track way and spoil heap in Blanket Nook, Donegal.

Japanese Knotweed (*Fallopia japonica*), Himalayan balsam (*Impatiens glandulifera*) and Giant hogweed (*Heracleum mantegazzianum*) are non-native species that have been introduced to Ireland. They occur along watercourses, ditches and transport routes. Many elements of their ecologies are similar – they have growth habit that aerially dominate or preclude other plant species from growing as an understorey. They grow rapidly, spread easily, out-compete native flora and readily colonise new areas. As such, they pose a threat to the native floral biodiversity along impacted river corridors. Giant hogweed is also harmful to humans as the sap can cause third degree burns. All species die back in winter leaving river banks very vulnerable to erosion during winter floods. This is a particular problem with Himalayan balsam (Plate 5.8) and Japanese Knotweed (Plate 5.9) which can form extensive stands over large areas. The plants can be dispersed by humans in two main ways. Firstly, by contaminated machinery/shoes or the moving of soil, or, secondly through disturbance of water courses (e.g. in maintenance) allowing fragments/seeds to float downstream and establish in new areas.

These plant species are an acute problem given the mechanical nature of OPW maintenance works. Such work fragments vegetation, contributing to dispersal opportunities. Removal leads to extensive areas of bare soil on bank slopes and bankfull lines, due to absence of any plant understorey. This can lead to destabilisation of bank areas and loss of sediment into the channel. From a fisheries perspective, an increased sediment load, from bank erosion, entering the channel represents a significant threat to salmon and trout spawning. It is crucial that a strategy is developed for OPW maintenance works that limits the spread of invasive species and minimises the ‘disturbance’ associated with their management and removal. The recommendations given below follow the best practice management documents produced by the Invasive Species Ireland project (a joint venture between Northern Ireland Environment Agency, NIEA, and the NPWS – (<http://www.invasivespeciesireland.com/downloads/>)).

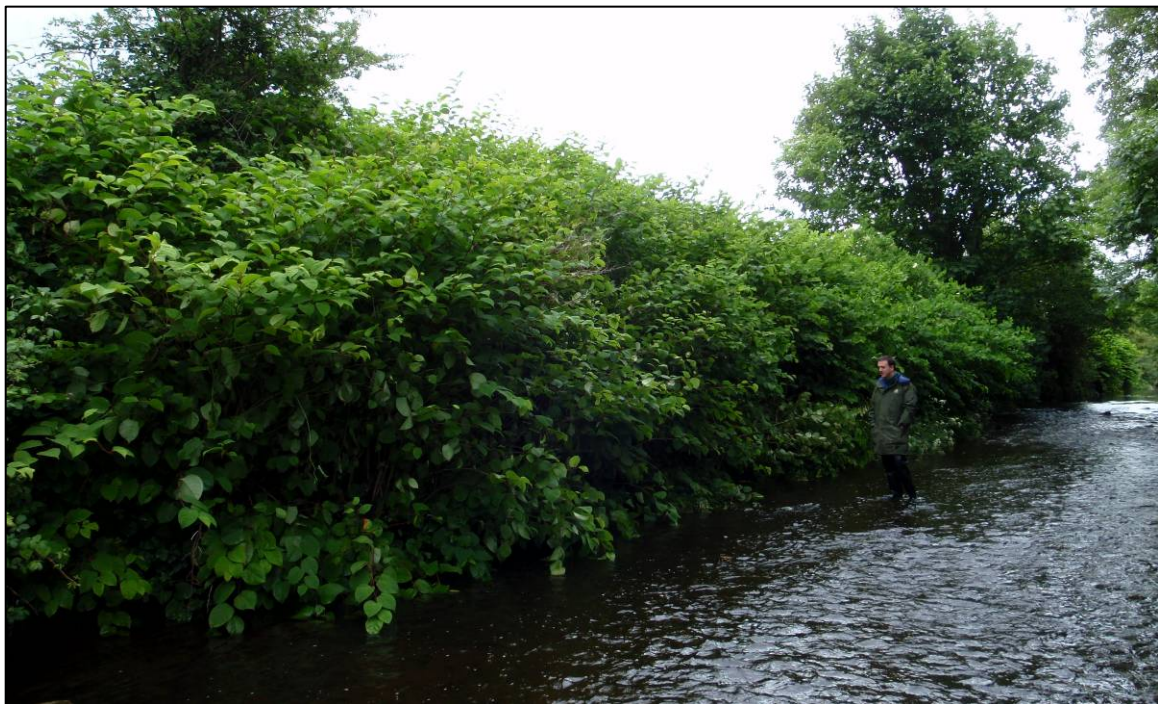
Plate 5.9: Japanese Knotweed is the dominant riparian vegetation on stretches of the River Maine, Kerry.

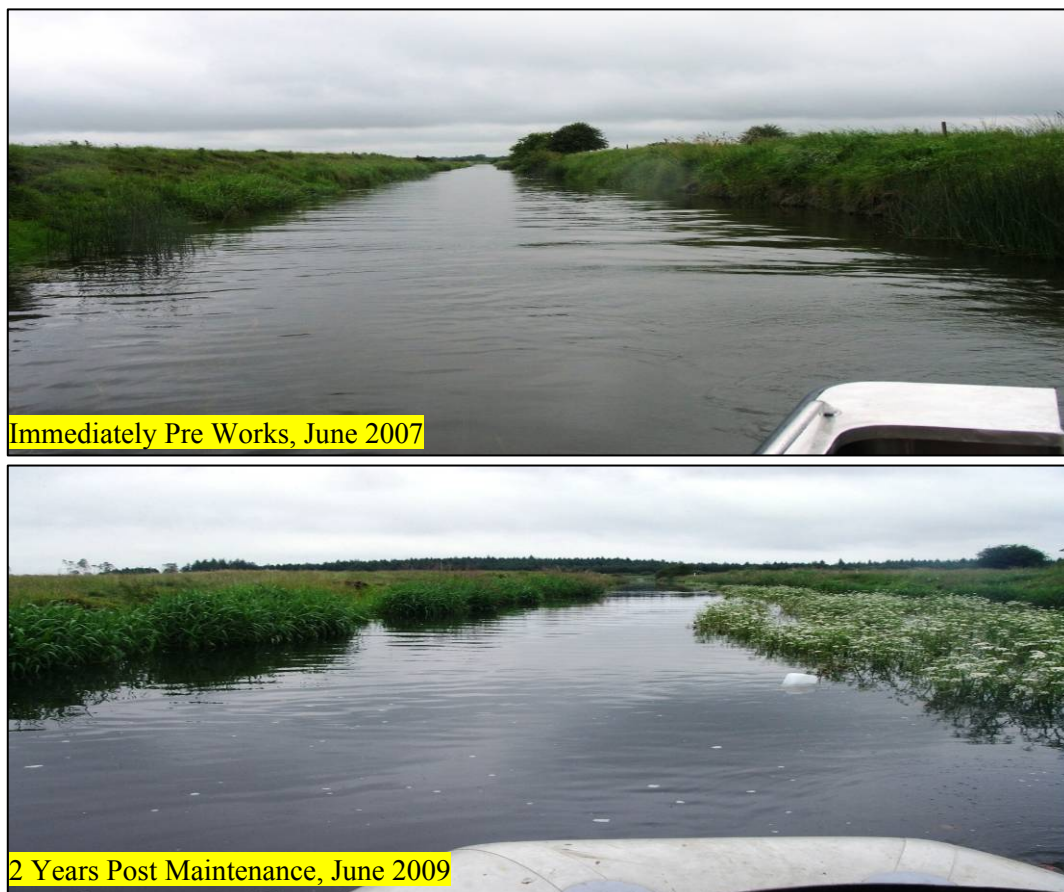
Plate 6.2.1 R. Brosna Site comparison photographs taken immediately post works, June 2007 and 2 years post maintenance, June 2009.

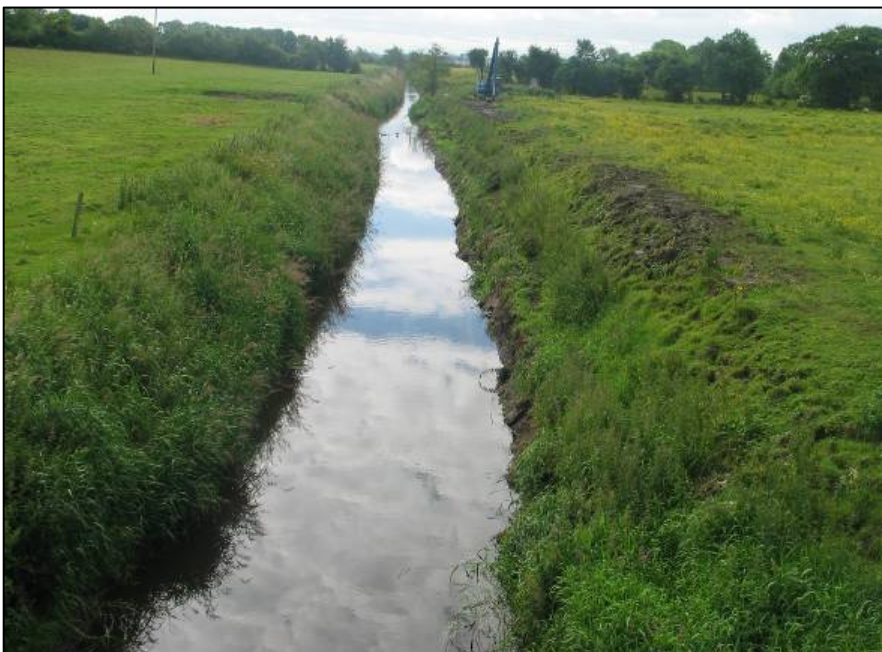
Figure 7.1. Example of a low RHAT score: uniform channels no diversity instream or on banks, evidence of channelisation.

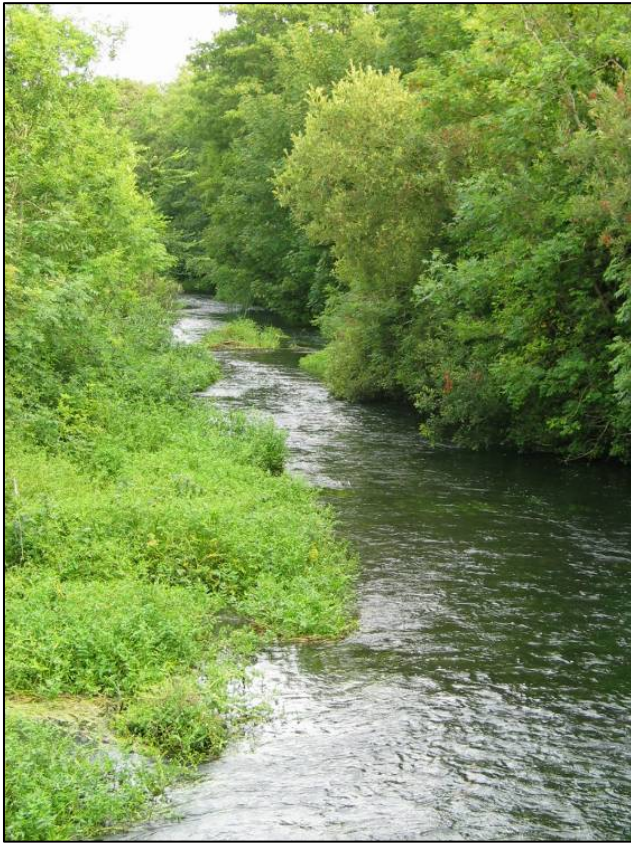
Figure 7.2. Example of a high RHAT score channel.

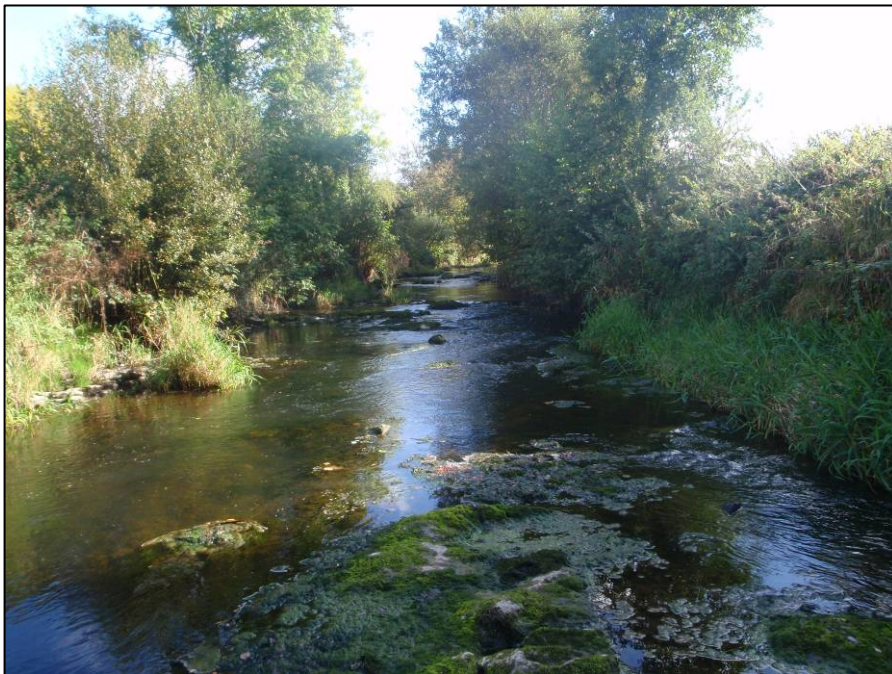
Figure 7.3. Example of a high RHAT score channel.

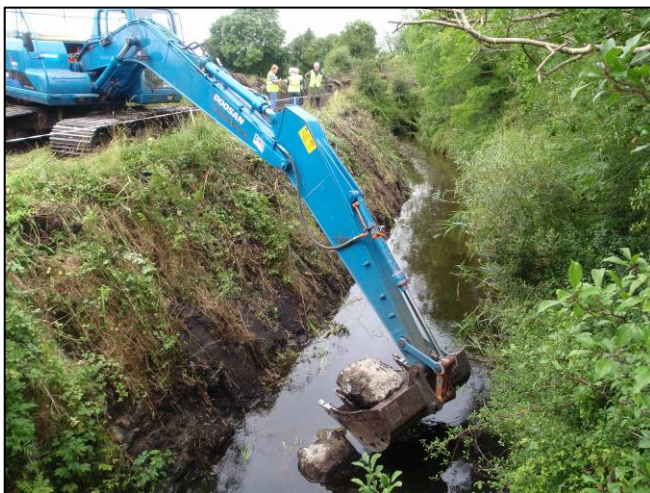
Plate 9.1. Good compliance of the “10 Steps” with instream fishery enhancement works also achieved.

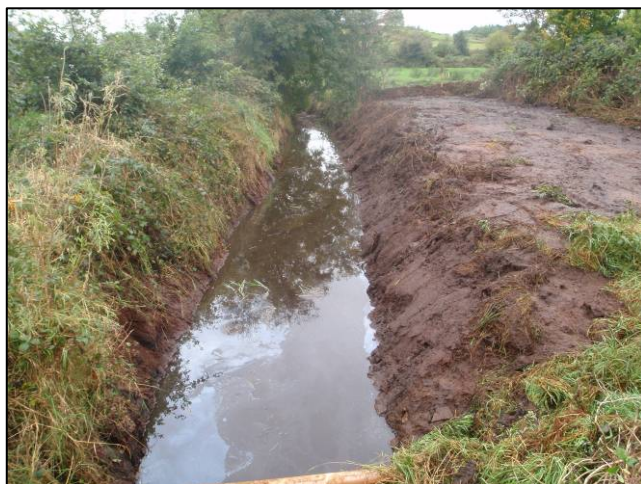
Plate 9.2. Excessive removal of bed material. Deposition of spoil on both bank slope and bank full line. Damage to non-working bank evident.

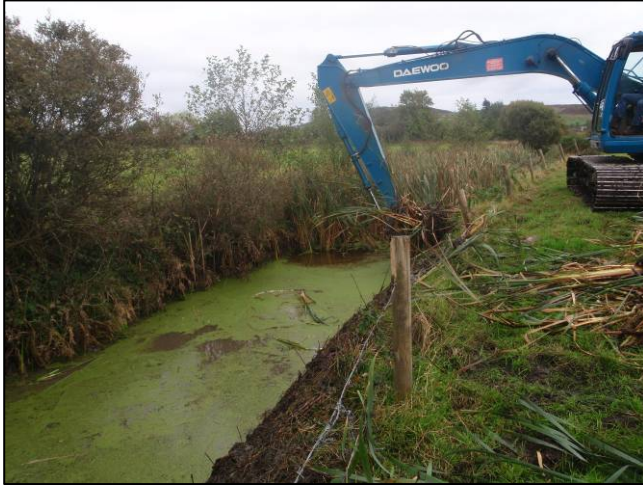
Plate 9.3. Excessive removal of instream and marginal vegetation and damage to non-working bank.
