River Boyne WFD III Barrier Assessment Obstacles to Fish Passage and Mitigation Options

Citation: Donovan, R., Coghlan, B., O’Brian, R., O’Connell, A., & O’Leary, C., (2023). River Boyne WFD 111 Barrier Assessment – Obstacles to Fish Passage and Mitigation Options. National Barriers Programme. Inland Fisheries Ireland. Citywest, Dublin.

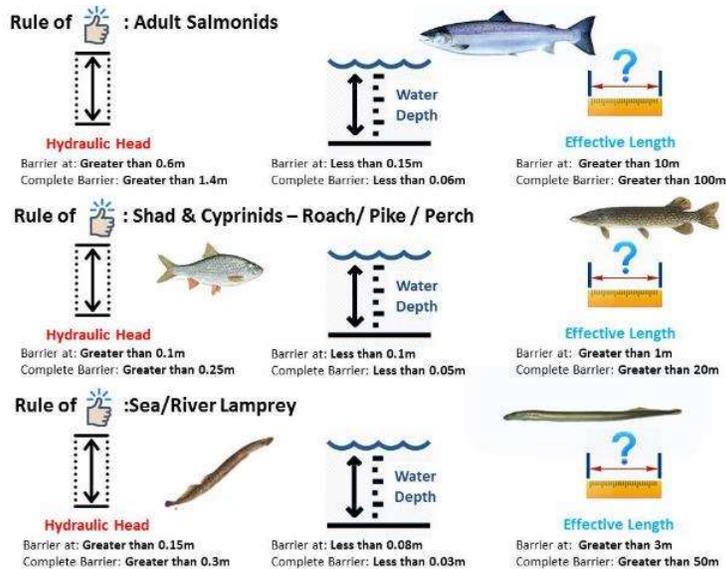
Figure 1. Guideline metrics for assessing barrier risk.

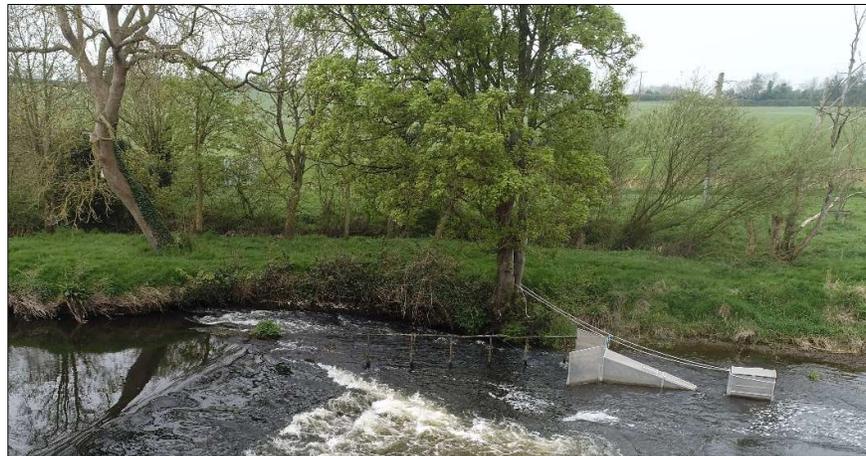
Transversal 1:

Figure 6. Transversal Section 1.

In prevailing conditions, the effective length (10.8 m) of this sloping section of weir created a high impact partial barrier (score 0.3) for the upstream migration of cyprinids, adult lamprey, and juvenile salmonids (Figure 6). The same effective length presented a low impact partial barrier for adult salmonids. The available climbing substrate meant that juvenile eel encountered no barrier (score 1.0) at this passage option. Downstream migrants faced no barrier (score 1.0) at this transversal due to sufficient depths and low velocities at the crest. Higher flows would be unlikely to improve the passability of species other than salmonids.

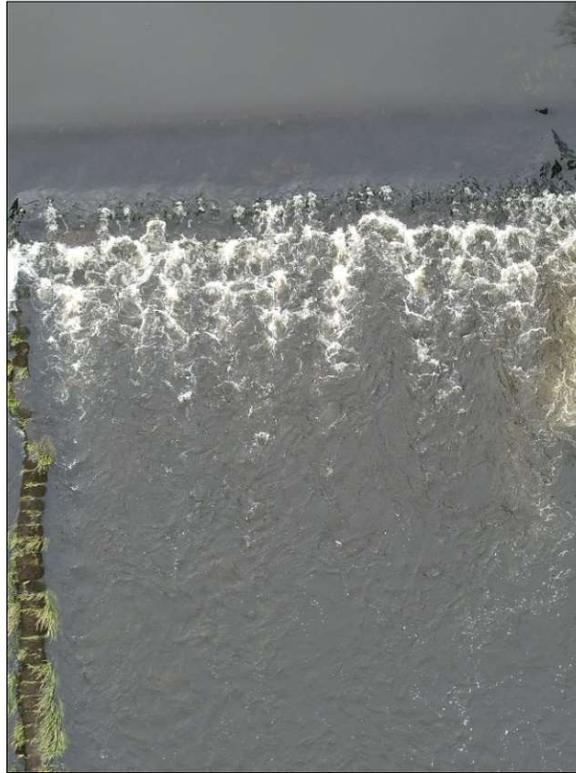
Transversal 2:

Figure 7. Transversal Section 2.

In prevailing conditions, this transversal was a complete barrier (score 0.0) to the upstream migration of juvenile eel. The streambed velocities at the outlet and midpoint created an insurmountable swim barrier for the species. Cyprinids, adult lamprey, and juvenile salmonids encountered a high impact partial barrier (score 0.3) when migrating upstream, primarily due to medium levels of turbulence (Figure 7). The turbulence also restricted passage for adult salmonids, although to a lesser extent. For adult salmon and adult trout, a low impact partial barrier (score 0.6) was established by the medium levels of turbulence. Migrants traversing the slope in a downstream direction encountered no barrier (score 1.0). In high flows, passability is unlikely to improve due to the potential for increased turbulence.

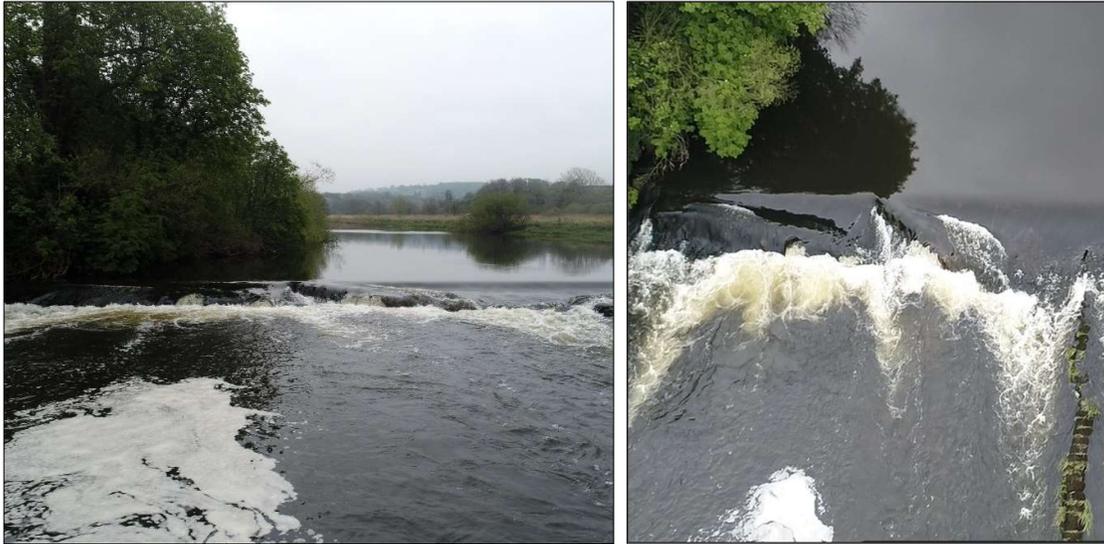
Transversal 3:

Figure 8. Transversal Section 3- facing upstream (left) and from above (right).

In prevailing conditions, this transversal was a high impact partial barrier (score: 0.3) for the upstream migration of cyprinids, adult lamprey, juvenile eel, and juvenile salmonids (Figure 8). Medium levels of turbulence and the slope (15.18%) were the primary obstacles. These factors also impeded the upstream migration of adult salmonids, creating a low impact partial barrier (score 0.6). Downstream migrants encountered no barrier (score 1.0). Higher flows are unlikely to improve the passability of this section of weir for any species.

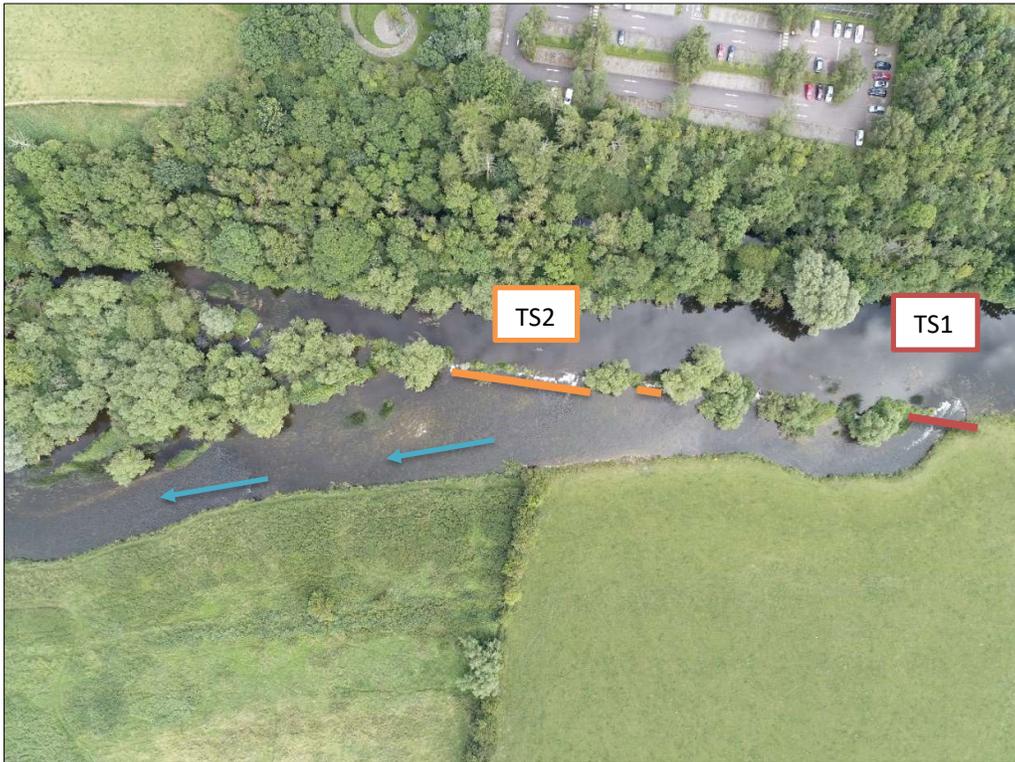
Figure 11. The two transversal sections of Dowth Weir. Drone imagery taken 15/07/2021.

On the date of survey, the water height at Slane Castle gauging station (07012) was 0.596 m. The hydraulic head height of the weir measured 0.44 m. The total width of the barrier along the crest was 402.4 m metres, while the total width of the channel at this point was 55.8 metres. The weir presented two transversal sections for fish to attempt passage (Figure 11), which are described below.

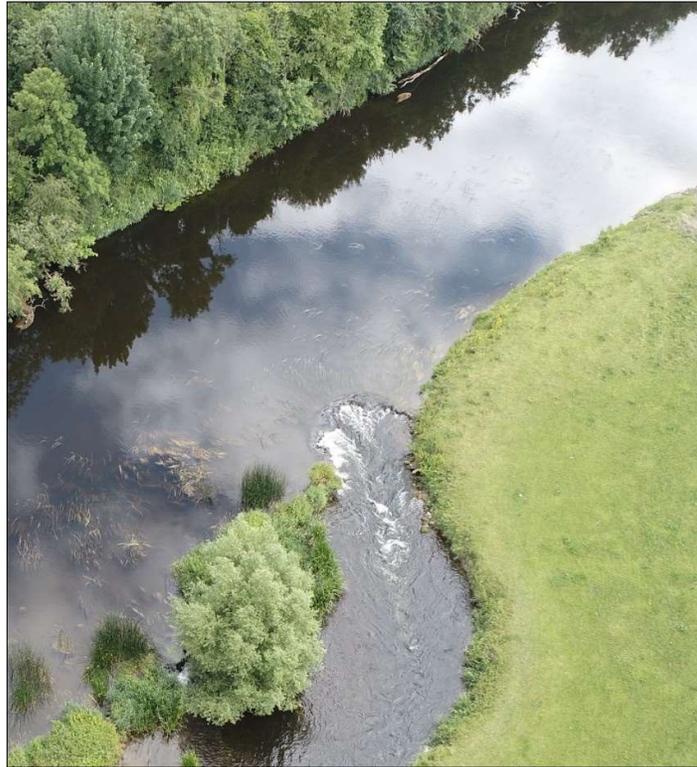
Transversal 1:

Figure 12. Transversal Section 1.

In prevailing conditions, the effective length (8.5 m) of this transversal was a barrier to all upstream migrating species except adult salmonids and juvenile eel (Figure 12). Juvenile eel could bypass what would have been a high impact partial barrier (score 0.3) by utilizing the available climbing substrate. Cyprinids traversing this section of the weir, however, had no alternative to the high impact partial barrier (score 0.3) created by the effective length. Juvenile salmonids and adult lamprey were impacted to a lesser degree, with the effective length representing a low impact partial barrier (score 0.6). Downstream migrants encountered no barrier (score 1.0) to passage at this transversal. Higher flows are unlikely to improve the passability of this section of weir for any species.

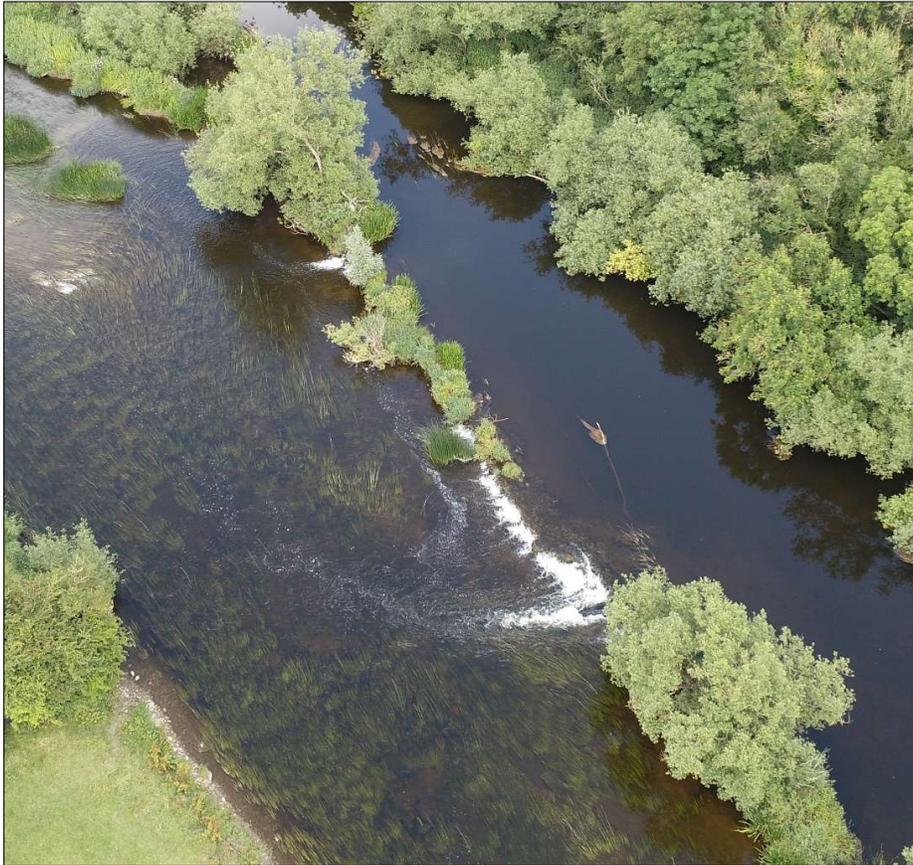
Transversal 2:

Figure 13. Transversal Section 2.

In prevailing conditions, the standing wave present at this transversal created a high impact partial barrier (score 0.3) for all species migrating upstream (Figure13). Medium levels of turbulence and high velocities at the outlet and midpoint compounded the challenge of upstream passage. Juvenile eel were able to circumvent the obstacles to passage by utilizing the available climbing substrate. However, cyprinids encountered a complete barrier (score 0.0) at this transversal due to the velocities. Downstream migrants faced no barrier (score 1.0) at this transversal. Higher flows are unlikely to improve passage for any species at this transversal.

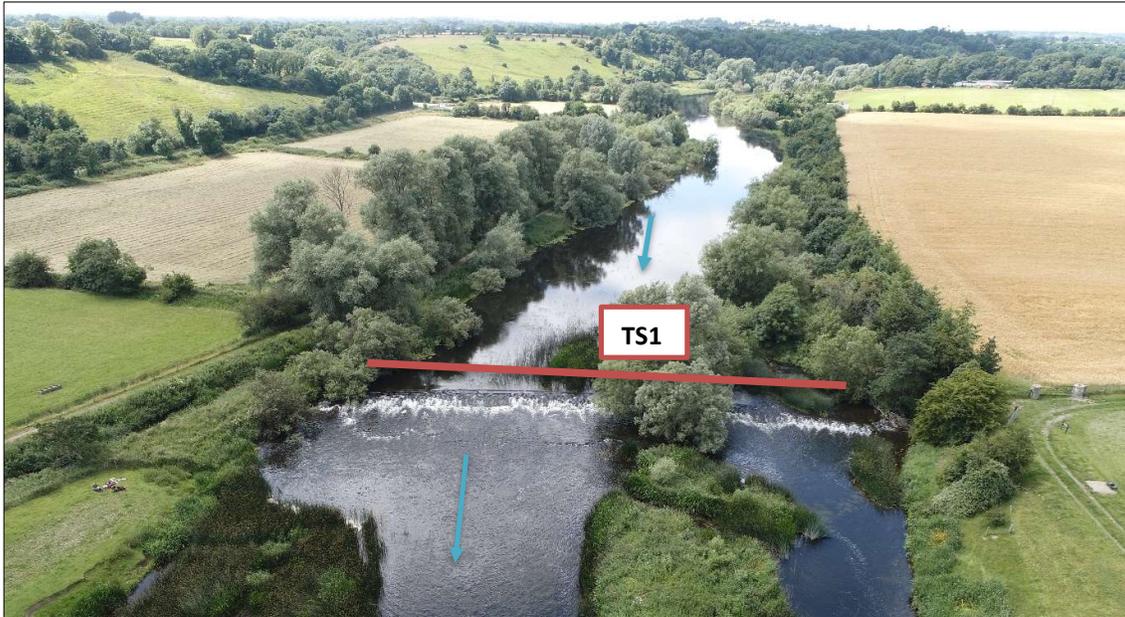
Figure 16. The single transversal section of Roughgrange Weir. Drone imagery taken 15/07/2021.

On the date of survey, the water height at Slane Castle gauging station (07012) was 0.616 m. The hydraulic head height of the weir measured 0.43 metres. The total width of the barrier along the crest was 78 metres. The structure crossed the river at a nearly 90-degree angle, as demonstrated by the

similar channel (77.09 m) and barrier crest (78 m) widths (Figure 16). The sloping weir presented a single transversal section for fish to attempt passage (Figure 16), which is described below.

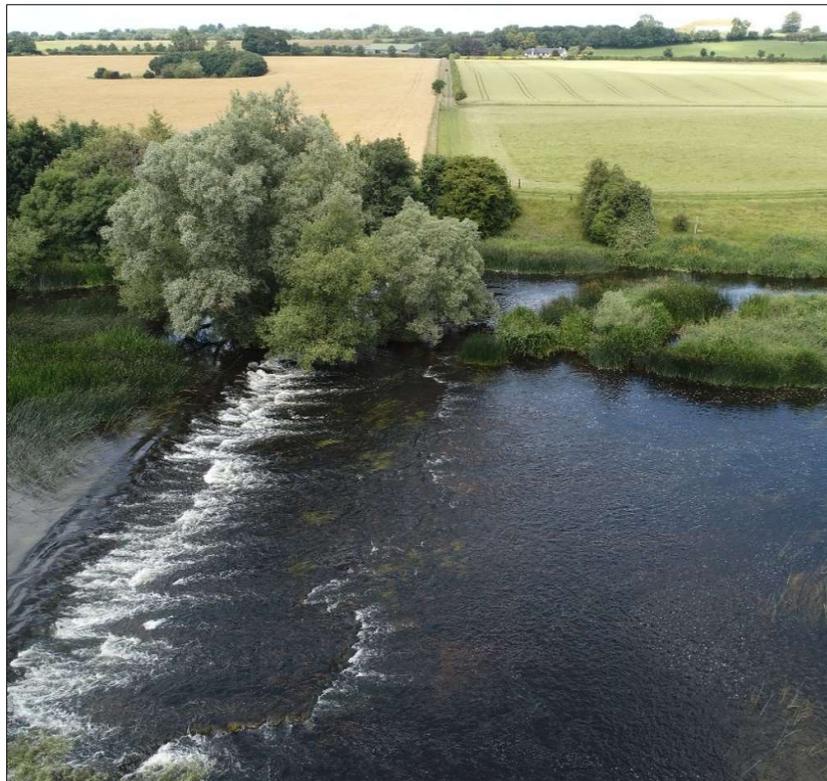
Transversal 1:

Figure 17. Transversal Section 1.

In prevailing conditions, this structure was a high impact partial barrier (score 0.3) to the upstream migration of all species except adult salmonids (Figure 17). Medium levels of turbulence were the primary issue. Adult salmonids were impacted to a lesser extent by turbulence and were met with a low impact partial barrier (score 0.6). Downstream migrants faced no barrier to passage (score 1.0) at this weir due to a lack of debris or damaging structures blocking the structure. Additionally, the crest supplied adequate depths and traversable velocities. Higher flows would be unlikely to improve the passage scores for any species.

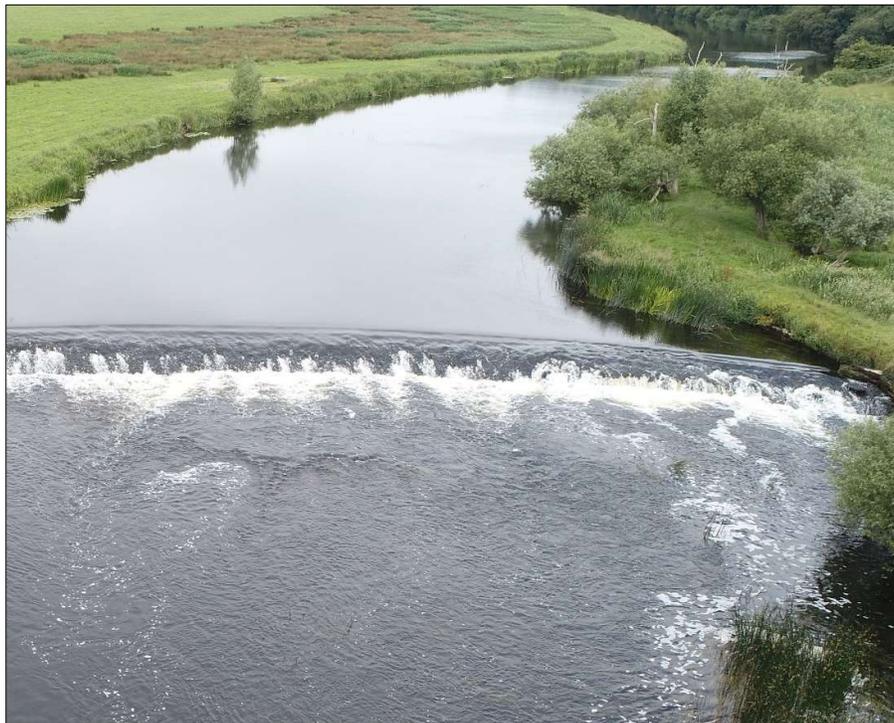
Transversal 1:

Figure 21. Transversal Section 1.

In prevailing conditions, this structure was a high impact partial barrier (score 0.3) to the upstream migration of all species except juvenile eel. The presence of a standing wave limited the progression of fish in an upstream direction (Figure 21). Due to the availability of a suitable climbing structure, juvenile eel were able to circumvent the aquatic elements and therefore encountered no barrier (score 1.0). The passage of cyprinids, adult lamprey, and juvenile salmonids was further obstructed by the slope (19.29%) and medium levels of turbulence. These factors created additional high impact partial barriers (score 0.3) for the species. Downstream migrants faced no barrier to passage (score 1.0) due to a lack of debris or damaging structures blocking the structure. Additionally, the crest supplied adequate depths and traversable velocities. Higher flows would be unlikely to improve the passage scores for any species.

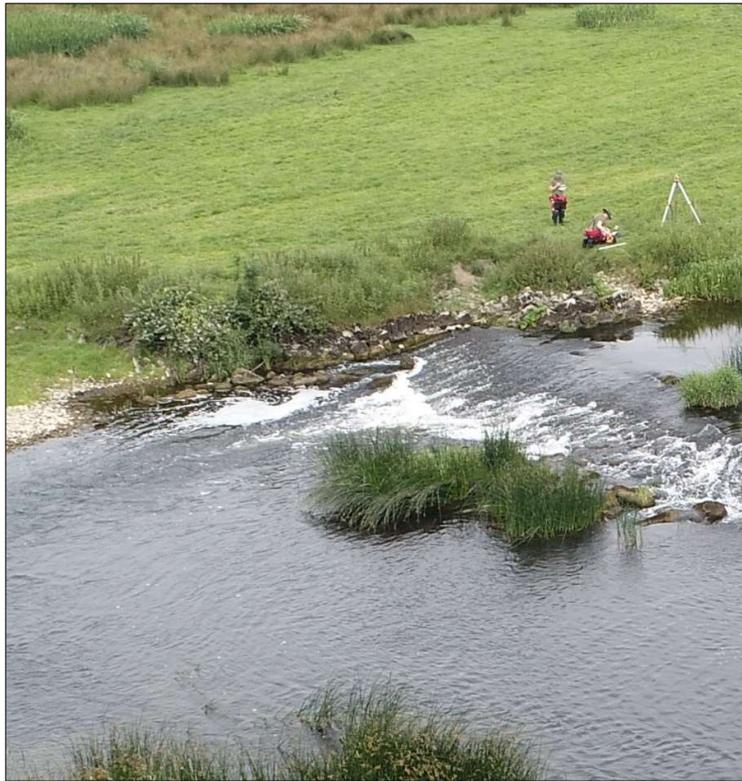
Transversal 2:

Figure 22. Transversal Section 2.

In prevailing conditions, this structure was a high impact partial barrier (score 0.3) to the upstream migration of salmonids and adult lamprey. The presence of a standing wave severely limited their migratory progress (Figure 22). Cyprinids and juvenile eel were also hindered by the standing wave but faced a greater obstacle in the form of high velocities. At the outlet and midpoint, the water velocity created a complete swim barrier for these species (score 0.0). Compounding factors impeding upstream migration for all species were the slope (18.84%) and medium levels of turbulence. Downstream migrants faced no barrier to passage (score 1.0) at this transversal. Higher flows would be unlikely to improve the passage scores for any species.

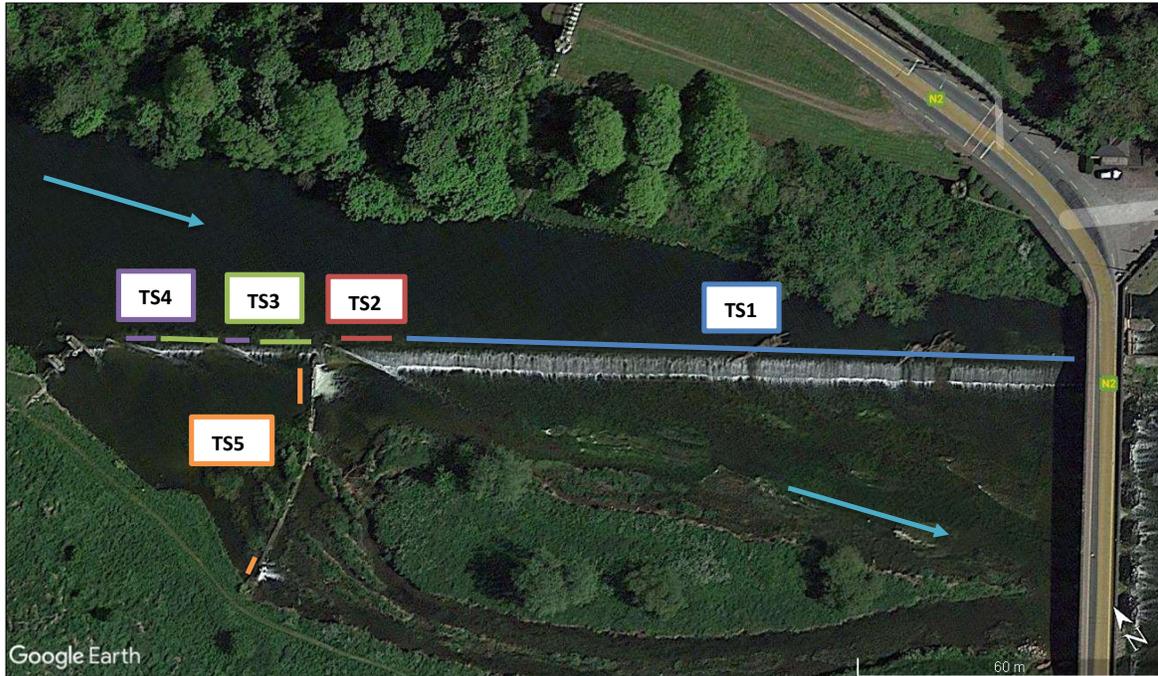
Figure 26. The five transversal sections of Slane Weir. Imagery from 05/07/2017, *Google Earth*, earth.google.com/web/.

On the date of survey, the mean water height at Slane Castle gauging station (07012) was 0.624 m. The hydraulic head height of the weir varied from 0.74 to 0.75 m. The total width of the barrier along the crest was 208.79 metres, excluding the perpendicular section containing transversal 5. The width of the channel at this point was 82.68 metres. The sloping weir presented five transversal sections for fish to attempt passage (Figure 26), which are described below.

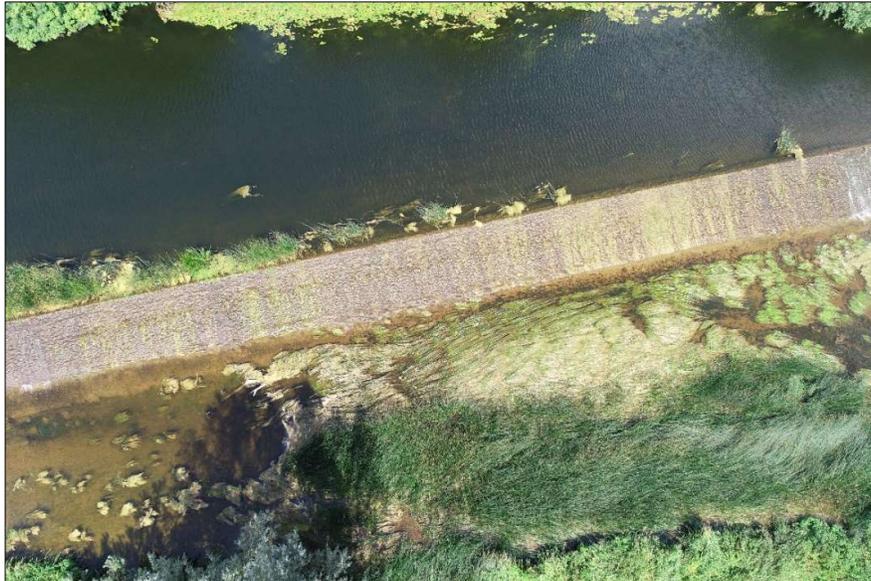
Transversal 1:

Figure 27. Transversal Section 1.

In prevailing conditions, this transversal was a complete barrier (score 0.0) to the upstream migration of all species, except for adult lamprey and juvenile salmonids (Figure 27). The consistently low depths across this passage option, but particularly at the outlet (0.04 to 0.05m) and midpoint (0.04 to 0.05 m) were the primary inhibiting factor. However, for juvenile eel it was not the depths, but the velocities greater than 0.8m/s that prevented upstream passage. Adult lamprey and juvenile

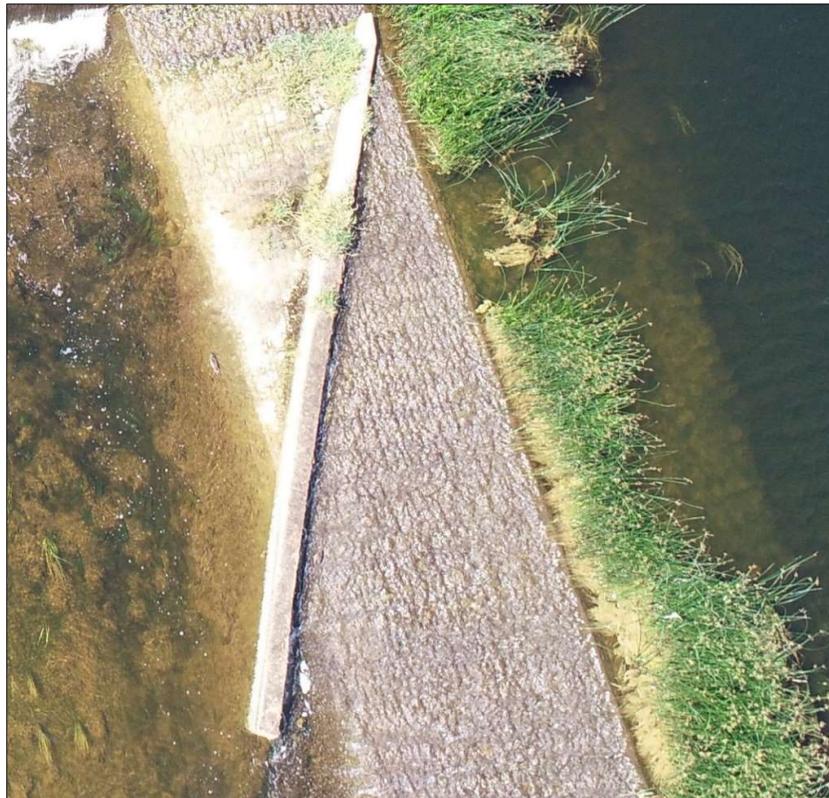
Transversal 2:

Figure 28. Transversal Section 2.

In prevailing conditions, this transversal was a complete barrier (score 0.0) to the upstream migration of cyprinids and juvenile eel. Salmonids and adult lamprey encountered a high impact partial barrier (score 0.3). The primary limiting factor to passage for all species were the velocities at the outlet (2.6 to 3.36 m/s). The lack of effective resting locations, medium levels of turbulence, and effective length

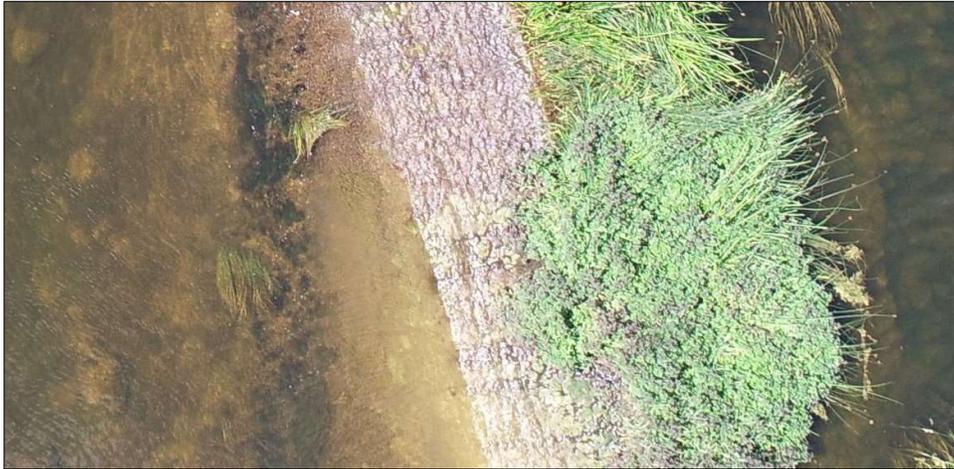
Transversal 3:

Figure 29. Transversal Section 3.

In prevailing conditions, this slope was a complete barrier (score 0.0) to the upstream migration of cyprinids and adult salmonids. Juvenile salmonids, juvenile eel, and adult lamprey were met with a high impact partial barrier (score 0.3). Low depths (0.04 to 0.06 m) across the transversal were the primary obstruction to passage affecting all species, except juvenile eel. Velocities at the outlet (0.57 to 1.33 m/s) were the main obstacle for juvenile eel. The slope (32.17%) was also a limiting factor. It created a low impact partial barrier (score 0.6) for adult salmonids, and a high impact partial barrier (score 0.3) for cyprinids, adult lamprey, and juvenile salmonids (Figure 29).

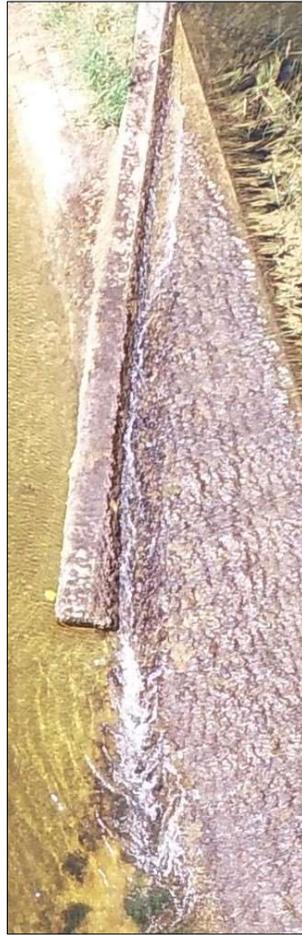
Transversal 4:

Figure 30. Transversal Section 4.

In prevailing conditions, this transversal was a complete barrier (score 0.0) to the upstream migration of adult salmon. For all other species, this section of weir represented a more surmountable high impact partial barrier (score 0.3). A combination of low depths at the crest (0.06 to 0.07 m) and high velocities at the outlet was the primary inhibitor to upstream passage (Figure 30). Medium levels of turbulence were an additional concern.

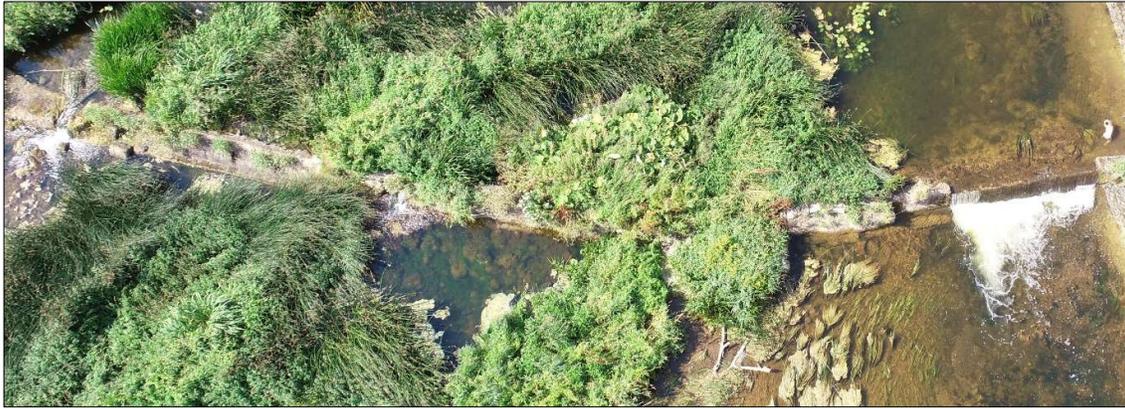
Transversal 5:

Figure 31. Transversal Section 5.

In prevailing conditions, this transversal was a complete barrier (score 0.0) to the upstream migration of all species, except adult salmonids and juvenile eel. The vertical hydraulic head height of 0.75 m was the primary obstacle (Figure 31). Juvenile eel were able to circumvent the transversal using the available climbing substrate. Therefore, this species encountered no barrier (score 1.0). For adult salmon the hydraulic head represented a low impact partial barrier (score 0.6). However, for adult trout, the vertical drop represented a high impact partial barrier (score 0.3).

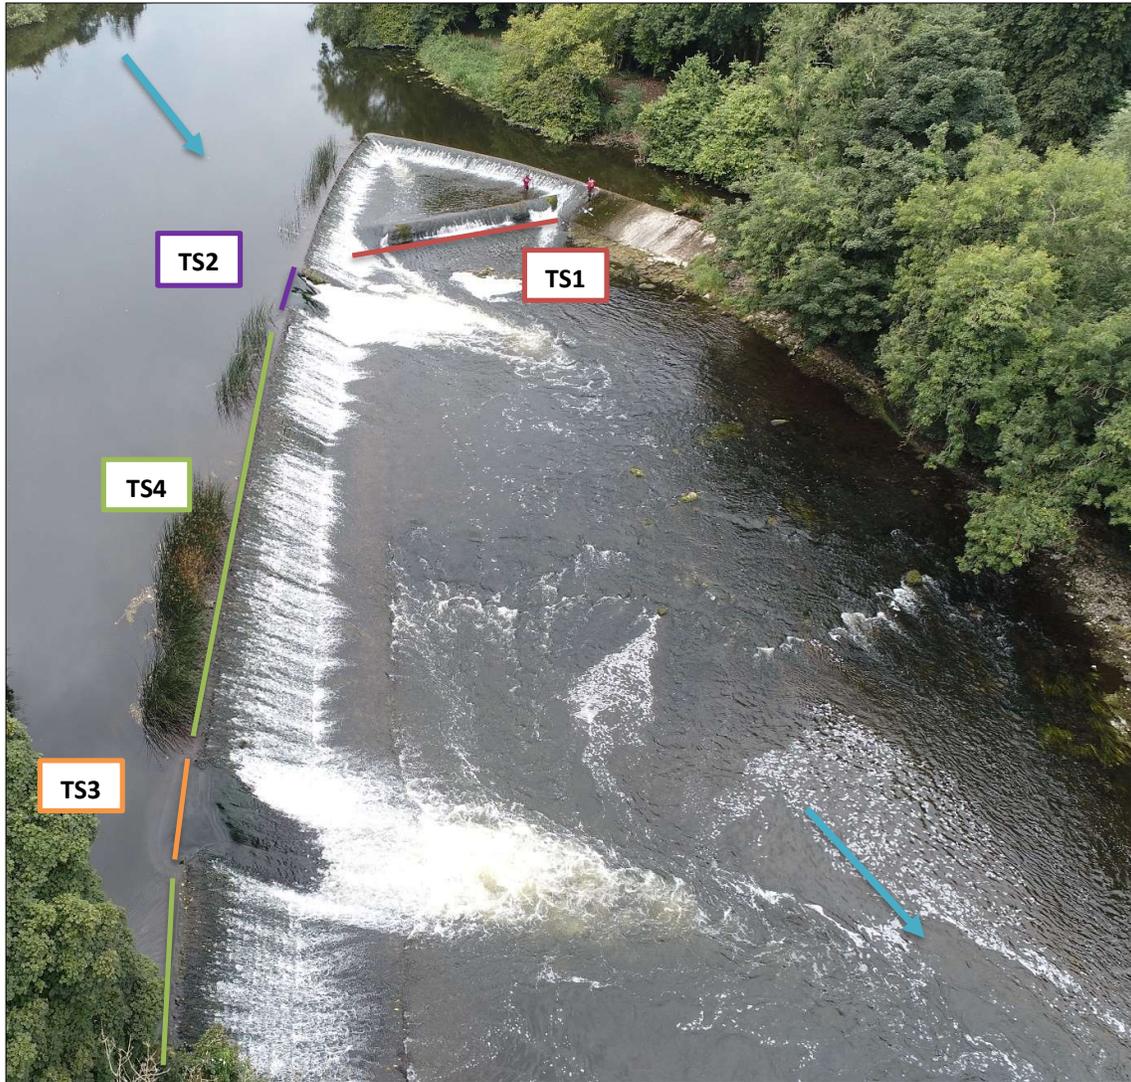
On the date of survey, the mean water height at Slane Castle gauging station (07012) was 0.573 m. The hydraulic head height of this horseshoe shaped weir was 1.593 m. The total width of the barrier along the crest was 122 metres, of which 104 metres were wetted. The width of the channel at this point was 50 metres. The sloping and stepped weir presented four transversal sections for fish to attempt passage (Figure 34), which are described below.

Figure 34. The four transversal sections of Carrickdexter Weir. Drone imagery taken 08/09/2021.

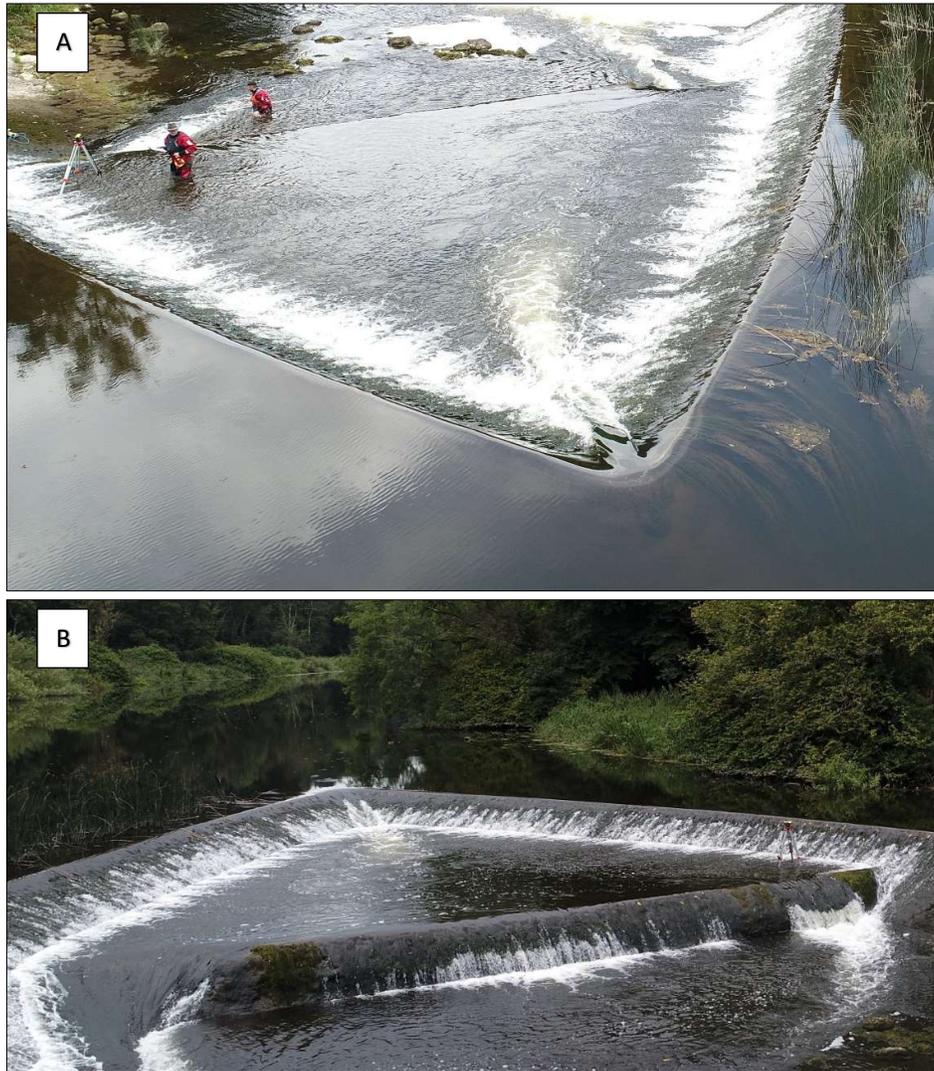
Transversal 1:

Figure 35. Transversal Section 1 from upstream (A) and downstream (B) perspectives.

In prevailing conditions, this transversal was a complete barrier to the upstream movement of juvenile eel and cyprinids (Figure 35). The velocity levels at the outlet completely barricaded the upstream environment from juvenile eel (score 0.0). For cyprinids, the step height (0.272m) represented an insurmountable jump barrier (score 0.0). The remaining upstream migratory species encountered a high impact partial barrier (score 0.3). Multiple factors compounded this score, including step water depth, the presence of a standing wave, and medium levels of turbulence. Downstream migrants were uninhibited. Higher flows could potentially improve the passage of adult salmonids by increasing step water depth. However, passage for other migratory species would likely remain unaltered.

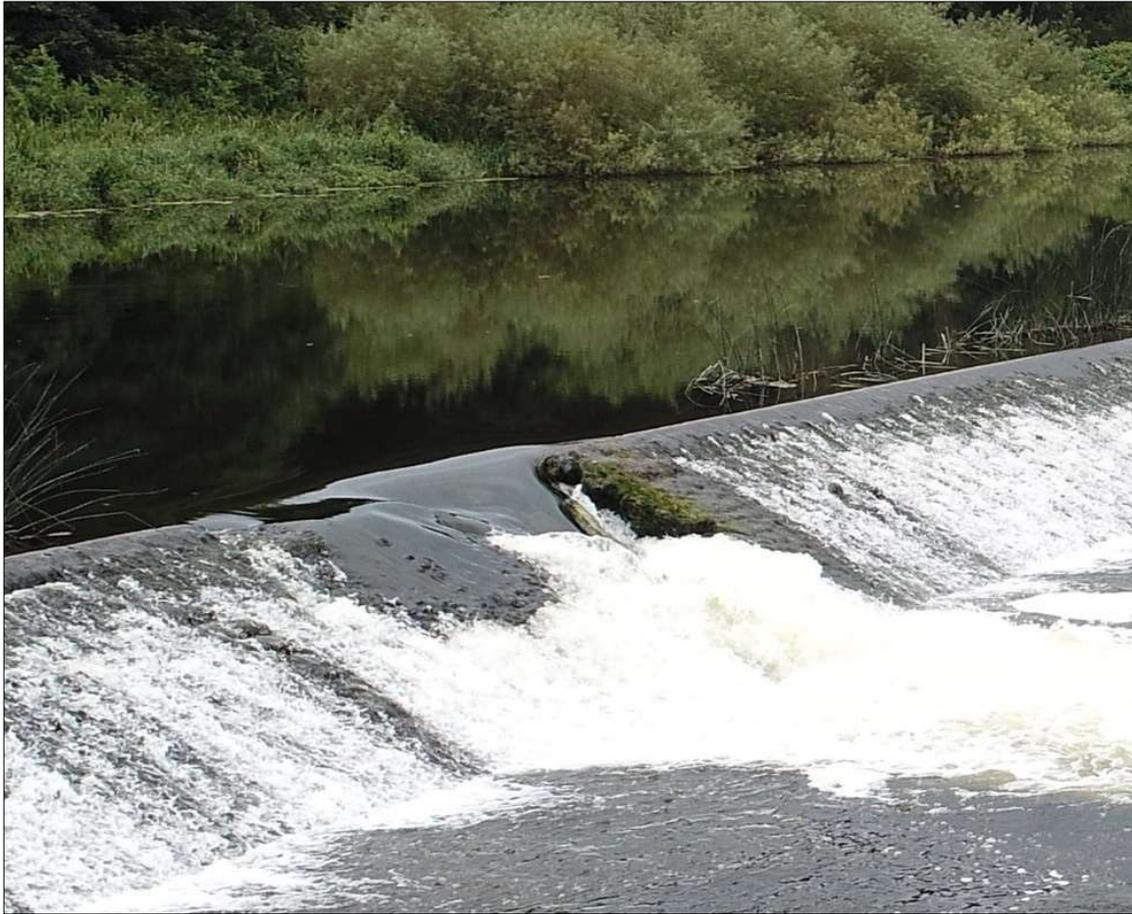
Figure 36. Transversal Section 2.

In prevailing conditions, this transversal was a complete barrier to the upstream movement of all species (score 0.0). The midpoint velocities (≥ 3.8 m/s) made this section of the weir insurmountable. Additional obstacles included a slope of 38.85%, the presence of a standing wave, and high levels of turbulence (Figure 36). The crest velocities inhibited the downstream migration of cyprinids (score 0.3) and juvenile salmonids (score 0.6). However, the remaining downstream migrants traversed the section unhindered. Higher flows would be unlikely to improve passage of upstream migrants other than, potentially, adult salmonids.

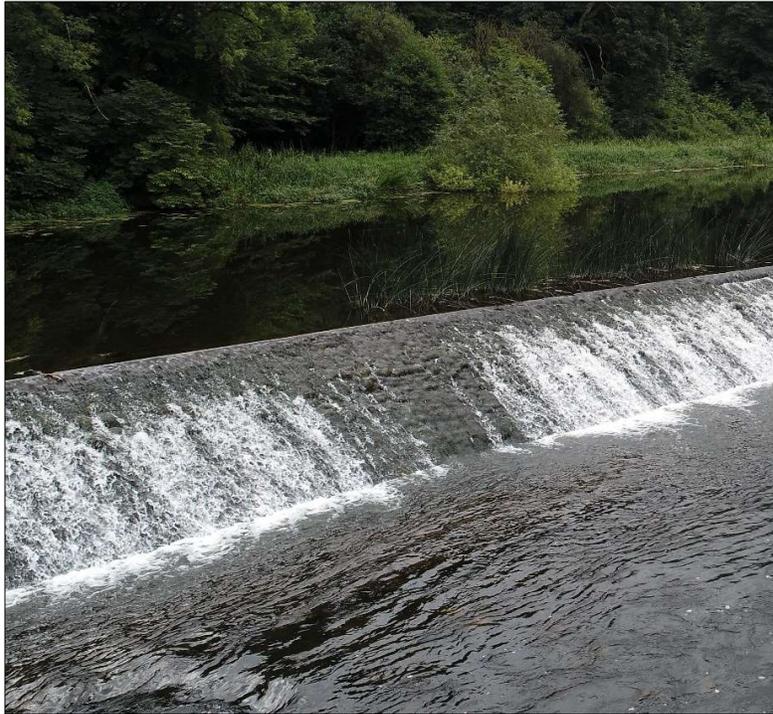
Figure 38. Transversal Section 4.

In prevailing conditions, this transversal was a complete barrier to the upstream movement of all species (score 0.0). Insufficient water depths ($\leq 0.04\text{m}$) at the crest, midpoint, and outlet of the weir entirely negated fish passage. Compounding factors hindering upstream migration included high levels of turbulence and 39.83% slope. Downstream migration for most species was also inhibited by limited water depths (Figure 38). Juvenile salmonids and adult eel encountered a high impact partial barrier (score 0.3). Adult salmonids and cyprinids were completely obstructed (score 0.0). However, due to low requirements, juvenile lamprey faced no barrier to downstream passage. Higher flows, and therefore increased depths, would likely improve passage for adult salmonids. The additional issues of slope and turbulence would block the remaining upstream migrants from availing of improvements to depth. Higher flows would likely completely alleviate obstacles to downstream passage and allow for unhindered movement of downstream migrants.

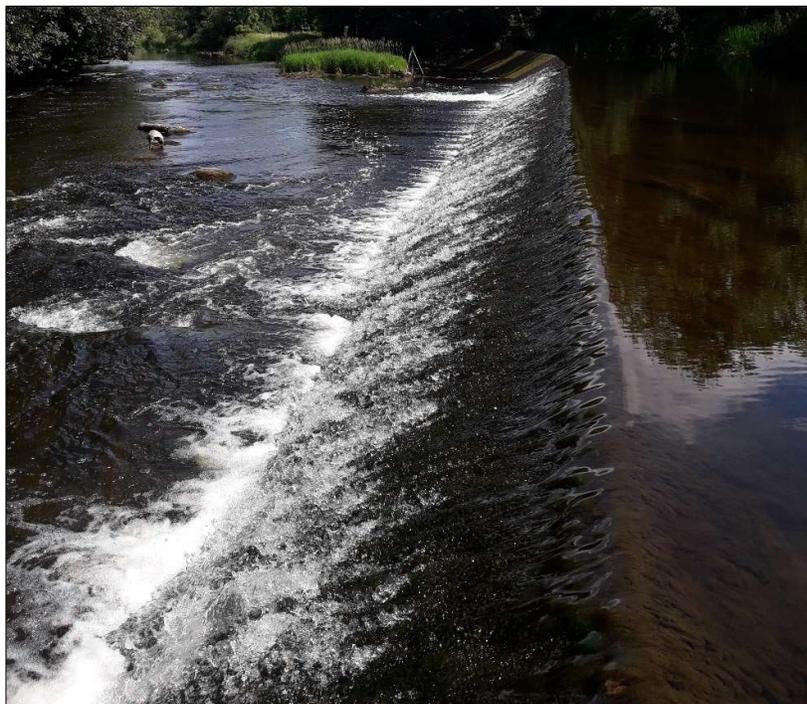
Figure 42. Transversal Section 1.

In prevailing conditions, this transversal was a complete barrier to the upstream movement of all species (score 0.0), with the exception of juvenile eel (score 1.0). Insufficient water depth (≤ 0.03 m) at the outlet was the primary obstacle. A compounding factor hindering upstream migration was the 45% slope (Figure 42). As a climbing substrate was available, juvenile eel were capable of surmounting the structure. Downstream migration for most species was similarly inhibited by limited water depths. Juvenile salmonids and adult eel encountered a high impact partial barrier (score 0.3). Adult salmonids and cyprinids were completely obstructed (score 0.0). However, due to limited depth requirements, juvenile lamprey faced no barrier to downstream passage (score 1.0). Higher flows, and therefore increased depths, would likely improve passage for adult salmonids. The additional issues of slope and turbulence would limit the remaining upstream migrants from availing of improvements to depth. Higher flows would likely completely alleviate obstacles to downstream passage and allow for unimpeded movement of migrants in that direction.

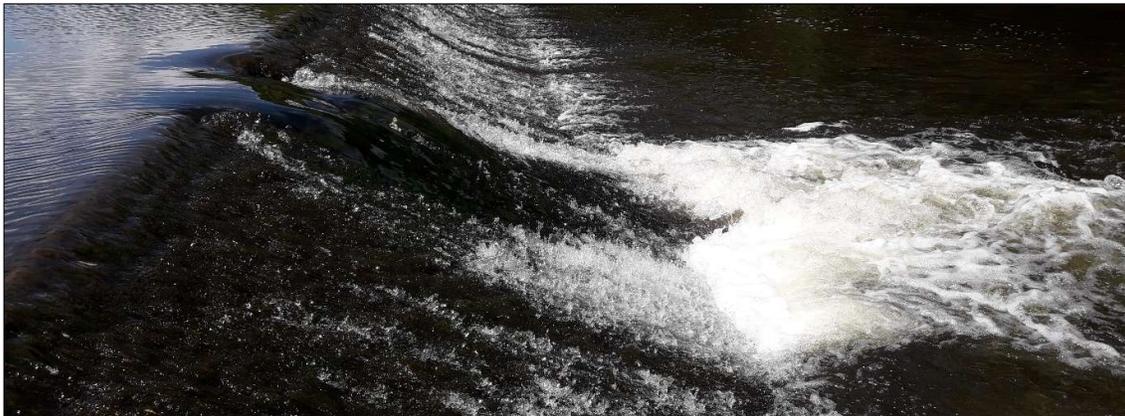
Figure 43. Transversal Section 2.

In prevailing conditions, adult salmonids encountered a high impact partial barrier (score 0.3) at this transversal, allowing limited passability. All other upstream migrants encountered a complete barrier (score 0.0) to their movements. The primary hurdles were high outlet velocities (≥ 2.15 m/s) and low outlet depths (0.04 to 0.1 m) (Figure 43). Additional obstacles included a slope of 45% and the presence of a standing wave. Downstream migrants were able to traverse the section without restraint. Higher flows would be unlikely to improve passage of upstream migrants.

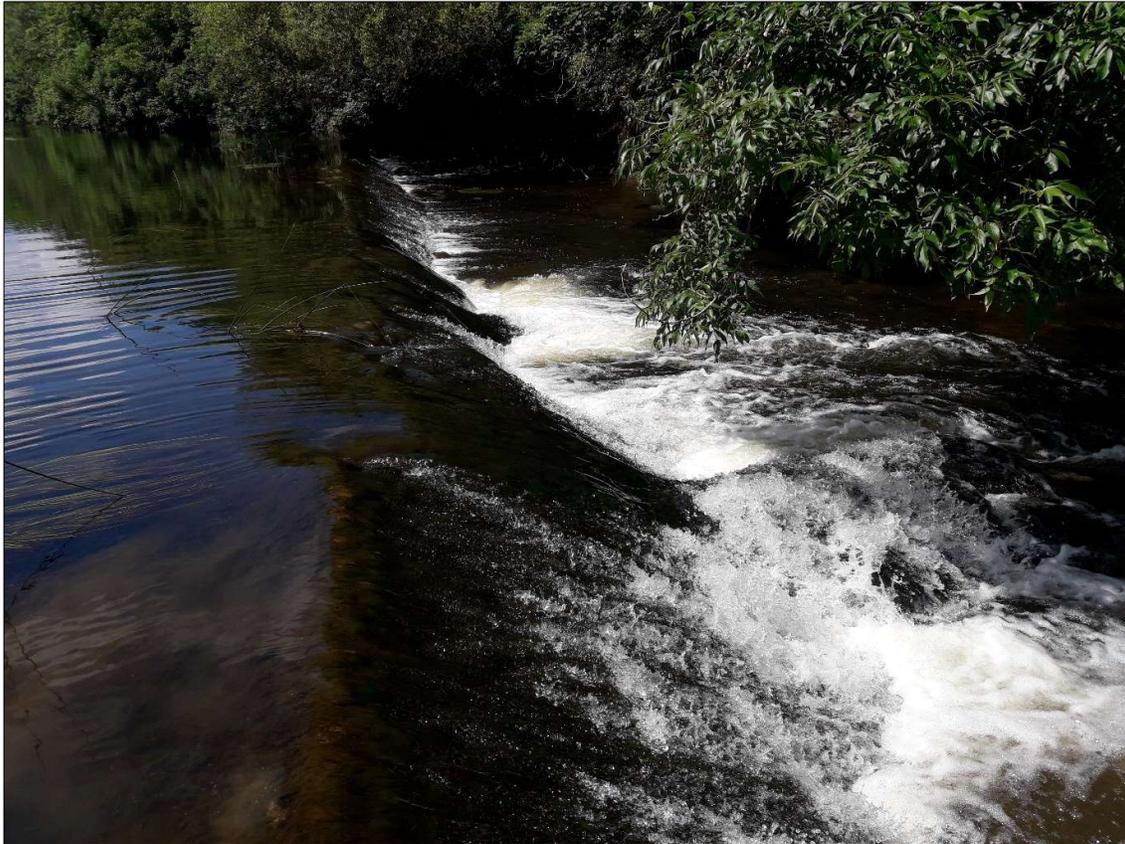
Figure 44. Transversal Section 3.

In prevailing conditions, this transversal represented a high impact partial barrier (score 0.3) for the upstream migration of adult salmonids and juvenile eel (Figure 44). Cyprinids, adult lamprey, and juvenile salmonids encountered a complete barrier (score 0.0). A variety of factors were responsible for the restrictions on passage. The hydraulic head height (0.93 m) was the primary obstacle for the latter three species. For adult salmonids, the most limiting factor was the low effective pool depth (0.5 m). Meanwhile, medium levels of turbulence checked the progress of juvenile eel. Downstream migrants encountered no obstacles to passage (score 1.0). Higher flows would have a limited effect on improving upstream passage. A greater pool depth in relation to a lowered hydraulic head height would increase the likelihood of adult salmonid passage. However, the jump barrier for the remaining species would remain in place unless substantially lowered. In addition, the increased turbulence associated with higher flows would further negate rather than facilitate the passage of upstream migrants.

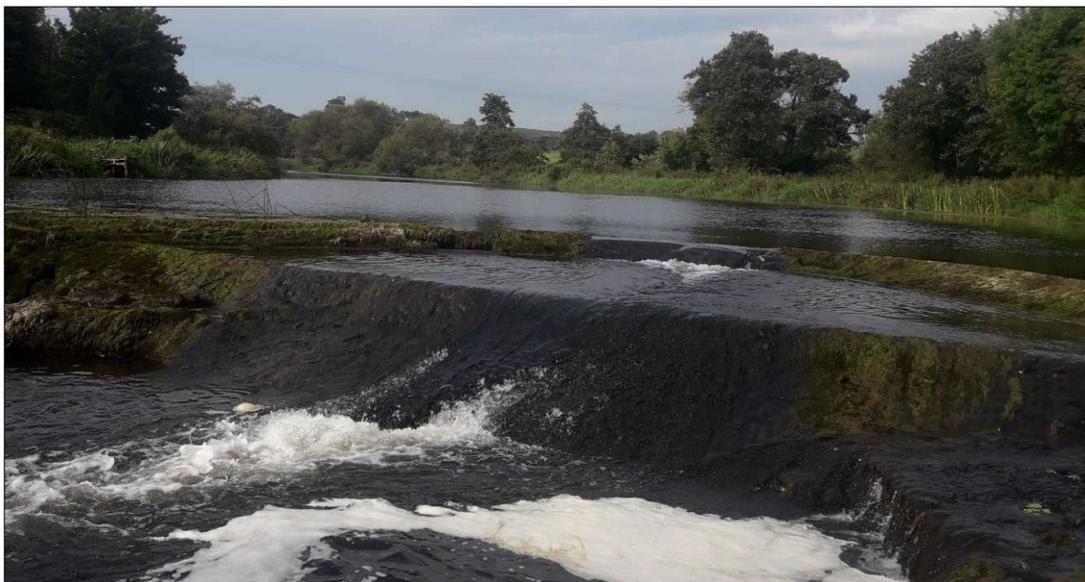
Figure 49. Transversal Section 1.

In prevailing conditions, this transversal was a complete barrier (score 0.0) to the upstream movement of all species except juvenile eel. The primary obstacle was created by low depths, particularly at the outlet (≤ 0.05 m) (Figure 49). An additional obstruction to passage was the slope (24.09%). Juvenile eel were able to surmount the transversal via a climbing substrate, and thus encountered no barrier (score 1.0) to their upstream migration. All downstream migrants were unimpeded in their movements (score 1.0). Higher flows would be likely to improve the passage of adult salmonids due to increased water depth. However, passage for juvenile eel would be likely to deteriorate as the climbing substrate would be drowned in the increased flow of water over the weir. The passage of other migratory species would likely remain unaltered.

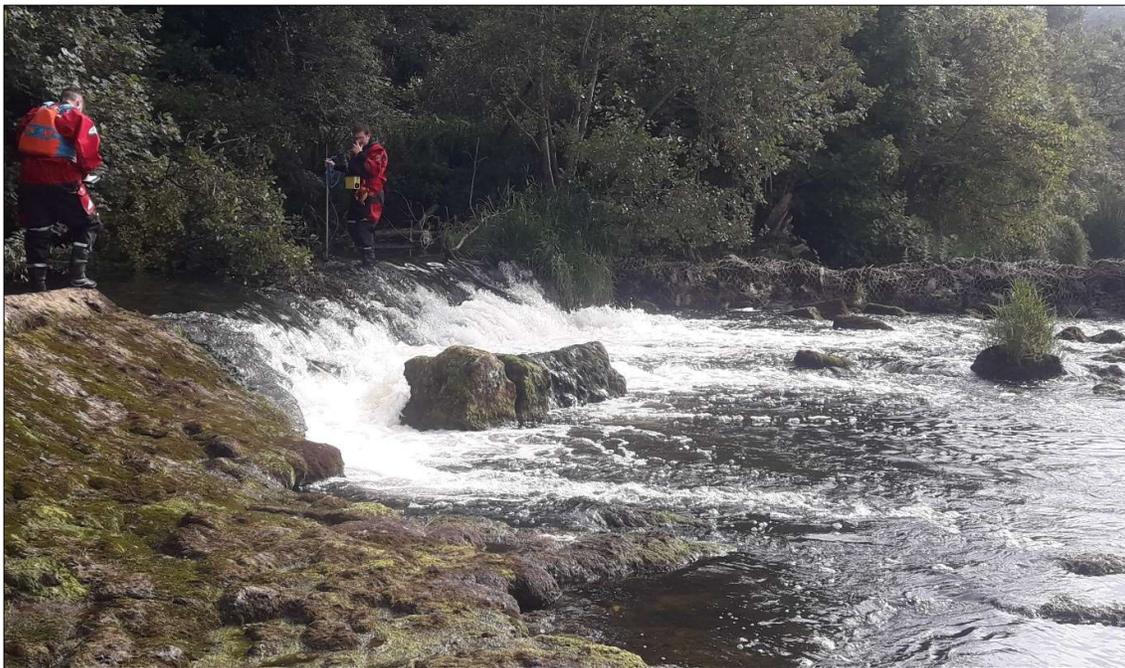
Figure 50. Transversal Section 2.

In prevailing conditions, this transversal was a complete barrier (score 0.0) to the upstream movement of all species. The primary obstacles to passage were the hydraulic head height (1.975m) and the high levels of turbulence (Figure 50). All downstream migrants were unimpeded in their movements (score 1.0). Higher flows have the potential to marginally improve the upstream passage of adult salmon by decreasing the hydraulic head height. However, passage for other migratory species would likely remain unaltered as turbulence levels would be maintained, if not increased, and the reduction in hydraulic head height would have to be substantially greater than what is surmountable for adult salmon.
