River Boyne WFD III Barrier Assessment Obstacles to Fish Passage and Mitigation Options

Citation: Donovan, R., Coghlan, B., O’Brian, R., O’Connell, A., & O’Leary, C., (2023). River Boyne WFD 111 Barrier Assessment – Obstacles to Fish Passage and Mitigation Options. National Barriers Programme. Inland Fisheries Ireland. Citywest, Dublin.

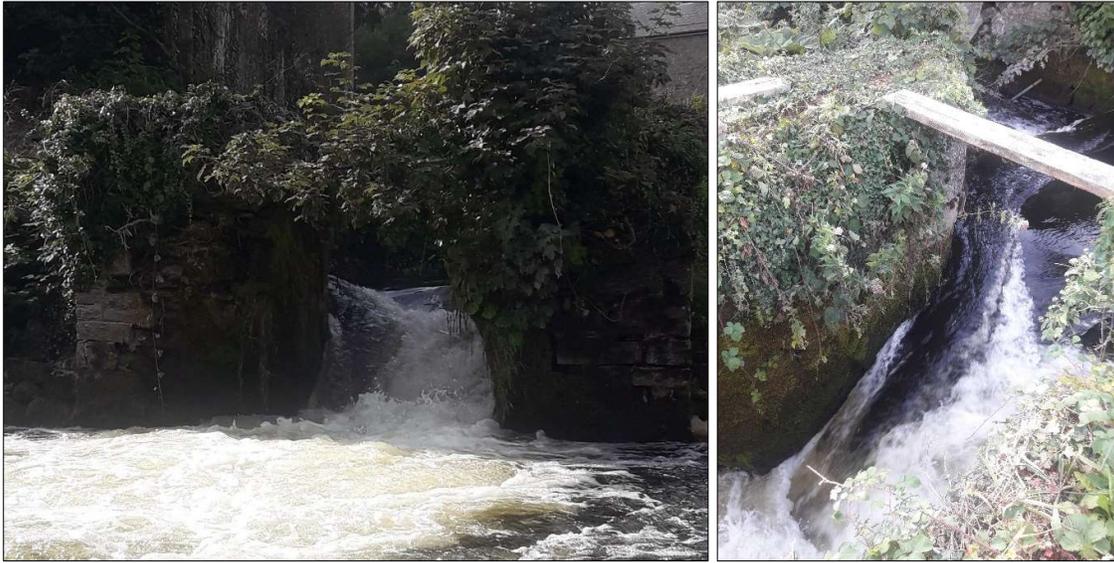
Figure 51. Transversal Section 3 from the outlet (left) and the crest (right).

In prevailing condition, velocity and water depth could not be measured at this transversal due to health and safety concerns (Figure 51). However, the standing wave, very high levels of turbulence, and hydraulic head height (1.975 m) were sufficient to create a complete barrier (score 0.0) for the upstream migration of all species. Potentially high velocity levels at the crest were likely to have encumbered downstream migration. Higher flows would be unlikely to improve passage as the funnelled flow of water would maintain velocity levels and turbulence.

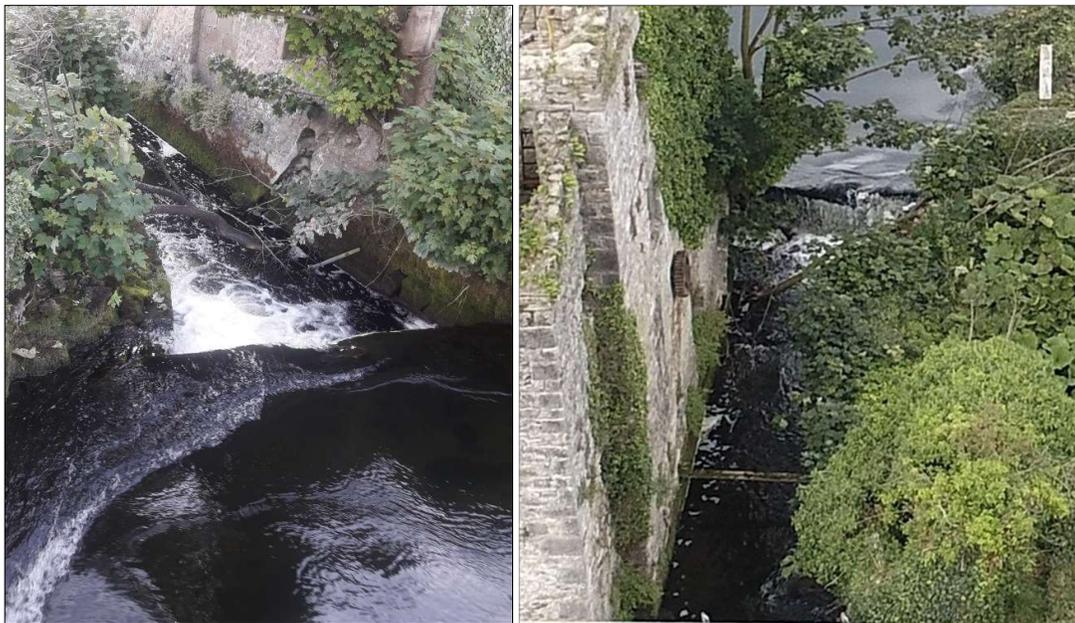
Figure 52. Transversal Section 4, perspective from the crest (left) and from downstream (right).

In prevailing condition, this segment of the weir was unsuitable for assessment due to health and safety concerns (Figure 52). However, the observed high levels of turbulence and the hydraulic head height (1.95 m) were sufficient to create a complete barrier (score 0.0) for the upstream migration of all species. Downstream migrants were unhindered as far as can be estimated with the restricted measurements. Higher flows would be unlikely to improve passage for any species.

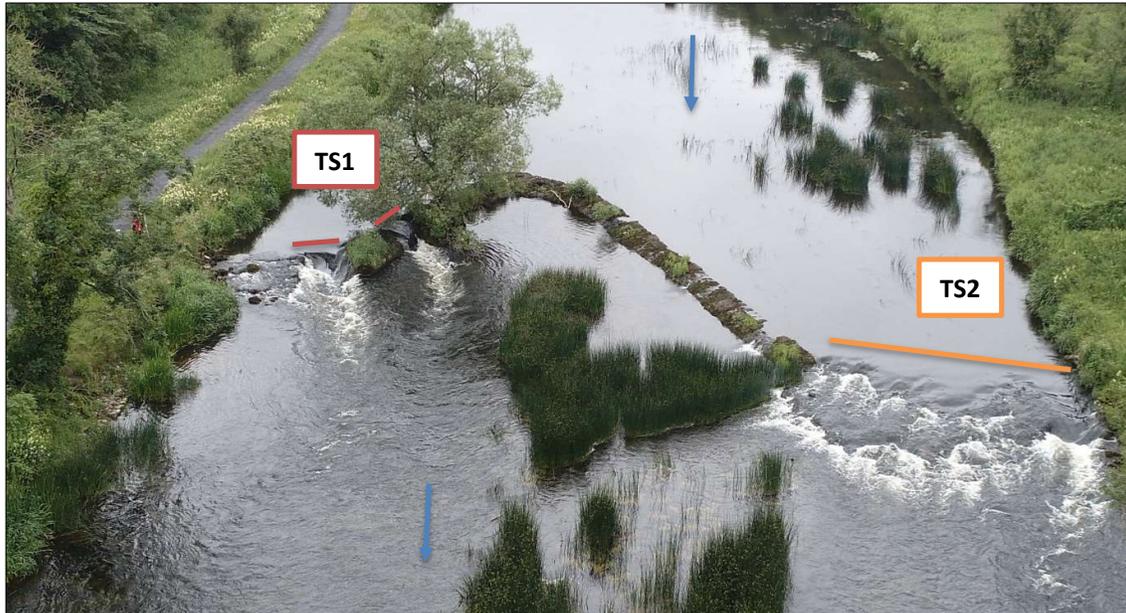
Figure 55. The two transversal sections of Ardmulchan Weir 1. Drone imagery taken 13/07/2021.

On the date of survey, the mean water height at Blackcastle gauging station (07037) was 0.389 m. The hydraulic head height of the weir was 0.58 m. The total width of the barrier along the crest was 74 metres, of which 25 metres were wetted. The width of the channel at this point was 48 metres. This sloping weir presented two transversal sections for fish to attempt passage (Figure 55), which are described below.

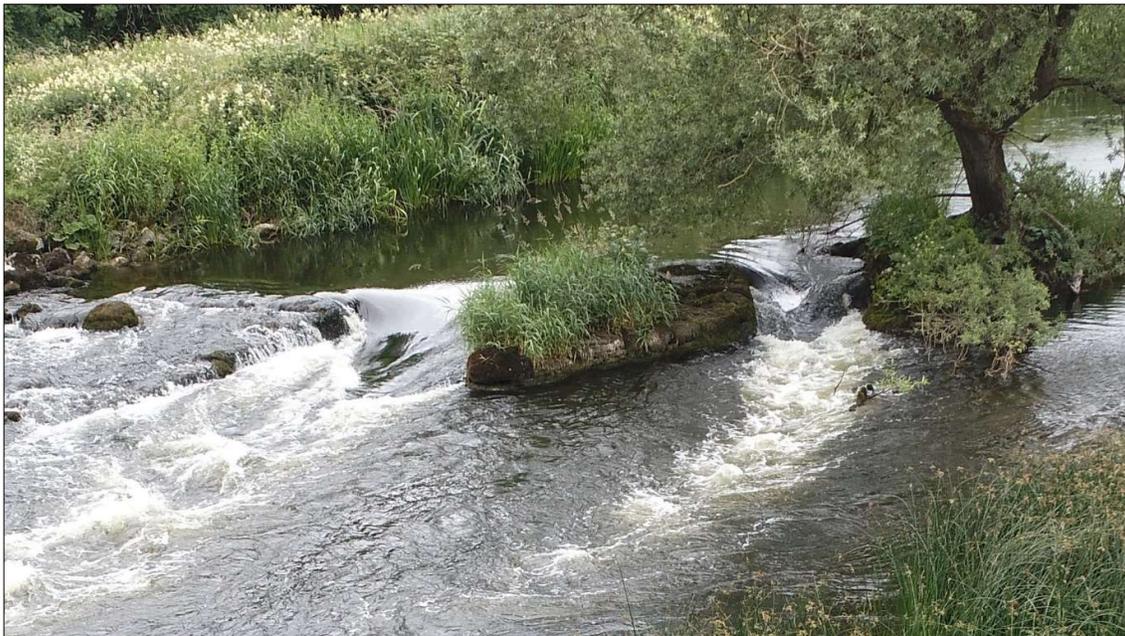
Figure 56. Transversal Section 1.

In prevailing conditions, this transversal presented no barrier (score 1.0) to the upstream movement of adult salmonids and juvenile eel (Figure 56). Cyprinids, adult lamprey, and juvenile salmonids encountered a low impact partial barrier (score 0.6) caused by the effective length (5.8 m). Juvenile eel were able to circumnavigate the transversal via a climbing substrate. Downstream migrants were unimpeded in their movements (score 1.0). Higher flows would be unlikely to alter passage.

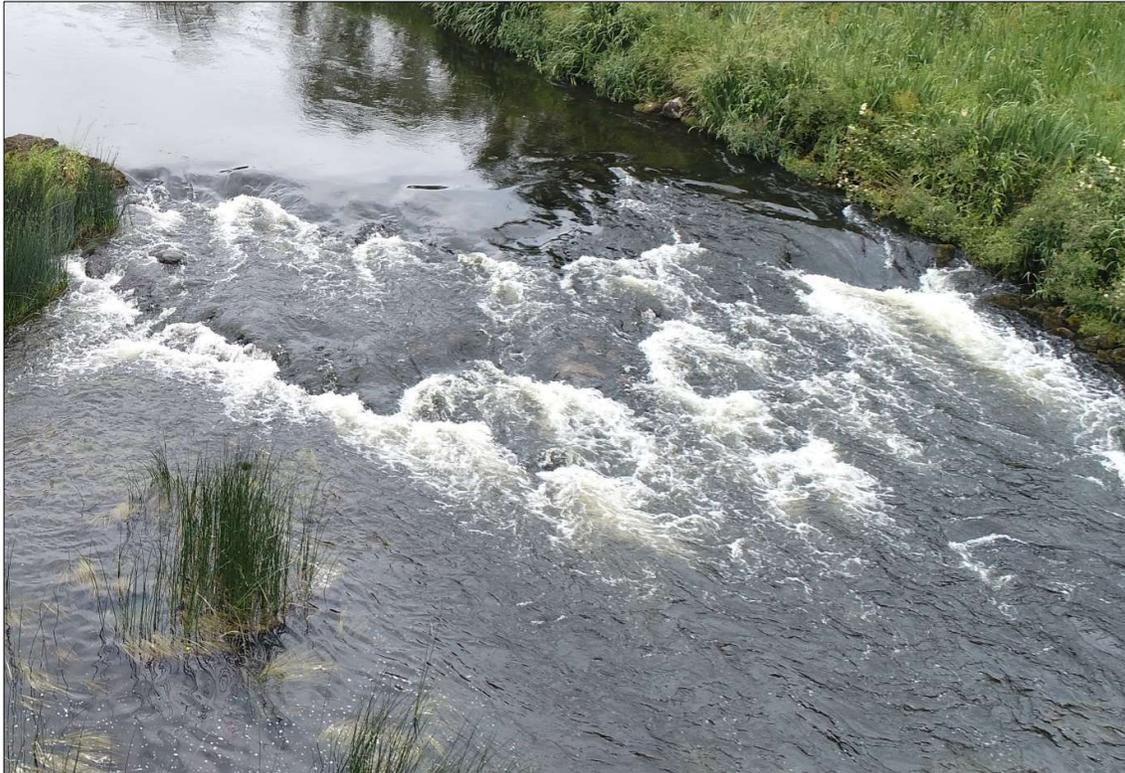
Figure 57. Transversal Section 2.

In prevailing conditions, this transversal presented a high impact partial barrier (score 0.3) to the upstream movement of all species except adult salmonids (Figure 57). Adult salmonids encountered a low impact partial barrier (score 0.6). The primary obstacle was created by medium levels of turbulence. The effective length (9 m) was a compounding limiting factor, particularly for cyprinids and juvenile eel. Downstream migrants were unimpeded in their movements (score 1.0). Higher flows would have the potential to improve passage for salmonids and adult lamprey.

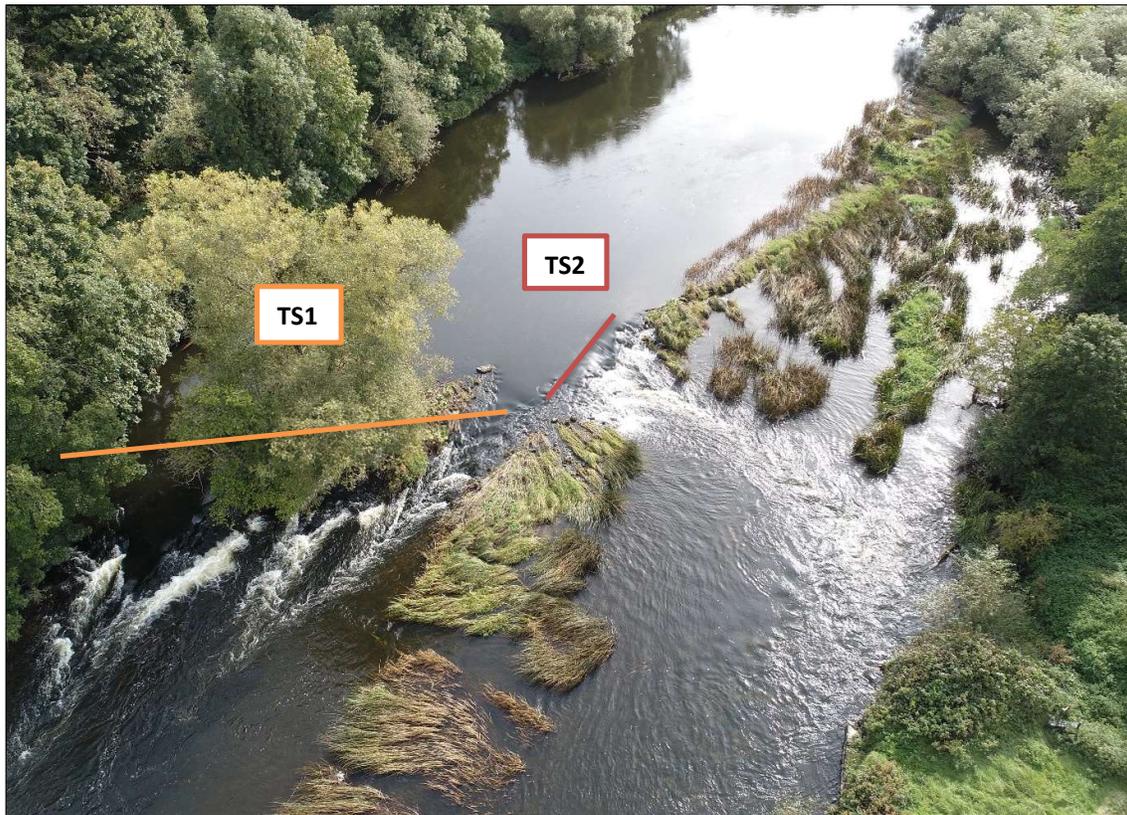
On the date of survey, the mean water height at Blackcastle gauging station (07037) was 0.389 m. The hydraulic head height of the weir was 0.62 m. The total width of the barrier along the crest was 93 metres, of which 35 metres were wetted. The width of the channel at this point was 49 metres. This sloping weir presented two transversal sections for fish to attempt passage (Figure 60), which are described below.

Figure 60. The two transversal sections of Ardmulchan Weir 2. Drone imagery taken 29/09/2020.

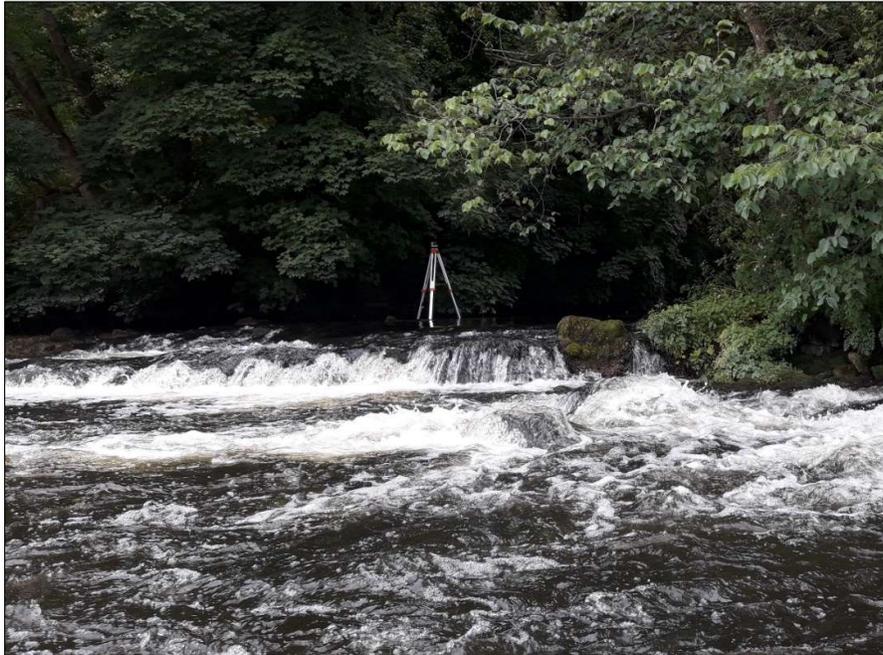
Figure 61. Transversal Section 1.

In prevailing conditions, this transversal represented a barrier, to differing extents, for all upstream migrants except juvenile eel (Figure 61). Adult salmonids encountered a low impact partial barrier (score 0.6). Cyprinids, adult lamprey, and juvenile salmonids were faced with a high impact partial barrier (score 0.3). Juvenile eel, however, were able to circumnavigate the structure via a climbing substrate, and thus were unimpeded in their migration (score 1.0). The primary obstacles to upstream passage were the effective length (11 m) and the medium levels of turbulence. Downstream migrants were unobstructed in their movements (score 1.0). Higher flows would be unlikely to alter passage.

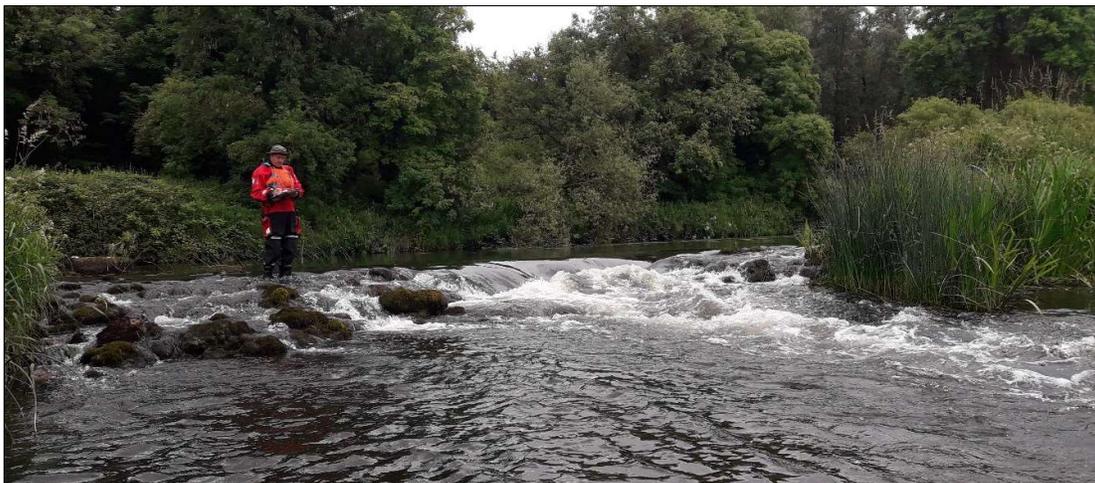
Figure 62. Transversal Section 2.

In prevailing conditions, this transversal represented a high impact partial barrier (score 0.3) to all upstream migrants except juvenile eel (Figure 62). Juvenile eel were able to circumnavigate the structure via a climbing substrate, and thus were unimpeded in their migration (score 1.0). The primary obstacles to upstream passage were the presence of a standing wave and medium levels of turbulence. Downstream migrants were unobstructed in their movements (score 1.0). Higher flows would be unlikely to alter passage.

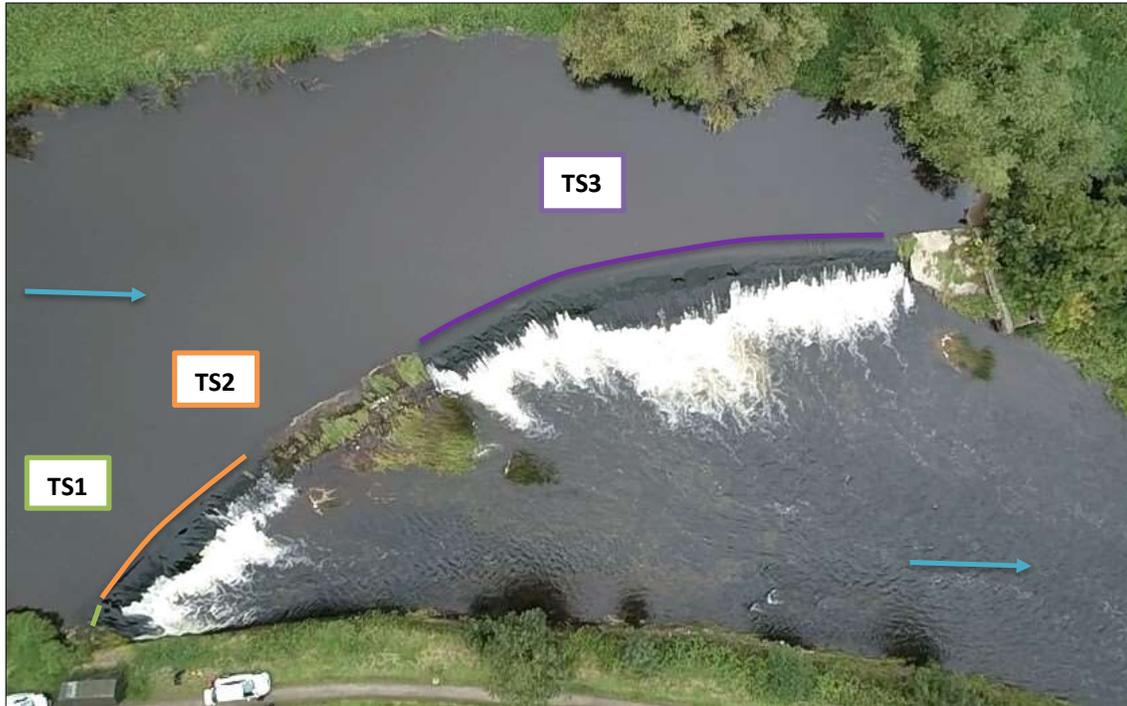
Figure 65. The three transversal sections of Dunmoe Weir. Drone imagery taken 22/09/2020.

On the date of survey, the mean water height at Navan Weir gauging station (07009) was 0.717 m. The hydraulic head height of the weir was 0.995 m. The total width of the barrier along the crest was 83 metres, of which 60 metres were wetted. The width of the channel at this point was 51 metres. This sloping weir presented three transversal sections for fish to attempt passage (Figure 65), which are described below.

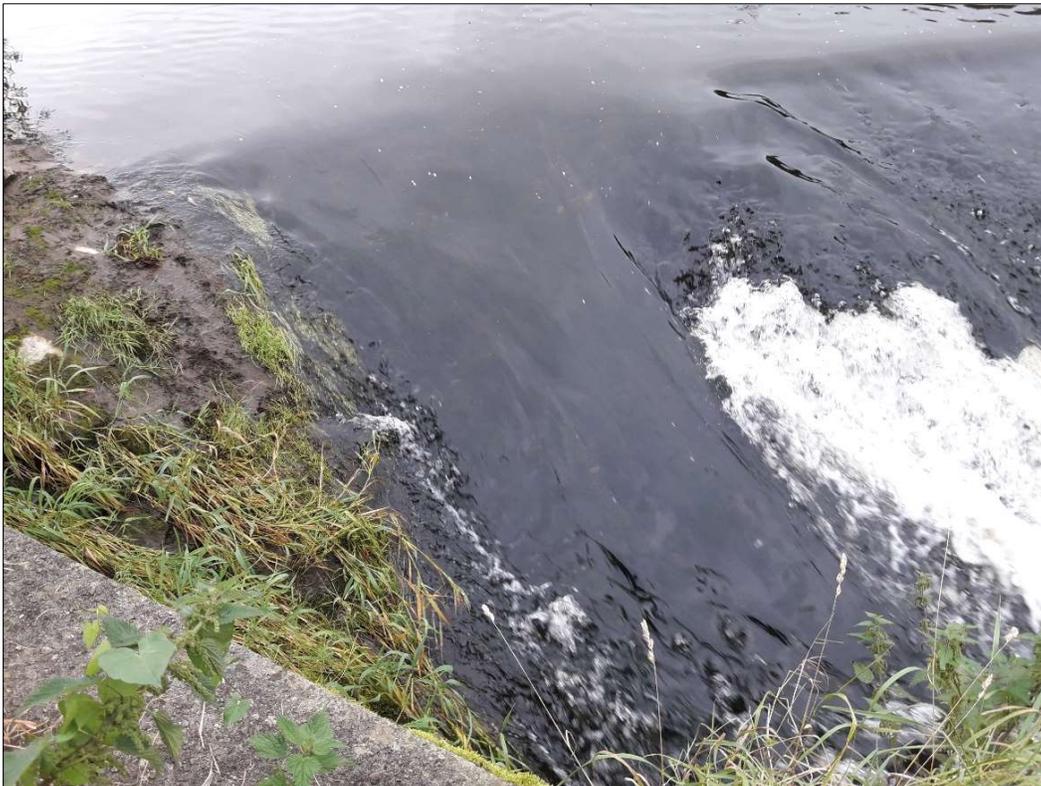
Figure 66. Transversal Section 1.

In prevailing conditions, this transversal represented a barrier, to differing extents, for all upstream migrants except juvenile eel (Figure 66). Salmonids and adult lamprey encountered a high impact partial barrier (score 0.3), while cyprinids were obstructed completely (score 0.0). Juvenile eel, however, were able to circumnavigate the structure via a climbing substrate, and thus were unimpeded in their migration (score 1.0). The primary obstacles to upstream passage were the lack of effective resting locations, the medium levels of turbulence, the 18.9% slope, and the crest velocities at 60% depth (2.19 to 3.21 m/s). Downstream migrants, with the exception of juvenile lamprey and adult eel, were also inhibited by crest velocities. For adult salmonids velocities represented a low impact partial barrier (score 0.6). Juvenile salmonids fared worse, encountering a high impact partial barrier (score 0.3). Meanwhile, the movement of cyprinids was completely curtailed (score 0.0). Higher flows would be unlikely to improve passage for most species attempting to traverse this segment of weir. However, adult salmonids could potentially benefit from elevated flows.

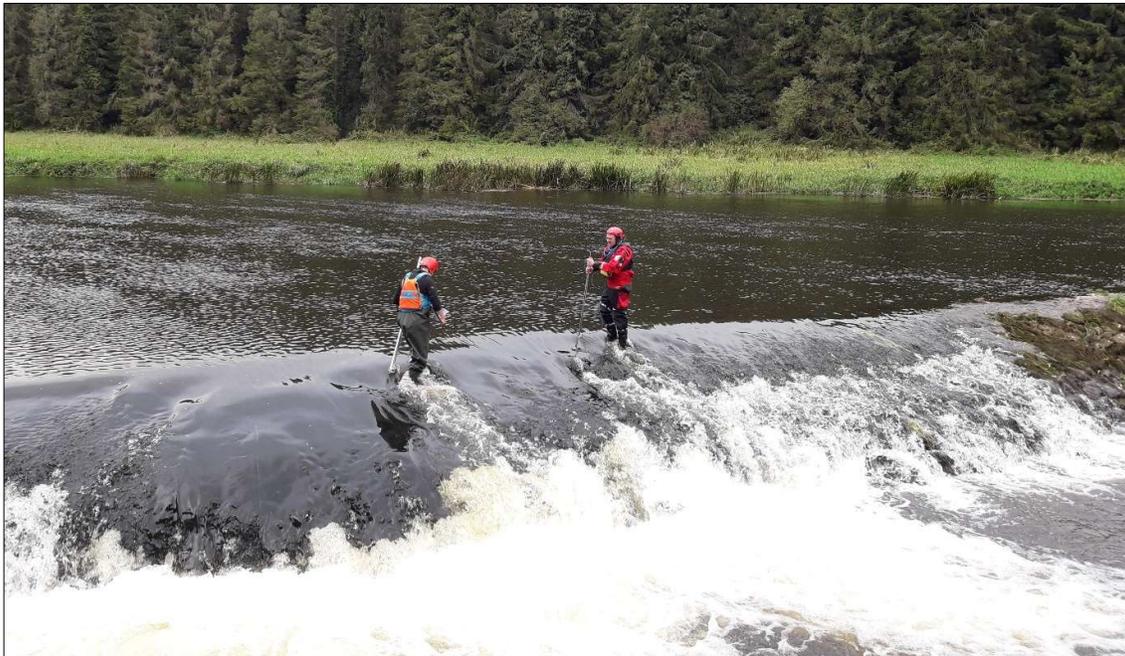
Figure 67. Transversal Section 2.

In prevailing conditions, this transversal represented a complete barrier (score 0.0) for all upstream migrants except juvenile eel and adult salmonids. Adult salmonids encountered a high impact partial barrier (score 0.3). Juvenile eel, however, were able to circumnavigate the structure via a climbing substrate, and thus were unimpeded in their migration (score 1.0). There were multiple factors limiting upstream migration. These factors included the 24.27% slope, a lack of effective resting locations, high levels of turbulence, and the presence of a standing wave (Figure 67). Downstream migrants had uninhibited passage (score 1.0). Higher flows would be unlikely to improve passage. In fact, as elevated water levels could potentially drown the climbing substrate, the passage of juvenile eels would deteriorate.

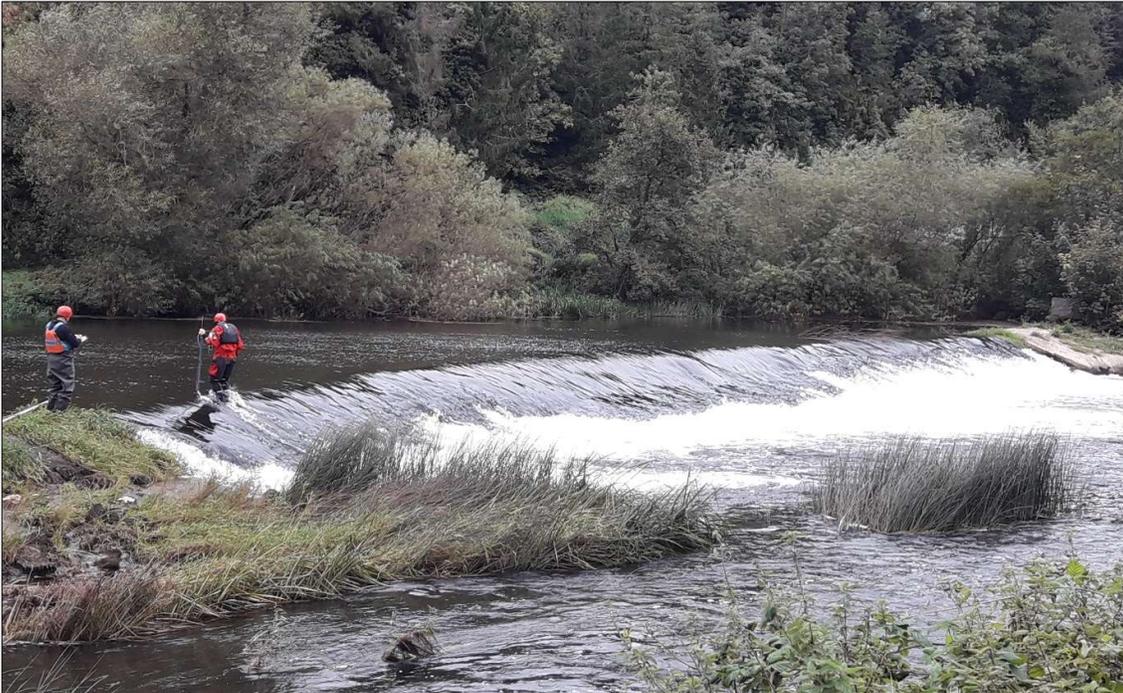
Figure 68. Transversal Section 3.

In prevailing conditions, this transversal represented a complete barrier (score 0.0) for all upstream migrants except juvenile eel. Juvenile eel were able to circumnavigate the structure via a climbing substrate, and thus were unimpeded in their migration (score 1.0). There were multiple factors limiting upstream migration. The most detrimental of these factors included the 20.31% slope, high levels of turbulence, low outlet water depths (≤ 0.05 m), and high outlet velocities (≥ 3.3 m/s) (Figure 68). In contrast to their upstream migrating counterparts, downstream migrants had uninhibited passage (score 1.0). Higher flows would be unlikely to improve passage.

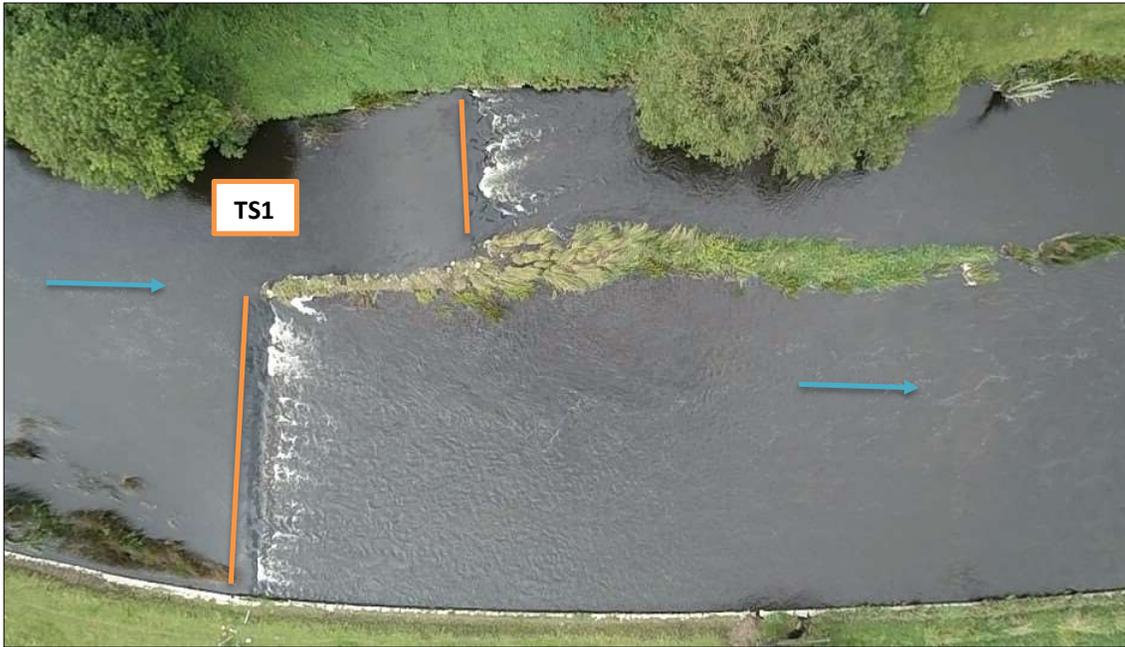
On the date of survey, the mean water height at Navan Weir gauging station (07009) was 0.717 m. The hydraulic head height of the weir was 0.210 m. The total width of the barrier along the crest was 65 metres, of which 41 metres were wetted. The width of the channel at this point was 48 metres. This sloping weir presented one transversal section for fish to attempt passage (Figure 72), which is described below.

Figure 72. The single transversal section of Blackcastle Demesne Weir 1. Drone imagery taken 22/09/2020.

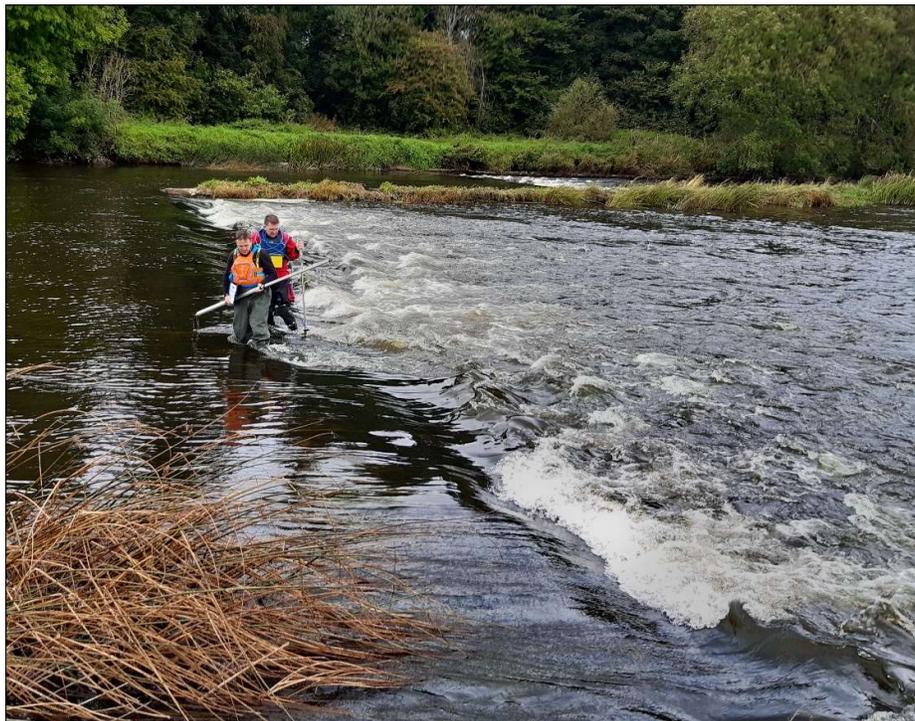
Figure 73. Transversal Section 1.

In prevailing conditions, this transversal represented no barrier (score 1.0) to adult salmonids and juvenile eel. Cyprinids and adult lamprey encountered a high impact partial barrier (score 0.3) as a result of the outlet velocities at 60% water depth (1.69 to 2.08m/s) and at the streambed (1.2 to

1.62m/s) respectively (Figure 73). Outlet velocities and the 22.11% slope were limiting factors for juvenile salmonids, creating a low impact partial barrier (score 0.6). Juvenile eel were able to bypass the structure via a climbing substrate. Downstream migrants were unhindered (score 1.0). Higher flows would be likely to improve passage for those species encountering restrictions under the prevailing survey conditions.

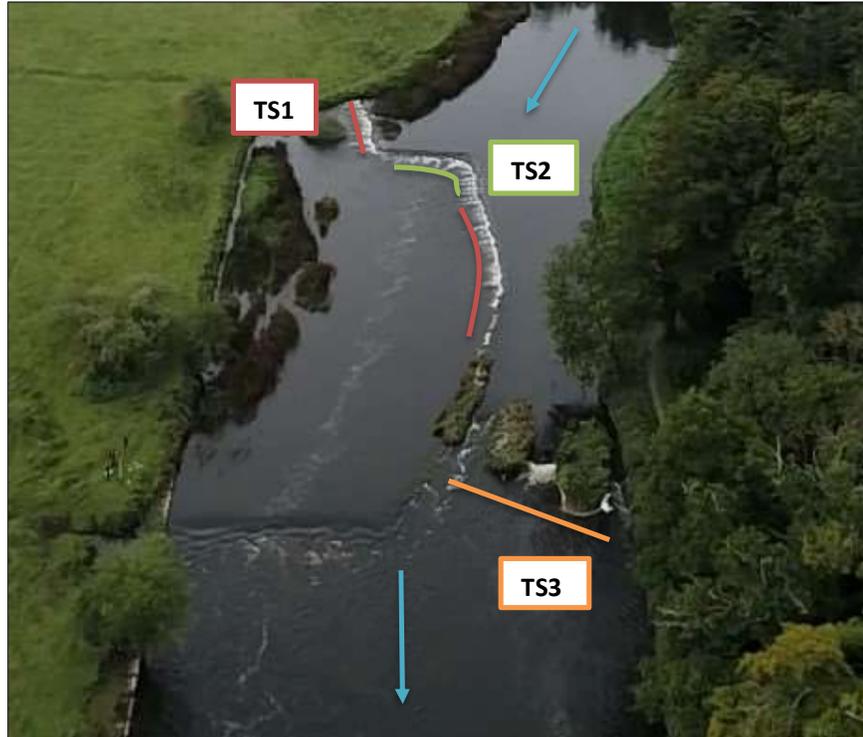
This sloping weir presented three transversal sections for fish to attempt passage (Figure 76), which are described below.

Figure 76. The three transversal sections of Blackcastle Demesne Weir 2. Drone imagery taken 22/09/2020.

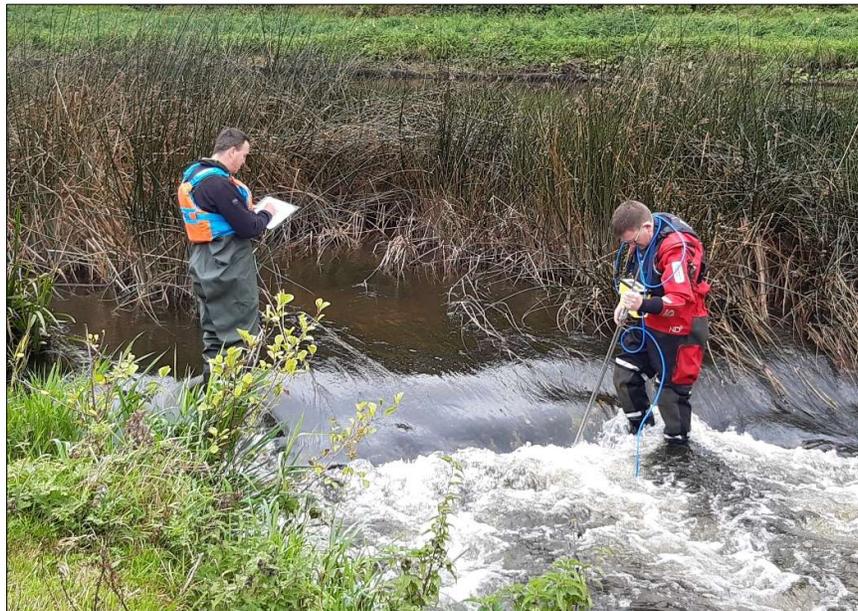
Figure 77. Transversal Section 1.

In prevailing conditions, this transversal represented high impact partial barrier (score 0.3) for all upstream migrating species, with the exception of juvenile eel. The primary obstacle to passage was the presence of a standing wave (Figure 77). A compounding limiting factor for cyprinids and adult lamprey was created by the midpoint and outlet velocities at 60% depth (1.75 to 2.33m/s) and the streambed (1.17 to 2.09 m/s) respectively. Juvenile eel were able to bypass the structure via a climbing substrate and thus encountered no barrier (score 1.0). Downstream migrants were unhindered (score 1.0). Higher flows would be likely to improve passage for all species.

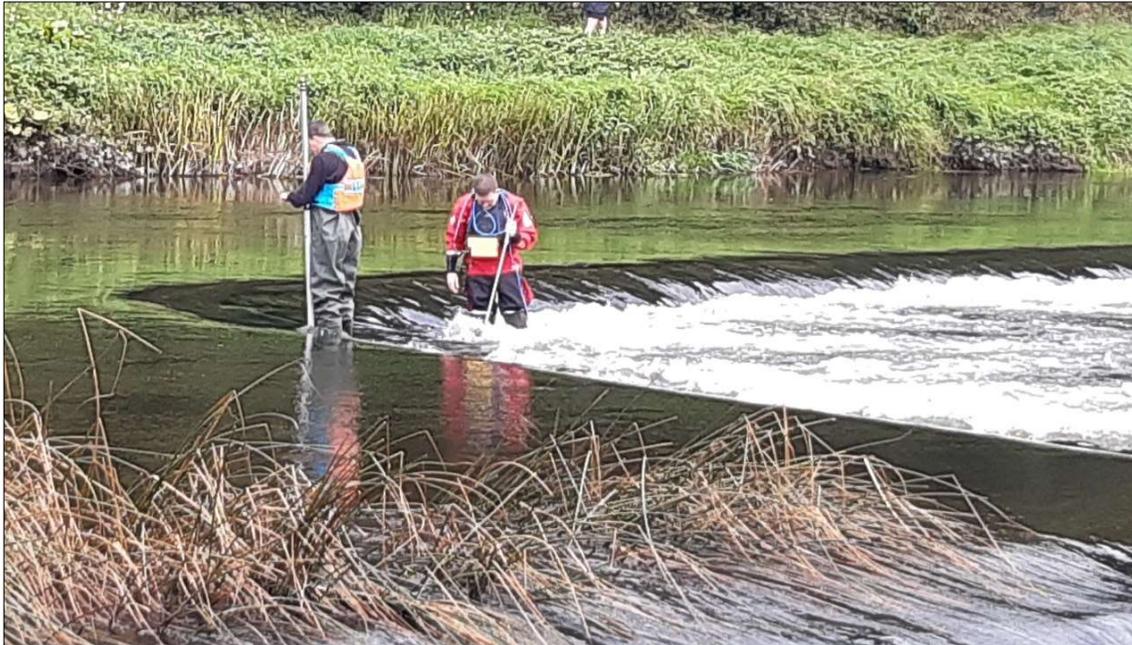
Figure 78. Transversal Section 2.

In prevailing conditions, this transversal represented high impact partial barrier (score 0.3) for all upstream migrating species, with the exception of juvenile eel. The primary obstacle impacting all upstream migrants was the presence of a standing wave (Figure 78). Additional challenges, that were particularly limiting for species other than adult salmonids, included midpoint velocities and medium levels of turbulence. Without an available climbing substrate, juvenile eel were fully exposed to water flow and encountered a complete barrier (score 0.0). Downstream migrants were unhindered (score 1.0). Higher flows would be likely to improve passage for all species except juvenile eel.

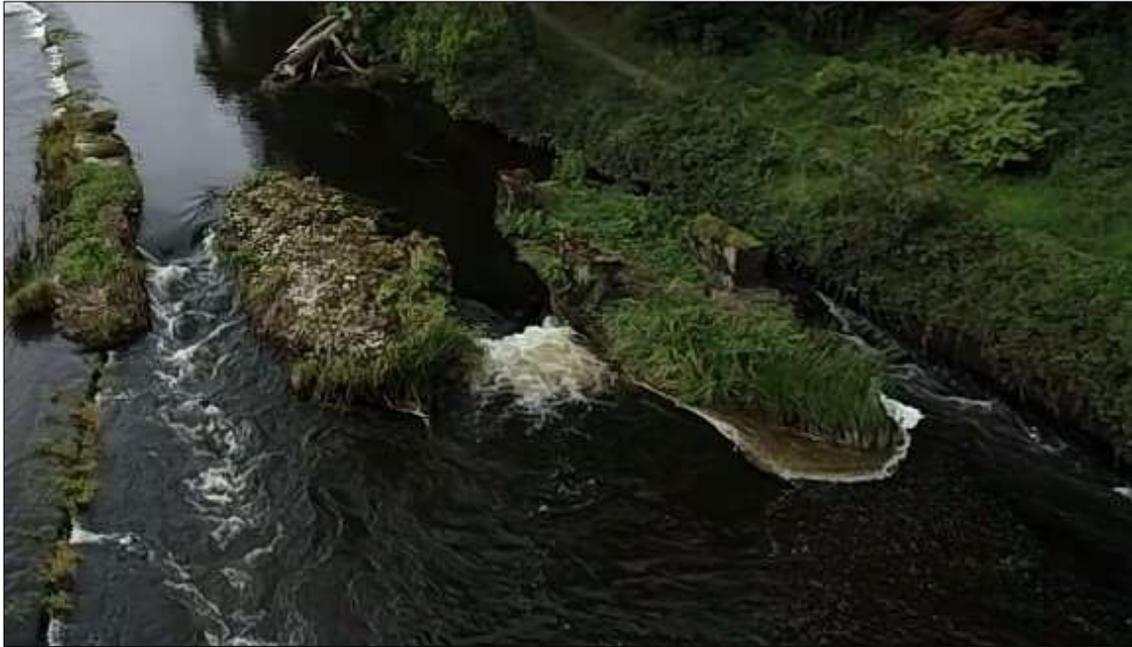
Figure 79. Transversal Section 3.

In prevailing conditions, this transversal represented high impact partial barrier (score 0.3) for all upstream migrating species, with the exception of juvenile eel. The primary obstacle impacting upstream migrants was the presence of a standing wave (Figure 79). Additional challenges, that were particularly limiting for species other than adult salmonids, included outlet and inlet velocities, medium levels of turbulence, and the effective length (6.2 m). Due to the presence of a climbing substrate, juvenile eel could bypass the water flow and encountered no barrier (score 1.0). Downstream migrants were unhindered (score 1.0). Higher flows would be likely to improve passage for all species.

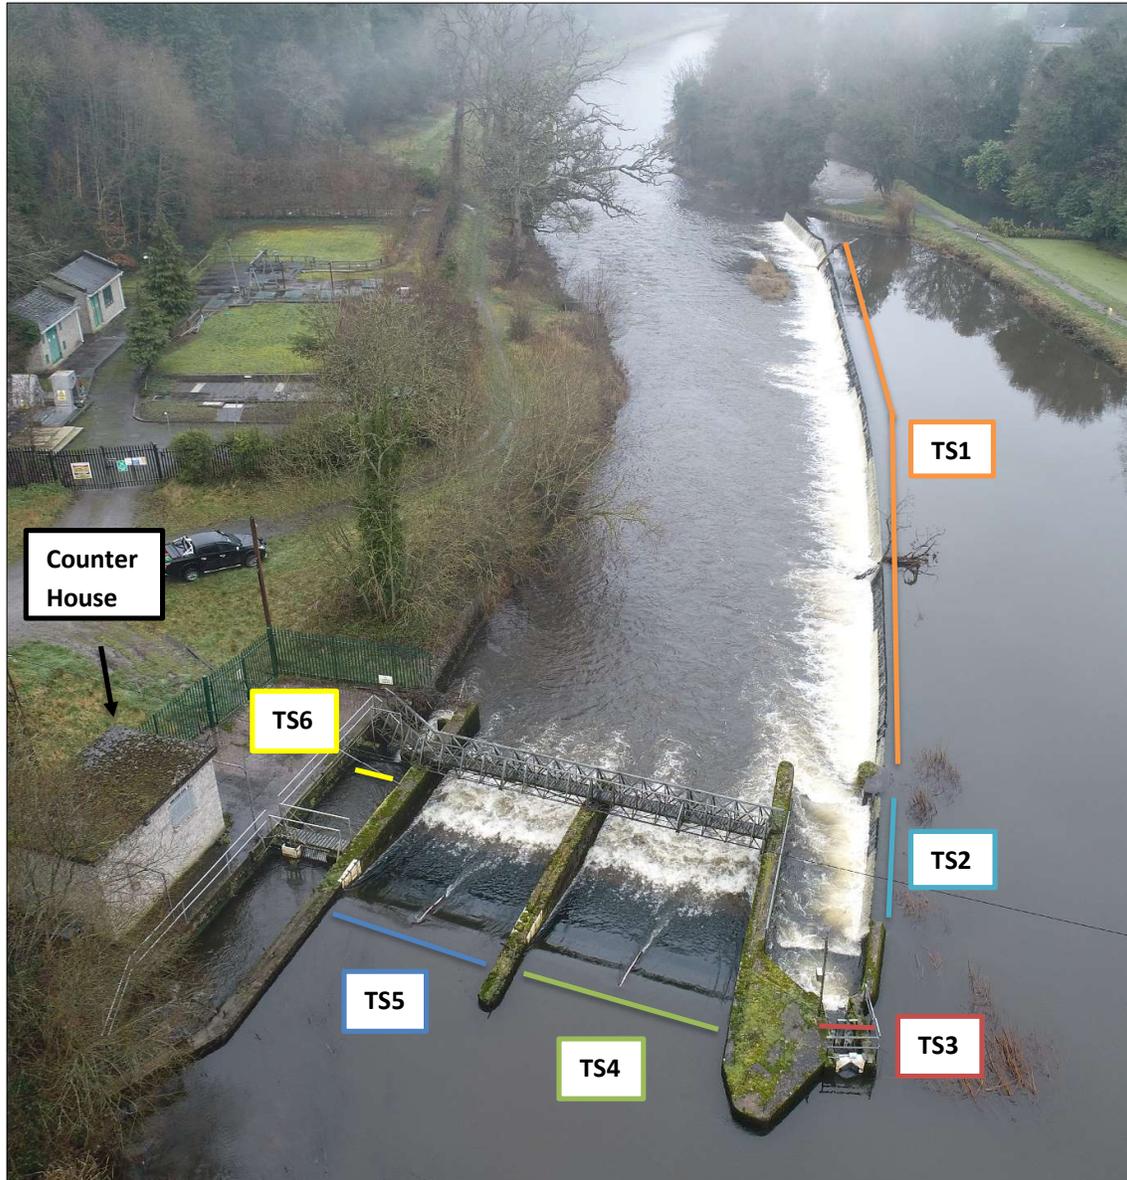
Figure 82. Blackcastle weir with transversal sections (TS) marked.

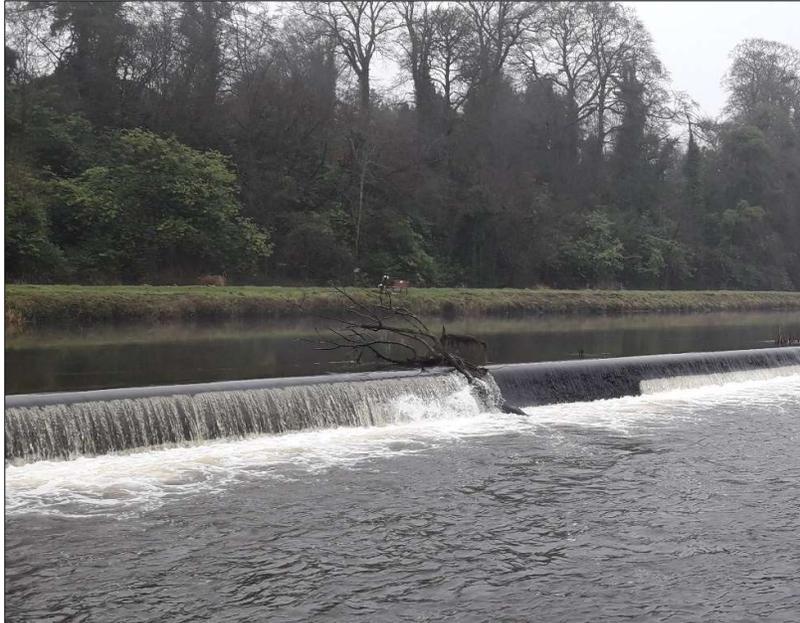
Figure 83. Transversal Section 1- vertical weir face.

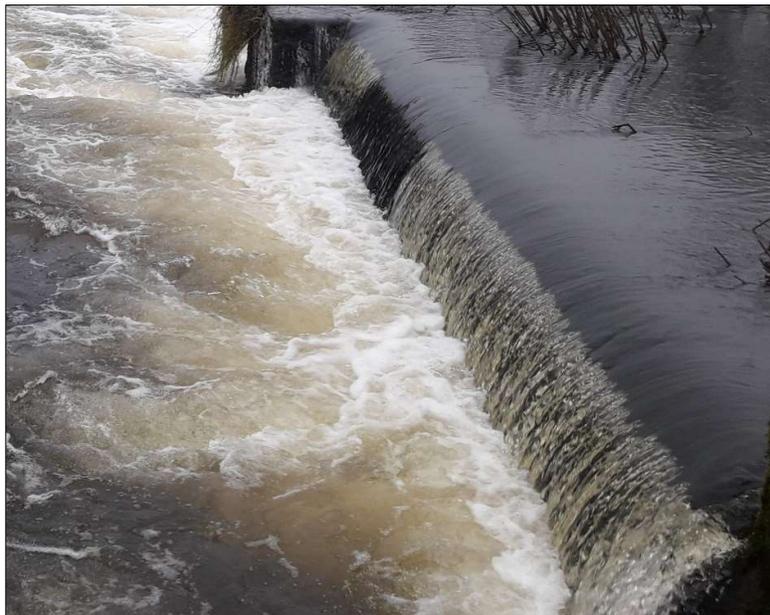
Transversal 2:

Figure 84. Transversal Section 2- vertical drop.

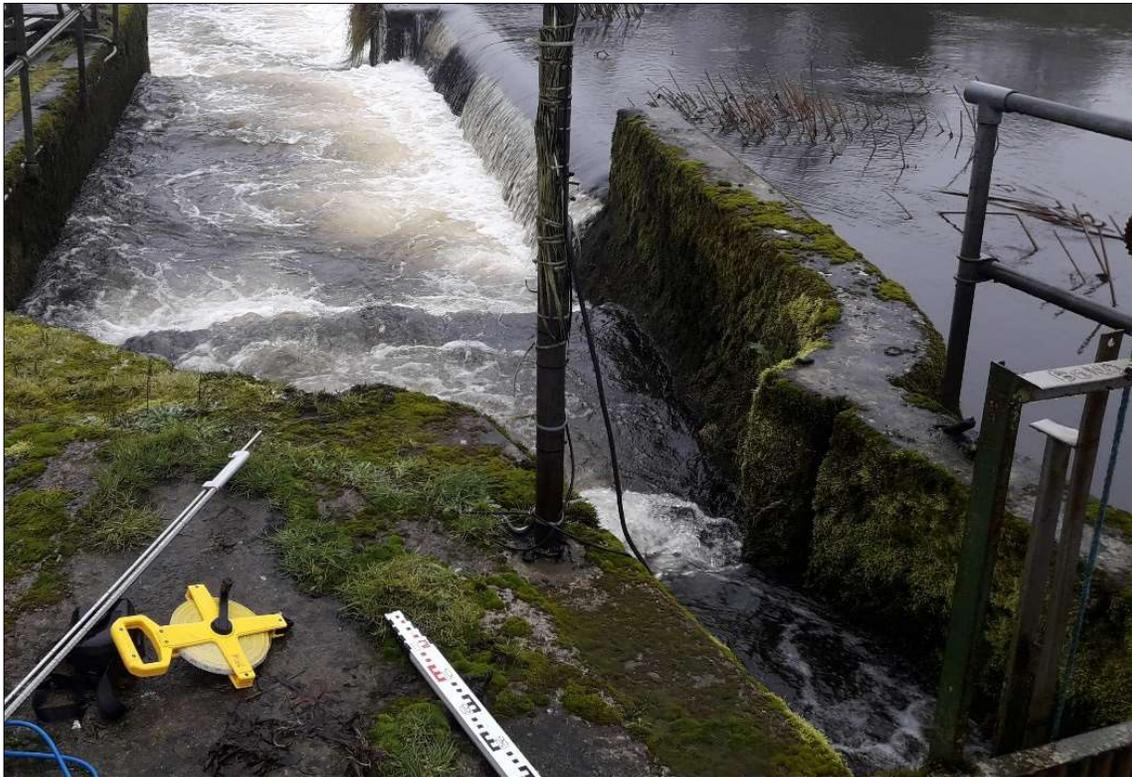
Transversal 3:

Figure 85. Transversal Section 3- three steps into Vaki trap.

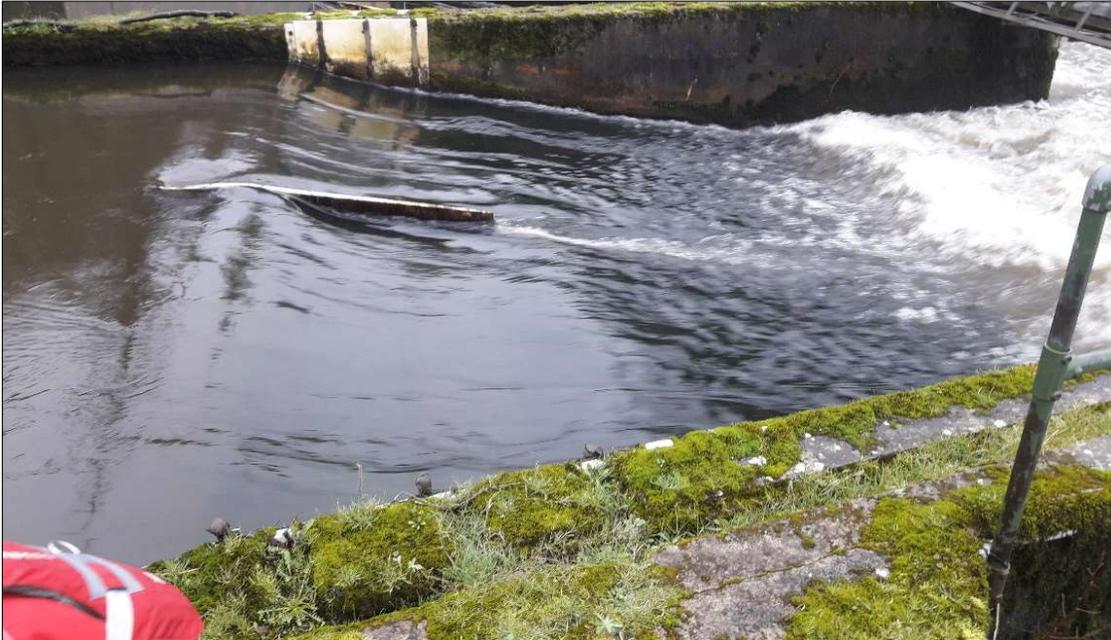
Transversal 4:

Figure 86. Transversal Section 4-crump, Logie counter.

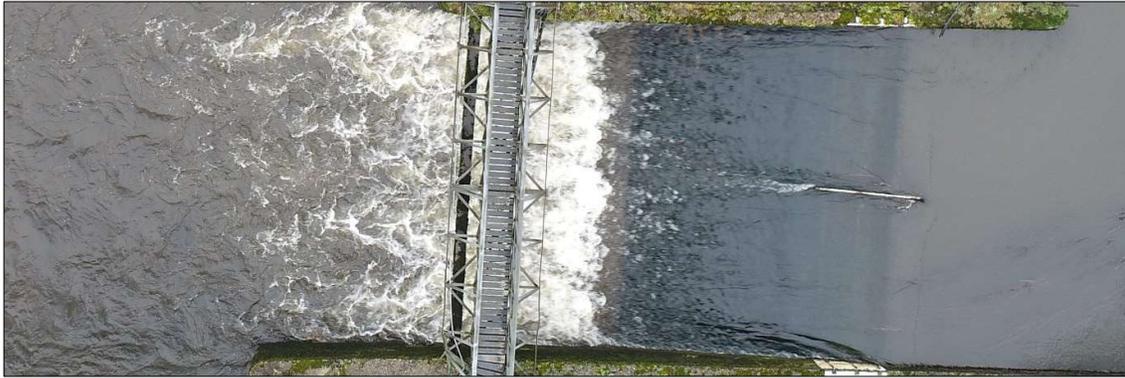
Transversal 5:

Figure 87. Transversal Section 5-crump, Logie counter.

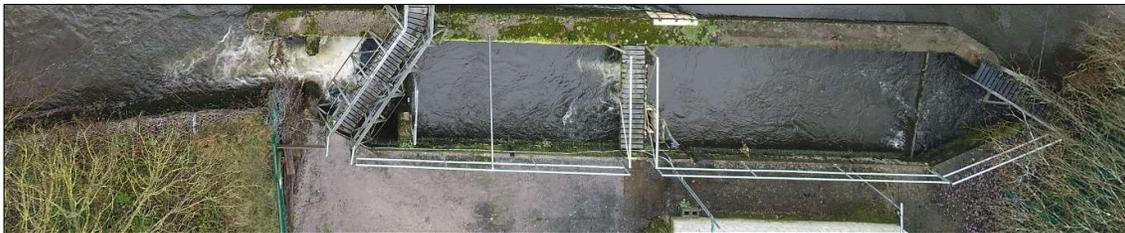
Transversal 6:

Figure 88. Transversal Section 6-sluice.

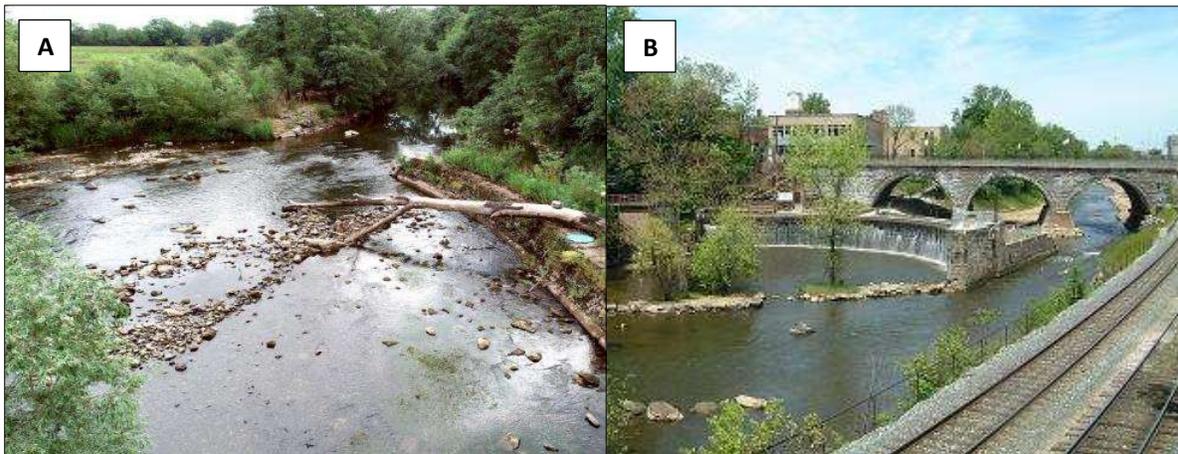
Barrier breaching: Barrier breaching is the next best option. Similar results to barrier removal are achieved, while retaining some part of the original weir structure (Figure 89). It solves all upstream and downstream fish passage issues, is cheaper than a built fish passage option, addresses other problems such as structural safety, and does not hinder future options. However, as with barrier removal, there may be some societal and cultural issues. For example, some weirs have historical value or form part of the social heritage of an area.

Figure 89. Photos of breached weirs: (A) Ballyclough Weir in the Mulkear River, Co. Limerick, and (B) Kent Dam in the Cuyahoga River, Ohio, USA (breach in far right of image).

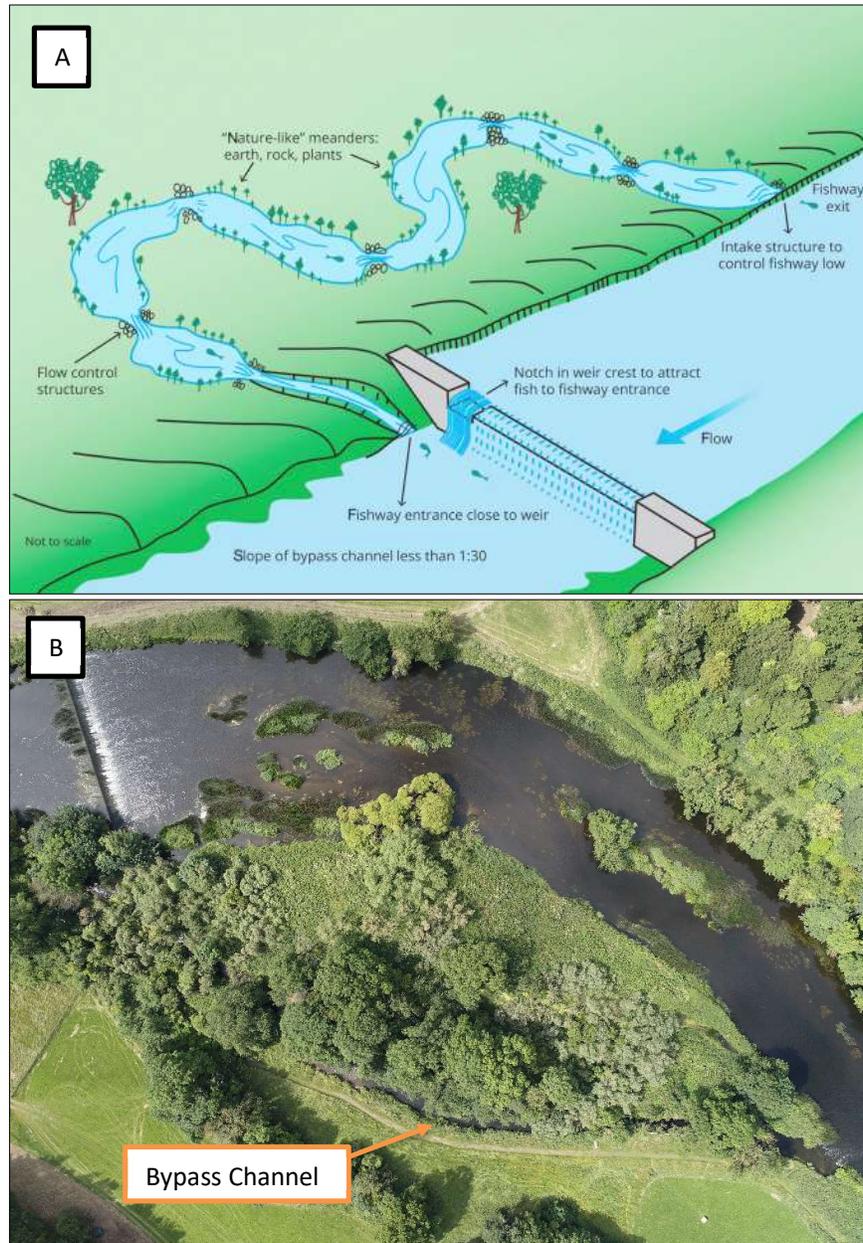
Figure 90. A) Illustration of a bypass channel for promoting the passage of fish and other stream biota (Thomas, 2017). B) Bypass channel on the River Boyne mitigating a weir by Slane Castle. Drone imagery taken 13/07/2021.
