River Boyne WFD III Barrier Assessment Obstacles to Fish Passage and Mitigation Options

Citation: Donovan, R., Coghlan, B., O’Brian, R., O’Connell, A., & O’Leary, C., (2023). River Boyne WFD 111 Barrier Assessment – Obstacles to Fish Passage and Mitigation Options. National Barriers Programme. Inland Fisheries Ireland. Citywest, Dublin.

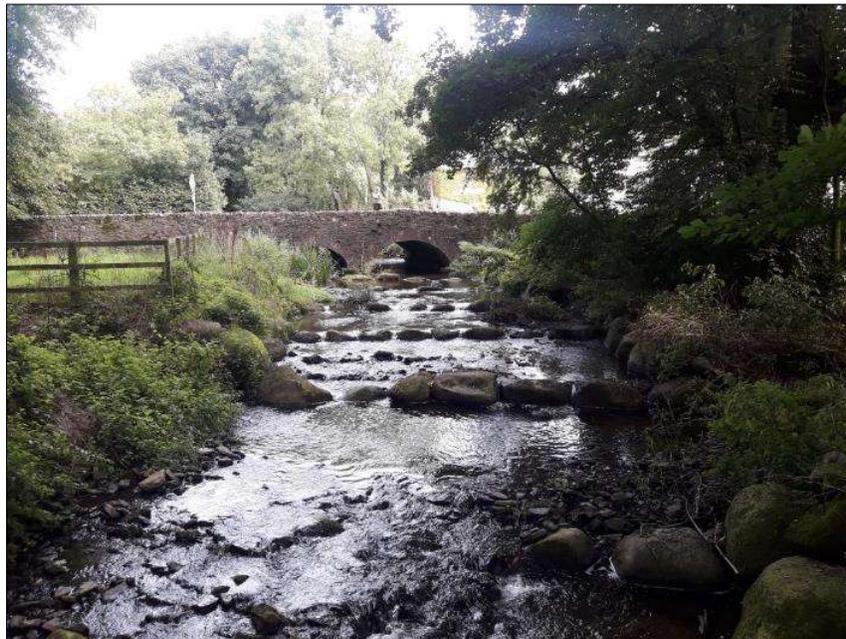
Figure 92. A full width pool and boulder rock ramp type fishway at Tuckmill Bridge, River Slaney, designed to mitigate the barrier impact of a bridge apron/culvert.

The pool and boulder rock ramp fishway is considered to be among the most effective form of fish pass (Figures 92). Its gentle gradient, availability of resting places within the pools and appropriately sized gaps between the transverse rock ridges can accommodate a large variety of fish species.

A final mitigation option is the provision of a fishway (Figure 91 and 92). This is the most limited option in terms of connectivity, but it will at least provide for fish passage, if designed correctly. Fishways are low-gradient, stair-like structures featuring a series of steps interspersed with resting areas. They are designed to dissipate flow velocity and turbulence, thereby allowing fish to swim up and over barriers. Globally, fishways have proven most effective at facilitating the passage of large-bodied salmonids, but are often ineffective for smaller-bodied, slower swimming species (Mallen-Cooper & Brand, 2000; Katopodis & Aadland, 2006). As such, due care must be taken during design to achieve effective fish passage for all species of concern.

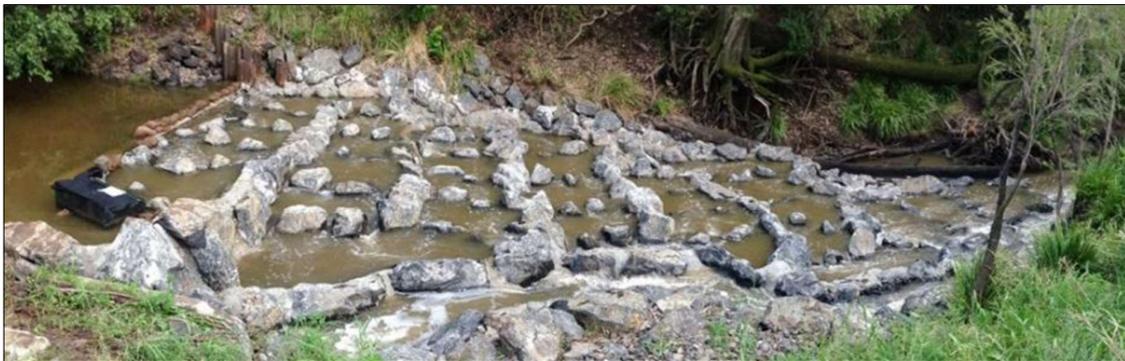
Figure 94. A full-width pool and boulder rock ramp fish pass designed to mitigate the impact of a weir on fish passage <https://catchmentsolutions.com.au/portfolio/rock-ramp-fishway/>.
