Environmental Drainage Maintenance Research Programme

Catchment-wide Assessment 2023

IFI/2024/1-4695

Inland Fisheries Ireland & the Office of Public Works

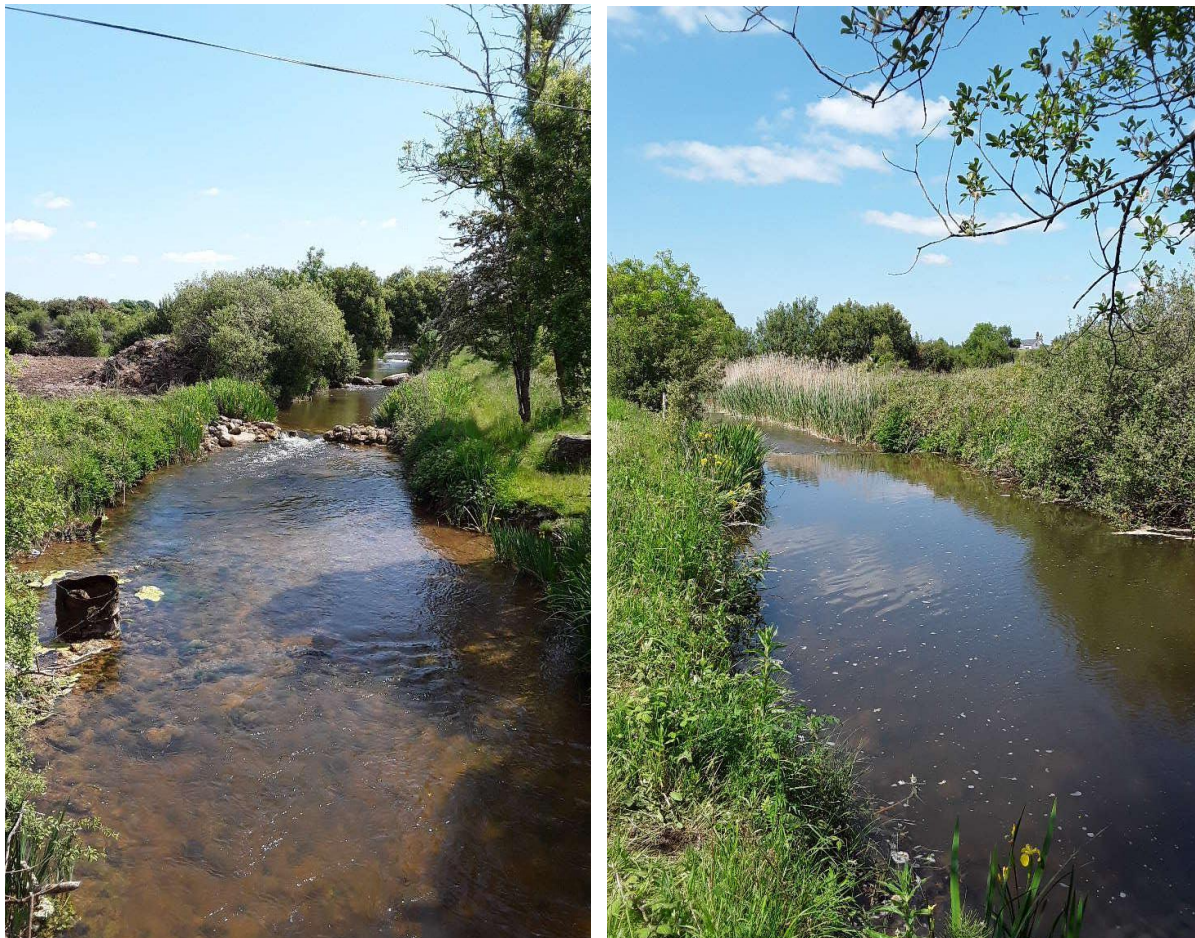
The site surveyed on the Glore River (C1/30) runs alongside a public walkway, park and an old mill. Overall it scored Poor status in the RHAT. This part of the Glore has been extensively straightened. Intermediate weirs (11) and deflectors (2) have been installed as structures within the channel which has altered the flows creating diversity in places, and impoundments elsewhere (Figure 3.3). The substrate condition on the day of the survey was quite poor – it appeared to be calcified and quite embedded. The substrate size was boulders and cobbles surrounded by a high proportion of finer material. It is likely that some of the coarser material was introduced to the channel. Reinforcement on both banks downgraded the score for bank structure and stability.

Figure 3.3 The Glore River (C1/30) showing calcified/embedded substrate and series of weirs (left) as well as impounded flow (right).

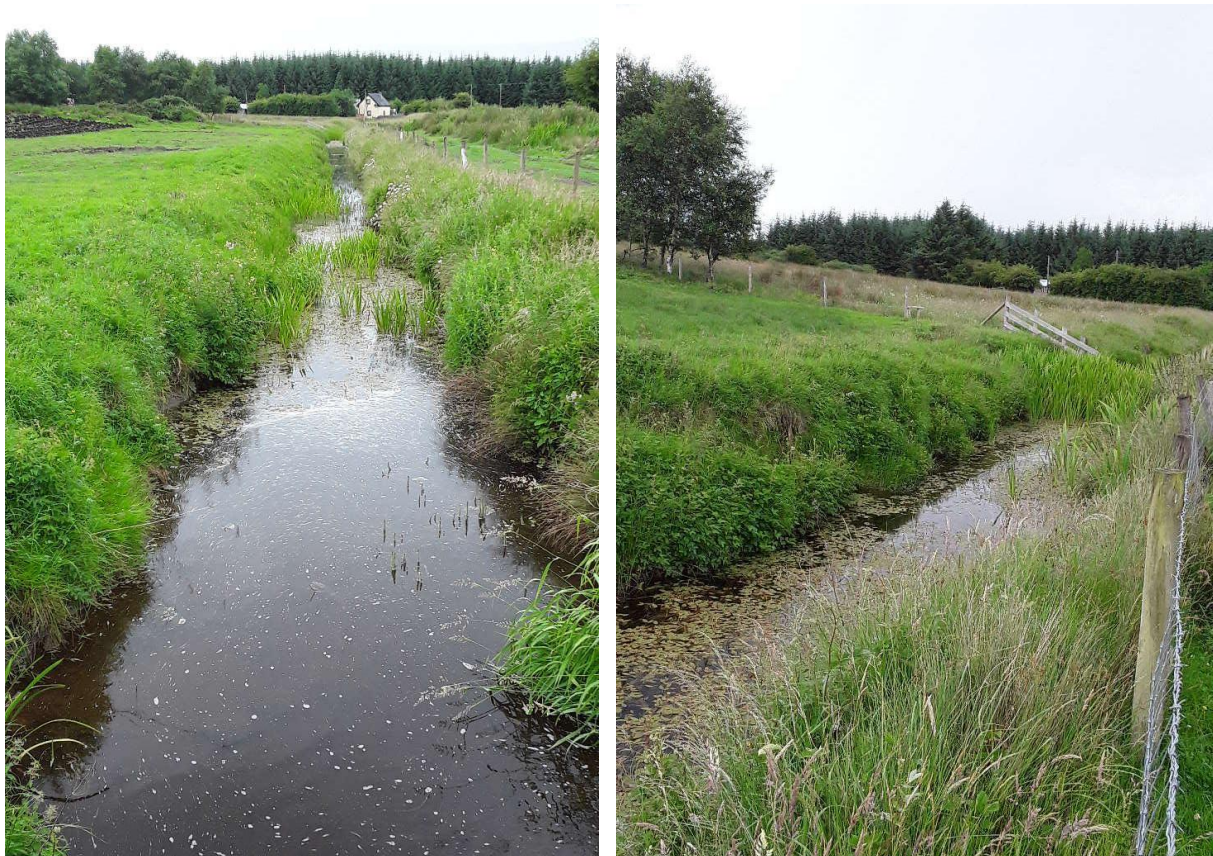
This site on the Corsallagh stream [C1/55 (F/156)] also scored Poor in the RHAT. It has been extensively straightened and re-aligned and suffers from a distinct lack of flow. The channel vegetation can be dense and in sections it is quite homogenous (Figure 3.4). Fine sediment is excessive which can also be typical of channels which are re-aligned and over-deepened to this extent. As can be seen in the images (Figure 3.4), there are no trees along the stretch surveyed.

Figure 3.4 Images of the Corsallagh Stream [C1/55 (F/156)] showing channel straightening, limited flows and lack of riparian vegetation (left), along with homogenous instream vegetation (right).

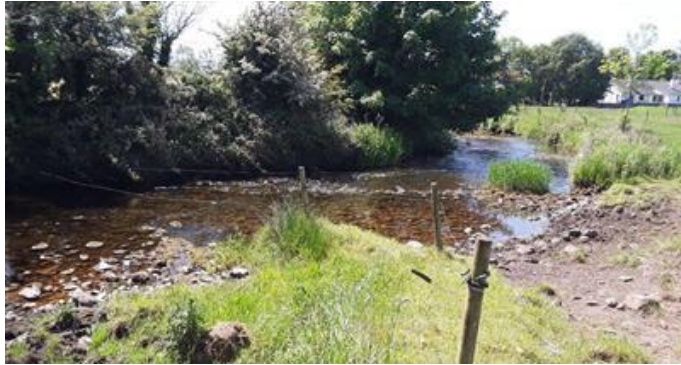
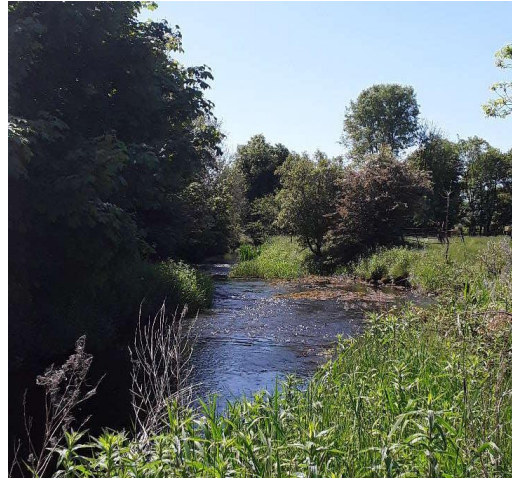
The site on the Trimoge (C1/30/5) is just upstream of the confluence with the Gweestion River. It scored as Moderate status overall but was on the higher end of the scale and very nearly achieved a Good result. The substrate condition and channel vegetation both scored Good. Riparian land use and floodplain connectivity scored Poor to Moderate, which brought down the score. The over-widening affected the score for channel form and flow. Bank structure and stability was one of the attributes which could be improved to augment the overall RHAT score. Poaching is extensive in one section in particular (Figure 3.5).

Figure 3.5 Extensive poaching extensive on the Trimoge River (C1/30/5, left). Geomorphological diversity including substrate, bank and channel vegetation (right).

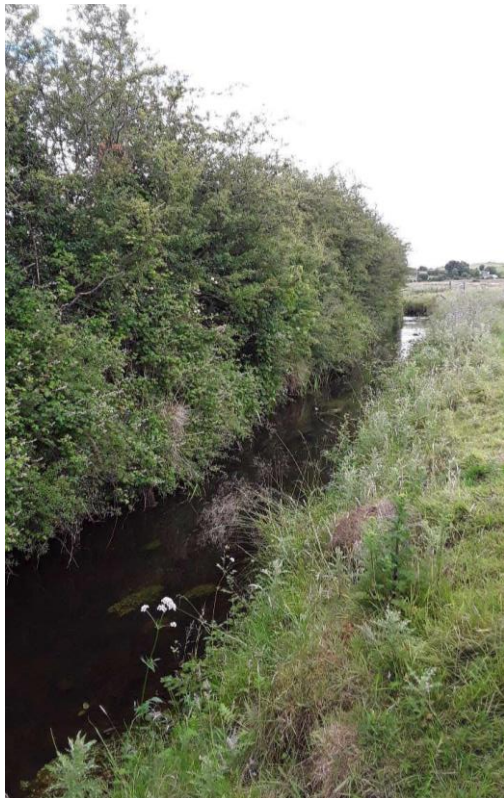
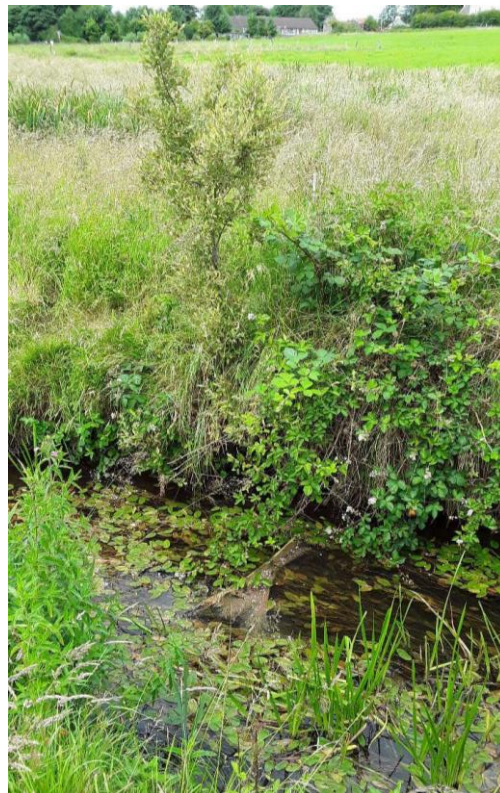
Another channel which ranked as Moderate status overall is the Killeen River (C1/31). This channel has been historically straightened, and it has resulted in minimal variation in flows and depths across the reach surveyed. Channel vegetation scored poorly as there were significant areas with excessive homogenous instream vegetation (Figure 3.6).

Figure 3.6 Minimal flows (left) and homogenous instream vegetation (right) on the Killeen River (C1/31).

There is also excessive fine sediment loading across the reach. The left-bank was extensively poached with minor reinforcement, reducing that score. The right-bank was mostly fenced, with minor poaching. It also had more tree cover, albeit in sections rather than continuous cover.

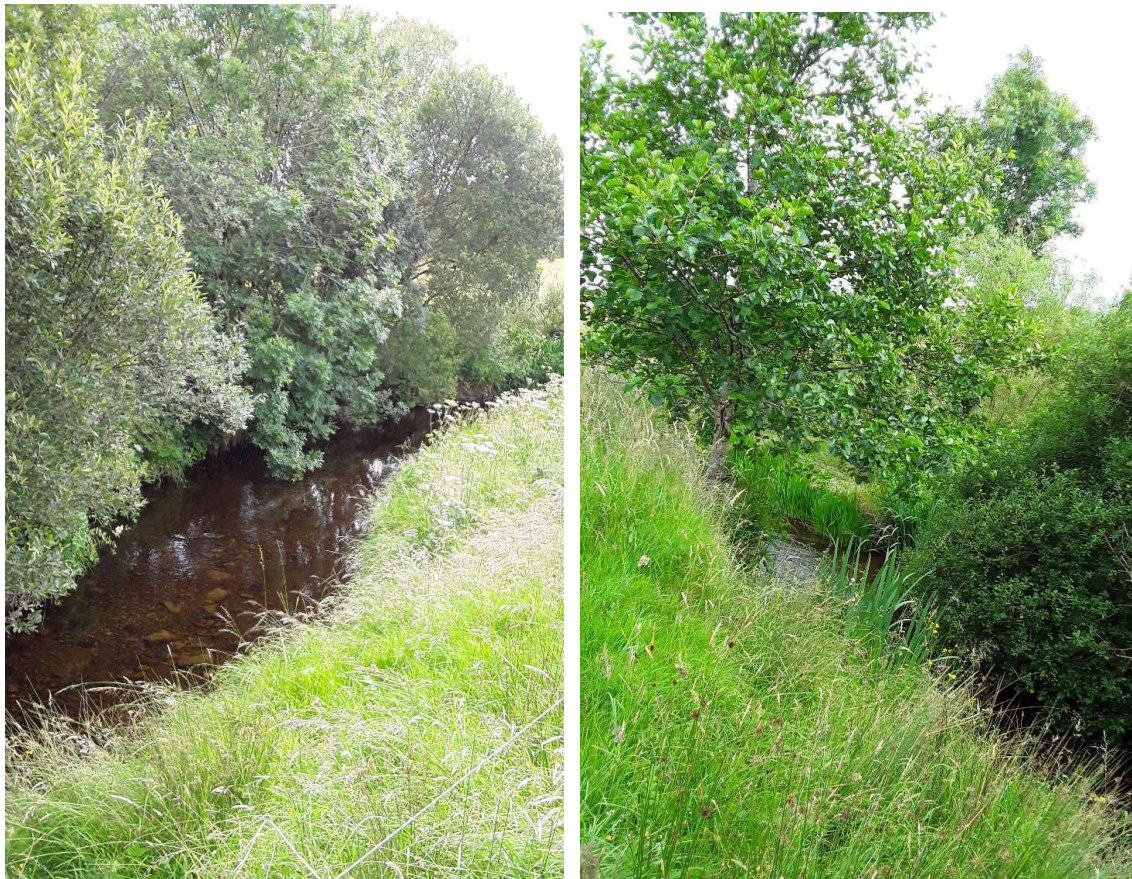
The site on the Bellanamean River [C1/49/5 (F/1518)] is quite high up in the Moy catchment, and the survey stretch is located where the river reduces in gradient coming off the hills southwest of Lough Talt. The site scored Good status overall. Historically the river was over-deepened, but there is extensive recovery evident. The channel vegetation and substrate condition both scored well. A mixture of woody habitat and some macrophytes is apparent instream with a good diversity of coarse cobbles and finer gravels (Figure 3.7). The left-bank has minimal bank vegetation, but shading from the opposite bank is sufficient for the channel width. Anecdotal evidence from the landowner suggests that this site has not been maintained in some time, and the recommendation would be to continue in this vein as it is self-cleansing channel with nice variation in geomorphological features.

Figure 3.7 Good substrate condition (left), riparian cover, and instream vegetation (right) on the Bellanamean River [C1/49/5 (F/1518)].

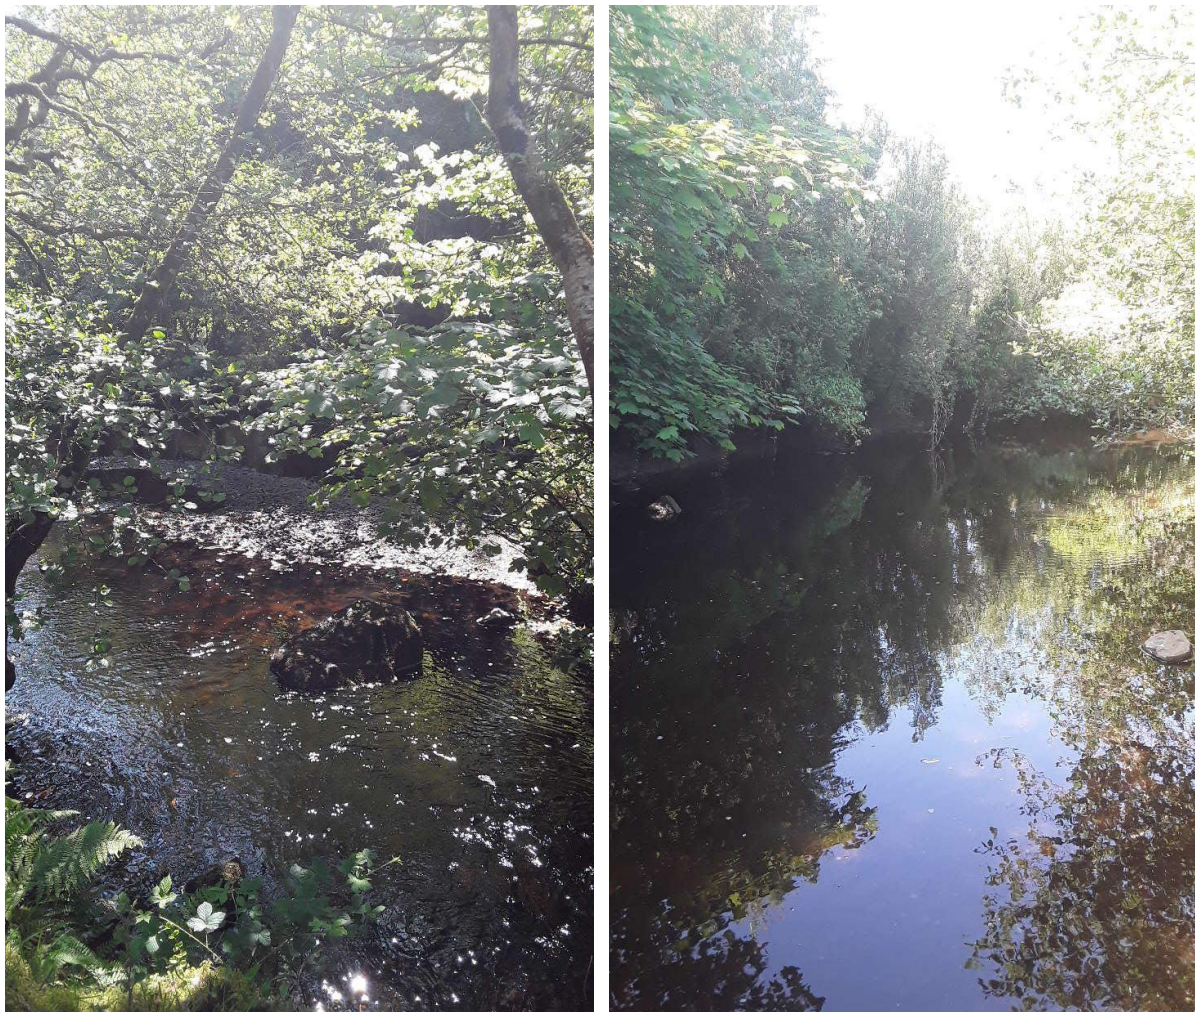
The site surveyed on the Owenaher River straddled a section of natural river channel, as well as a section which has been arterially drained (C1/54). Like the Bellanamean River it also has good gradient as it comes down off the Ox Mountains. The section of river at this site which falls under the OPW scheme does not appear to be recently maintained. In that respect channel form and flow scored good as the channel is recovering from anthropogenic (human-induced) interference. It is notable that the flows are much less diverse in the area which has been severely over-deepened (Figure 3.8). There is good substrate and flows through most of the site, and the instream vegetation is predominantly woody habitat and mosses/lichens. The site was scored down for surrounding land use which is coniferous plantation on the right-bank.

Figure 3.8 The Owenaher river upstream of the OPW scheme (left) and section of channel within the scheme (C1/54, right).

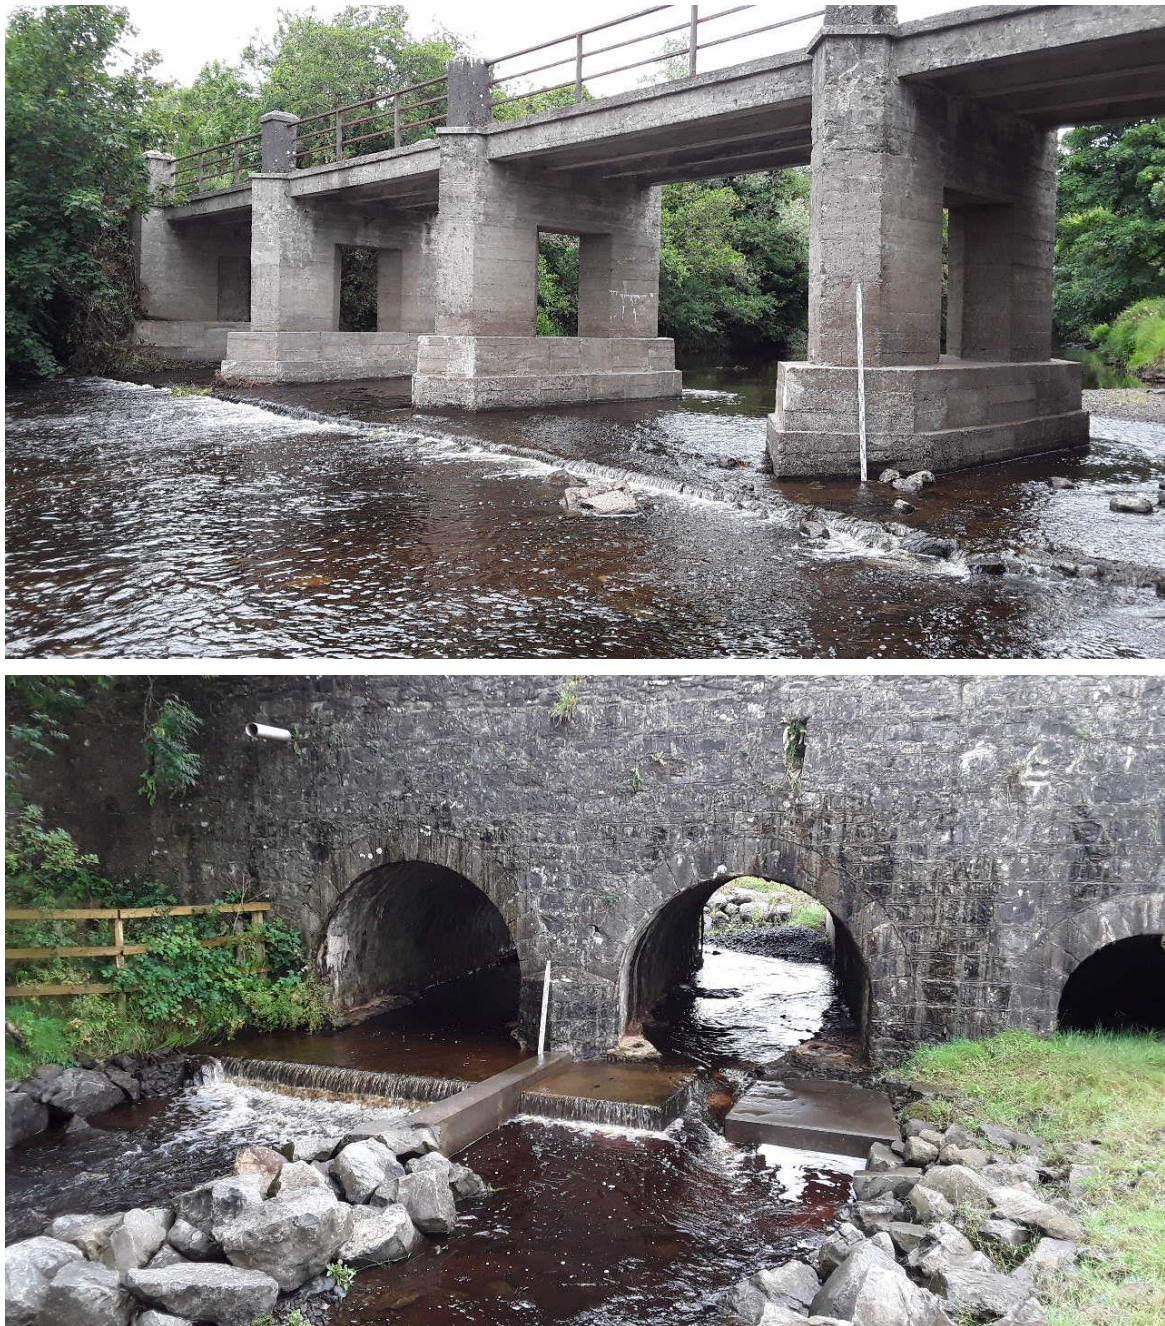
Not many issues with barriers were encountered on the main channel of the River Moy. One notable barrier was an elevated bridge apron, upstream of the confluence with the River Eignagh, east of Aclare (see Figure 4.2). The shallow apron is impassable to some species in low flows as can be seen in the photograph. Some of the main tributaries had barriers including the Little River (Figure 4.2), Sonnagh (Figure 4.3) and the Trimoge, Glore, Strade, Carroward, Killeeen (not pictured).

Figure 4.2 Examples of barriers on the main Moy (C1, top) and the Little River/Strade (C1/23/3, bottom).

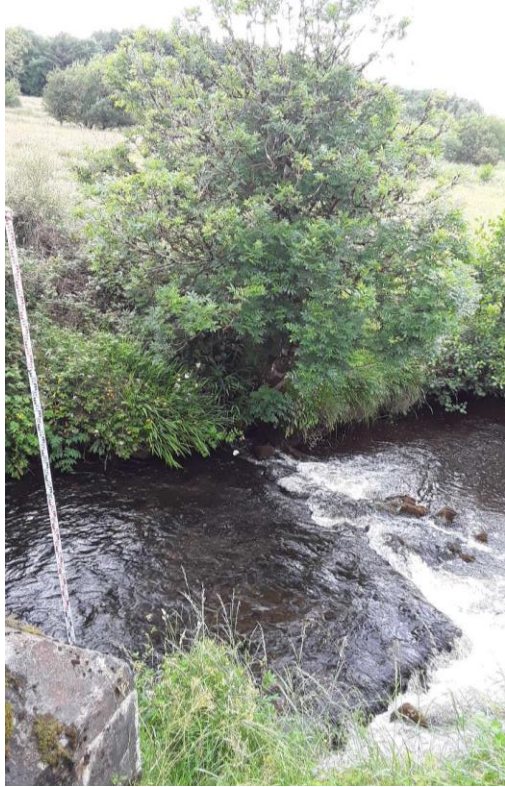
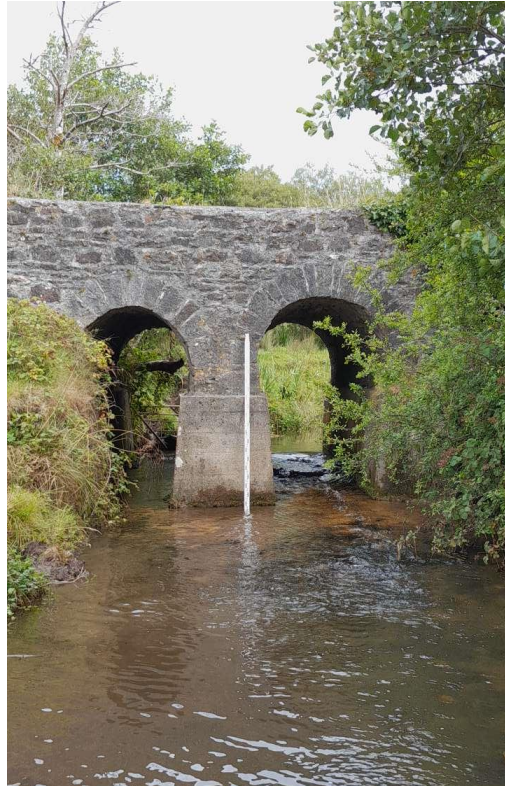
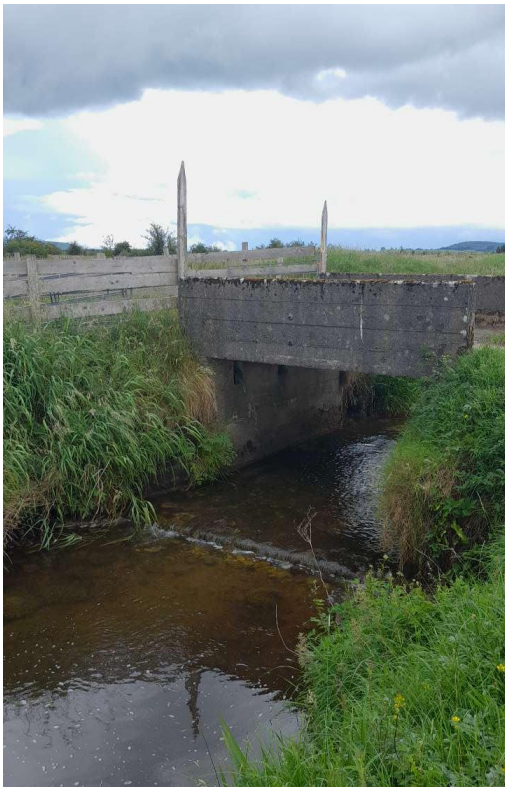
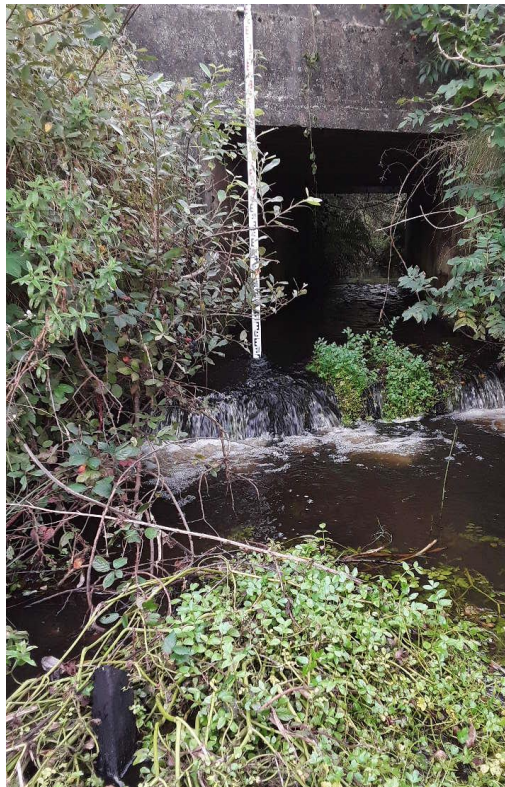
Figure 4.3 Examples of barriers on the Sonnagh (C1/44/1, top left), Tiraninny (C1/41, top right) Corsallagh Stream [C1/55 (F/156), bottom left] and Tawnamullagh (C1/40, bottom right).

As is visible in the pictures, some bridge aprons have obvious steps in them, presenting a jump barrier to any fish moving in the channel during lower flows. In addition to this, the floor of such perched bridge aprons is usually covered with a shallow amount of water, also presenting a swim barrier to potential migratory species. The example on the Little River (Figure 4.2) looks recently retrofitted, however the solution does not address passability for all fish species.

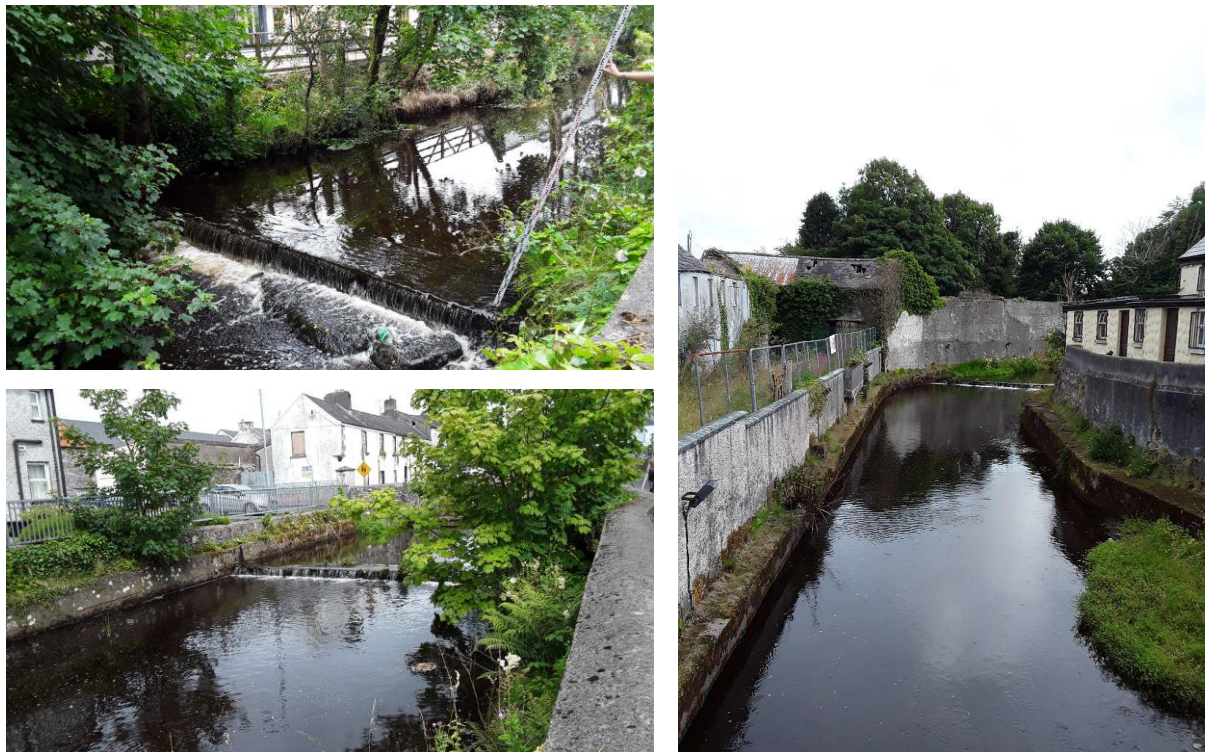
There are a small amount of weirs in the section of the Moy which was surveyed (Table 4.2). Many of these include weirs with a small hydraulic head height such as those in the Charlestown Stream (Figure 4.4). Similarly, a series of small weirs are present in the Newpark stream in which also runs through an urban area, the town of Swinford.

Figure 4.4 Series of small weirs in the Charlestown stream (C1/45).

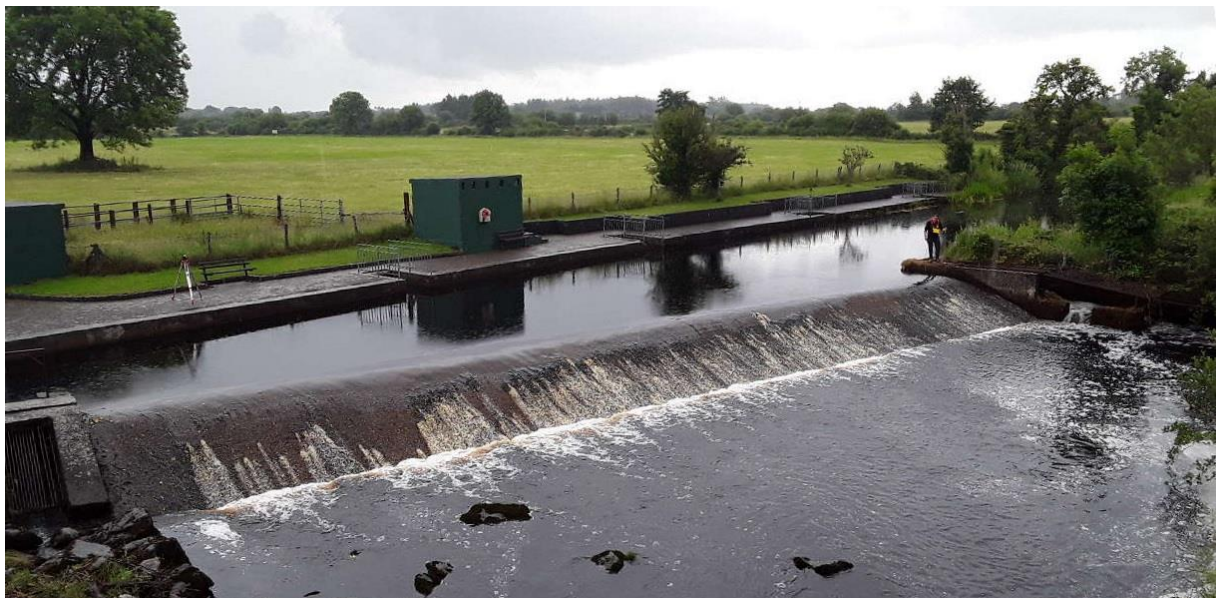
There is one major weir in the section of the Moy surveyed for barriers, on the Owengarve River. It is an historic structure, present on the Ordnance Survey six inch maps. It was surveyed using the WFD111 methodology developed by SNIFFER (Scotland and Northern Ireland Forum for Environmental Research, 2010) by the National Barrier Programme team in June 2023. Using this methodology, surveyors assess each structure dividing it into transects with similar hydraulic properties. Depending on the type of transect, various measurements of same are taken including hydraulic head height and dimensions. Flow is measured across each transect at the inlet, mid-point and outlet. Each transect is assessed for fish passability for a range of target species, and subsequently the structure is assigned an overall passability ranking.

It is a sloping weir with a total hydraulic head height of 1.24 m (Figure 4.5), with a pool-type fish pass located on one side. Transversal 1 – the face of the weir – was a swim barrier to fish passage. Passage issues at this transect are from the jump/swim height (1.24 m) required to pass the weir, the depth of water on the face of the weir (0.03 m) and the slope of the weir (35.4%). These factors in the prevailing water level conditions represented a complete jump and swim barrier to all fish species and their life stages, apart from juvenile eels. It also posed a high impact partial barrier to adult salmon and trout in flood conditions. Transversal 2 – the pool fish pass – was a jump barrier to fish passage. The step height (0.45 m) in the fish pass represents a high impact partial barrier to adult salmonids and a complete barrier to cyprinids, adult lamprey and juvenile salmonids. Limited climbing substrate is present for juvenile eel. It poses a low impact partial barrier to adult salmon and trout in flood conditions.

Figure 4.5 The weir on the Owengarve (C1/48) at Curry.

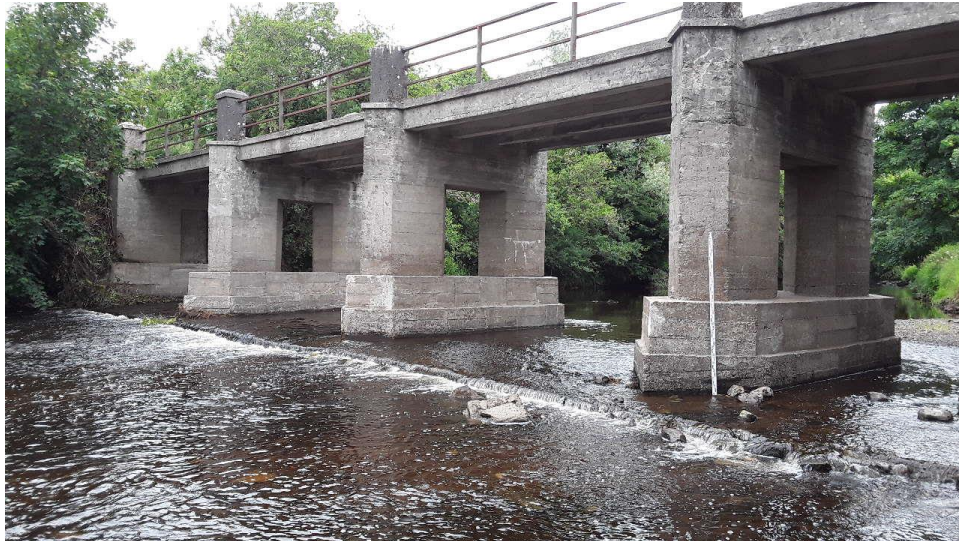
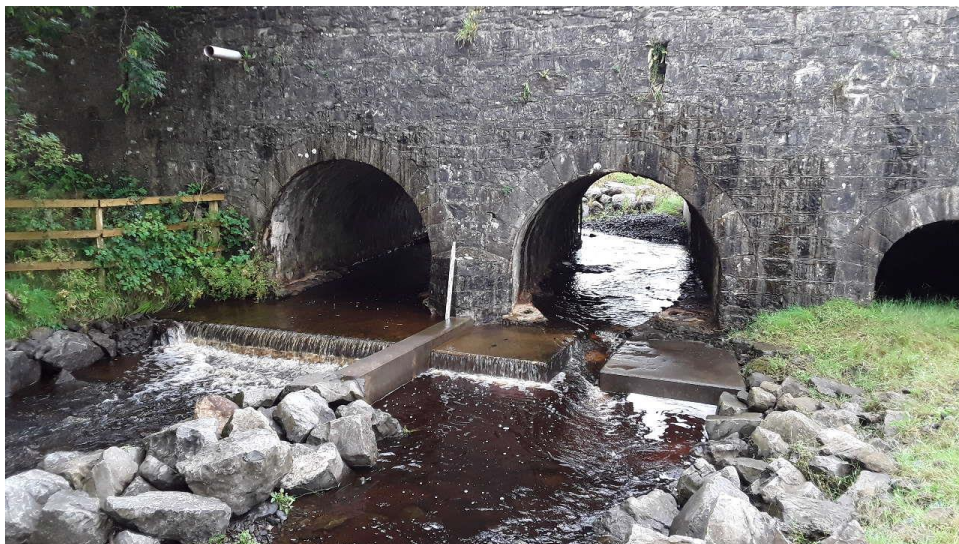
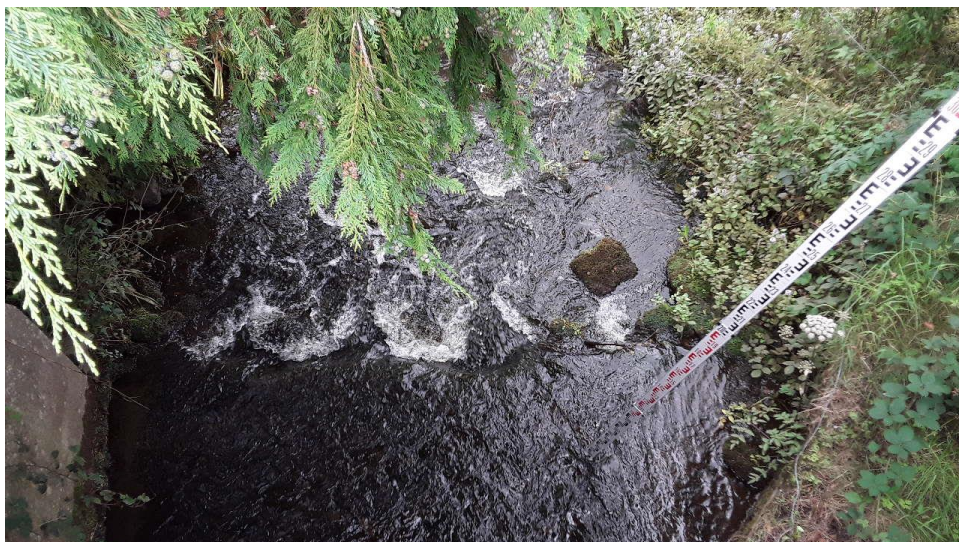
Figure 7.1 Barrier removal/mitigation recommendations: Photos of Moy (34_344_40), Strade (34_1132_258) and Oughtagh (34_3376_82).

Longitude	Latitude	Relative project size	U28 ID *	OPW channel reference [Bridge reference]	River	Nature of Obstruction	Photo page number
-8.86203	54.02658	Large	34_344_40	C1	Moy	Bridge with apron	35
-9.11069	53.89281	Medium	34_1132_258	C1/21/3 [B2]	Strade	New bridge apron with poor fish pass retrofitted to old masonry bridge	35
-8.95229	53.8553	Medium	34_2188_344	C1/30 [B10]	Glore	Bridge apron with a drop. Notched in apron, velocity a passage issue more as well as a jump	36
-8.86415	53.97428	Medium	34_2274_2	C1/44/1	Sonnagh	Bridge apron with drop	36
-9.10149	53.92794	Small	34_3376_82	C1/25 [B2]	Oughtagh	Apron with a drop	35
-8.678	53.95926	Small	34_2260_258	C1/48/7 [B1]	Owenlobnaglaun	Apron with drop	36
-8.77656	54.0797	Small	34_751_47	C1/55 (F/156)	Corsallagh	Shallow bridge apron, minor drop	37
-8.98085	53.96938	Small	34_3165_202	C1/41 [B1]	Tiraninny	Shallow bridge apron, impoundment upstream. Fast water over floor	37

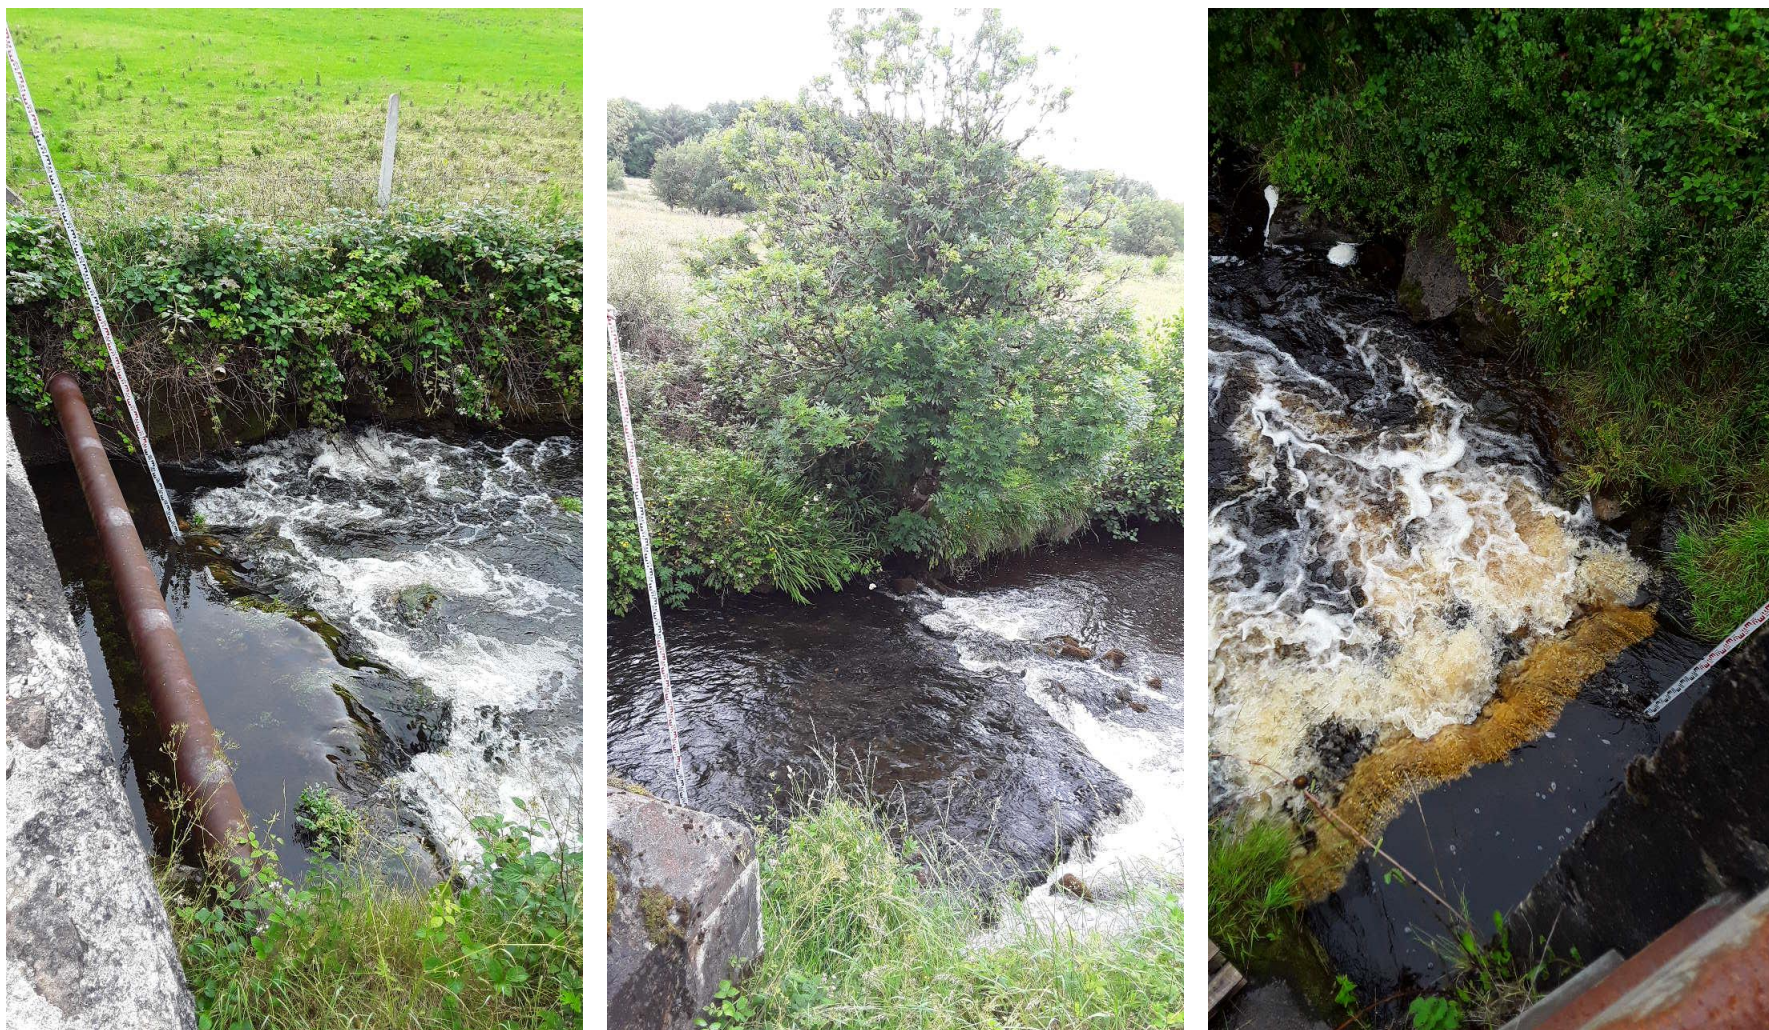
Figure 7.2 Barrier removal/mitigation recommendations: Photos of Glore (34_2188_344), Sonnagh (34_2274_2), Owenlobnaglaur (34_2260_258).

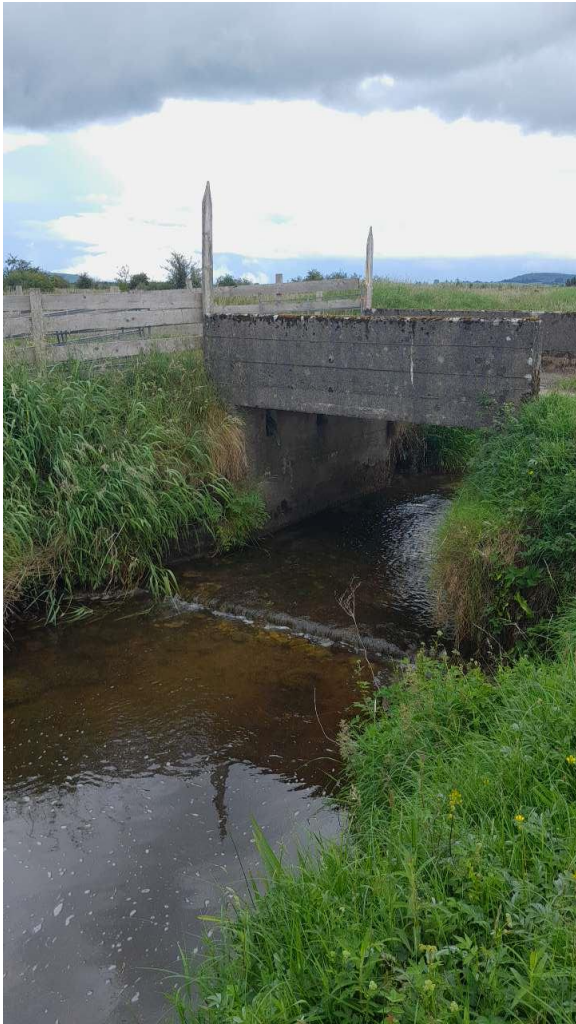
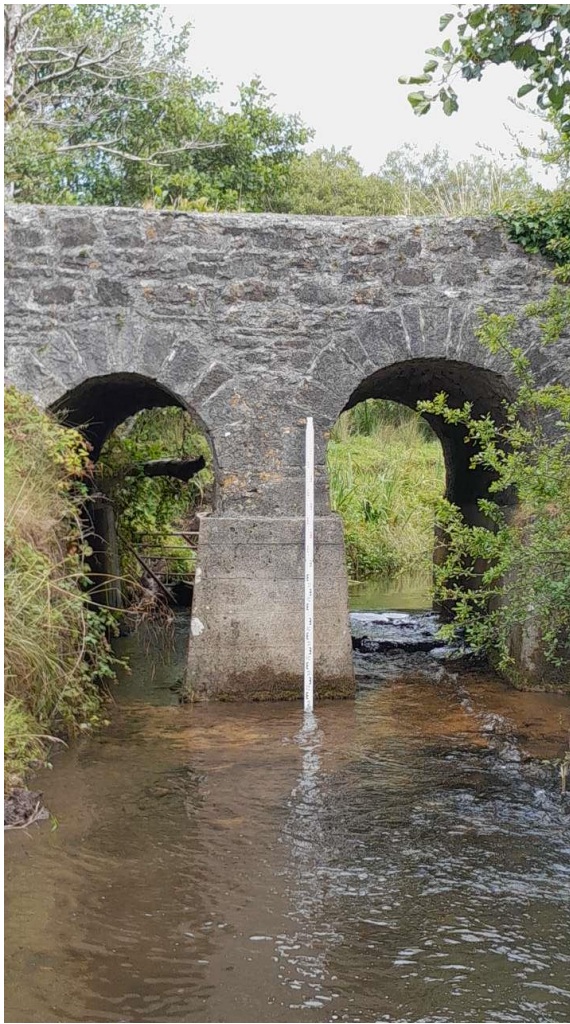
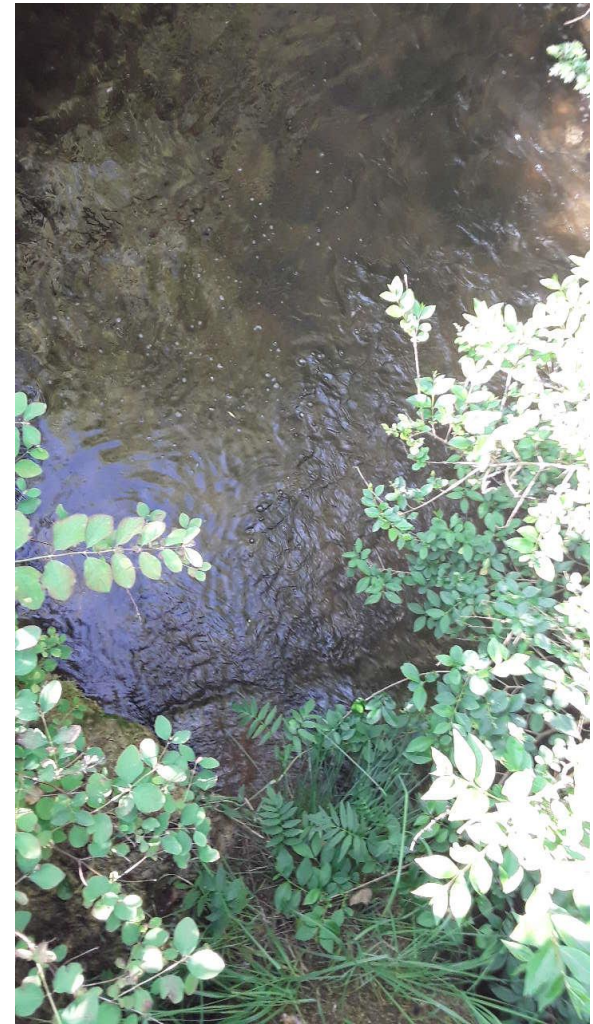
Figure 7.3 Barrier removal/mitigation recommendations: Photos of Corsallagh (34_751_47), Tiraninny (34_3165_202) and Tubercurry (34_2633_59).

-8.80062	54.04941	Small	34_2633_59	C1/52	Tubercurry	Slope into short drop	37
