BAKERY WEIR

The Bakery Weir Partial Removal project is located on the River Suir, in Cahir, County Tipperary. Bakery Weir consists of an 18th Century masonry weir with adjacent Mill structure. IFI completed a barrier assessment in 2018, which found that the structure at Cahir was a significant barrier to migrating salmonids, lamprey and coarse fish.

NATIONAL BARRIER MITIGATION PROGRAMME

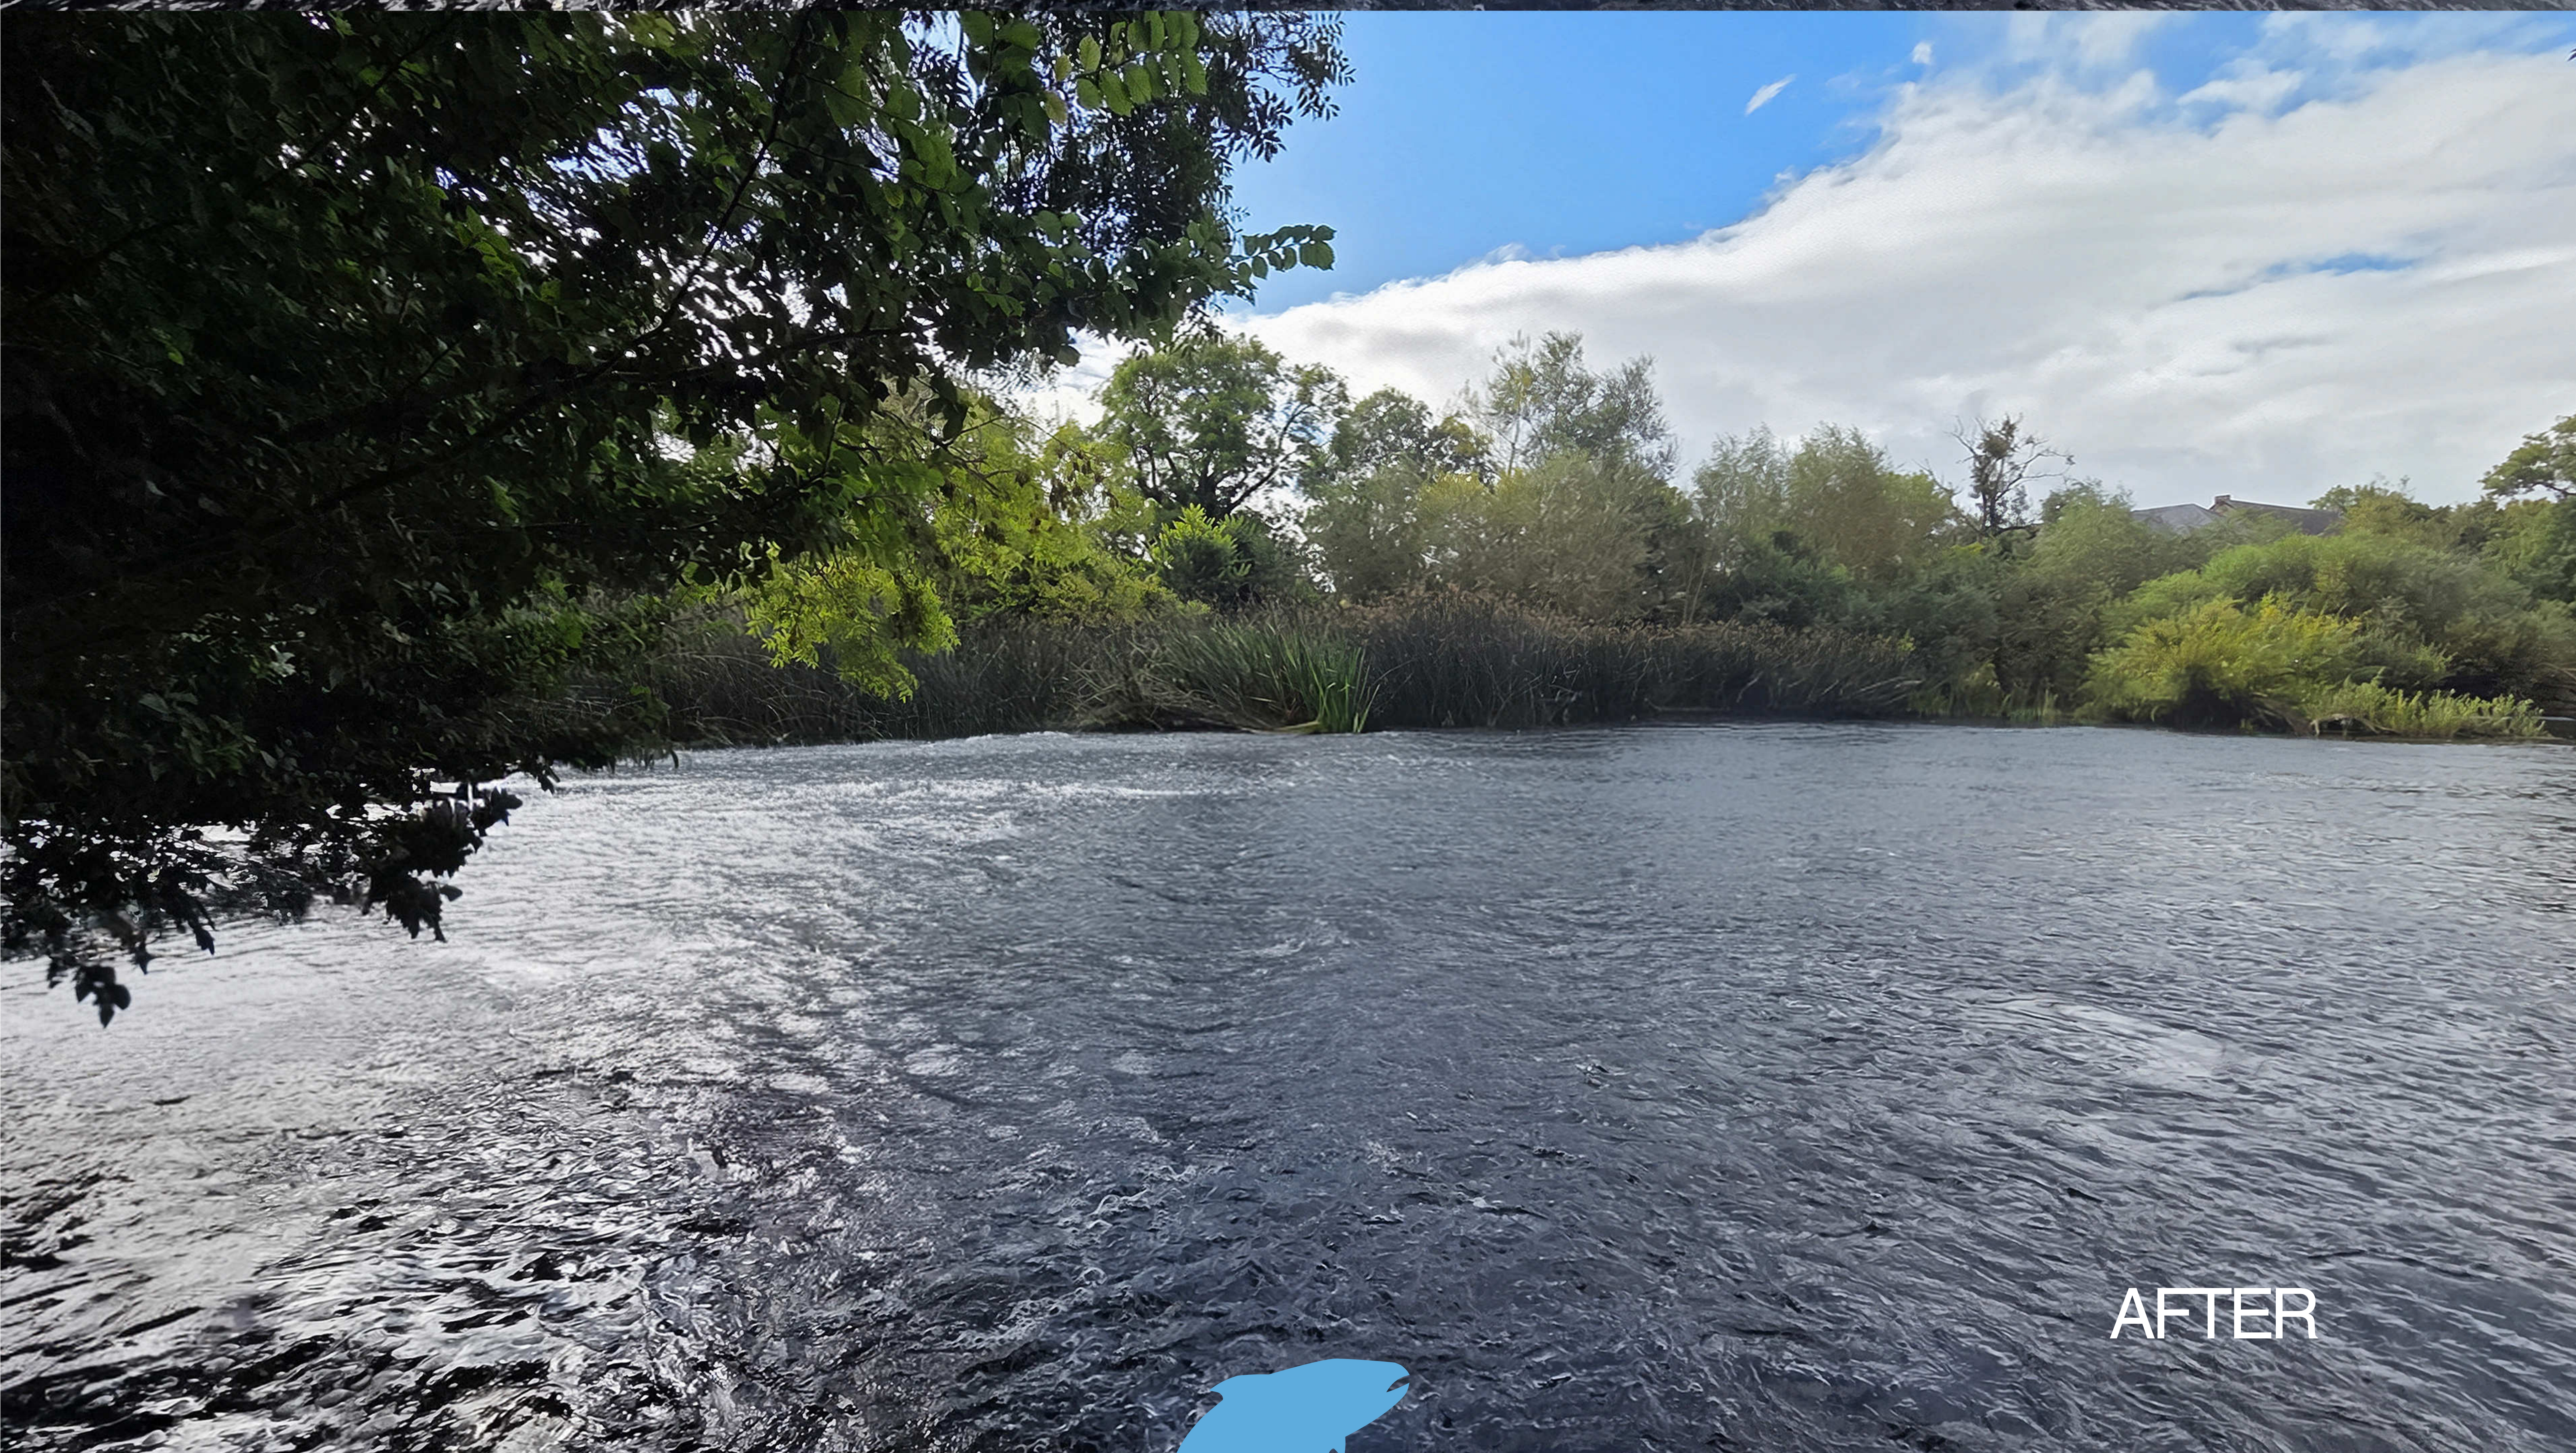
AFTER

The proposed design at Bakery Weir consists of the removal of two thirds of the weir and fish pass on the western side of the barrier. This design provides the best ecological benefits and it allows the creation of a hydromorphologically diverse watercourse and provides a habitat for a variety of small animals, aquatic plants and fish due to the natural characteristics of the restored river channel.

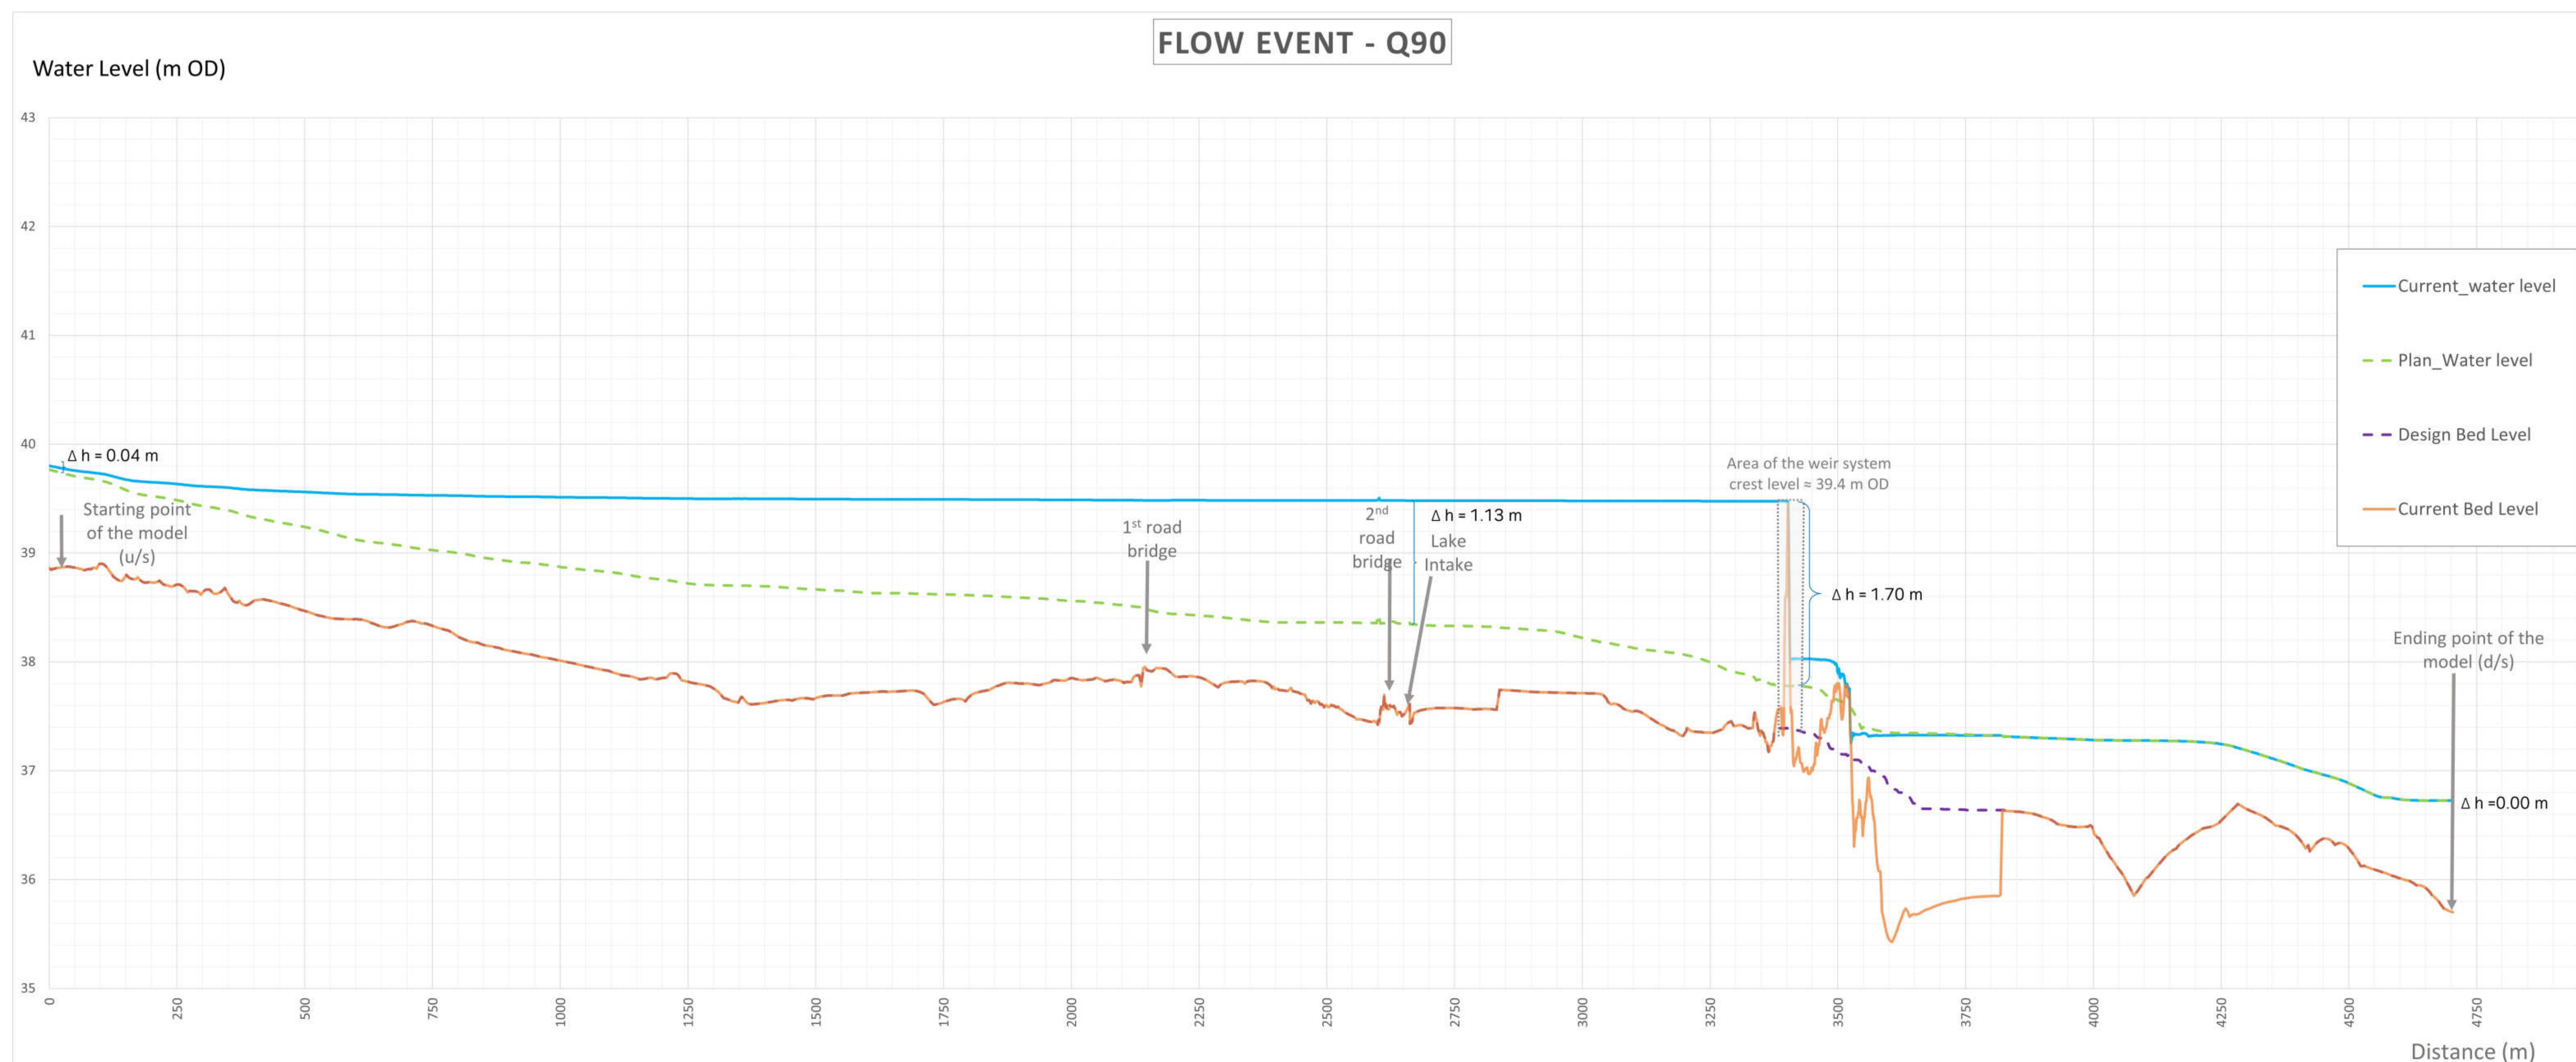
Q90 flow (low flow) The backwater effect upstream of the weir and the water-level difference compared to the design state is clearly visible. At the upstream model boundary (confluence with River Aherlow), the difference is essentially zero, considering a model accuracy of ± 5 cm. At the weir, there is a max. water level drop of about 1.7 m. At the downstream model boundary, near Cahir, there is no noticeable difference from the current state.

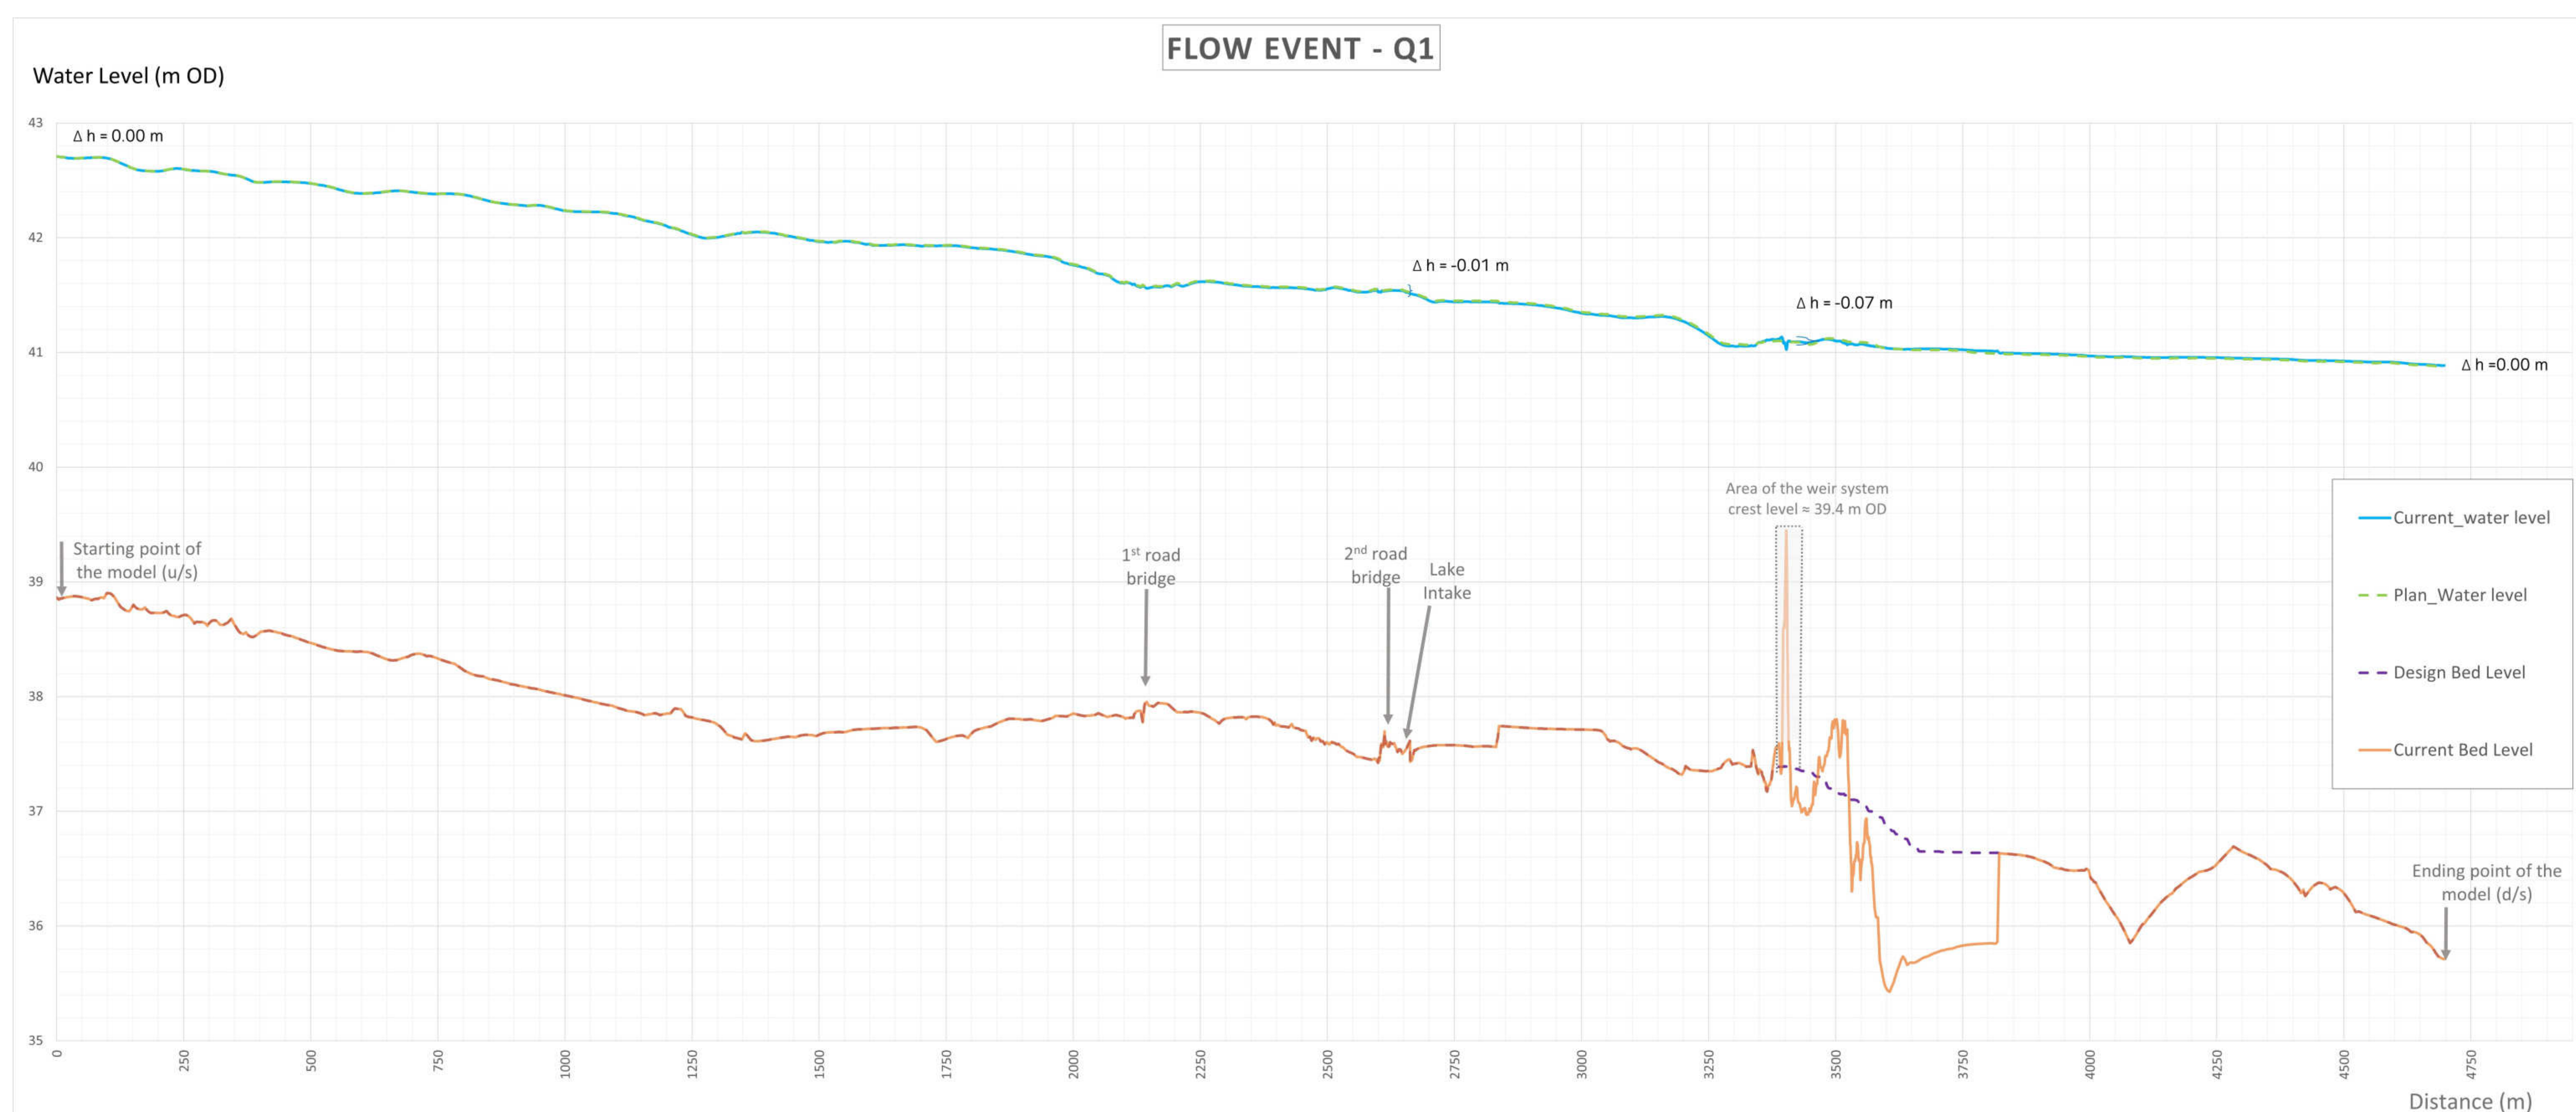
Q1 flow (Year Flood Flow) The design water level remains almost unchanged compared to the current state. The model shows a slight local increase at the weir, which is due to the planned bed elevation in that area, this is clearly visible when comparing the orange and purple dashed lines. However, this difference is within the model's accuracy range and therefore not considered significant. Overall, this is a positive result from an ecological perspective, as the Q1 flow plays an important role in regularly flooding the alluvial woodlands.

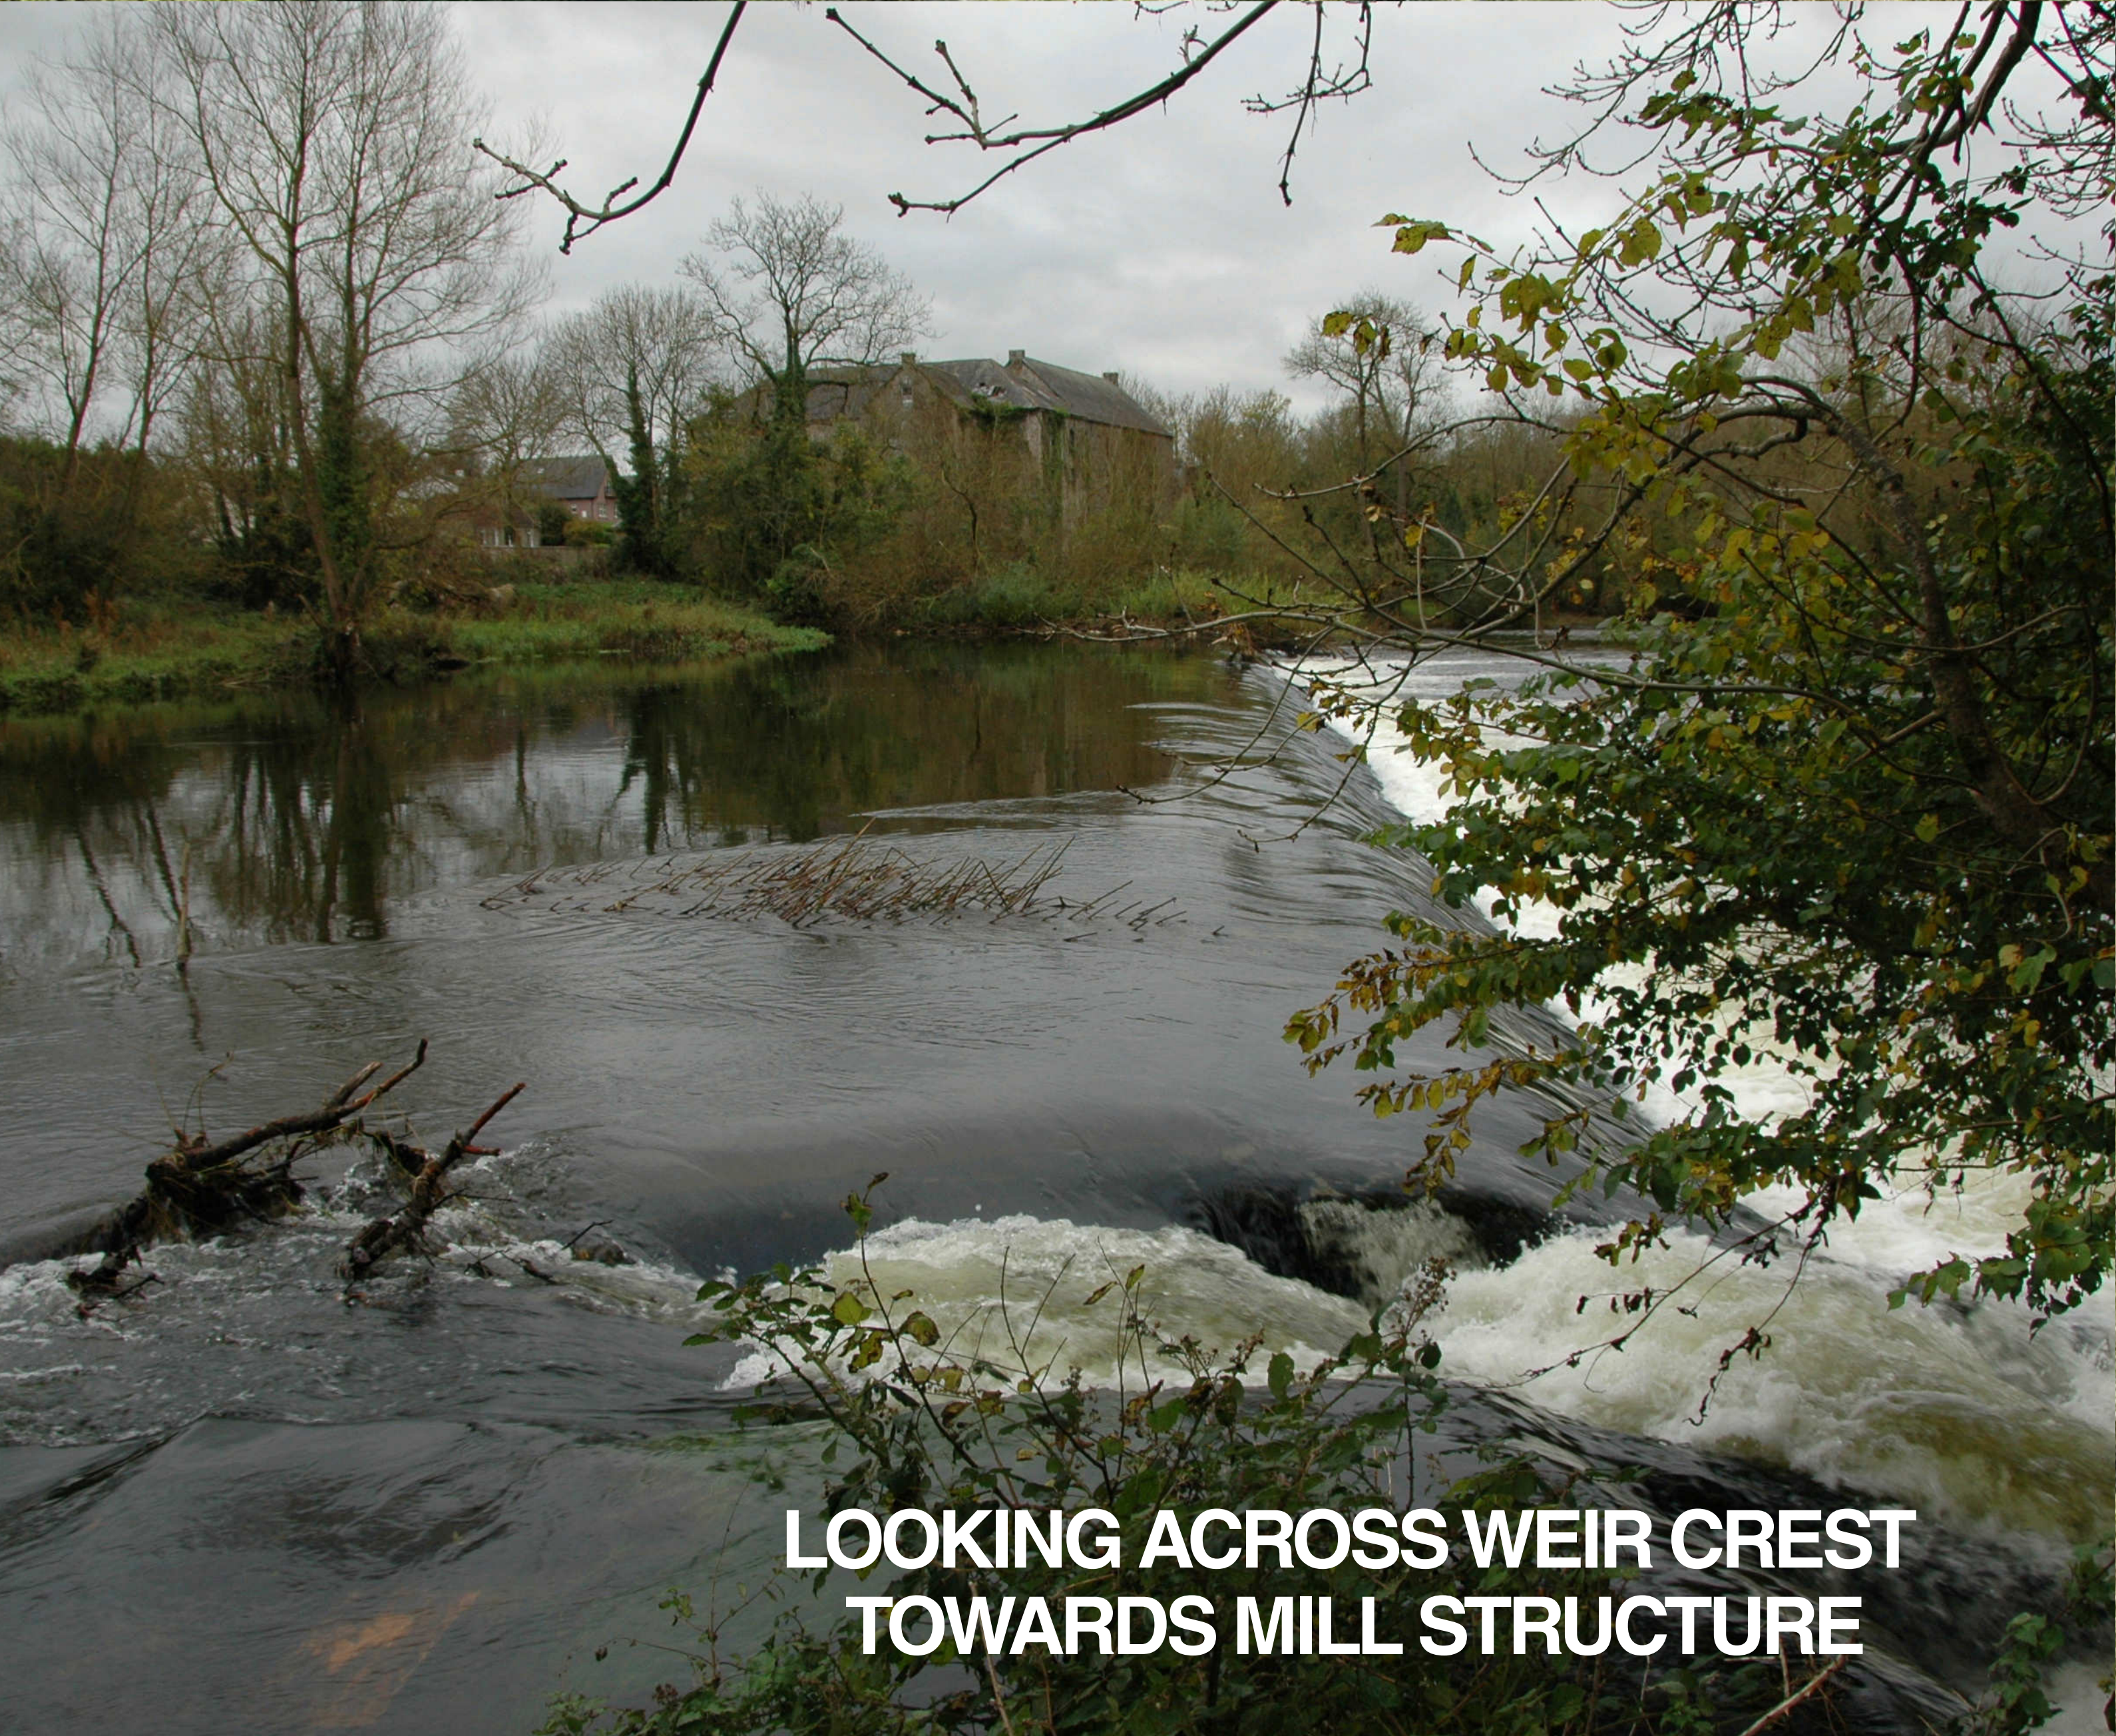
LOOKING ACROSS WEIR CREST
TOWARDS MILL STRUCTURE
