Environmental River Enhancement Programme

Annual Report 2019

IFI/2020/1-4515

**Inland Fisheries Ireland & the Office of Public Works
Environmental River Enhancement Programme**

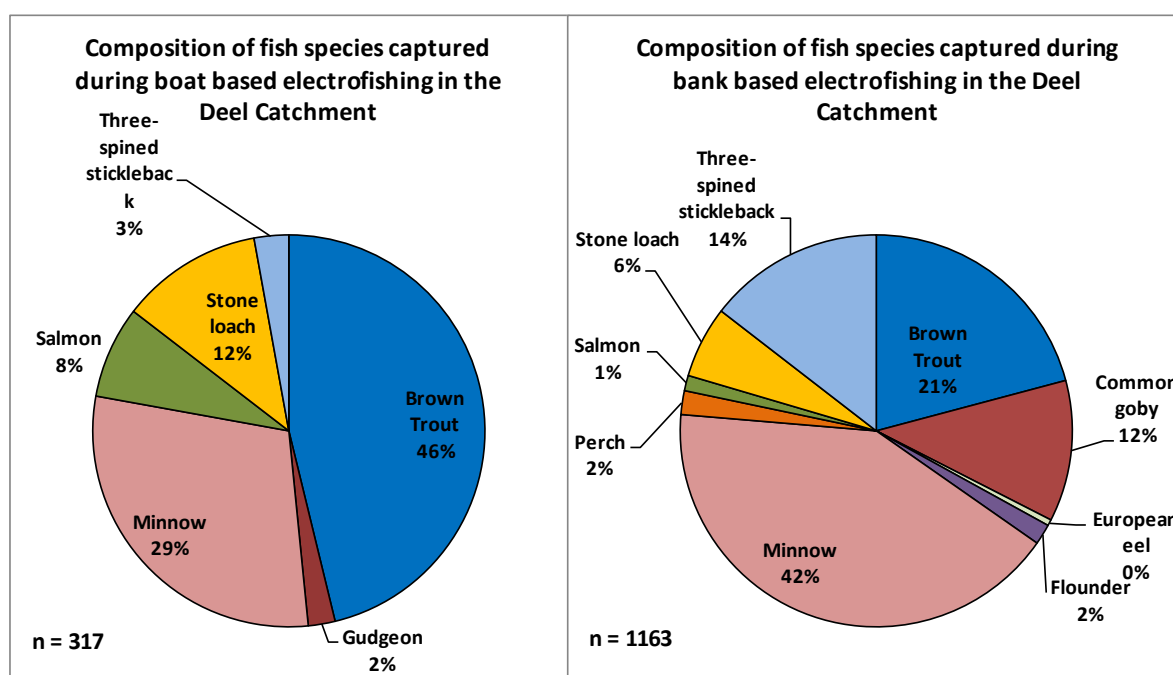
Figure 2.3 Composition of fish species captured in the Deel FPI survey using bank and boat based electrofishing equipment.

In completing the 2019 FPI survey, 36 bank-based and 11 boat-based electrofishing sites were fished. The boat sites were located on the main stem of the river Deel. In total, 1480 fish were captured, measured and returned during the survey. Brown trout was the most abundant species encountered in the boat fishing whereas the bank based fishing catches were dominated by minnow, followed by brown trout and 3-spined stickleback and the common goby (Figure 2.3). Common goby were abundant at one of the bank sites located in north of the catchment close to the estuary, where brackish water provided suitable goby habitat.

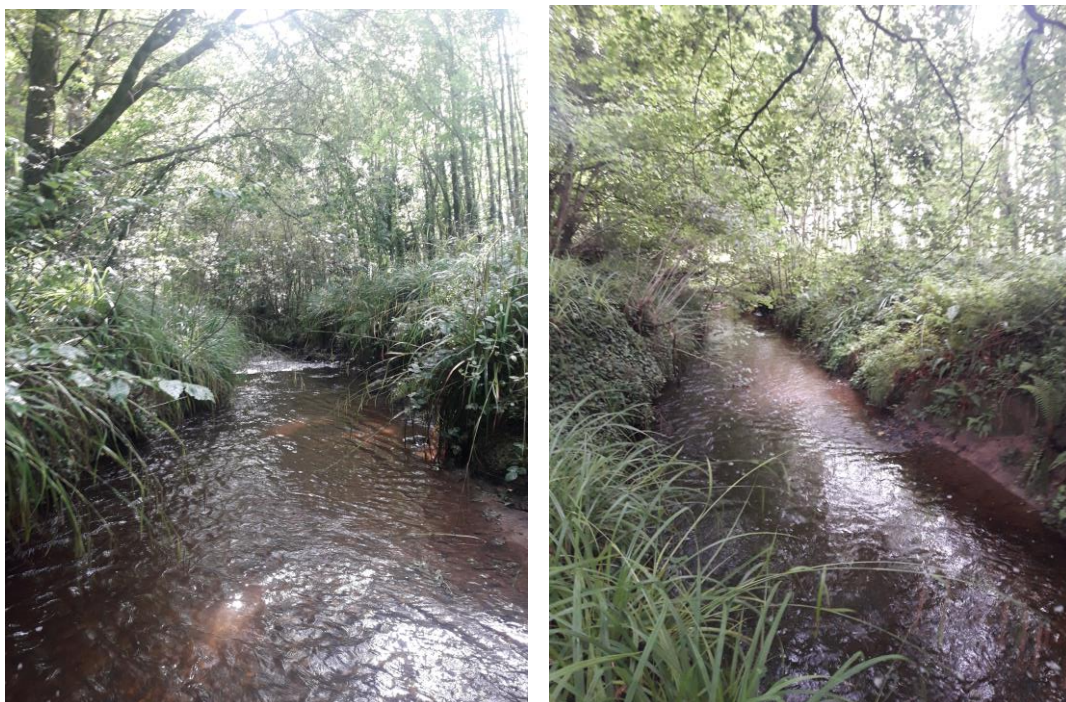
Figure 2.10 Example of a RHAT site achieving 'Good' status on the River Arra.

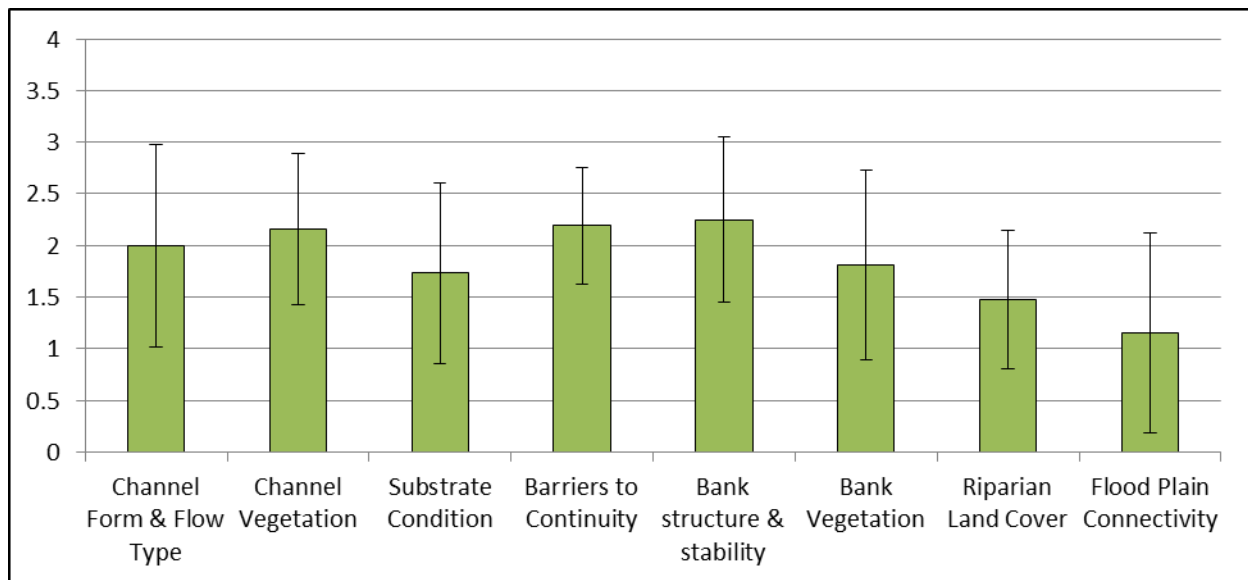
Figure 2.11 Mean and standard deviation for all 8 components of the RHAT survey in the Deel catchment (n=26).

When each element is broken down and averaged for the Deel dataset, the scores range between 1.15-2.25. Given that 50% of the RHAT scores in the Deel resulted in Moderate status, this distribution is not surprising. Flood Plain Connectivity and Riparian Land Cover scored the lowest, on average, with Bank Structure & Stability and absence of Barriers to Continuity scoring the highest on average. In arterially-drained catchments, it can be expected that Flood Plain Connectivity would have a low outcome, as the channel becomes isolated from the floodplain by design.

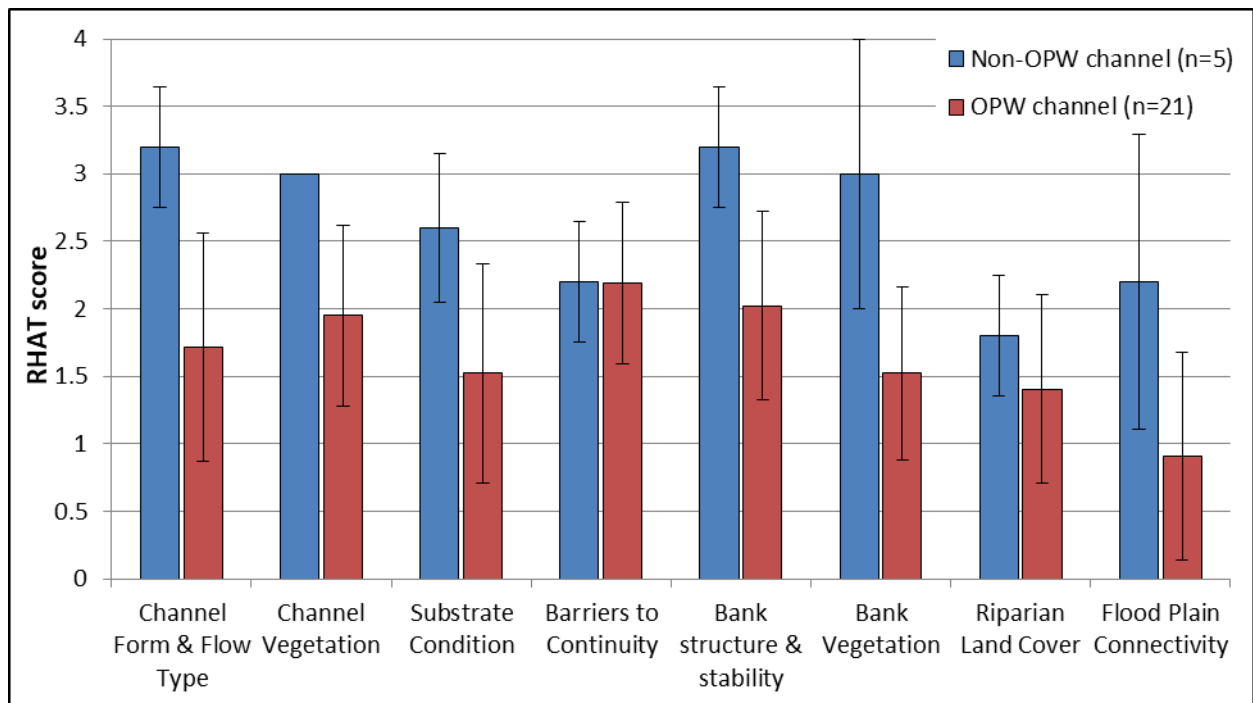
Figure 2.12 Mean and standard deviation for all 8 components of the RHAT survey, separated into undrained channels (n=5) and OPW-drained channels (n=21) for the Deel catchment.

The data for the eight attributes in the Deel catchment was divided into average RHAT component scores for both drained and undrained channels (Figure 2.12). There is little difference in the Riparian Land Cover or Barriers to Continuity components. For the remaining six components of the RHAT, the undrained channels achieve higher values on average than the OPW channels. The range for RHAT scores from the undrained channels varies from 2.2-3.2 compared with drained channel range of 0.9-2. It should be pointed out that the majority of the undrained sites were in small streams in the upper reaches of catchments. However, the comparison does indicate the scope to achieve higher RHAT scores in drained channels.

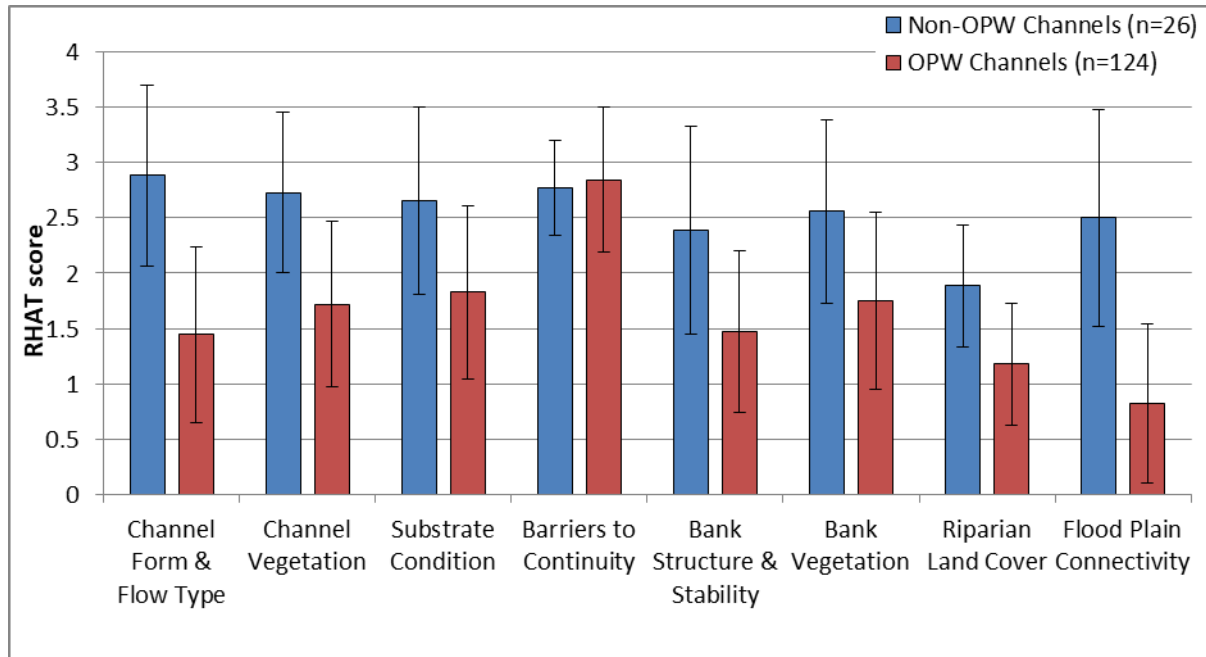
Figure 2.14 Mean and standard deviations for the 8 scoring components of the RHAT survey, separated into undrained channels (n=26) and OPW-drained channels (n=124) in the Dee, Bonet, Inny, Blackwater and Deel catchments.

When the individual components of the RHAT scores from the four catchments are separated and averaged (Figure 2.14) there are clear differences in the mean scores between OPW (n=124) and non-OPW channels (n=26). The only similarity is the close result in the Barriers to Continuity component. The largest difference is in the Flood Plain Connectivity component, followed by Channel Form & Flow type.

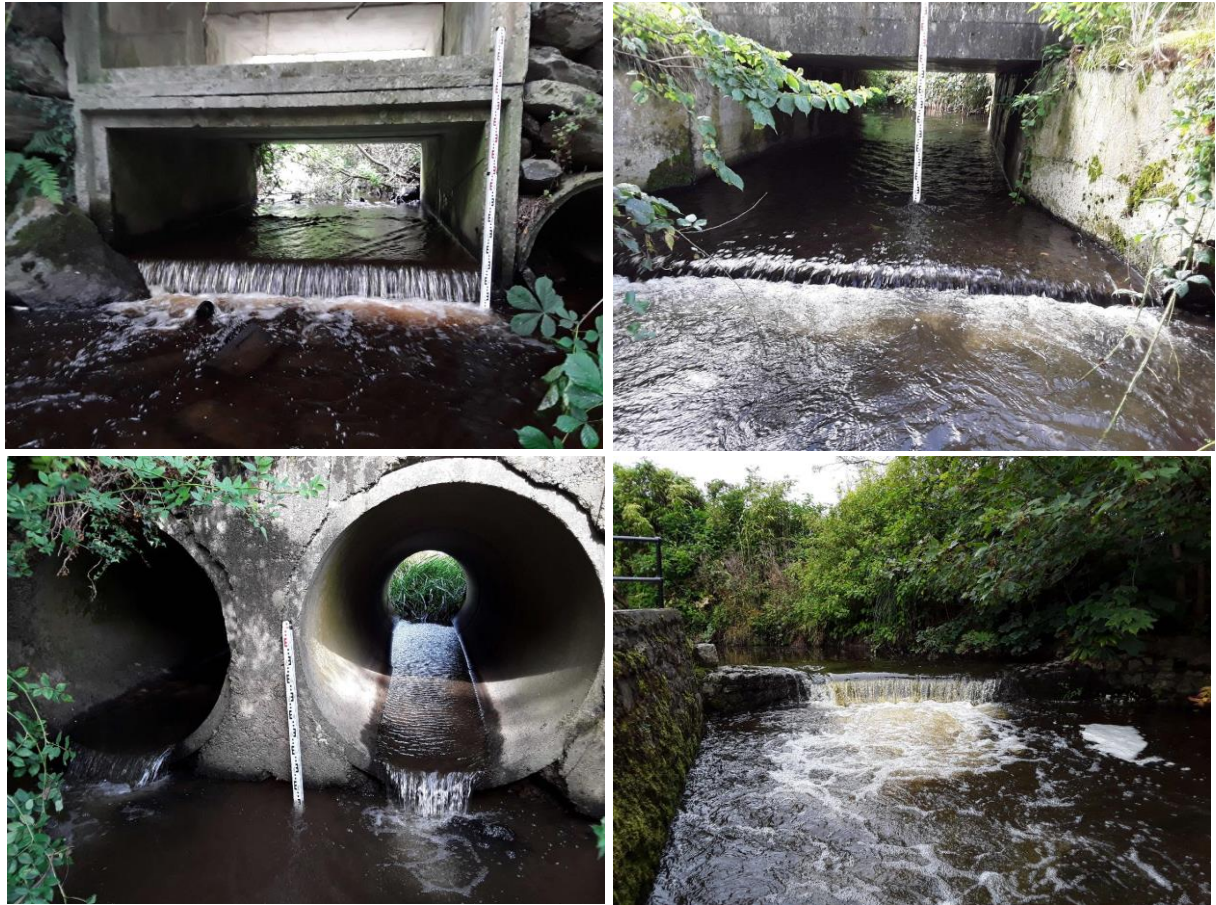
Figure 2.19 Examples of barriers identified during the Deel survey, including a box culvert, bridge apron, pipe culvert and small weir.

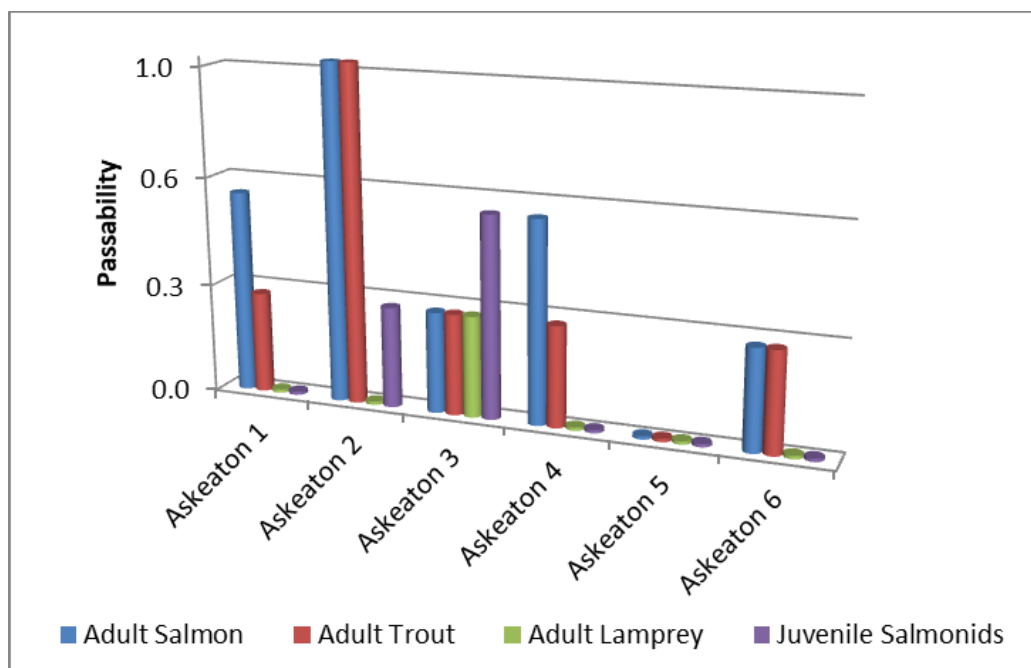
Figure 2.20 Passability assessment for the six structures in Askeaton on the River Deel. The 0-1 range is a passability scale. 0-Complete Barrier; 0.3-Partial high impact barrier; 0.6-Partial low impact barrier; 1-Passable Barrier.

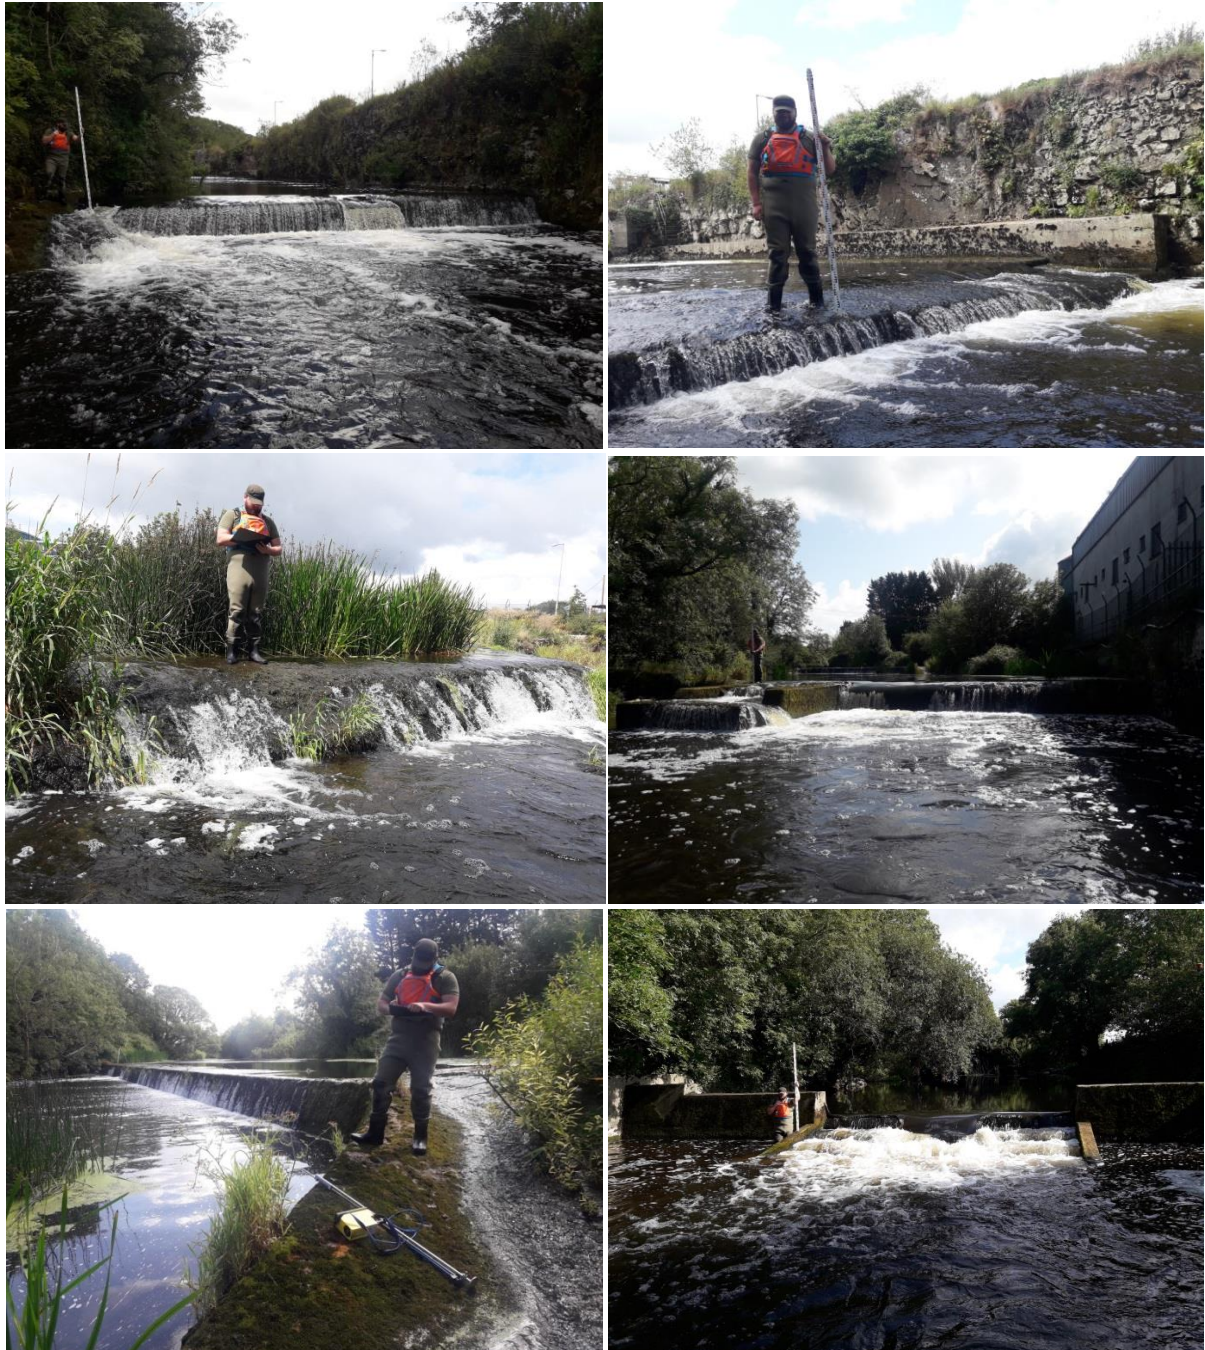
Figure 2.21 Askeaton weirs presenting barriers to migrating fish. Top row (1-2); middle (3-4); bottom (5-6).

This series of structures represents a significant hydromorphological pressure in the Deel catchment, preventing the free migration of keystone fish species. The free passage of migratory species - salmon, sea trout, eel and lamprey is fundamental in achieving 'Good' ecological status for the Water Framework Directive as their absence represents a deviation from reference conditions.

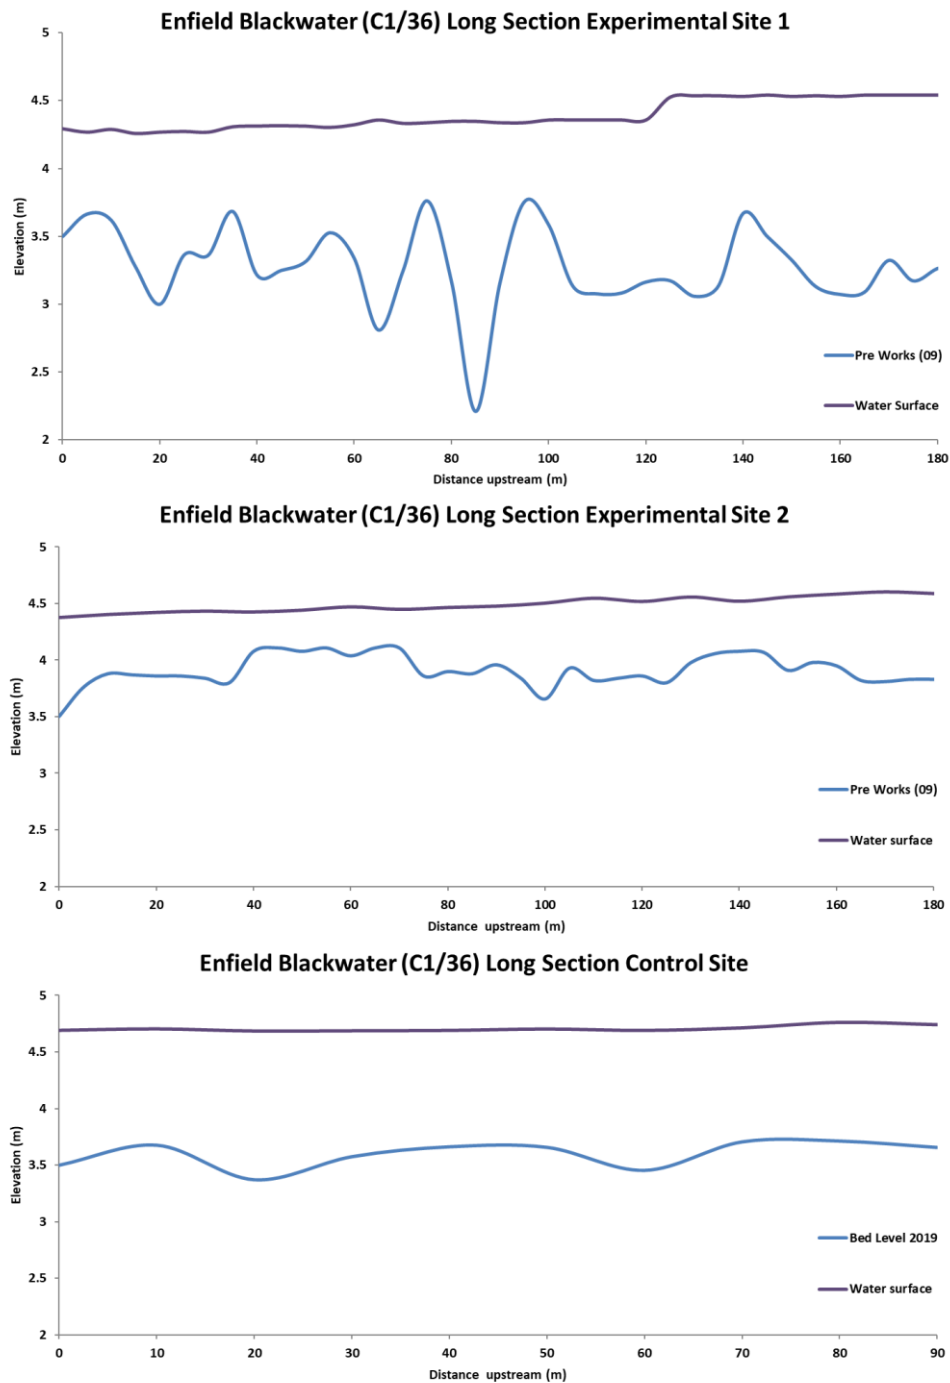
Figure 3.4 Longitudinal profile for Experimental site 1 (top); Experimental site 2 (middle) in 2009, prior to works completed. Longitudinal profile for the site selected as a control (bottom) in 2019.

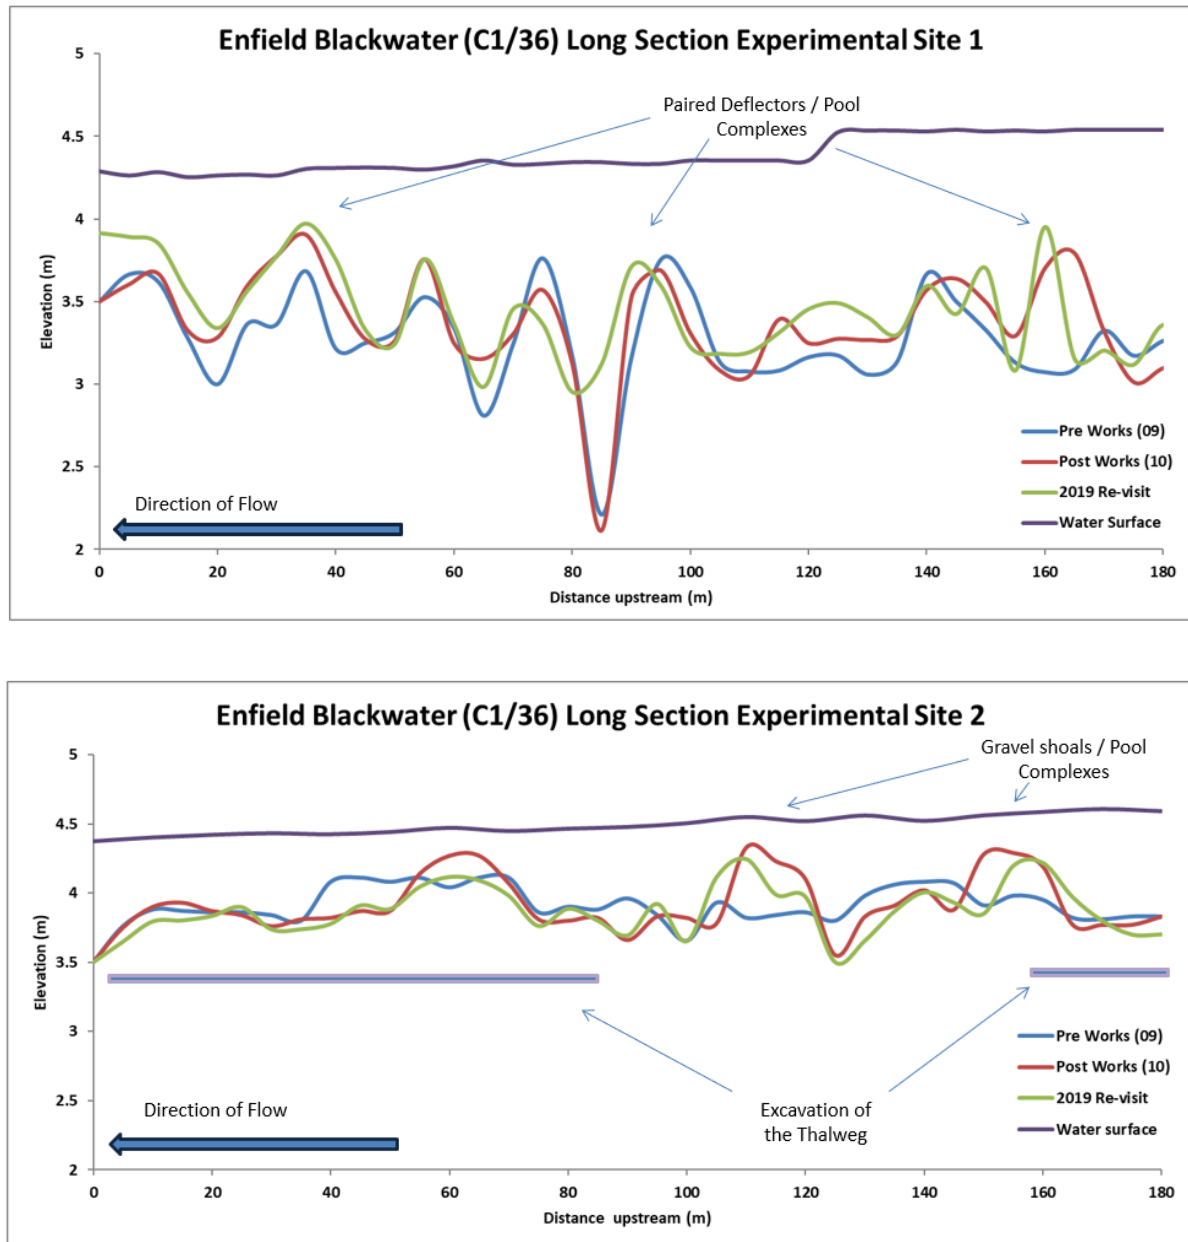
Figure 3.5 Long sections from the two experimental sites on the Enfield Blackwater, pre- and post- works along with re-surveyed results from 2019.

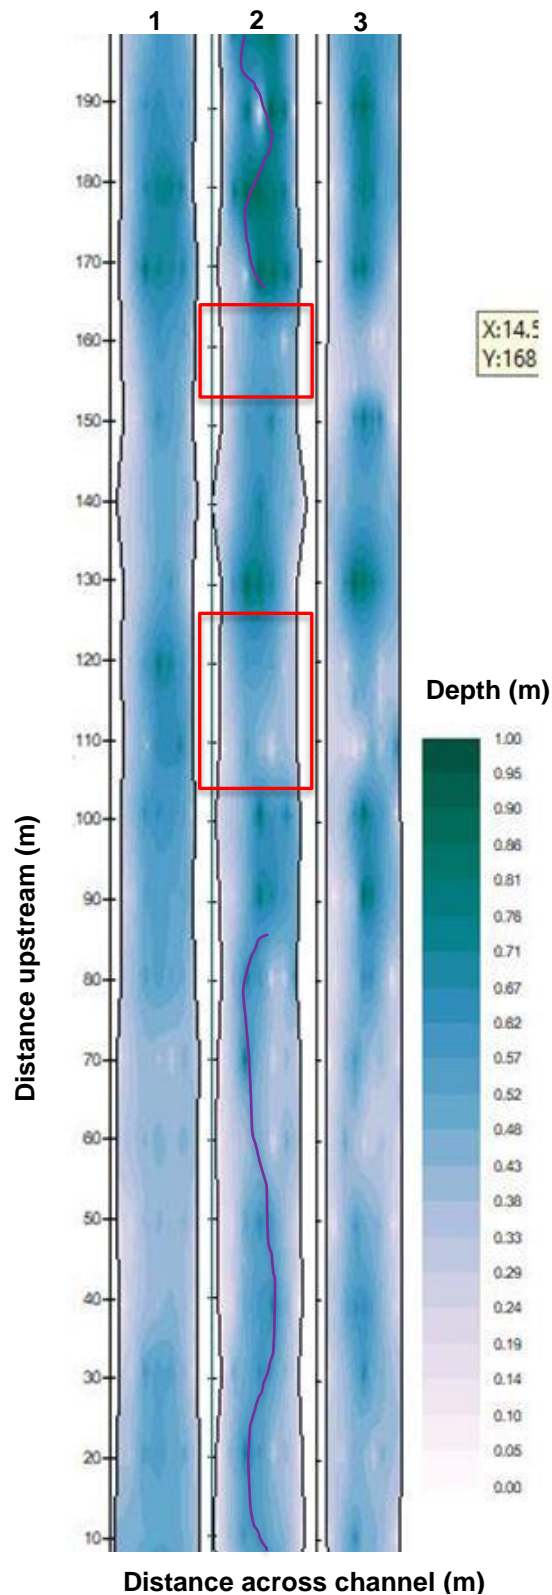
Figure 3.6 Variations in depth pre- (1) and post- (2) capital works at Experimental site 2, (upstream of Rourkestown Bridge) and depths recorded in 2019 (3). Red boxes indicate spawning gravel shoals, purple line is the thalweg constructed through the alternating deflectors.

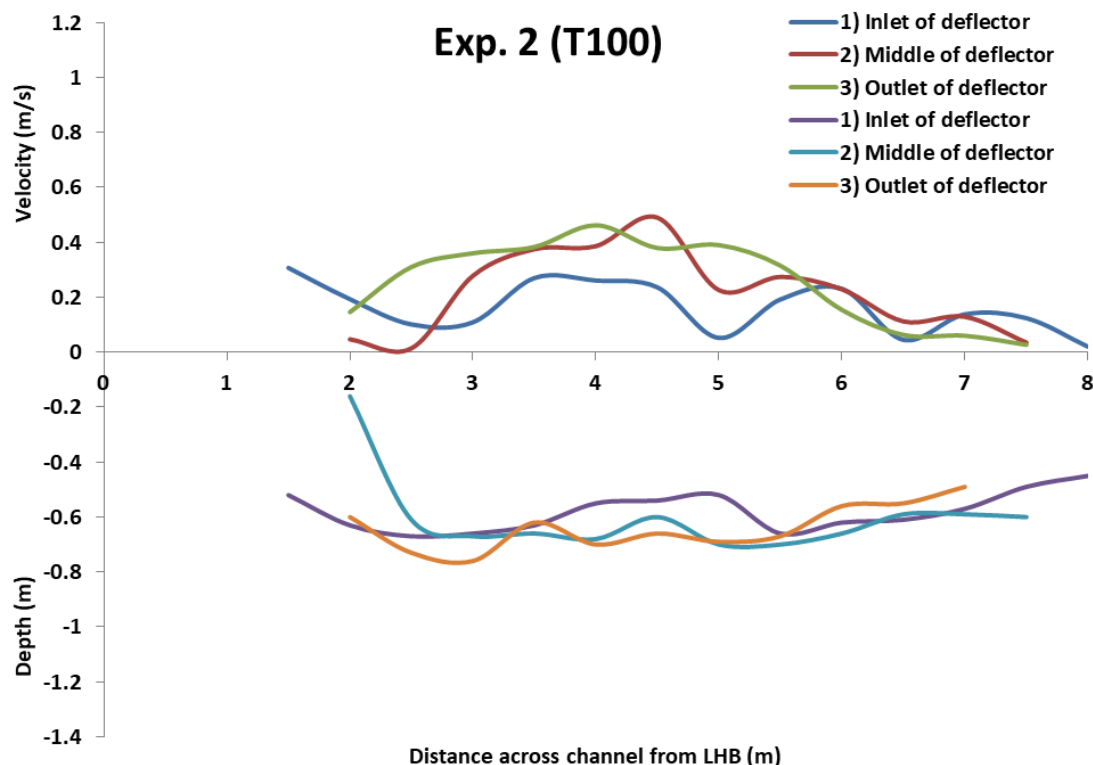
Figure 3.13 Depth velocity profile of a single deflector located at T100 in experimental site 2.

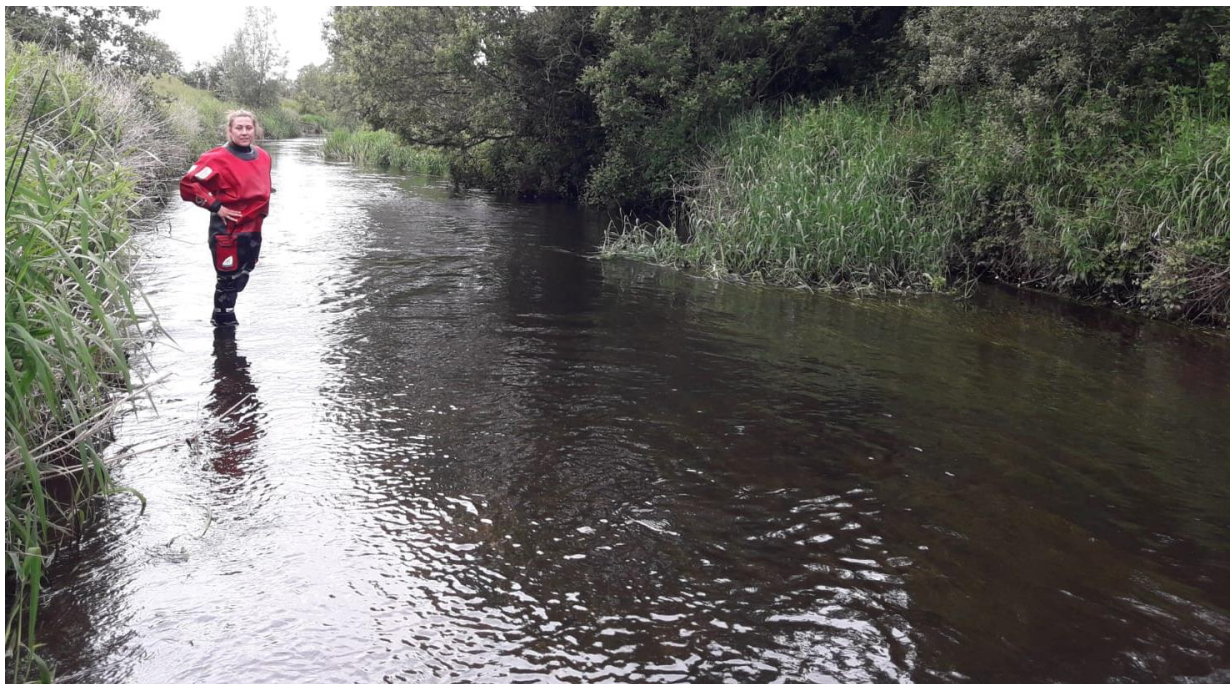
Figure 3.15 Photo looking downstream at rubble mat located at T120 in Experimental site 2.

Velocities at the inlet and outlet of structure were similar while velocities over the midpoint of the structure increased greatly, peaking at 0.77m/s mid channel (Figure 3.14). The river is slower at the edges of the river channel due to friction with the banks (average velocity 0.11m/s). The depth profile shows the extent of shallowing caused by the rubble mat, reducing depths from an average of 0.72m at the inlet to 0.33m through the structure. The shallowness of the rubble mat is evident in the photo (Figure 3.15).

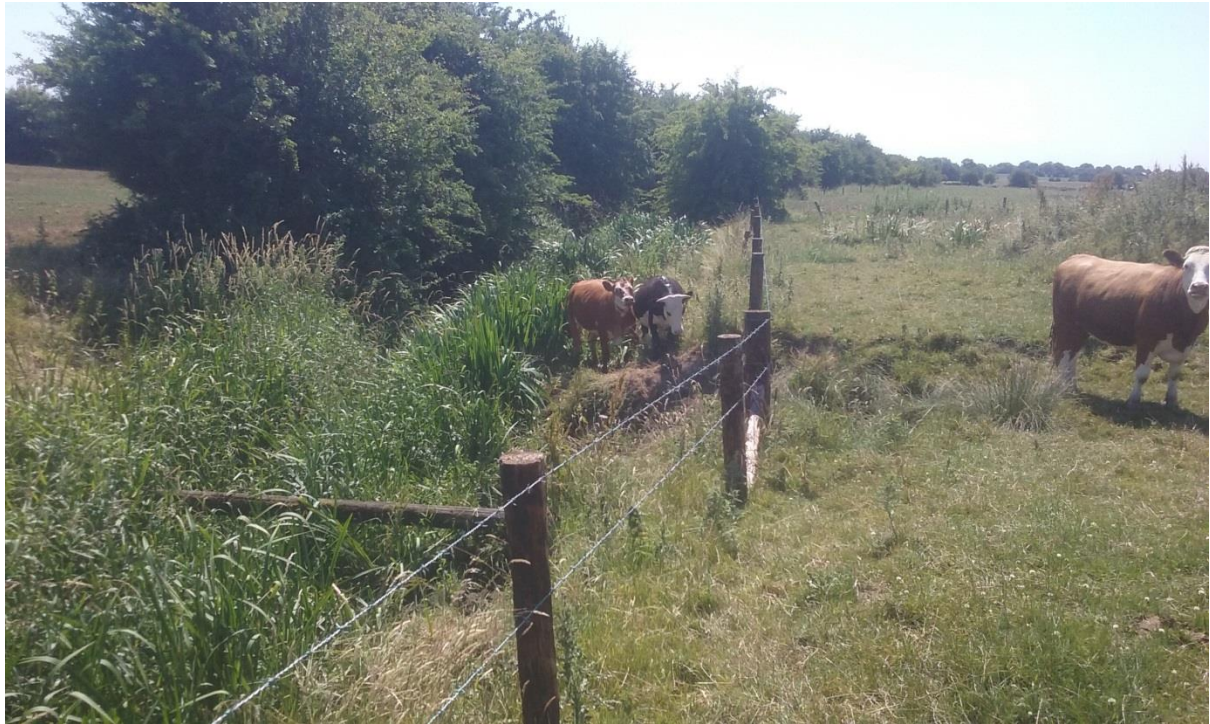
Figure 5.11 Dungolman Site 4 (2018) showing cattle ingress into the cross section despite robust fencing.

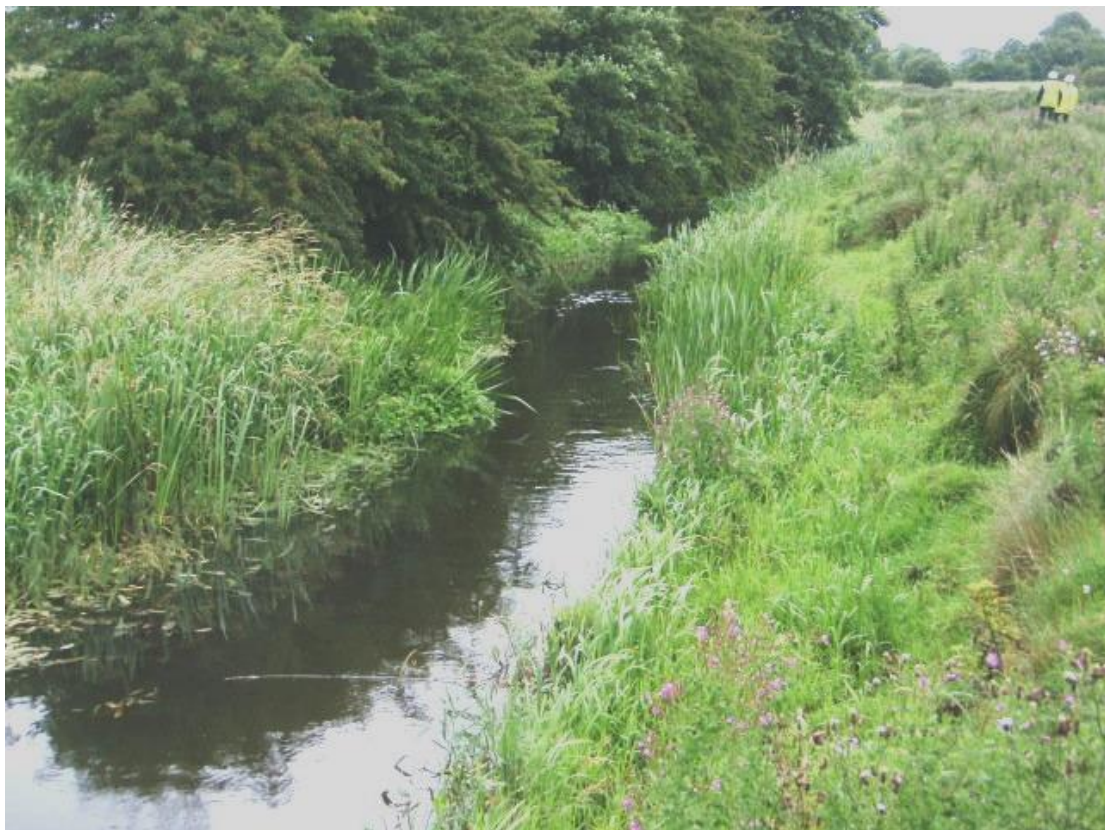
Figure 5.13 Tullamore Silver approx. 2007, showing open channel flow through a wedge-shaped cross section excavated in maintenance.

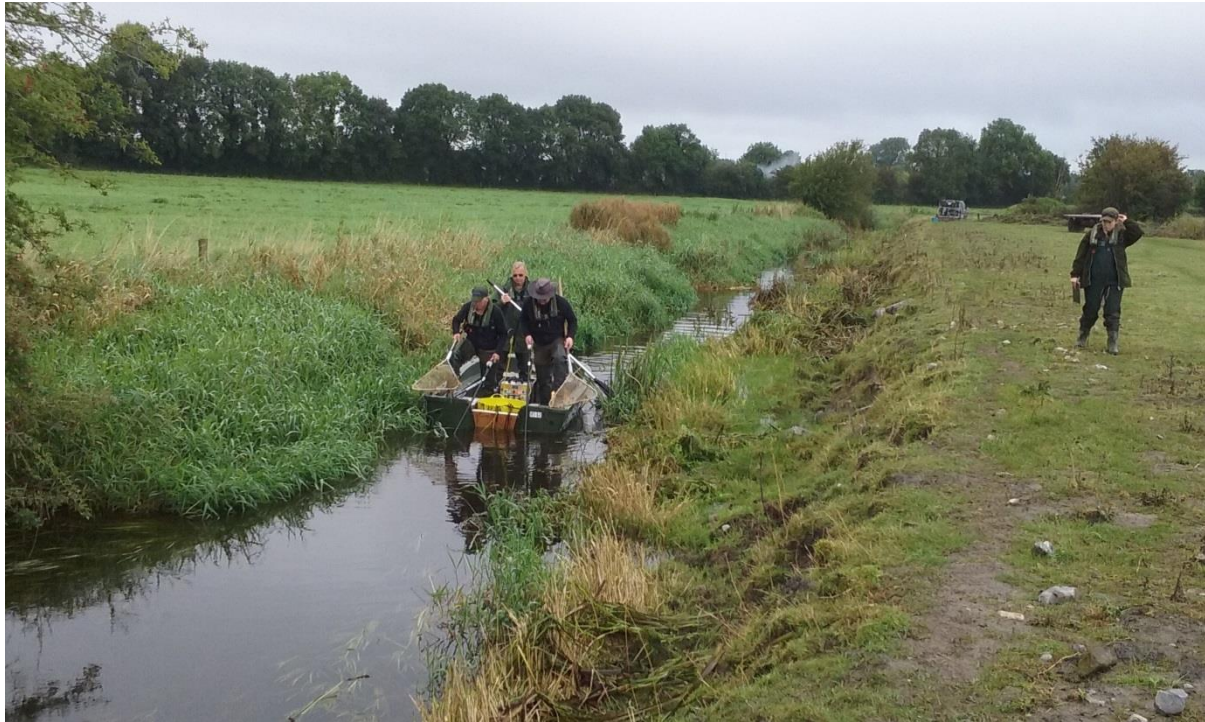
Figure 5.15 Electro-fishing following the removal of instream flaggers at site 9 in 2016. Note prevalence of berm on left bank (OPW machine working bank).

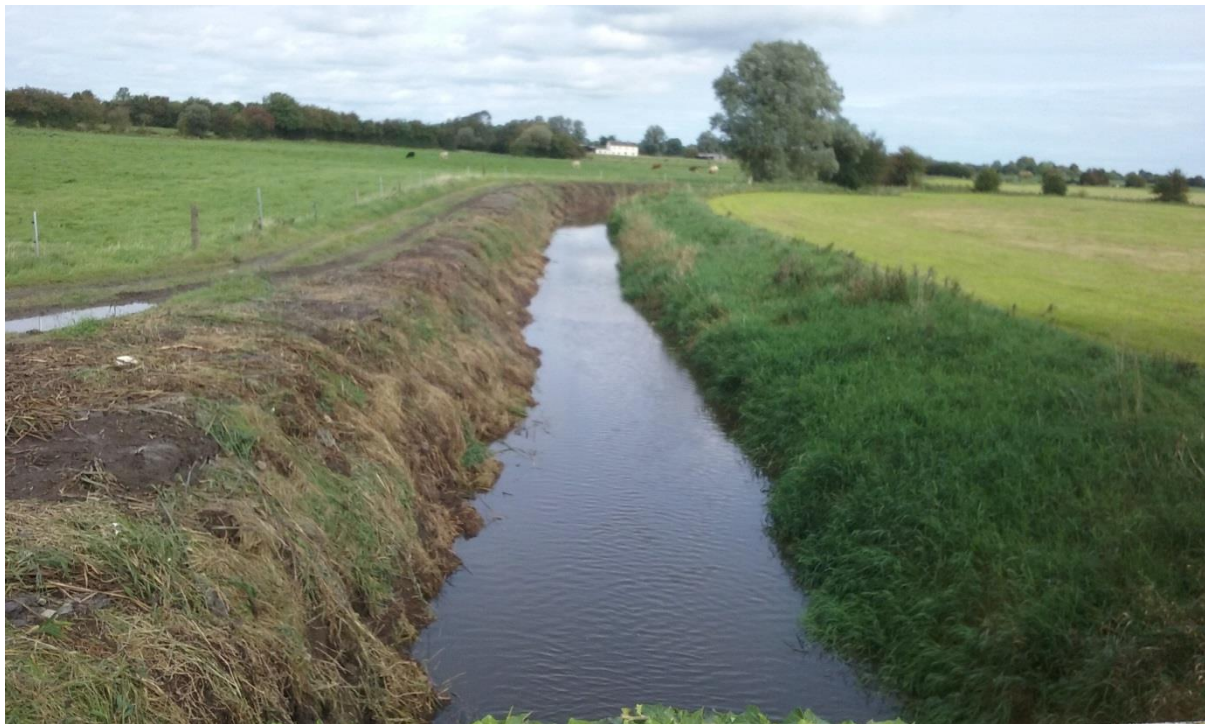
Figure 5.18 Site 10 – upstream view from Newbridge following maintenance in 2016. Evidence of low berm on left bank

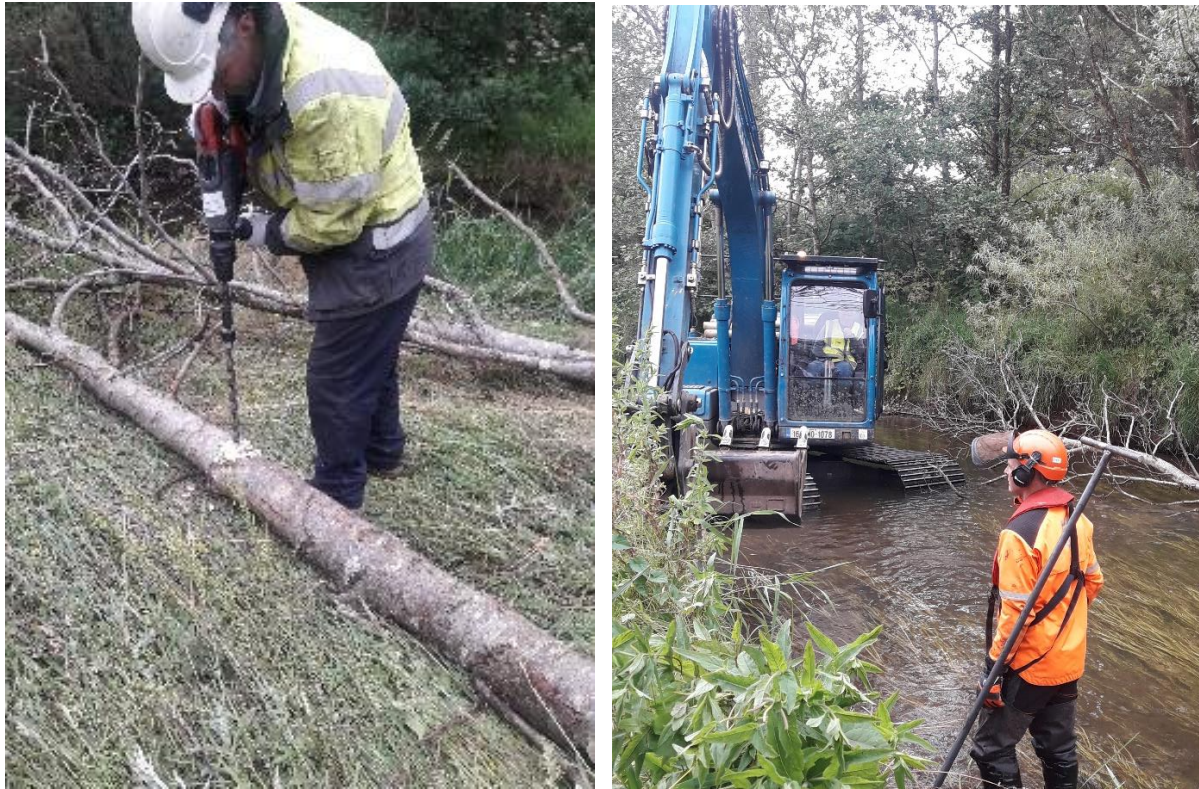
Figure 6.3 Photos of the various steps required to install the timbers.

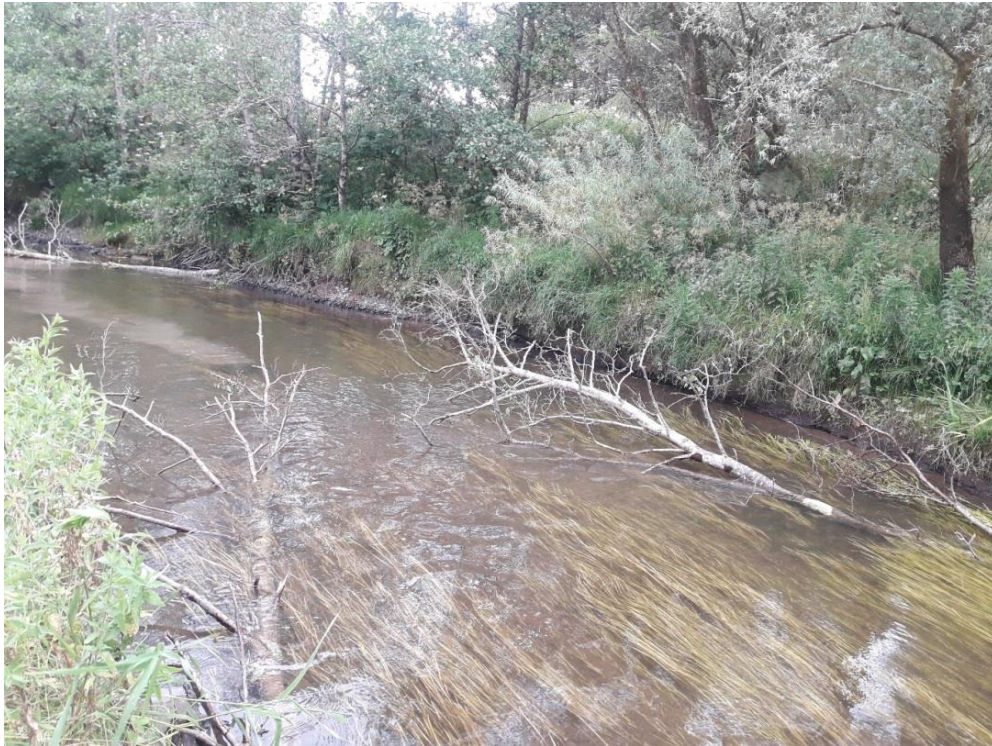
Figure 6.4 Completed pair of deflectors in the Eignagh River, Co. Mayo, July 2019 during low water levels.

These features were installed to aid the generation of scour pools for fish. Deflectors function by concentrating flow vertically or horizontally, increasing the speed of flow locally and creating areas of differential scour and deposition. It was important that the timbers were placed securely enough into streambed substrate to make sure they were stable and be at an appropriate height so that they are visible during low flow but overtopped during high flow conditions. This positioning is vital for the structures to work, contributing to new riverine processes within the channel (Figure 6.4).

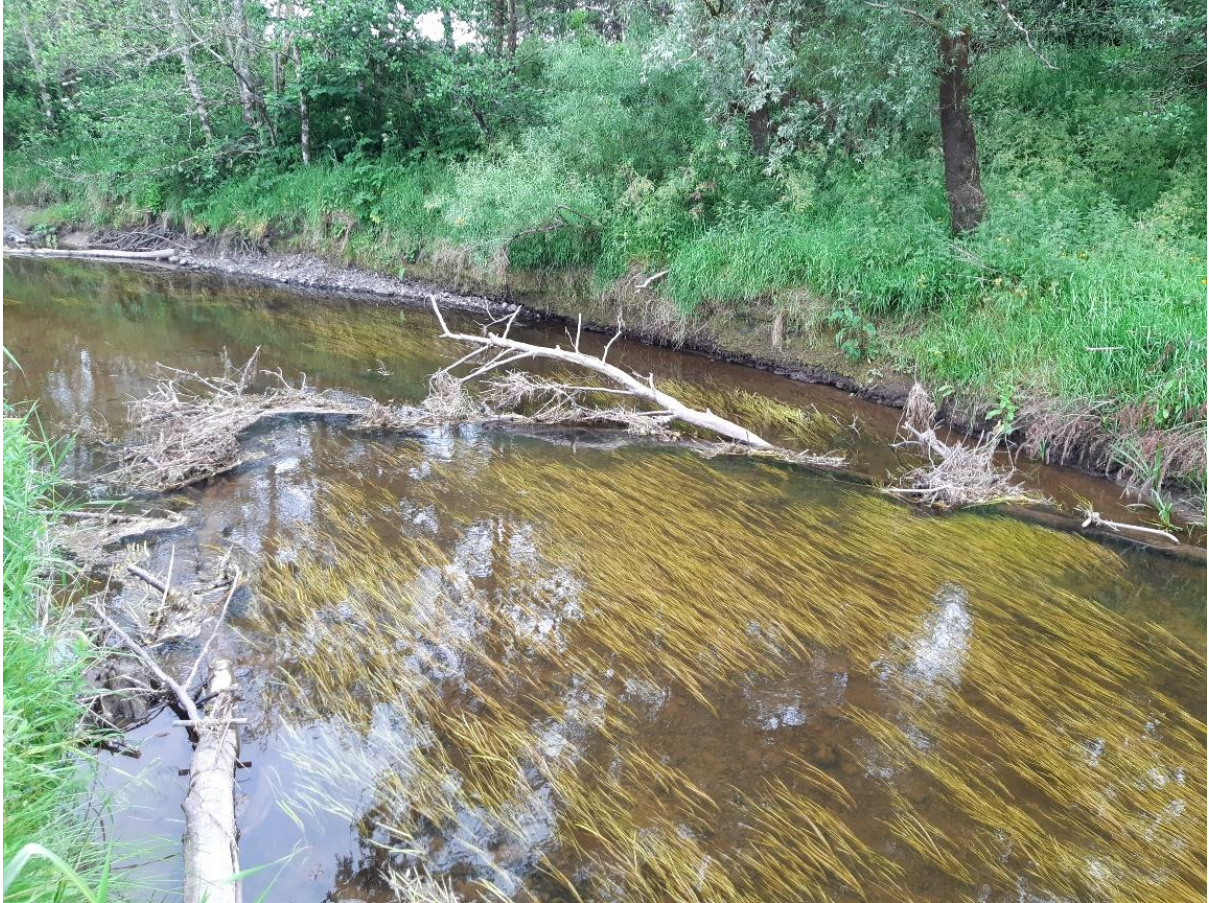
Figure 6.5 Photo of the deflectors taken in June 2020 during very low water levels.

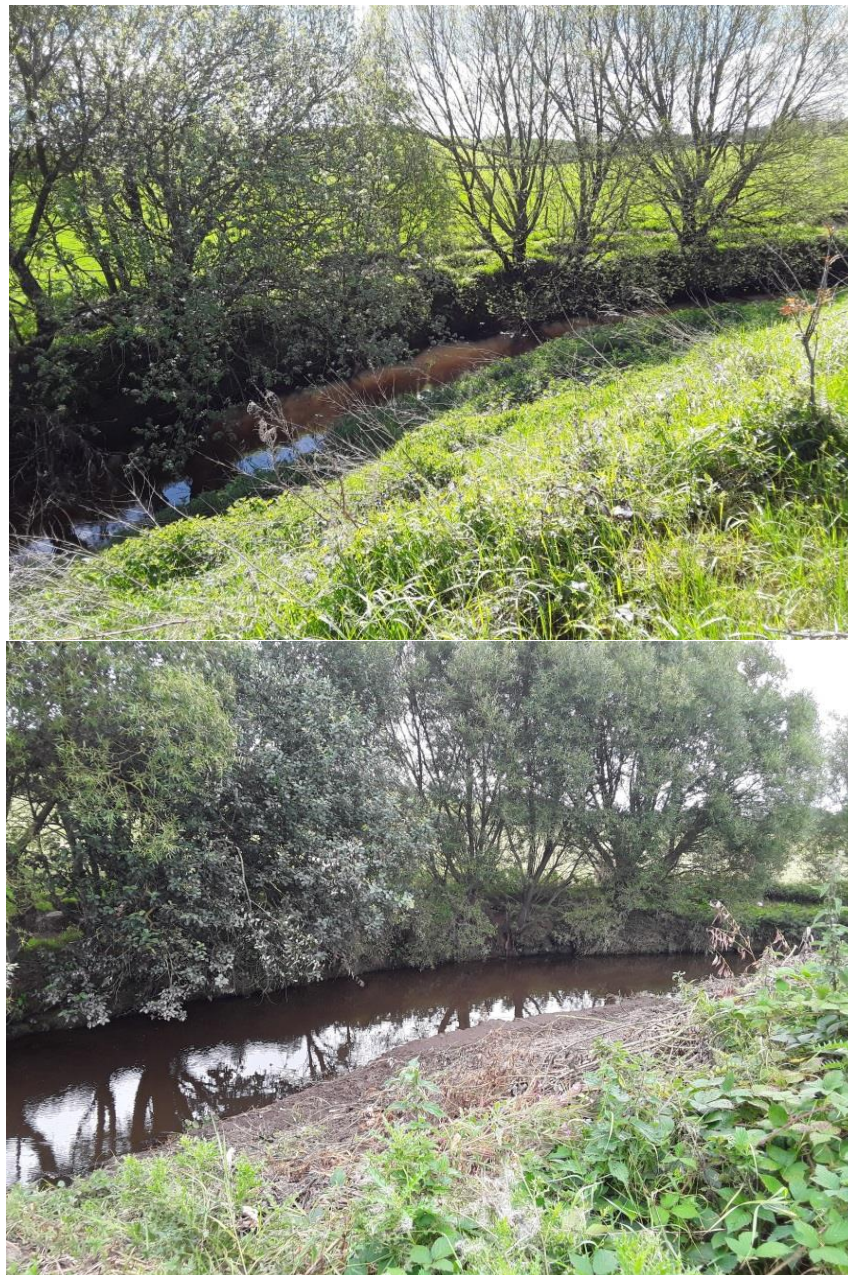
Figure 6.8 Example of berm management with retention of mature tree cover on the non-working bank.

Topping of berms allows for a greater area for overflow during higher water levels. An example with before and after pictures on this stretch of the Cor is shown. In this case there was evidence of minor erosion on the right-hand bank, so topping the berm on the left-hand bank increases the cross-sectional area creating a larger area for flows, therefore alleviating the pressure/impact on the right-hand bank. Moreover, allowing the channel to be narrow in low-flow conditions in this small section may create more diversity in flow types and lead to habitat creation. The roots of vegetation in the berm may stay *in situ* stabilising this feature within the river channel.

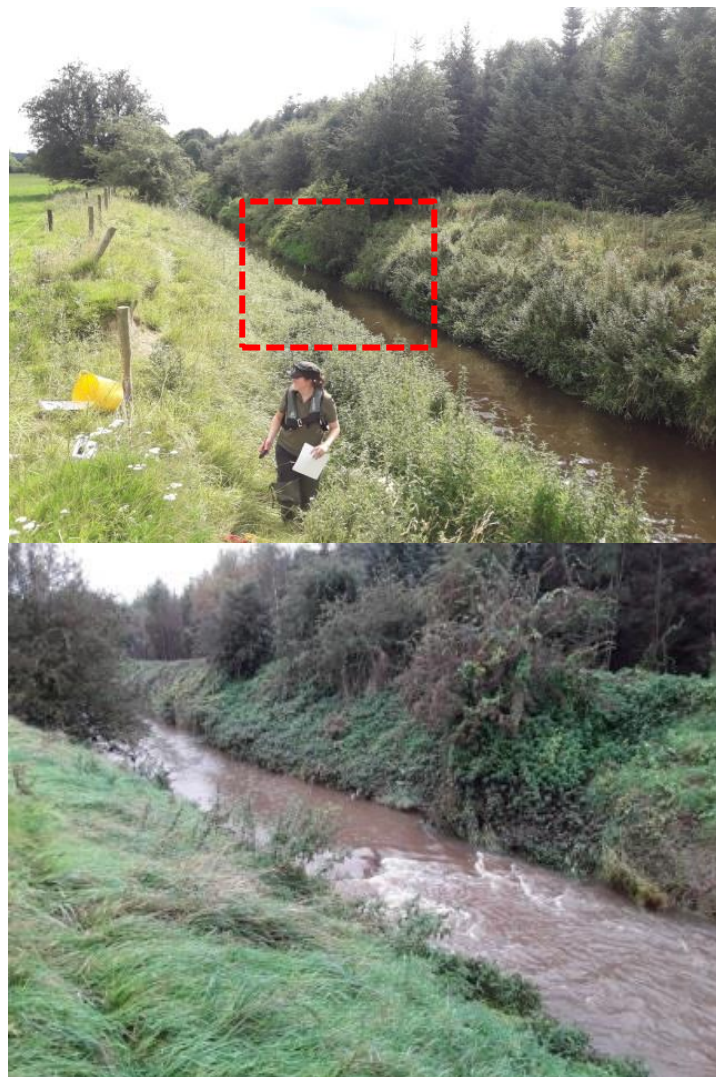
Figure 6.9 Example of pool excavation and riffle creation – before and after experimental digging.
