Environmental River Enhancement Programme

Annual Report 2019

IFI/2020/1-4515

**Inland Fisheries Ireland & the Office of Public Works
Environmental River Enhancement Programme**

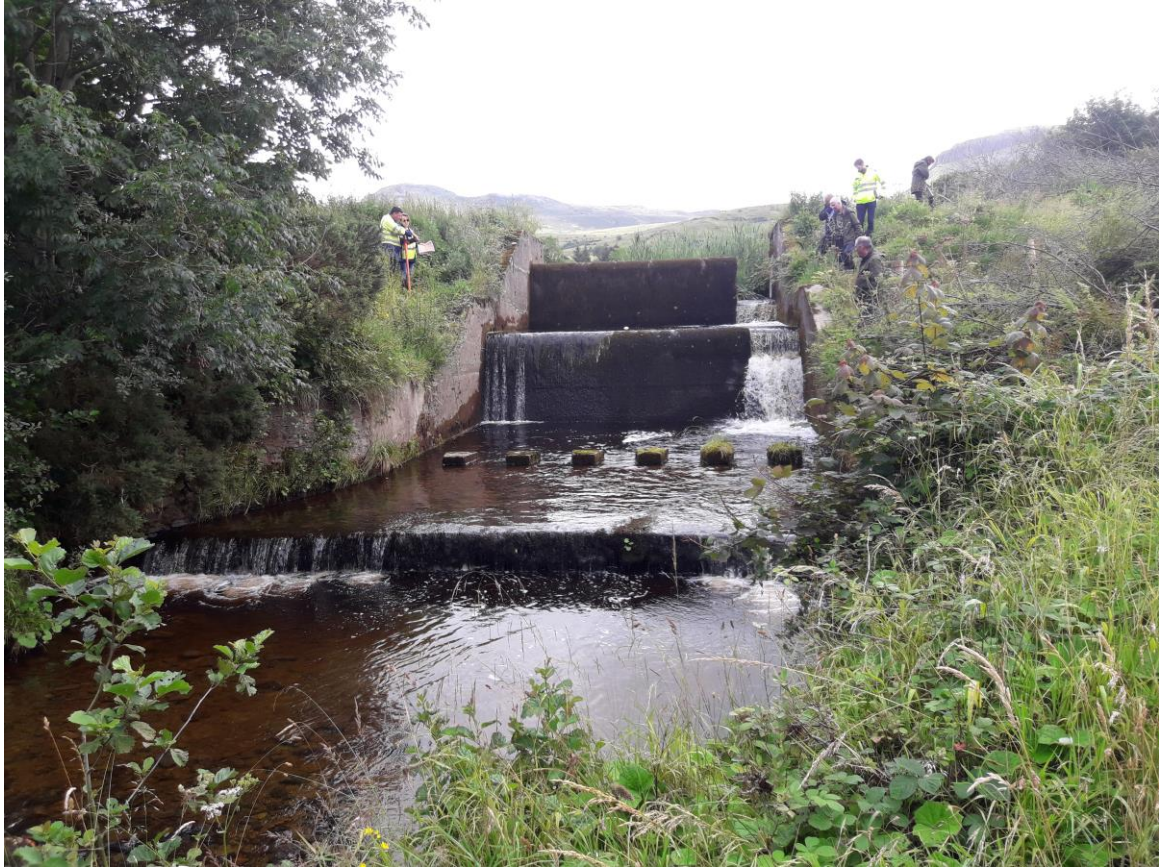
Figure 7.2 Gravel trap on the Largydonnell Stream, Duff catchment (ST8).

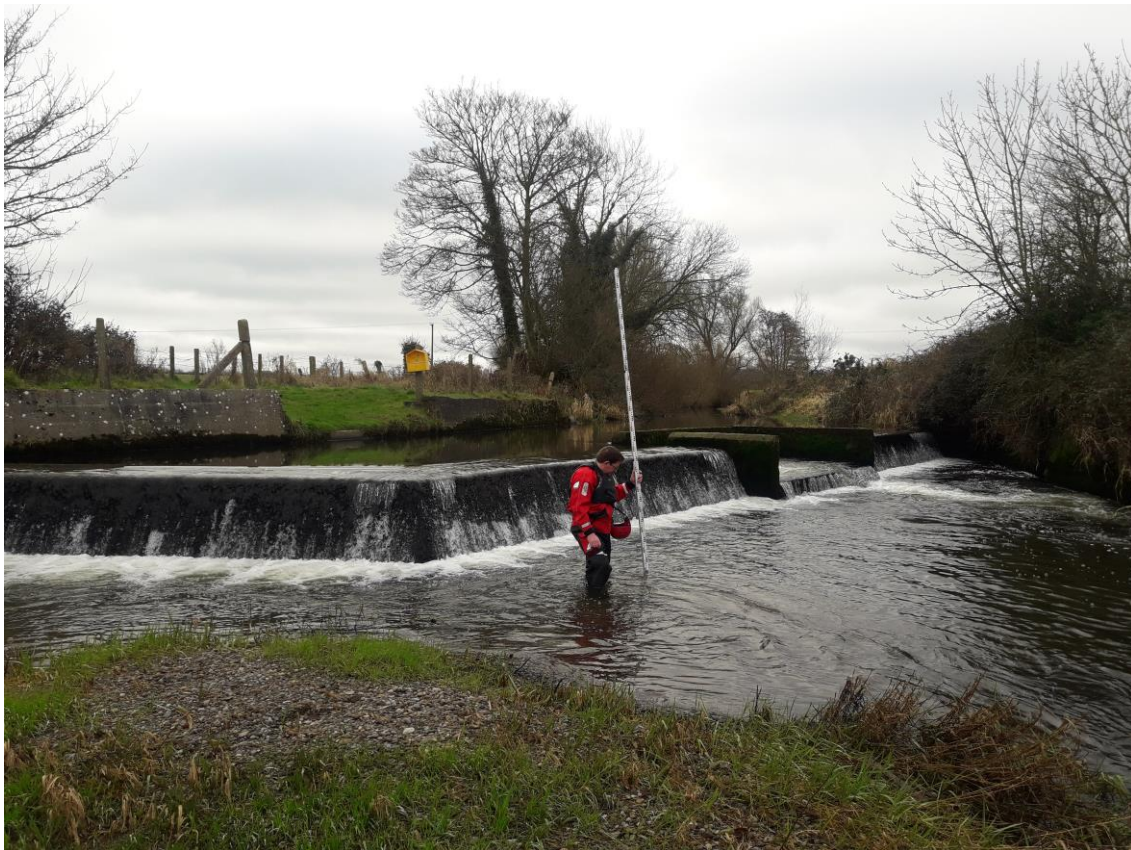
Figure 7.3 Gravel trap on the River Loobagh, Maigue Catchment (ST12).

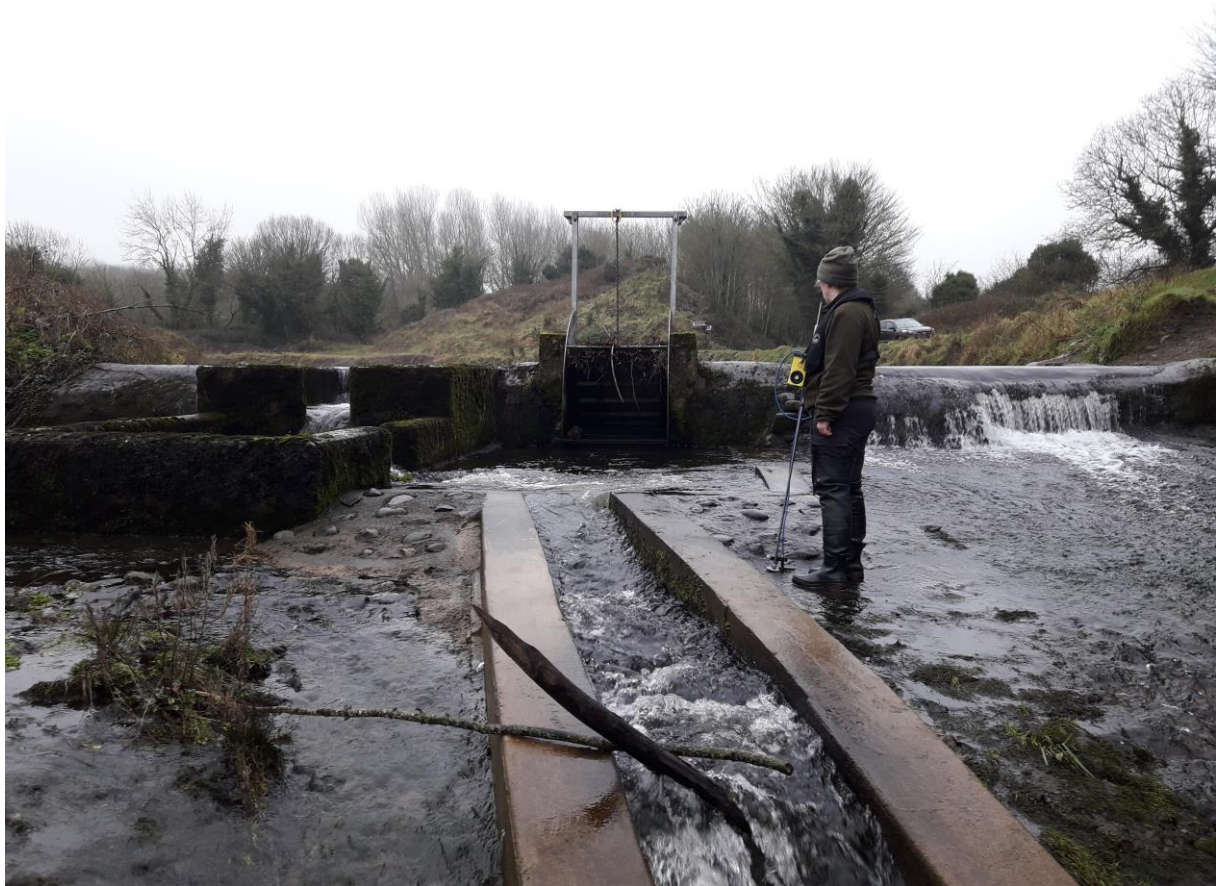
Figure 7.4 Gravel trap on the Kilcormac Silver, Brosna catchment (ST6).

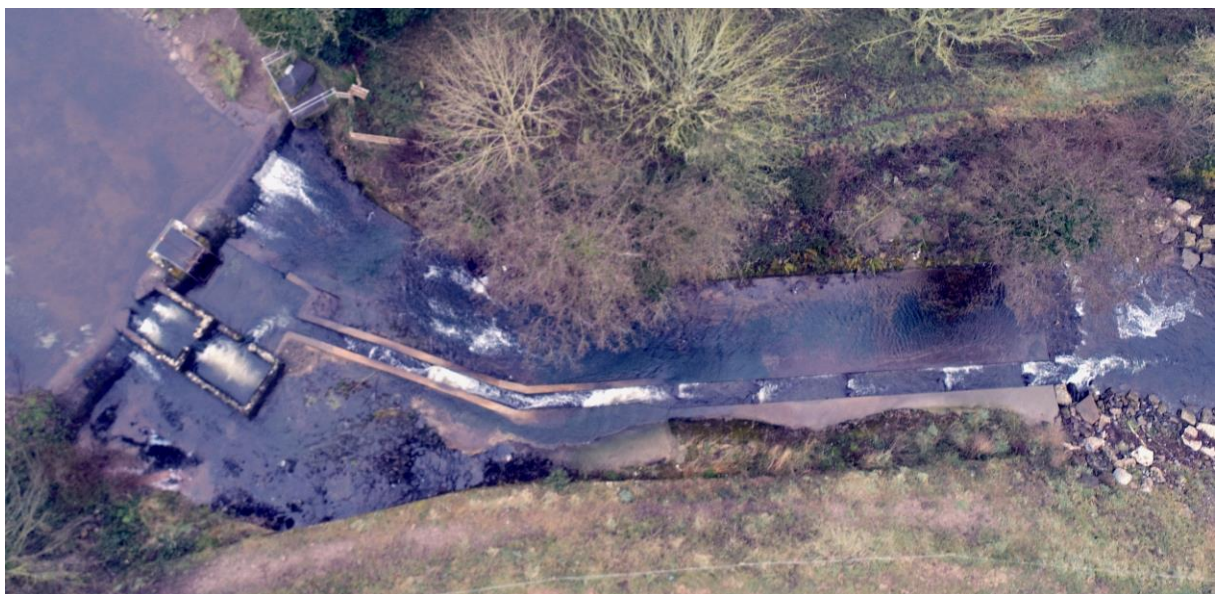
Figure 7.5 Drone image of the gravel trap on the Kilcormac Silver, Brosna catchment (ST6).

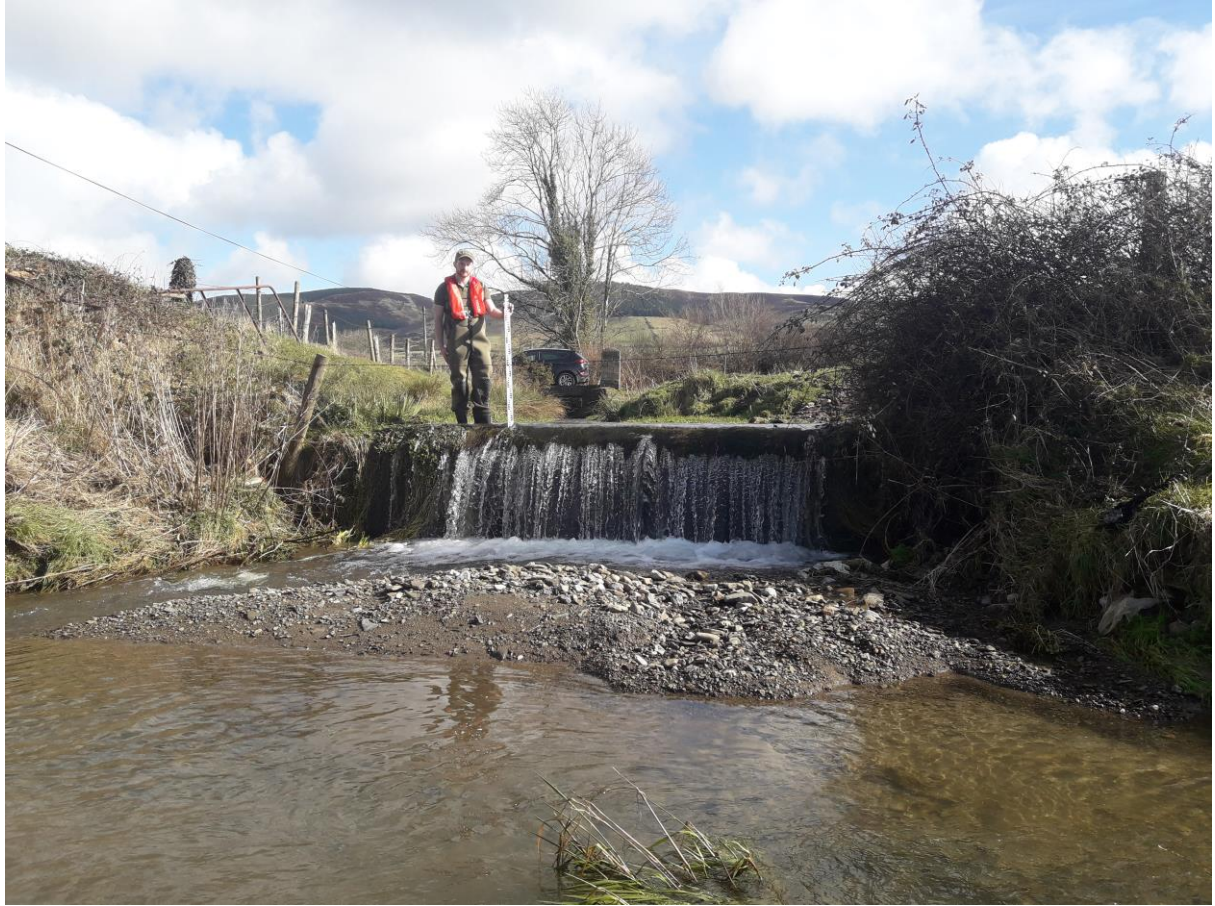
Figure 7.6 Gravel trap on the Ollatrim River, Nenagh Catchment (ST13).
