# Environmental River Enhancement Programme

## Annual Report 2021

IFI/2022/1-4586

### **Environmental River Enhancement Programme**

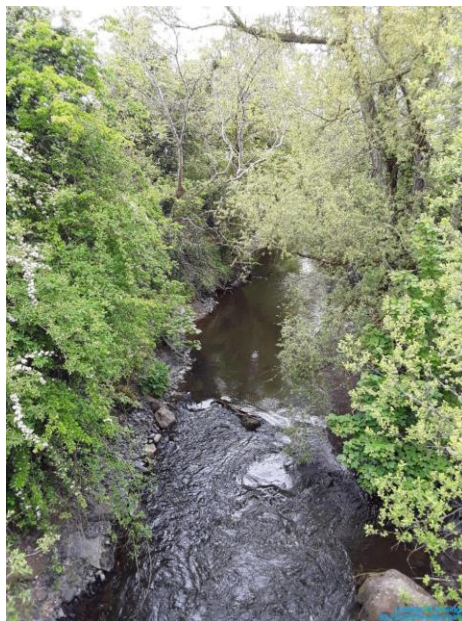
benefitting land (Ryan Hanley 2014b). The OPW scheme within the Blackwater covers about 379km of channel length, over half the total length of channel within the catchment area. As can be seen in Figure 2.4 many of the upper tributaries north of Lough Ramor are unaffected by the drainage works. In the lower parts of the catchment, the effects of drainage are still evident with some of the channels deeply entrenched in bedrock (Figure 2.3).

**Figure 2.3 Example of an entrenched site on the Moynalty River (C1/8/10).**

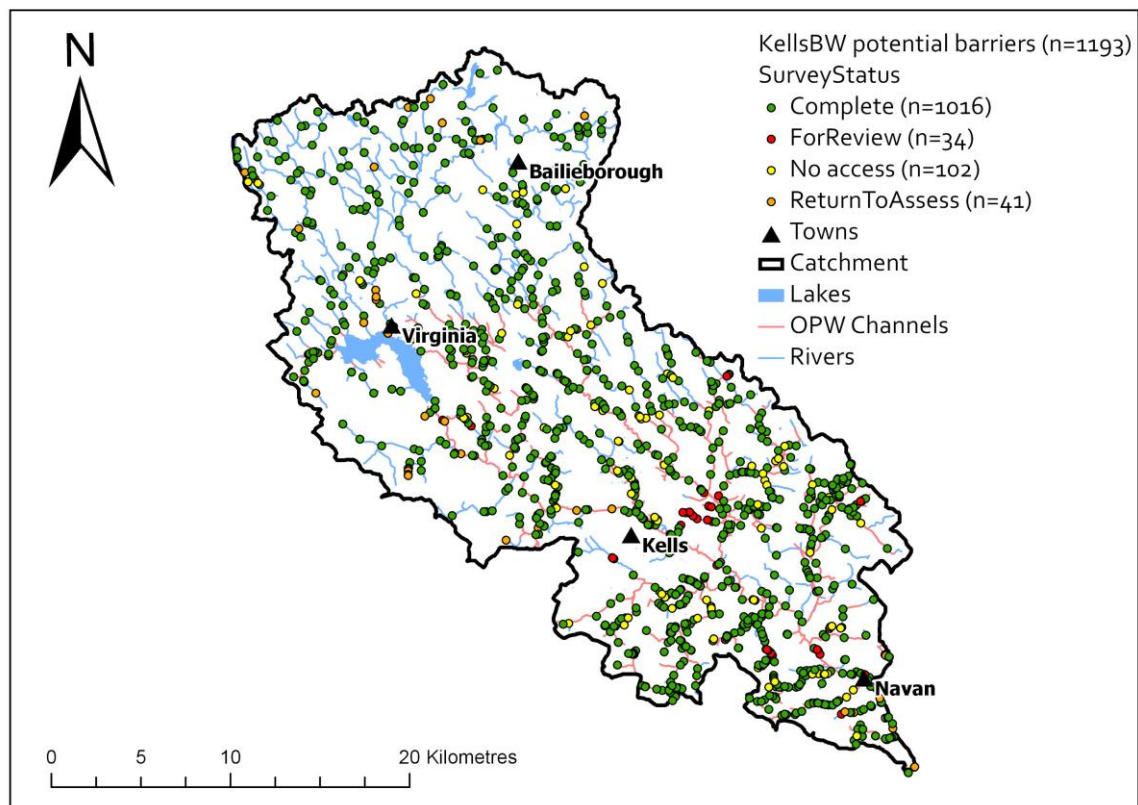
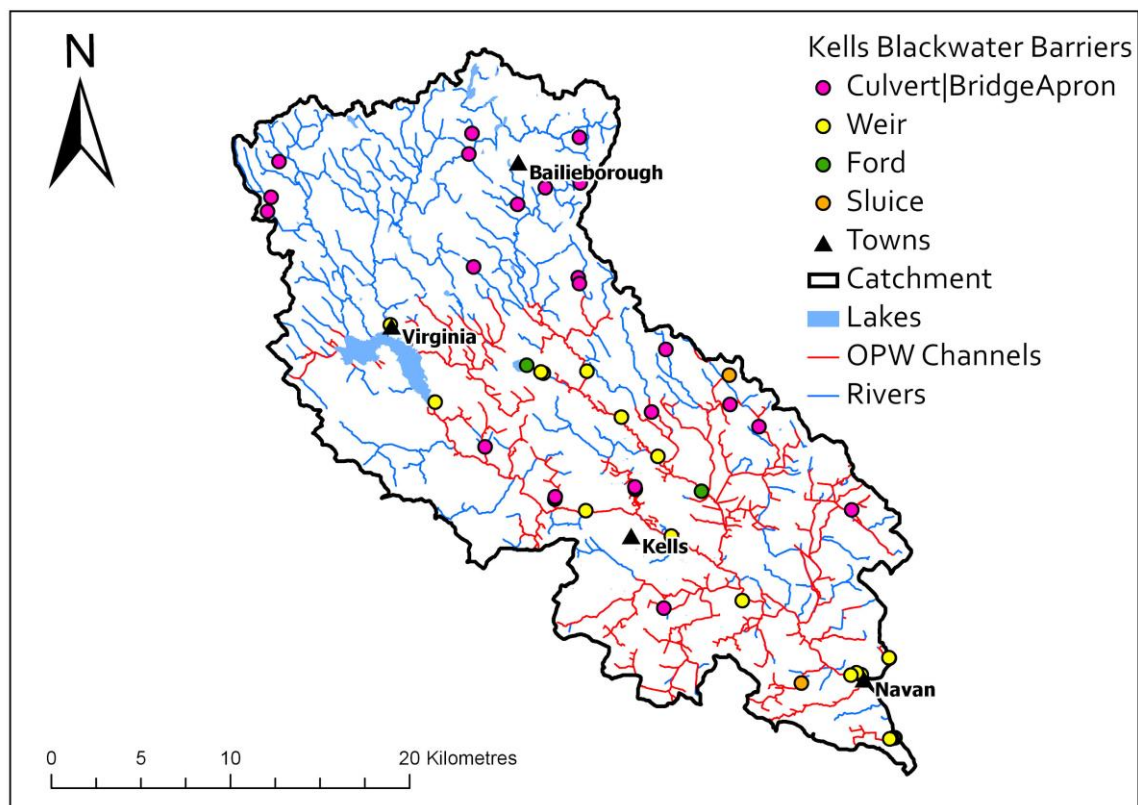
**Figure 2.20 Distribution of all potential barriers within the Kells Blackwater (top, n=1193). Barriers assessed and surveyed to date (bottom, n=47).**

Out of the total of 1,016 visited and assessed, approximately 4.6% (n=47) barriers to fish migration were identified. Given that 75 potential structures remain, this proportion may change and indeed is likely to increase. As many as 40 of the remaining 75 structures are likely to be barriers. These structures were visually assessed remotely or in the field by one person and need to be visited and measured by a two-person team. Within the currently assessed cohort of 47 barriers, 13 coincide with the OPW structures database. These include bridge aprons/culverts (n=9), weirs (n=2) and sluices (n=2). Using the recently published OPW guidance for fish passage on small barriers (OPW, 2021), it may be possible to mitigate these types of structures in future. Examples of some of the smaller barriers identified on OPW channels are included below (Figure 2.21).

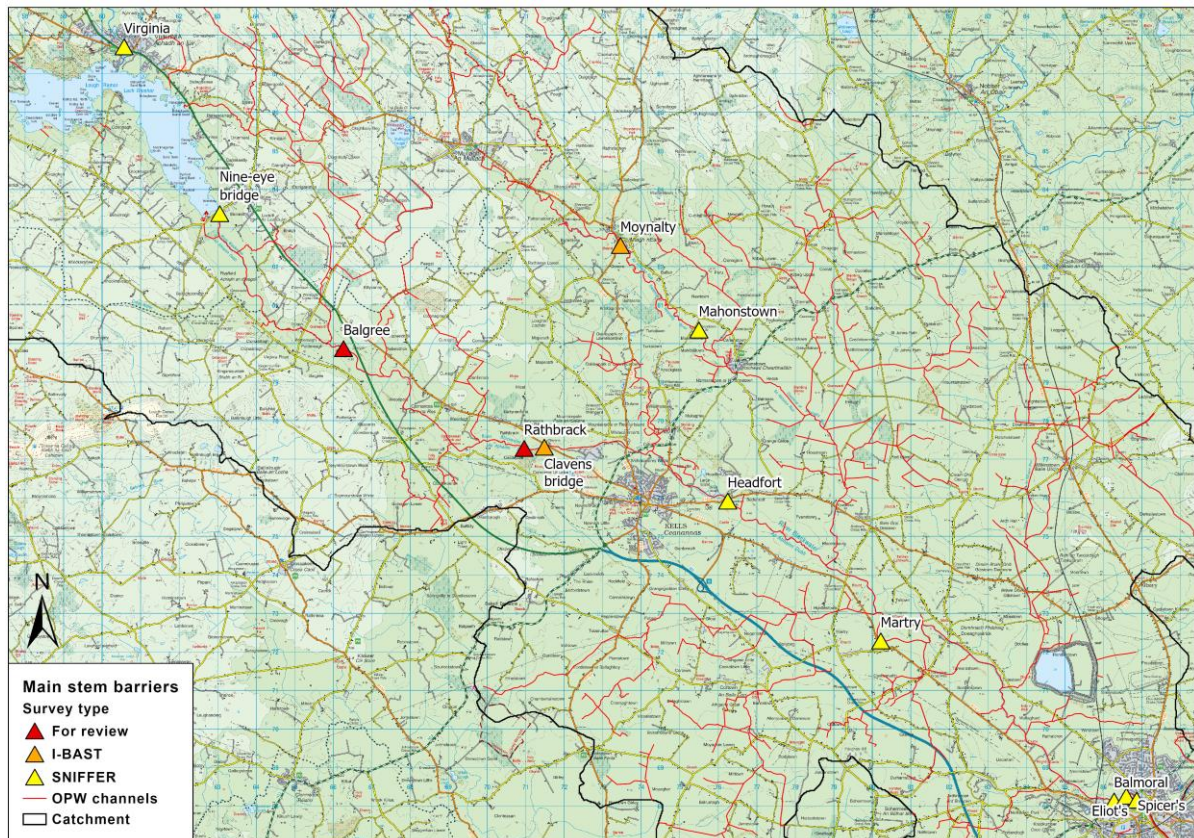
**Figure 2.22 Large barriers on the main Blackwater and Moynalty channels.**

Navan was a prominent trading and industrial centre in the late eighteenth century. Mills with weirs alongside to power them are a prominent feature of the lower Blackwater landscape. Three weirs are still intact within the first kilometre up from the Boyne confluence. Many more exist on the main channel of the Blackwater up to Lough Ramor and beyond, as well as on the Moynalty River. The weirs which are still in existence today pose problems for longitudinal

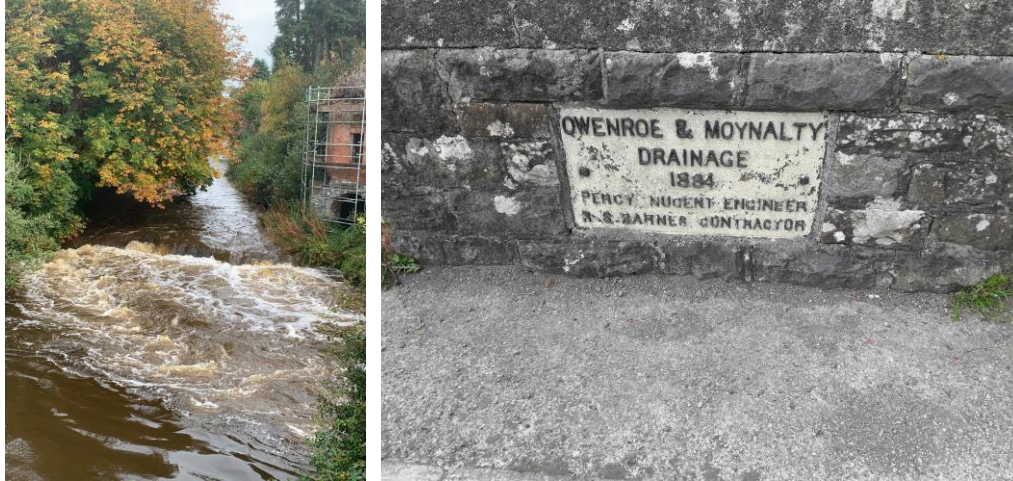
The Moynalty (also called Owenroe river) is the main tributary of the Blackwater. It is visible from RHAT surveys that this channel was more affected by arterial drainage (see Figure 2.3). Indeed there is even a drop at the confluence with the Blackwater at Bloomsbury which would be unusual with a natural channel form (Figure 2.26). The section from the confluence up as far as Carlanstown was initially part of the Drainage District, with initial drainage works dated to 1884 (Figure 2.26). The Moynalty has changed its course in parts of the lower reaches, and elsewhere has been straightened artificially. Some of the old course can be easily seen in the landscape using satellite imagery and historical maps.

**Figure 2.26 Confluence of the Moynalty (facing opposite) and Kells Blackwater rivers during flood (left); inscription on a bridge over the Moynalty river (right).**

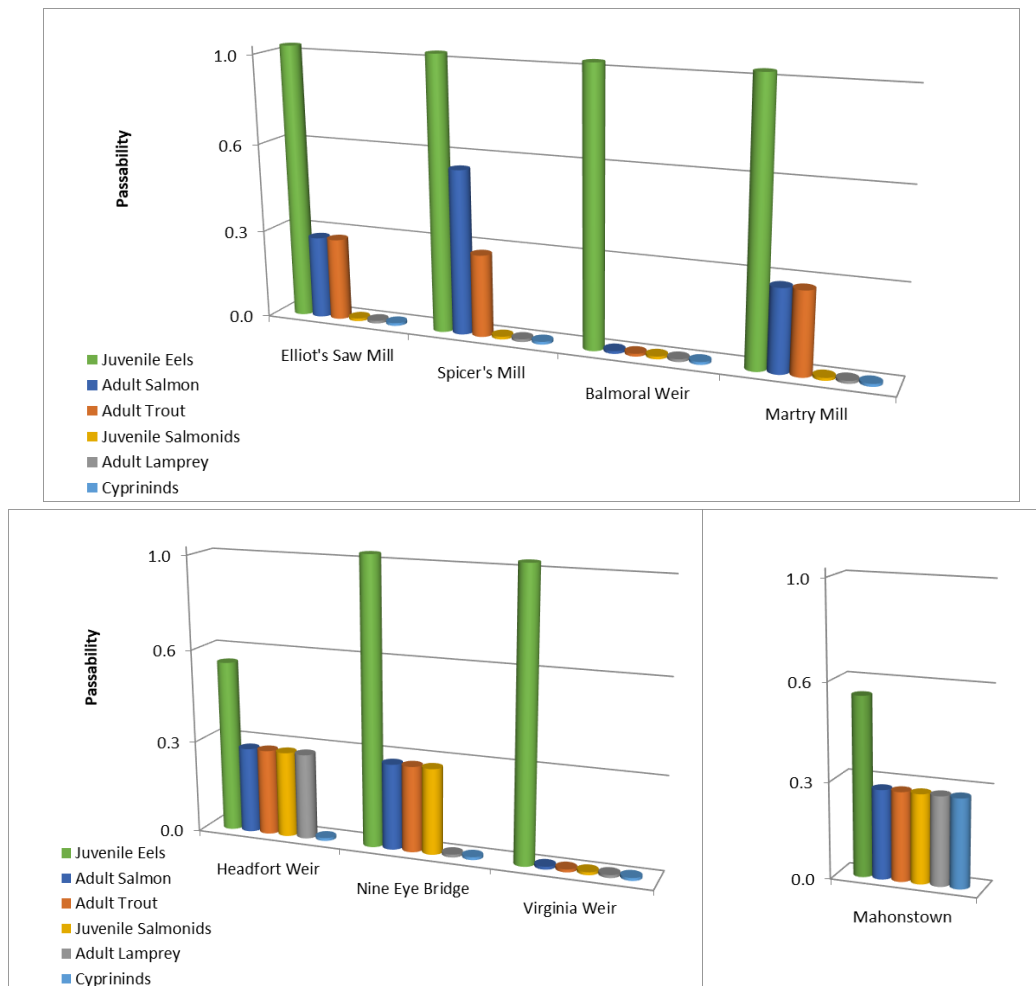
The above details 7 structures surveyed on the Kells Blackwater main channel using the WFD111 methodology (SNIFFER, 2010) and 1 using the i\_BAST methodology, with 3 more potential barriers remaining to be assessed. On the Moynalty tributary, there is currently one structure measured using i-BAST at Moynalty village and one measured using the WFD111 method at Mahonstown. The passability assessments for all 4 structures on the lower Blackwater are summarised in Figure 2.28. From here, anadromous fish could migrate up the Kells Blackwater or the Moynalty tributary. Although not all structures have yet been assessed in these locations, the data shows both directions have more passage problems (Figure 2.28). All of the structures represent significant issues in relation to passage of salmonids and lamprey.

**Figure 2.28 Passability assessment for 4 weirs on the lower Blackwater (top), 3 on the upper Blackwater (bottom left) and 1 on the Moynalty (bottom right). The 0-1 scale is as follows: 0 – Complete Barrier; 0.3 – Partial High Impact Barrier; 0.6 Partial Low Impact Barrier; 1 – Passable Barrier.**

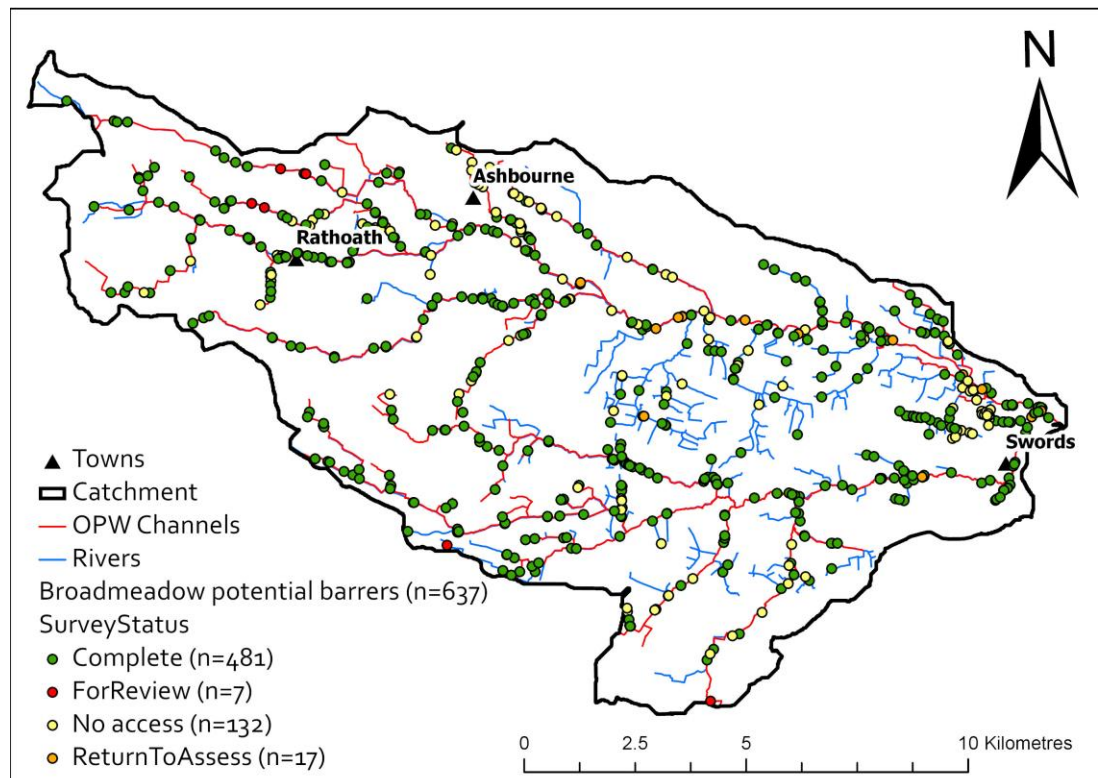
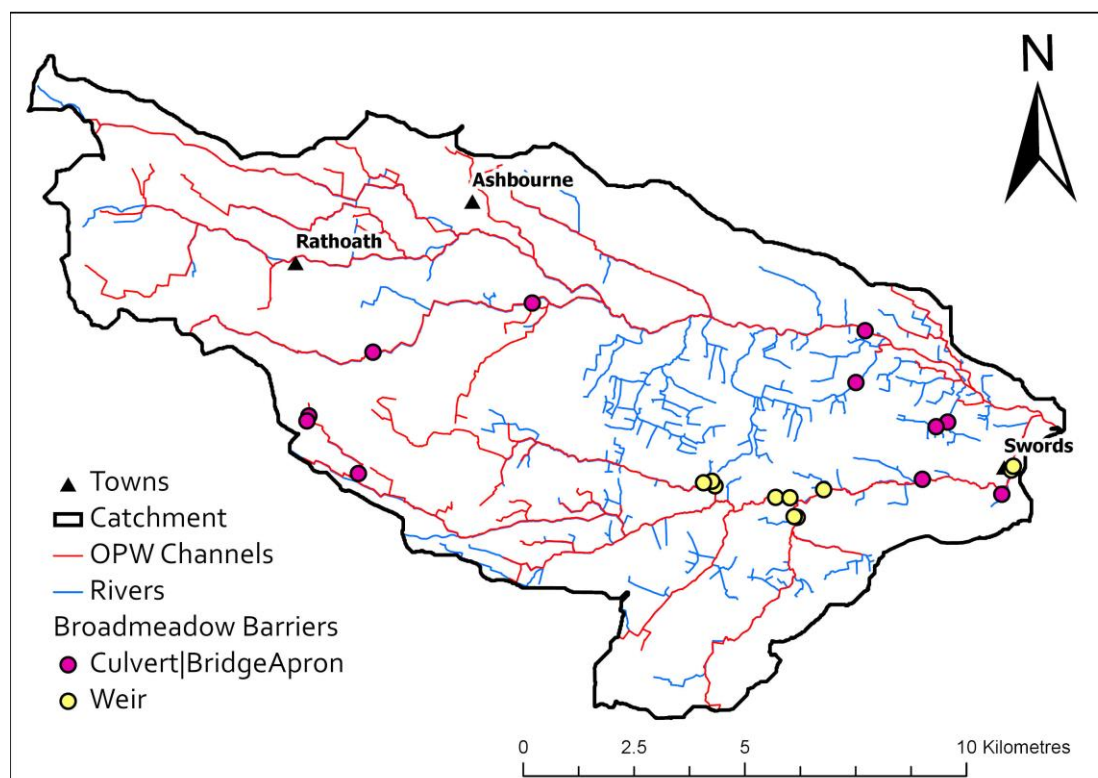
**Figure 3.1 Distribution of all potential barriers within the Broadmeadow and Ward Catchment (top, n=637). Barriers assessed and surveyed to date (bottom, n=21).**

There were 637 potential barriers identified within the Broadmeadow and Ward catchment (Figure 3.1). Structures can prove difficult to access in urbanised areas, and indeed 132 were visited but deemed not accessible. 481 structures were visited and assessed with just 21 measured (Table 3.1), giving a relatively low proportion of barriers within the catchment, approximately 4.3%. However, of the remaining locations to visit (n=24), at least 13 may also pose problems for fish passage, therefore the overall proportion of barriers in the catchment is likely to increase when the full survey is complete. Examples of problematic structures recorded are shown in Figure 3.2. These examples are all listed on the register as OPW structures.

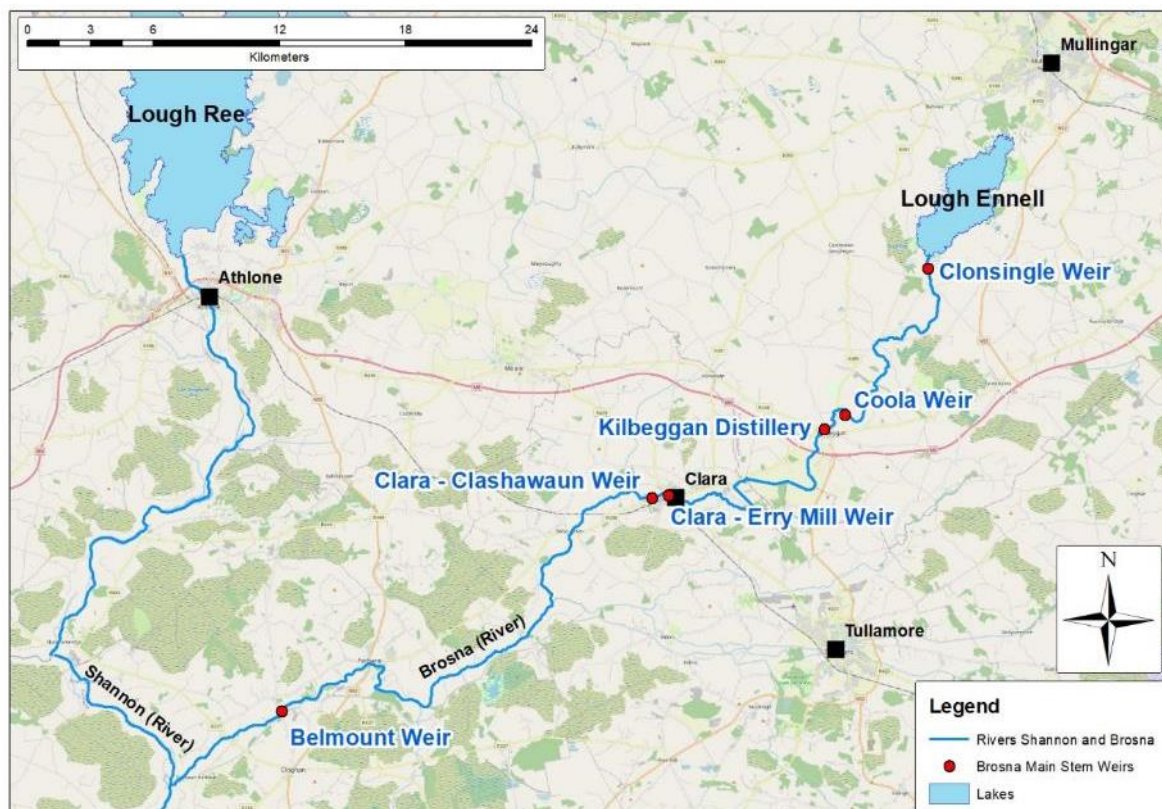
Figure 3.3 Location of the 6 main stem barriers on the River Brosna

The Brosna scheme is located in the midlands. This scheme is one of the major schemes drained by the Office of Public Works between 1948-55, benefitting 34,883 hectares of land (Ryan Hanley 2014b). The River Brosna is approximately 79 km in length, draining an area of 1,248km<sup>2</sup> and is part larger Shannon River Basin, flowing through the Counties Westmeath and Offaly. Discharging from Lough Owel in a south-south-westerly direction it flows through Mullingar, into Lough Ennell. From Lough Ennell, the river flows to Kilbeggan, then southwest through Clara, Ballycumber and Pullough. East of Fermoy it is joined by the Silver River. From Fermoy it heads to Shannon Harbour, north of Banagher, where it joins the Shannon. The Brosna from Lough Ennell to its outflow in Shannon Harbour now has 6 significant weirs rated as an issue for fish passage (Figure 3.3). The river has a long history of industrial use and associated modifications including construction of weirs and sluices, as well as diversion channels. When the Brosna catchment was subjected to a major OPW arterial drainage scheme, modifications were also made to the instream structures (weirs/sluices), with similarly constructed sluices, winches and concrete structures still evident in many of the 6 main stem barriers on the river Brosna.

Detailed passability assessments were completed on these 6 structures by IFI's National Barrier Programme during 2021. These are detailed in the report Coghlan *et al.* (2022) and demonstrate the significant fish passage issues in the Brosna. The presence of these artificial barriers in the Brosna has contributed to the fragmentation of brown trout populations and hinders upstream migration of annex species including Atlantic salmon and European eel. Furthermore, recommendations are made as regards to priorities for a large-scale barrier mitigation programme in a catchment context. Smaller-scale recommendations are also outlined which would help to address some of the issues observed with these barriers in the short term.

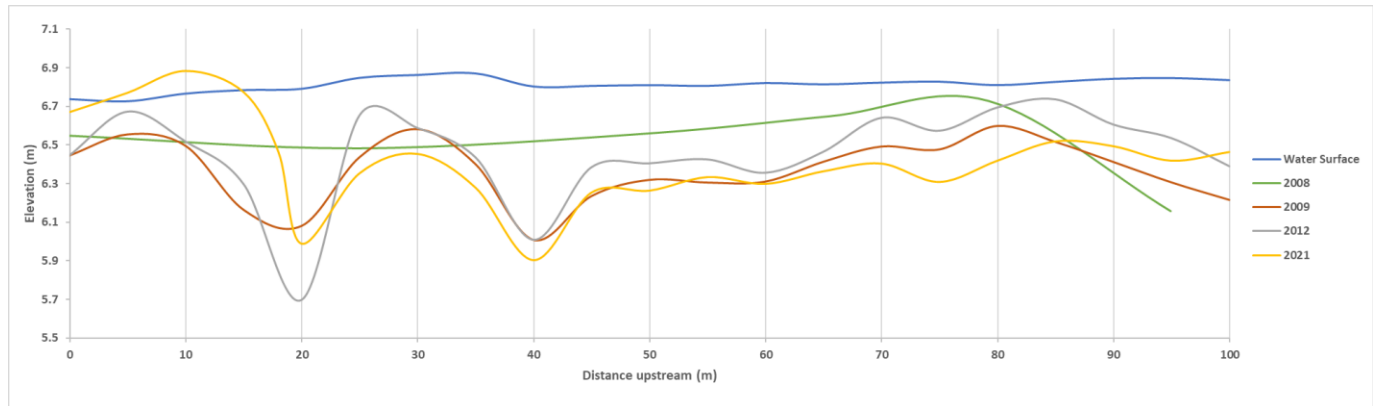
**Figure 4.2 Longitudinal Profile of Dee Survey site pre- and post-works completed in 2009.**

A longitudinal profile of the site was generated for 2008 pre-works (Figure 4.2). This shows the riverbed and its characteristics before and after the completion of capital works activities by the OPW. The green line (2008) shows a uniform channel bed typical of a deep glide, supporting little to no variance in depths or flows. The blue dashed line shows the water surface level recorded in 2009 giving a visual indication of water depths. Repeating the levelling surveys of the channel longitudinal sections post-works indicate changes made to the riverbed. Alterations to the channel bed are evident when comparing the 2008 (green line) profile to the 2009 (orange line).

Two significant pools were excavated at T20 and T40 located directly upstream and downstream of the vortex weir constructed at T30 (T meaning transect and x metres upstream from the bottom of the site). Gravels were also positioned downstream of T20, at T5, as part of the capital works programme to create a shallow riffle.

This levelling survey was carried out again in 2012 (grey line) which indicated the new channel form remained intact 4 years post-works. The pool downstream of the vortex weir deepened by approximately 0.4m perhaps due to scouring caused immediately below the structure in heavier flows. Repeating this longitudinal profile in 2021, 13 years post-works, this pool has filled to the level it was excavated to in 2008. As substrate and sediment moved within the riverine system it is expected that pools will retain some material over time. Also, as part of the vortex weir works smaller gravels were used as part of the construction process filling spaces between larger boulders, and it is likely that these have shifted over time and washed downstream into the pool.

Repeating the levelling surveys of channel longitudinal sections post-works indicates the nature and impact of the initial works between 2008 and 2021. Overall, the works remain intact, adding a variety of depths to a section of channel which originally pre-works was a uniform glide. Within its modified cross-section, the channel has adjusted post-works to being more dynamic with associated diversity in flows and depths. This positive impact of Capital Works has been previously observed in the likes of the Enfield Blackwater, for example (Fleming *et al.*, 2020).

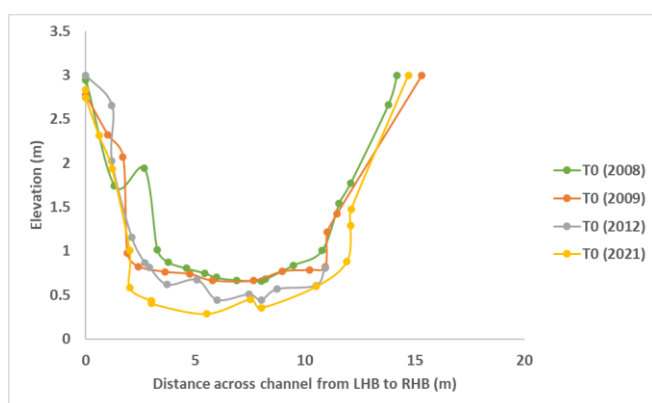
**Figure 4.4** Cross section located at T0.

T0 shows little difference in the cross-section profile throughout all the survey years (Figure 4.4). The LHB was re-profiled slightly during the works in 2008 and is evident here.

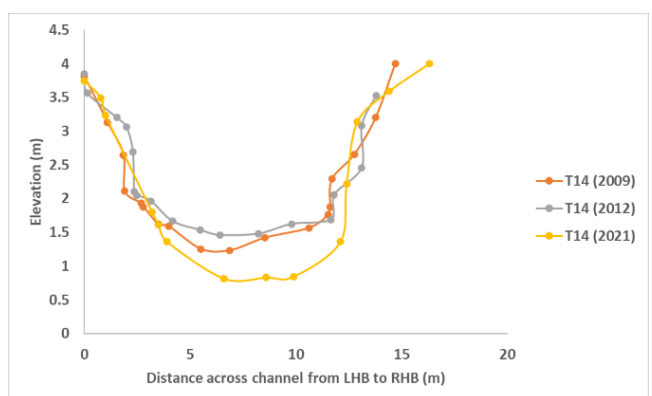
**Figure 4.5** Cross section located at T14.

T14 cross section was first recorded in 2009 post-works. Works completed downstream of the structure were minimal. The profile shows the channel bed is deeper in 2021 compared with 2012 (Figure 4.5) This is possibly due to natural moving of substrate and erosion within the river channel.

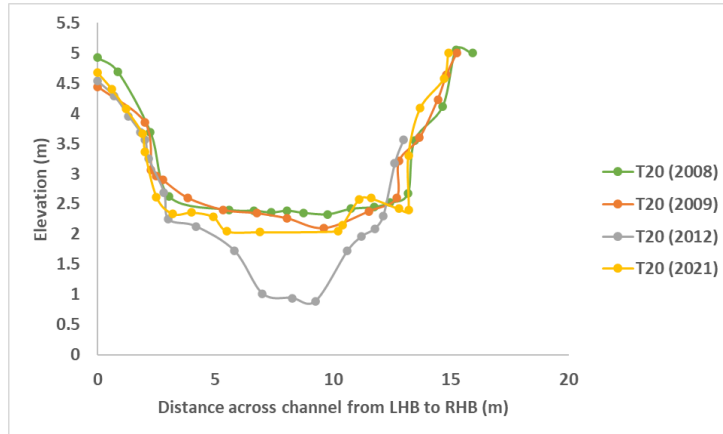
**Figure 4.6 Cross section located at T20.**

T20 was located directly downstream of the vortex weir. This cross section shows a pool formation downstream of the structure (Figure 4.6). The scoured pool in 2012 is distinctively evident from the longitudinal profile shown previously in Figure 4.2.

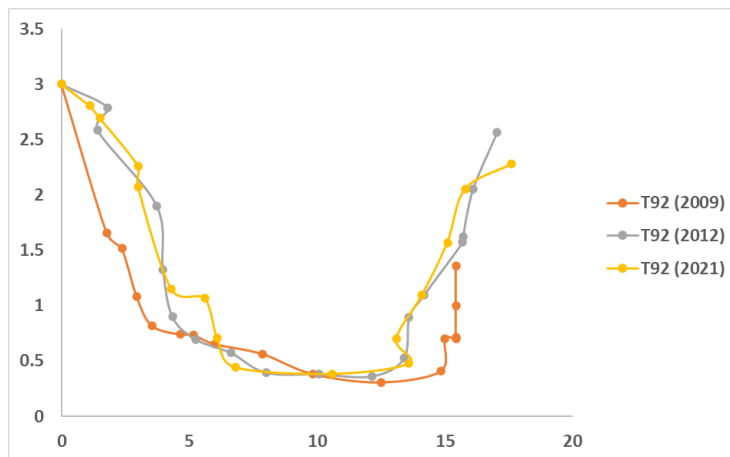
**Figure 4.7 Cross section located at T92.**

T92 was the only cross section located upstream of the vortex weir. The section of channel upstream of the structure was characterised as a deep uniform glide for all years of the surveying works. The cross-sectional profile of the channel shows changes in channel width between 2009 and 2021 (Figure 4.7). Works carried out in 2009 consisted of various methods to stabilise the riverbanks which included rock armour and strategic positioning of Christmas trees along the bank. During recovery, the channel has narrowed as the banks stabilise and vegetation colonises (Figure 4.8).

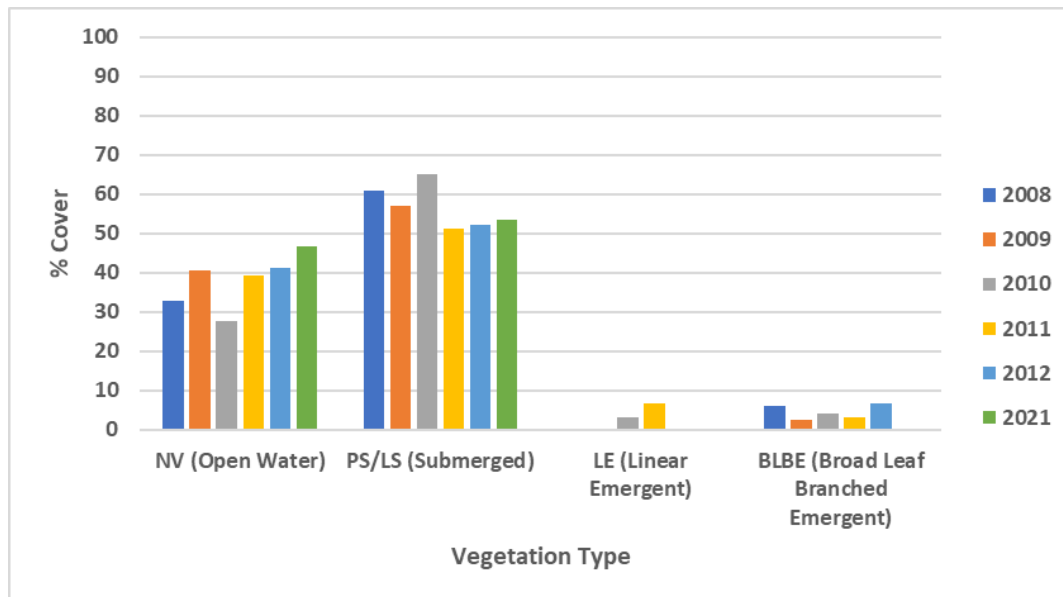
**Figure 4.9 Percentage cover of instream vegetation before and after capital works were completed on the Dee River in 2009.**

Instream vegetation was not impacted by the instream works completed and instream cover remains similar for all years monitoring post-works (Figure 4.9). Even though the capital works improved flows and depth diversity within the channel, they caused limited changes to instream vegetation as pre-works conditions were already favourable for the river vegetation that is present in the channel.

Submerged vegetation was the most abundant type present all years of the survey. The presence of in-stream vegetation patches reduces velocities within vegetated patches and increase flows in adjacent non-vegetated areas. Water levels are altered in vegetated areas compared to unvegetated areas (Verschoren *et al.*, 2016). Instream vegetation in turn increases the diversity of habitats and resources, therefore influencing habitat choice, survival and growth of migrating fish (Diehl and Kornijow, 1998).

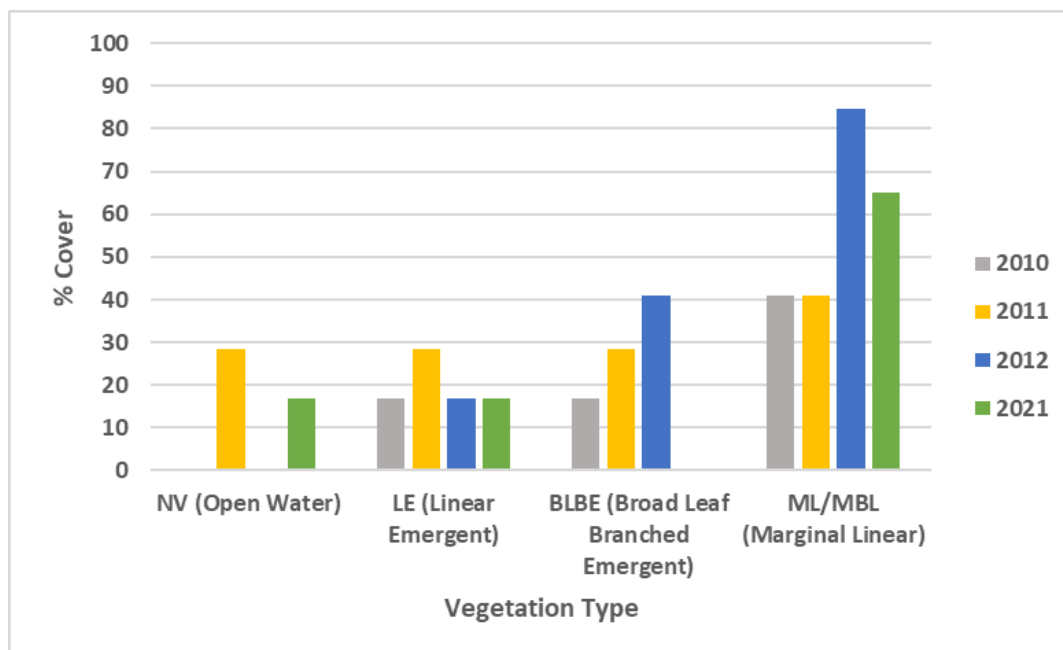
**Figure 4.10 Percentage Cover of marginal vegetation following the erection of fencing during capital works completed on the Dee River in 2009.**

Marginal/fringing vegetation was not recorded pre-works as there was limited amounts present along the channel banks due to extensive cattle poaching. Marginal vegetation colonised the newly re-profiled banks 1 year post-works as cattle had been omitted due to the erection of extensive fencing. Marginal vegetation has been surveyed since 2010. Examining Figure 4.10 it has thrived since then, colonising the banks which assists in bank stability.

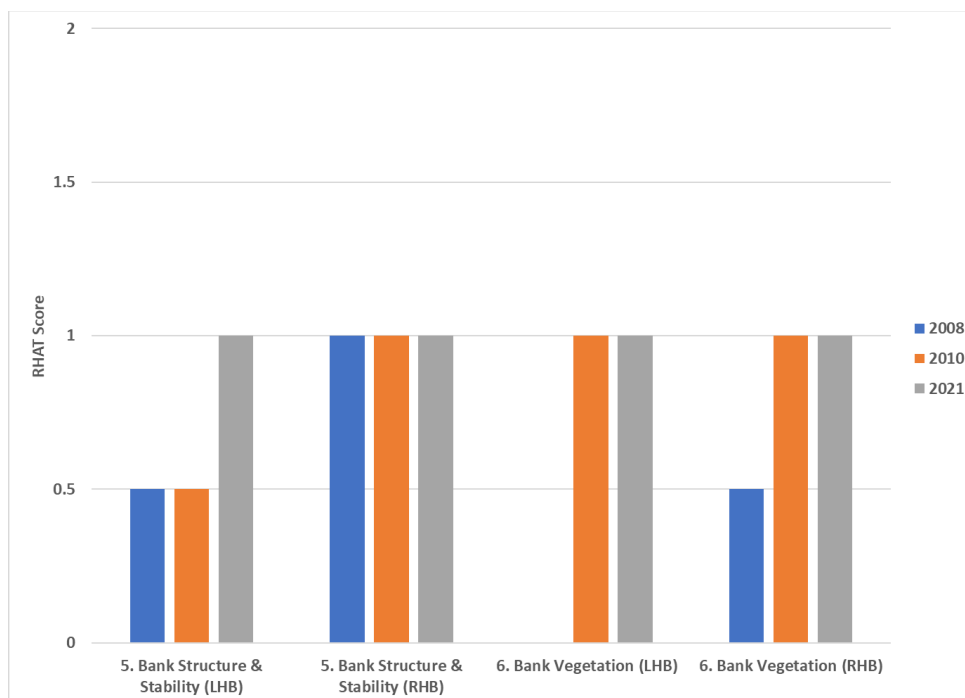
**Figure 4.11 RHAT Scores for survey site pre- and post- capital works.**

The RHAT survey completed in 2008 post-works classified the site as having Poor hydromorphological status overall. The bank vegetation attribute had the lowest score for both banks with a 0 score for the LHB and 0.5 for the RHB (Figure 4.11). Bank vegetation improved after the implementation of the Capital Works, scoring 1 for both banks in 2010 and 2021. The slight improvement in scores post-works led to a Moderate hydromorphology status. Fencing the left bank as part of the capital works omitted cattle access, allowing vegetation growth to take hold. The highest score that can be given to each bank is a 2 and in this case bank vegetation scored no higher than a 1 as trees were absent from the banks. Planting trees along the newly fenced banks in 2009 would have improved this score greatly for 2021.

Bank structure and stability scores remained the same for the RHB for all years, whereas the LHB scored 0.5 pre- and post-works. This score improved to a 1 in 2021 as the hard reinforcement had renaturalised over the intervening 11-year period.

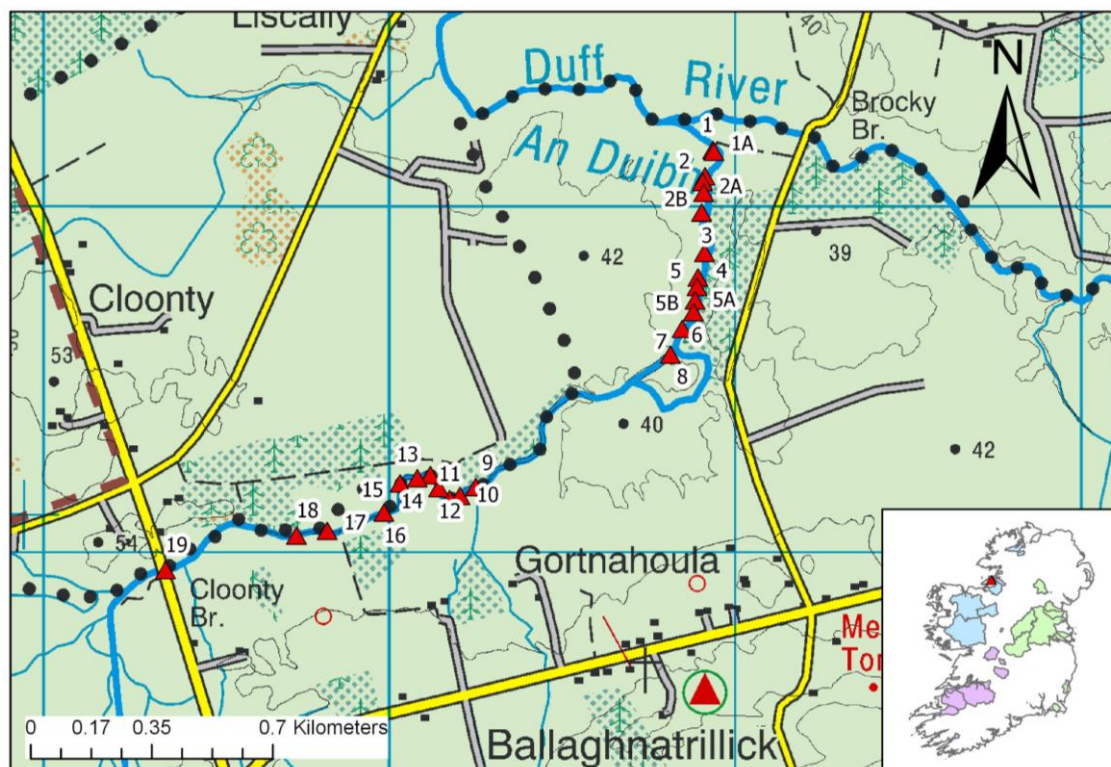
**Figure 5.1 Map showing work site locations identified during a walkover undertaken in July 2020 on channel C1/8.**

During the initial walkover in 2020 advice was given on the implementation and best practice of the 10 Steps to Environmentally Friendly Maintenance (Brew and Gilligan, 2019). Within the 2km of channel walked 19 work sites were identified (Figure 5.1) with removal of blockages that hindered flood conveyance was the main area of focus. They were also advised to leave many sections untouched where no maintenance was required.

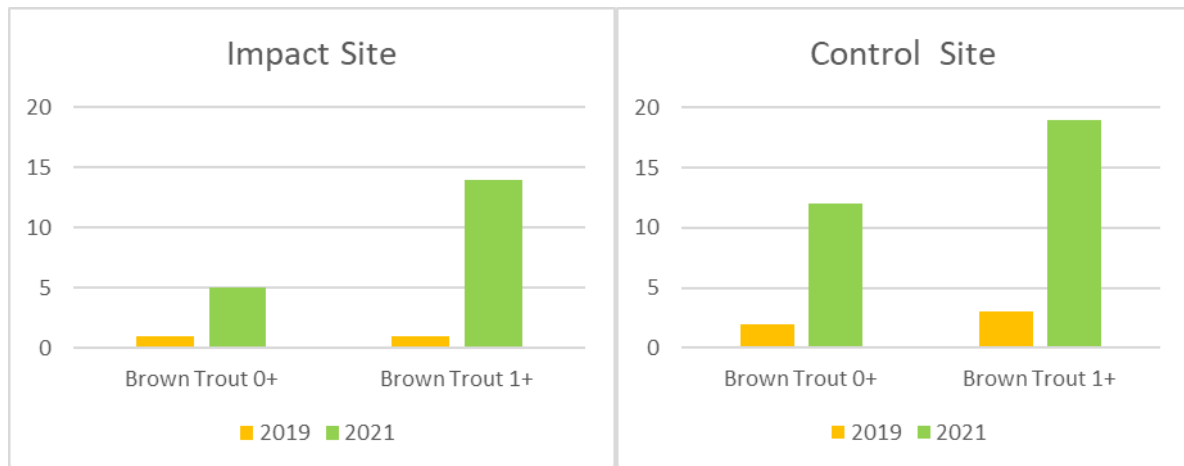
**Figure 5.9 Abundance of 0+ and 1+ brown trout caught at the Control and Impact sites, pre- and post-works.**

The EQR results show improvement from Poor to Moderate at one Impact site and two Control sites (Table 5.1). In addition, there is an improvement from Moderate to Good in two Control sites. The nature of electrofishing and the observed results should be interpreted with caution. Overall, there were low numbers of fish caught (Figure 5.9) and the numbers increased in both the control and impact sites over the survey years.
