Environmental Drainage Maintenance Research Programme

Catchment-wide Assessment 2024

IFI/2025/1-4755

Inland Fisheries Ireland & the Office of Public Works

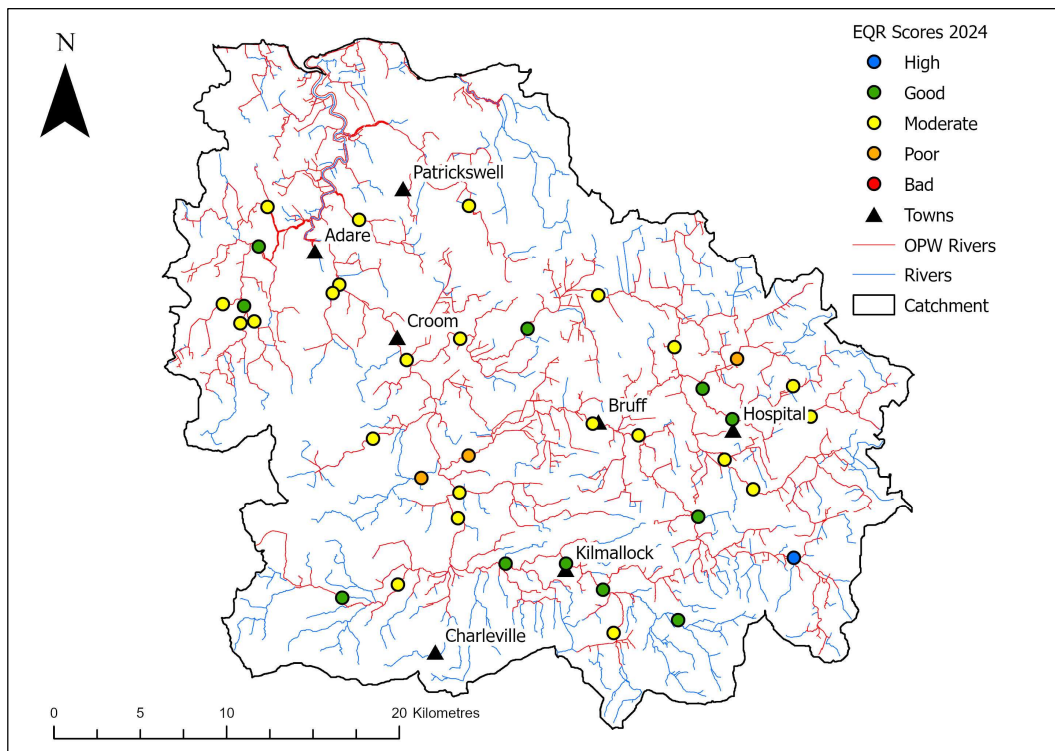
Figure 2.6 Fishing locations surveyed in 2024 with Ecological Quality Ratio (EQR) scores generated for each site.

Focusing solely on the 2024 EQR results, 3% of sites graded as Bad status, 8% Poor status, 58% scored Moderate status, 28% scored Good status and the remaining 3% classified as High status. The WFD requirement is Good status and above, therefore 31% (n=12) of the sites from the Mague catchment-wide fishing survey are meeting WFD standards for fish.

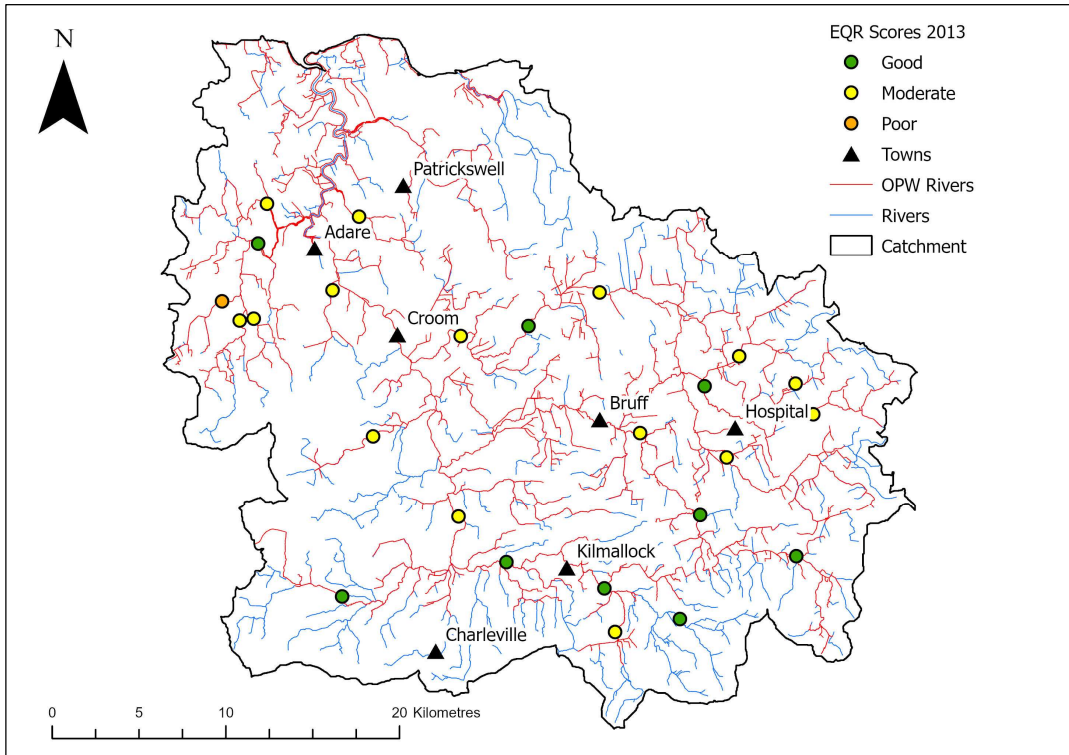
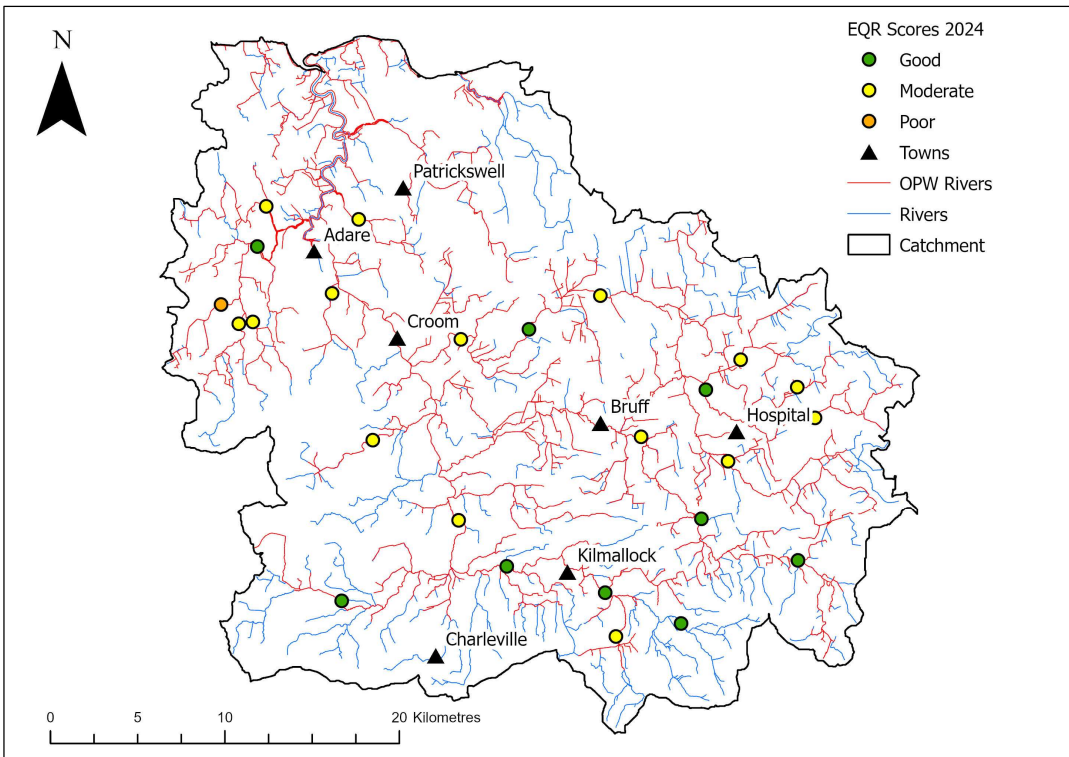
Figure 2.7 Ecological Quality Ratio (EQR) scores generated for 25 sites fished in 2013 (top) and 2024 (bottom).

See Figure 2.7 & Figure 2.8 where over the 11-year period EQR status of 5 sites deteriorated, 11 remained the same and 9 sites improved. 3 sites downgraded from Good Status to Moderate, 1 site from Good to Poor and 1 site went from Poor down to Bad. From the improved sites, 5 sites went from Poor status to Moderate status, 3 went from Moderate Status to Good and another from Poor to Good.

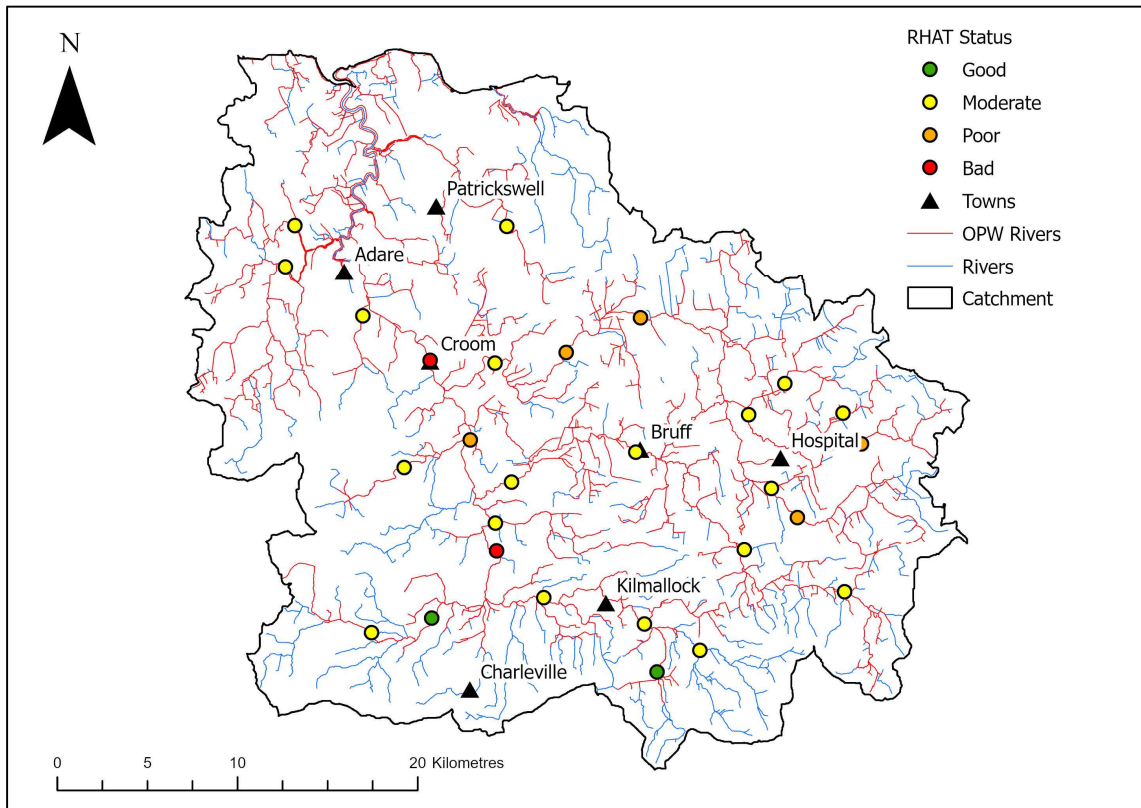
Figure 3.1 RHAT Scores for sites surveyed in the Maigue Catchment (n=28).

Using the River Hydromorphology Assessment Technique (Murphy & Toland, 2014), a total of 28 sites were assessed for hydromorphological status in the Maigue catchment (Figure 3.1). The RHAT is the standard assessment for assessing hydromorphology for the WFD nationally at a field site scale. Visual field observations are recorded every 50 metres over a 500-metre walkover and an overall score assigned at the conclusion of the survey. All of the sites on the Maigue were surveyed between May and June in 2024. The OPW Arterial Drainage Scheme in the Maigue is quite extensive, so just one site was located on a non-drained channel leaving 27 sites located on OPW scheme channels. Just 2 sites (7%) of the 28 scored Good status, the minimum WFD requirement. The remainder of the sites failed for hydromorphology, with the scores ranging from 68% Moderate (n=19) to 18% Poor (n=5) and 7% Bad (n=2).

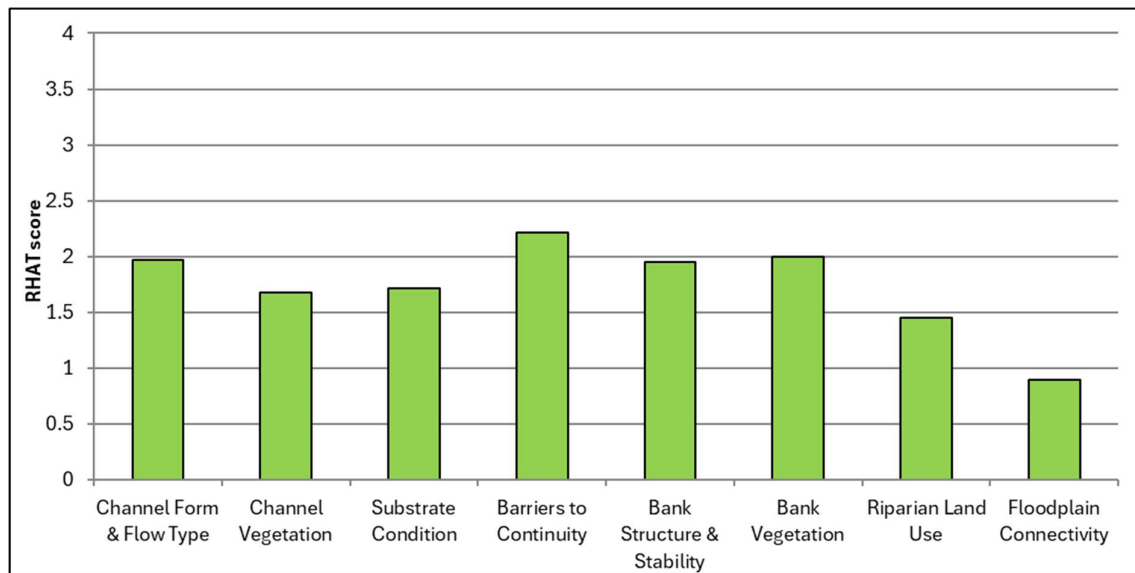
Figure 3.2 Mean RHAT scores for sites surveyed in the Mague (n=28)

When RHAT scores are averaged, they range from 0.89 (Floodplain Connectivity) to 2.21 (Barriers to Continuity). Riparian Land Use averages out at a relatively low score of 1.45. Channel Vegetation and Substrate Condition are also among the lower scoring attributes, on average (Figure 3.2).

Floodplain connectivity scored very low (0.89) indicating the significance of historic over-deepening and widening of all channels surveyed. Riparian land use was the next attribute scoring poorly and land management influences these scores. Channel vegetation and substrate condition scored relatively low for this catchment, both averaging less than 2.

Correct application of the OPW 10 steps during maintenance can positively influence attributes 1, 2, 3, 5 and 6 namely left to right.

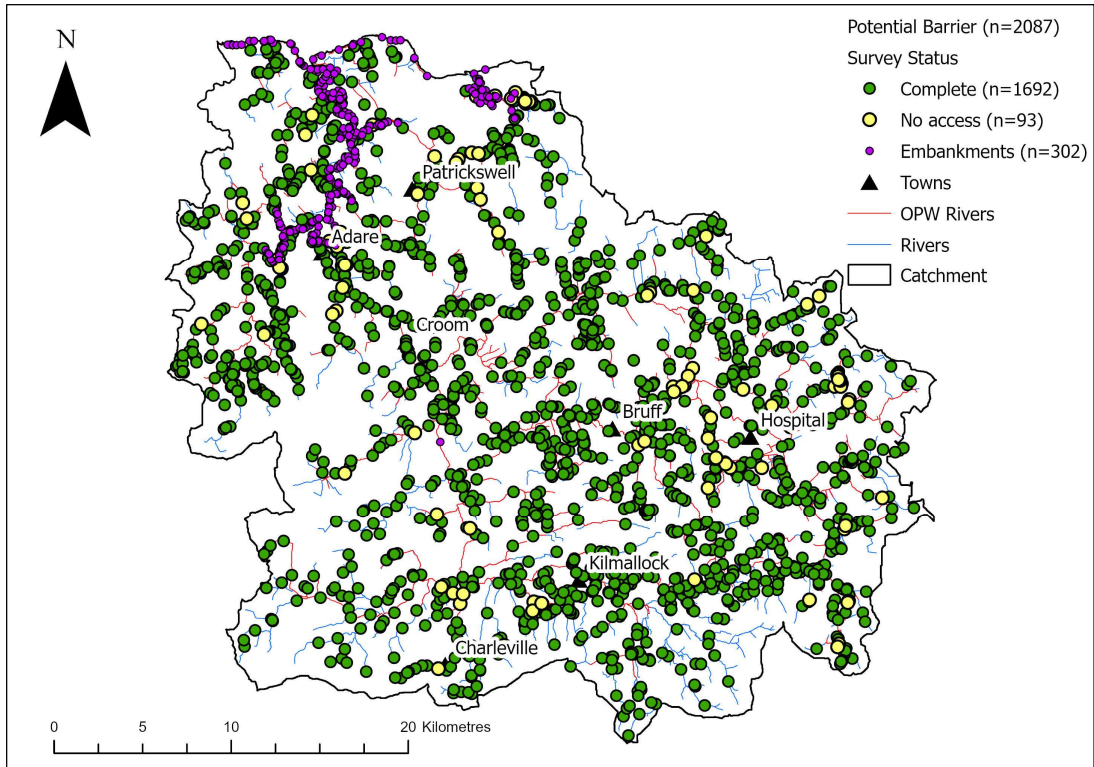
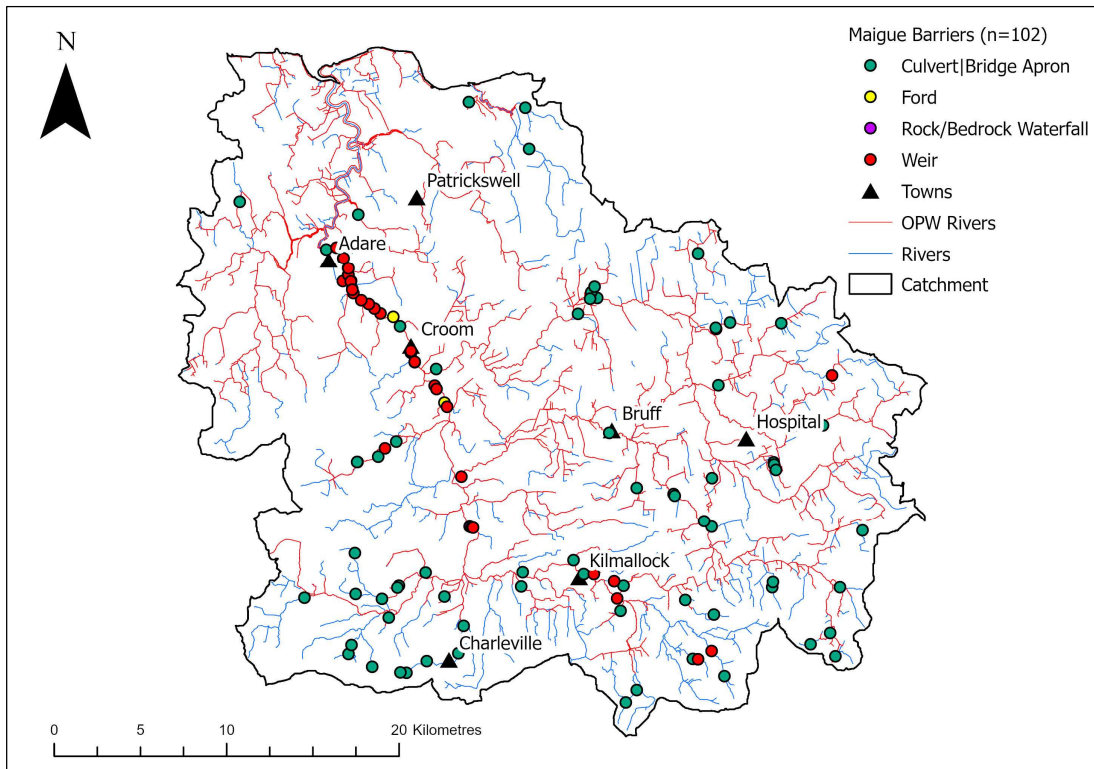
Figure 4.1 Potential barriers and survey status (top) and barriers identified and surveyed to date (bottom).

As seen in Table 4.1, culvert/bridge apron is the most abundant barrier type identified in the Mague Catchment. Structures assessed as barriers varied in size and were located on all stream orders. Exploring all barriers classified as a culvert/bridge apron, structure width ranged from 0.3–20 metres and structure length ranged from 3.5–40 metres.

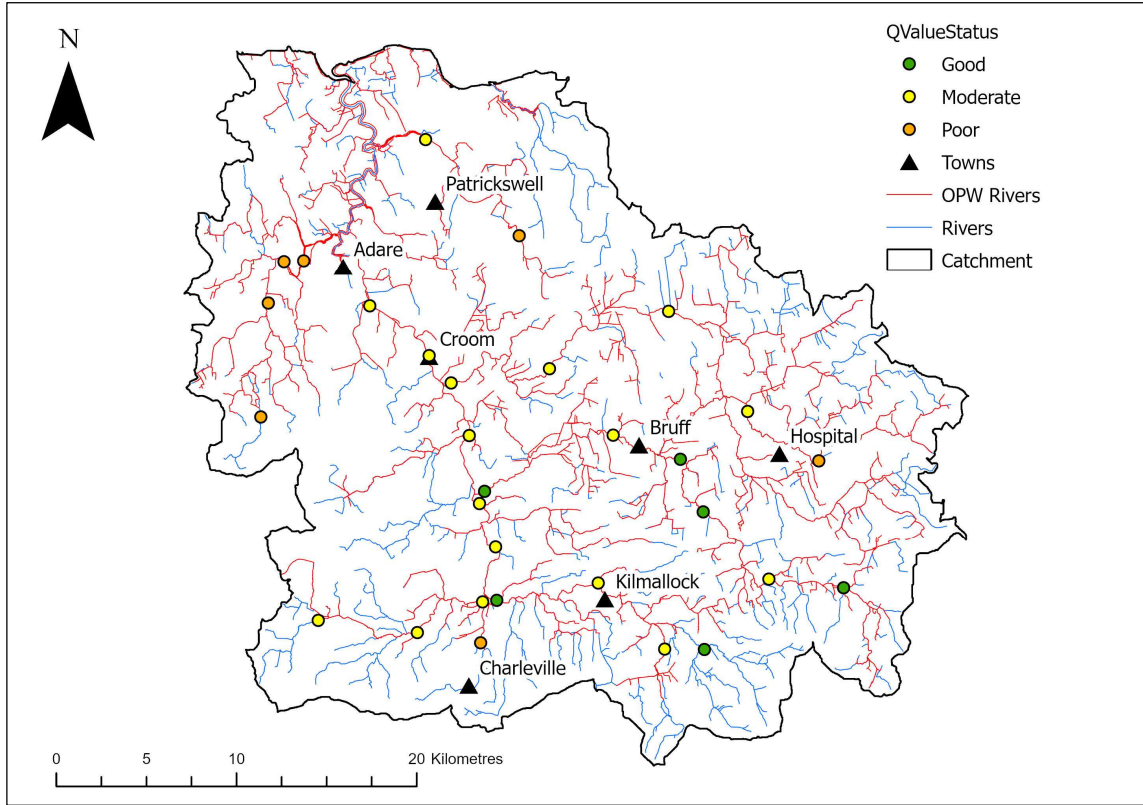
Figure 5.1 Water quality assessments undertaken by the EPA in 2023.

Water quality can be accessed on the Environmental Protection Agency website. For the Maigne Catchment, it was assessed in 2023, the year previous to this catchment wide survey. Similar to other WFD metrics, Good status is the requirement. 30 sites were monitored for water quality in 2022. 20% (n=6) of the sites passed the minimum requirement and received a classification of Good status. The remainder of the sites (80%) failed to pass WFD standards, of which 17 sites (57%) scored Moderate and 7 sites (23%) were classified as Poor (Figure 5.1).

Exploring water quality scores from the 2023 assessment, it is noted that the main tributaries of the catchment mostly score Moderate status. All four of the sampling sites on the Camoge scored Moderate as well as some sites on the Morningstar and the Loobagh. The upper sections of the Morningstar and the Loobagh scored a higher classification of Good. Sites scoring poor are located within the Clonshire watershed and on the upper reaches of the Barnakyle. Salmonids generally fare better at sites with Q3 and above i.e. Moderate, Good and High (Kelly *et al.*, 2007).
