Aerial & fish stock survey of the River Crana catchment, Co. Donegal

September 2018

IFI/2018/1-4438

Inland Fisheries Ireland Research & Development preliminary report

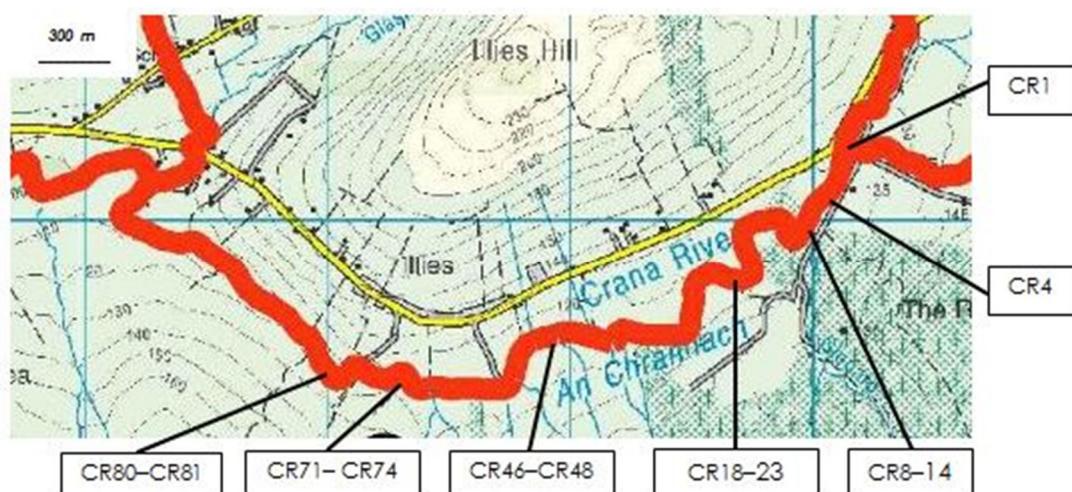
Figure 3 Crana (upper) showing key features identified in the aerial survey.

The Crana (upper) appears to be in a good physical state to support salmonid stocks. The channel substrate principally comprises a boulder-cobble mix interspersed with gravels and sands. There are no obvious signs of excessive siltation which may be detrimental to salmonid spawning and nursery areas. Land use adjacent to the river channel largely comprises agricultural grassland with some plantation forestry present in the upper section of this river segment (Table 2). Some localised bank reinforcement works have been undertaken at the Twin Sisters bridge and in the vicinity downstream of this (Table 3; Figure 3, Figure 4 and Figure 5). Installation of fencing along exposed areas of the riparian zone is recommended to encourage its natural development and consequently aid long-term bank stability (Table 3; Figure 3).

Measures	Observations	Image reference
Measures implemented by landowners in response to the flooding	Bank reinforcement works at Twin Sisters bridge	CR1
	Some earth bank reinforcement works and riparian fencing installed on RHB	CR4
	Riparian fencing installed on LHB	CR 8–CR14
	Levee is being installed here with locally excavated material since the survey took place.	CR18–CR23
Recommended measures	Riparian fencing maintenance proposed on RHB	CR46–CR48 CR71–CR74 CR80–CR81

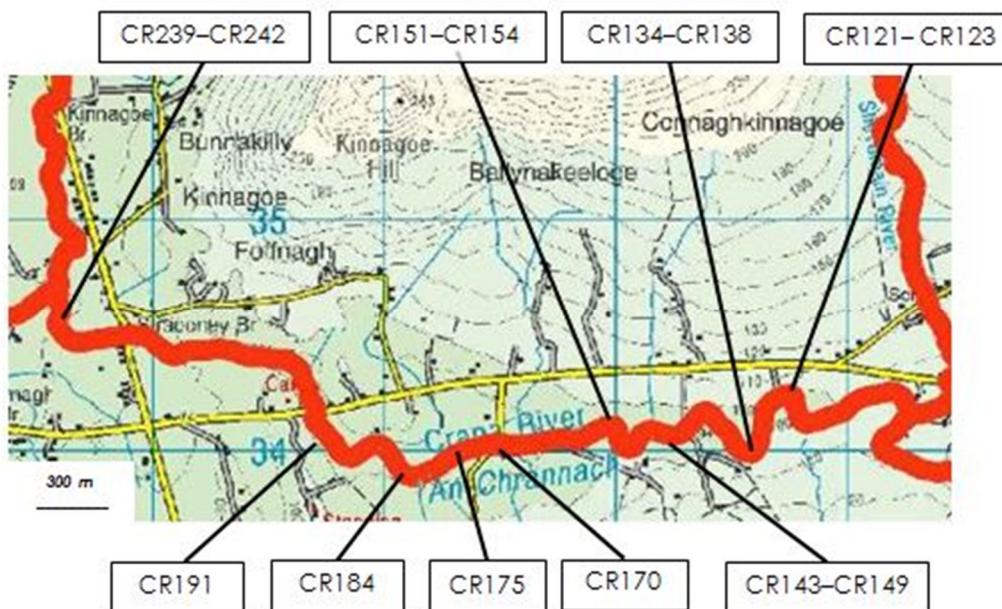
Figure 6 Crana (mid) showing key features identified in the aerial survey.

The Crana (mid) appears to be in a good physical state to support salmonid stocks. Channel substrate composition and land use adjacent to the river channel is similar to the Crana (upper). However, tree-lined banks and exposed bedrock were present in extended sections of this river segment (Table 2). Some localised bank reinforcement works have been undertaken within this river segment with more extensive such works evident directly upstream and in the vicinity of the Owenboy confluence (Table 4; Figure 6, Figure 7 and Figure 8). Installation of fencing along exposed areas of the riparian zone is recommended to encourage its natural development and consequently aid long-term bank stability. In addition, fish passage should be assessed at CR144 (Figure 9) and CR 170 (Figure 7).

Measures	Observations	Image Reference
Measures implemented by landowners in response to the flooding	Bank reinforcement works along riparian zone	CR121– CR123
	Bank reinforcement works on LHB	CR134–CR138
	Rock armour installed on LHB in vicinity of road bridge near soccer pitch	CR143–CR149
	Temporary pipe-culverted bridge and boulder footbridge installed as adjacent bridge collapsed in flood.	CR170
	Bank reinforcement works	CR170–CR175 CR184–CR191
	Extensive bank reinforcement works on LHB	CR239–CR242
Recommended measures	Riparian fencing proposed on both banks where this is not already installed	CR119 –CR136 CR151 –CR154 CR172 –CR178
	Assess if fish passage may be impeded in low to medium flows by bridge apron near soccer pitch	CR144
	Assess if fish passage may be impeded in low to medium flows by temporary pipe-culverted bridge and boulder footbridge. Footbridge should be removed as soon as is feasible.	C170

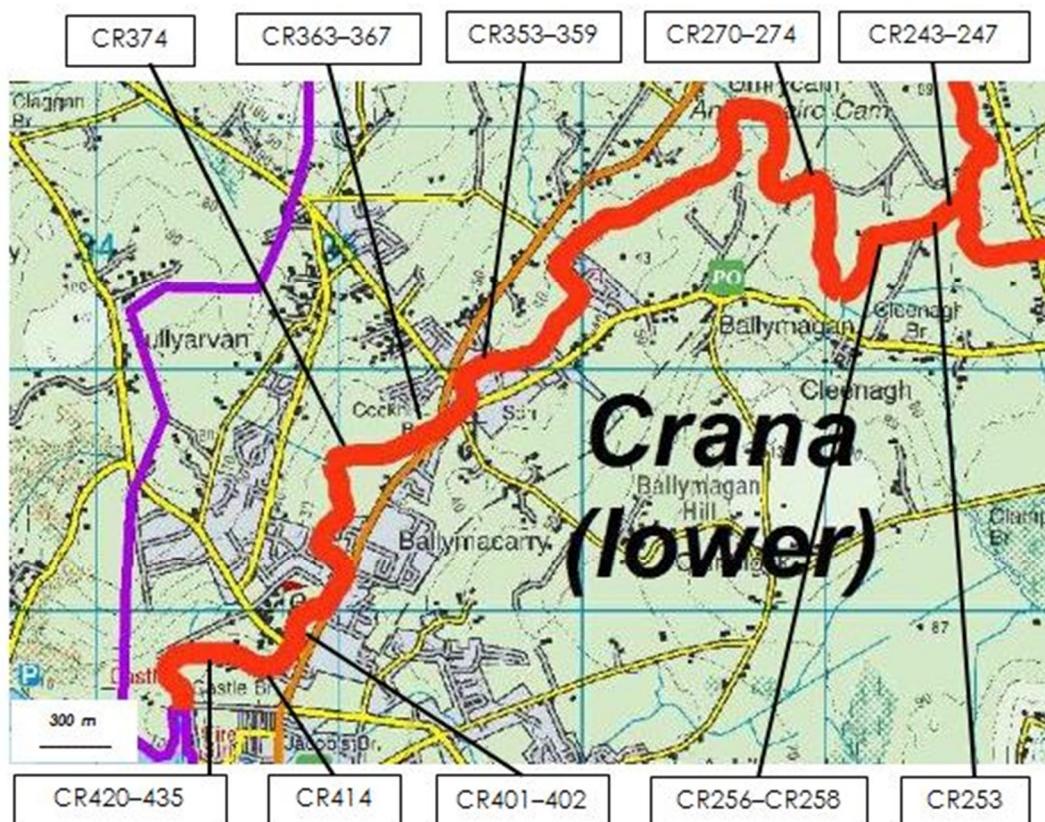
Figure 10 Crana (lower) showing key features identified in the aerial survey.

The Crana (lower) appears to be in a good physical state to support salmonid stocks and facilitate their passage although remnant impacts of the flood (structural damage to weirs and bank walls) remain evident in the Buncrana town area which potentially could somewhat impede fish migration. Land use adjacent to the river is principally agricultural (pasture and grassland) in the upper and mid-portions of this river segment. Overall, the channel substrate is boulder-dominated interspersed with cobble, and exposed bedrock regularly features (Table 2). The river banks are extensively tree-lined and heavily vegetated in stretches, thus providing natural stability to the river channel. In the town area, some low density housing estates back onto largely inaccessible sections of the river channel. The final section of the river flows through semi-natural wooded parkland at Swan Park where an old stone bridge and a number of weirs remain in disrepair since the flood (Figure 11). Preliminary inspections indicate that these appear unlikely to impede fish passage. However, such flood-impacted sections as noted in Table 5 should be assessed further to confirm that fish passage is not impeded. The impact of the flood is also very notable at the Owenboy confluence and remedial bank reinforcement works have been undertaken along the LHB downstream of this. Further such remedial works using locally-sourced stone are evident on the outskirts of the town directly downstream of the new road bridge at Cockhill. In addition, an earthen levee has been constructed along the margin of the GAA pitch which was severely degraded in the flood (Figure 12). Measures such as fencing to facilitate the establishment of mature riparian vegetation in areas where remedial bank reinforcement works or levees have been

installed will be important to further aid the future stability of the associated river channel and fisheries habitat (Table 5; Figure 10).

Measures	Observations	Image Reference
Measures implemented by landowners in response to the flooding	Bank reinforcement works along LHB of riparian zone (continuation of works noted previously)	CR243– CR247
	Bank reinforcement works on RHB	CR253
	Bank reinforcement works on LHB	CR256–CR258
	Earthen levee along channel at GAA pitch	CR353–CR359
	Some rock armour and remedial bank reinforcement works at Cockhill Bridge	CR363–CR367
Recommended measures	Bank reinforcement works	CR374
	Riparian fencing proposed on LHB bank	CR270 –CR274
	Assess if fish passage may be impeded by channel modification after flooding	CR401 –CR402
	Assess fish passage at damaged weir	CR414
	Assess fish passage at damaged weirs and generally through Swan Park	CR420–CR435

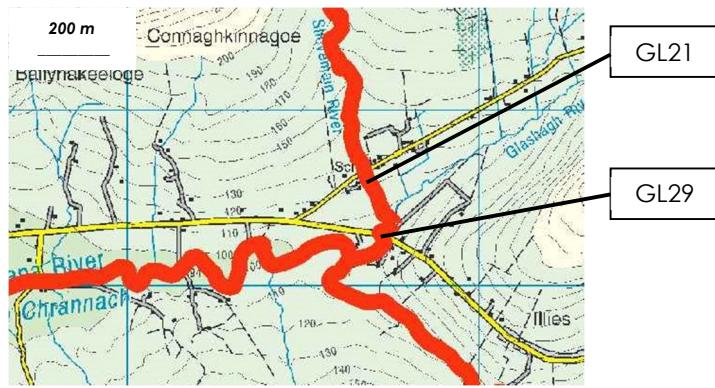
Figure 13 Glashagh showing key features identified in the aerial survey.

The Glashagh tributary transitions from a typical upland high gradient system dominated by bedrock and boulders interspersed with some cobbles, gravel and sand to a low gradient system in its lower reaches with a predominant boulder-coble mix interspersed with gravels (Table 2). The upper portion is fenced along its LHB and is principally sheep-grazed moorland while the lower portion is agricultural. In the lower reaches, locally-sourced boulder rock armour has been installed along some of the channel margin (Figure 13; Figure 14) and also in the vicinity of the road bridge (Figure 13; Figure 15). The physical habitat of the river channel is considered adequate to support healthy salmonid stocks and preliminary results from the CWEF indicate that reasonable numbers of juvenile salmon (in lower portion) and trout are present here. No physical fisheries enhancement measures are likely to facilitate improvements in the carrying capacity of fish stocks in this tributary (Table 7).

Measures	Observations	Image Reference
Measures implemented by landowners in response to the flooding	Boulder rock armour installed in the lower portion of the Glashagh	GL21
	Bank reinforcement works	GL29
Recommended measures	No physical fisheries enhancement measures are likely to facilitate improvements in the carrying capacity of fish stocks in this tributary.

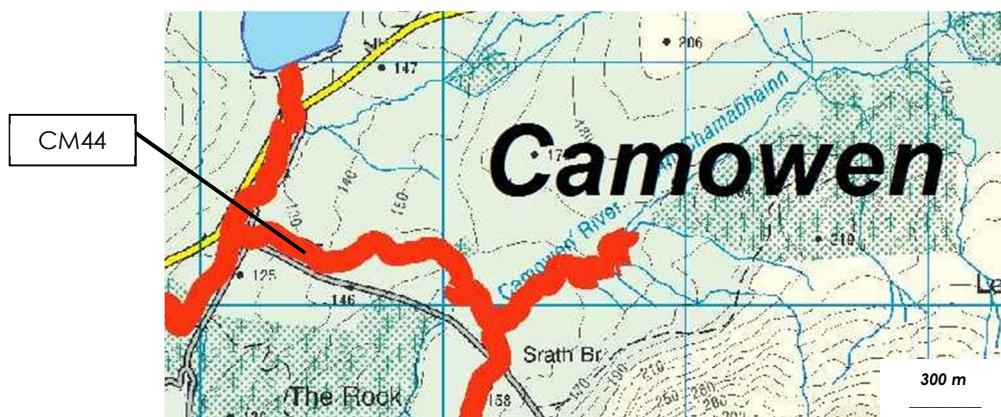
Figure 16 Camowen showing key features identified in the aerial survey.

The Camowen is a typical upland high to moderate gradient system dominated by bedrock and boulders interspersed with some cobbles, gravel and sand. The channel principally flows through sheep-grazed moorland with some farmland present in its lower reaches (Table 2). The RHB is extensively fenced. A likely impediment to migrating salmonids is present c. 200m upstream of the Twin Sisters bridge (Figure 16; Figure 17; CM44). Further assessment of a possible impediment to fish passage here (using SNIFFER or equivalent approach) is recommended (Table 8). Although the Camowen experienced significant flooding in August 2017, no notable impacts to the channel were observed during the aerial survey. No physical fisheries enhancement measures are likely to be beneficial to salmonid fish stocks in this river segment with the exception of improving fish passage if required.

Measures	Observations	Image Reference
Measures implemented by landowners in response to the flooding	None observed	
Recommended measures	Assess fish passage	CM44

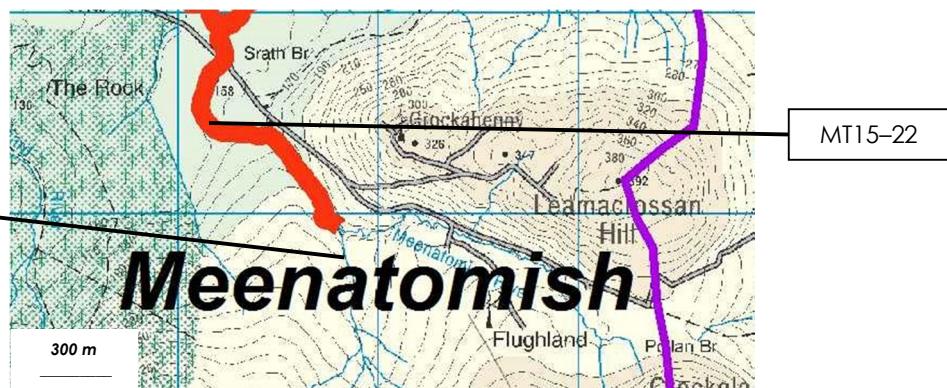
Figure 18 Meenatomish showing key features identified in the aerial survey.

The upper Meenatomish is a typical high gradient upland system dominated by bedrock and boulders interspersed with some cobbles, gravel and sand. In its lower portion, it flows through farmland remediated after the flood and sheep-grazed moorland over a boulder-cobble mix with some gravel and sands present (Table 2). Although this tributary experienced significant flooding impacts in August 2017, no notable impacts to the lower portion of the river channel were observed during the aerial survey (Figure 18). However, some bank subsidence is evident further upstream (MT1–MT 4; Figure 19) and downstream of the farm buildings the RHB has been reinforced with natural boulder rock armour and re-fenced (MT15–MT22; Figure 20). The channel is physically in a good state to support salmonid stocks. Thus, no such fisheries restoration measures are likely to be beneficial. As the Meenatomish is a tributary of the Camowen, the potential fish passage impediment on the latter (CM44; Figure 17) will also be relevant to this sub-system (Table 9).

Measures	Observations	Image Reference
Measures implemented by landowners in response to the flooding	Boulder rock armour installed and refencing on RHB and farmland remediated	MT15–MT22
Recommended measures	No physical fisheries enhancement measures are likely to facilitate improvements in the carrying capacity of fish stocks but assessment of fish passage at impediment in the lower Camowen is recommended.

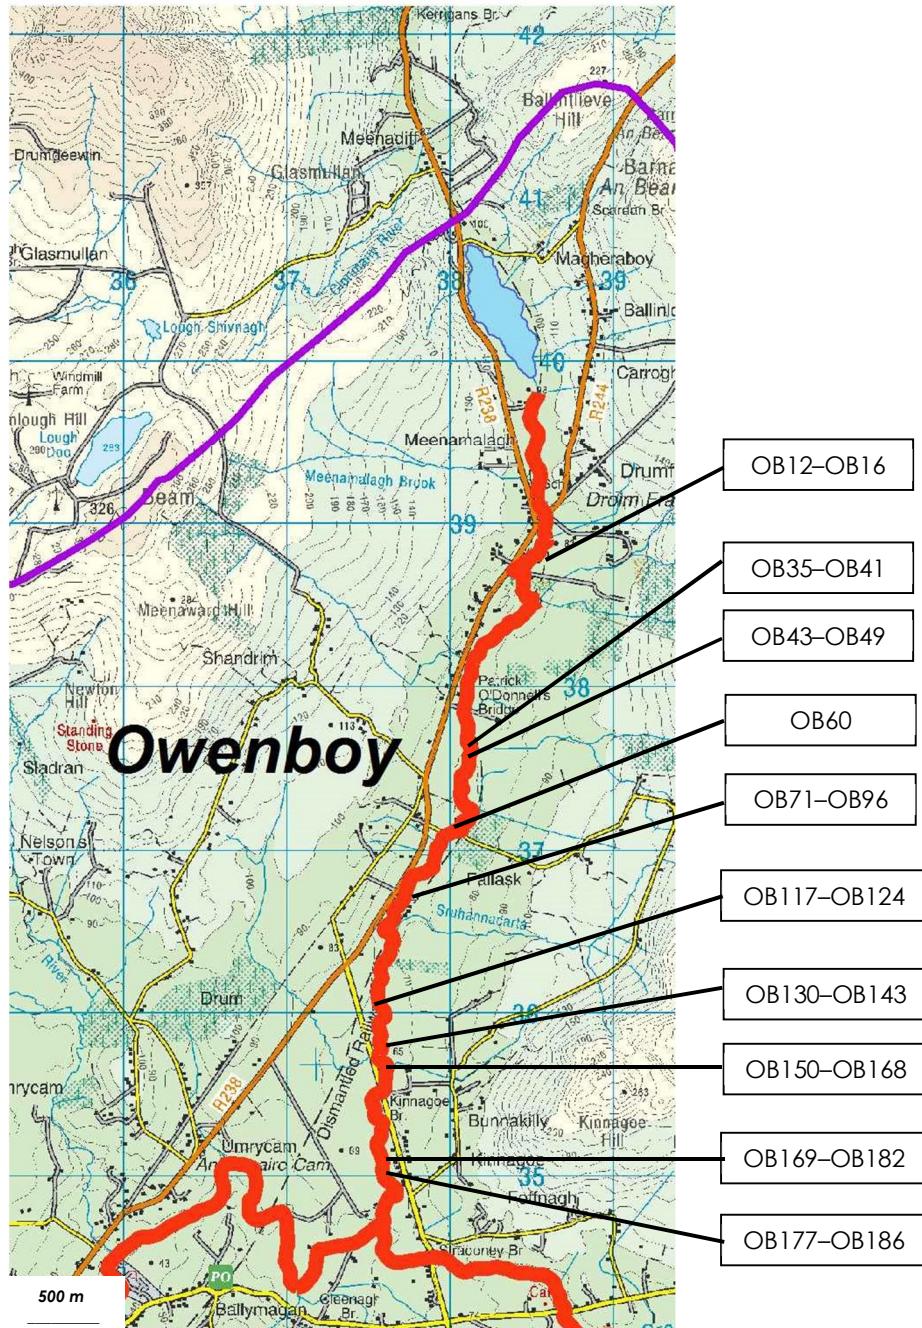
Figure 21 Owenboy showing key features identified in aerial survey.

The section of the Owenboy surveyed is a low gradient system flowing principally through agricultural pasture grazed by sheep with some areas of rough uncultivated land present. The channel has extensive stretches with a mature and stable riparian zone lined with trees and other vegetation. The channel substrate is principally comprised of cobble interspersed with boulder and gravel and there is generally good instream aquatic plant cover. There are no obvious signs of flood-impact or bank degradation (Table 2) although farmland and associated property were reportedly heavily-impacted by the flood. The physical character of the habitat is considered adequate to support salmonid stocks. The channel would benefit from fencing to facilitate the establishment of mature riparian vegetation and better protect the river from livestock ingress in areas where this is currently absent (Table 10; Figure 21).

Measures	Observations	Image reference
Measures implemented by landowners in response to the flooding	Not apparent from the aerial survey.	OB
Recommended measures	Riparian fencing proposed on LHB bank where this is not already installed	OB12–OB16 OB43–OB49 OB71–OB96 OB117–OB124 OB130–OB143

OB150–OB168 OB169–OB182
	Riparian fencing proposed on RHB bank where this is not already installed	OB35–OB41 OB60 OB71 OB177–OB186
