Environmental River Enhancement Programme

Annual Report 2014

**Inland Fisheries Ireland & the Office of Public Works
Environmental River Enhancement Programme**

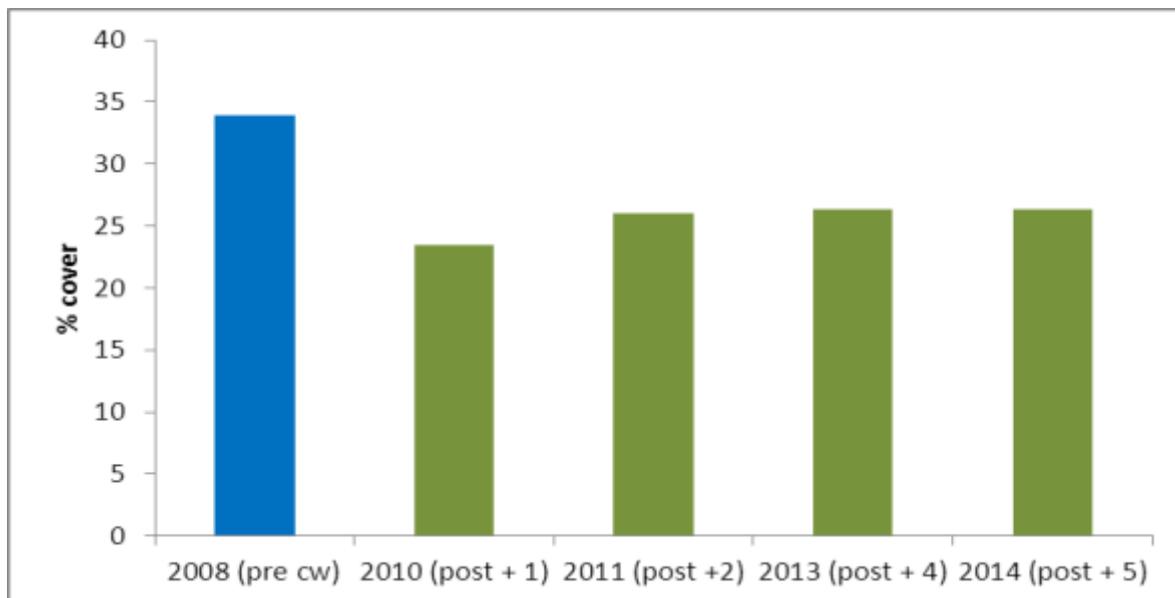
Figure 3.1: Tall emergent vegetation % cover pre and post works in the experimental site.

Monitoring of the channel flora at Sheepwash bridge has been ongoing since 2008. The tall emergent vegetation is predominantly comprised of *Scirpus lacustris*, and *Sparganium ercetum* with some *Phalaris arundinacea*. Capital works in 2009 resulted in a 32% reduction of tall emergent vegetation one year post-works (Figure 3.1). The decrease can be attributed to the construction of a series of stone deflectors at sites where tall emergent vegetation was previously present. In recent years, these deflectors have been colonised by terrestrial plant species that are tolerant of damp conditions (Plate 3.1). Following capital works, tall emergent vegetation has continued to occupy approximately 25% of the channel area year on year (Figure 3.1).

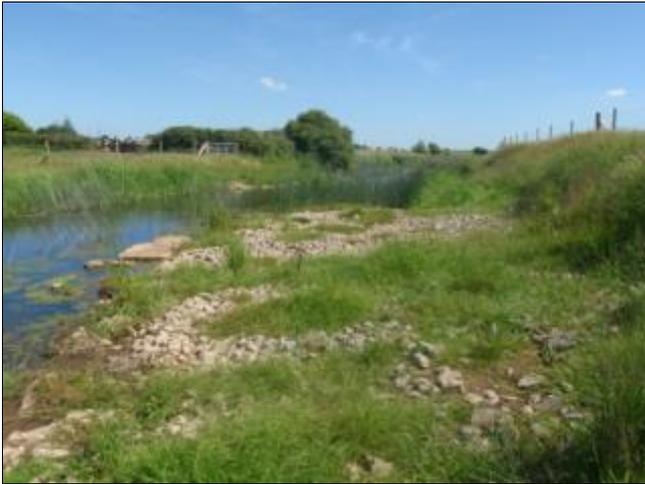
Plate 3.1: Deflector occupied by terrestrial grasses one year post works (2010).

Excessive vegetation removal, carried out by the external contractor hired by OPW in 2013, is the most likely cause of the reduction in crayfish numbers in the control site in 2014 (Plates 3.1 and 3.2). This control site can now not be considered a 'control site' any longer. Tall emergent vegetation is an important component of crayfish habitat in Ireland and its wholesale removal represents severe habitat degradation from a crayfish perspective. Removal of vegetation upstream and downstream of the experimental will have caused crayfish throughout the channel to migrate to the experimental where refuges were still available (Peay, 2003) despite increased silt loads. 78% of crayfish captured in the experimental works site were in the fyke net closest to the control site (>200m) as evidenced by the very large standard deviation (Figure 3.3).

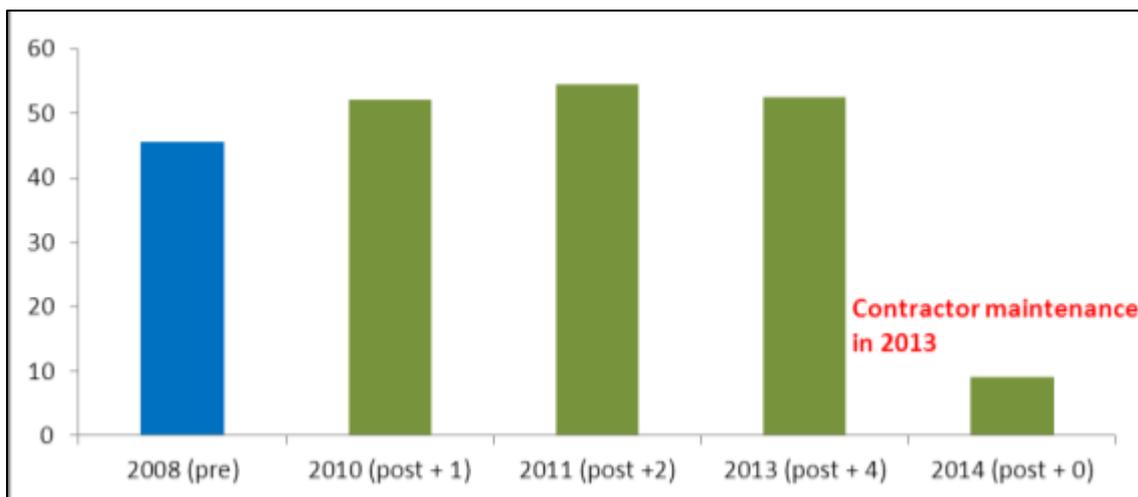
Figure 3.2: Tall emergent vegetation % cover pre and post works in the control site. Maintenance by the private contractor in 2013 occurred post the 2013 survey work. The experimental site was not maintained by the private contractor.

Prior to 2013, tall emergent vegetation cover remained relatively unchanged in the control site (Figure 3.2). In 2013 maintenance work on the Robe main channel was carried out by an external contractor hired by OPW (as part of a benchmarking exercise) and as part of their drainage operations the control site downstream of Sheepwash Bridge was maintained. The extent of this maintenance work resulted in an 85% decrease in tall emergent vegetation (Plate 3.2). This reduction in tall emergent vegetation is not consistent with OPW’s environmental protocol and has obvious adverse implications for other river biota including brown trout and crayfish. These are discussed below.

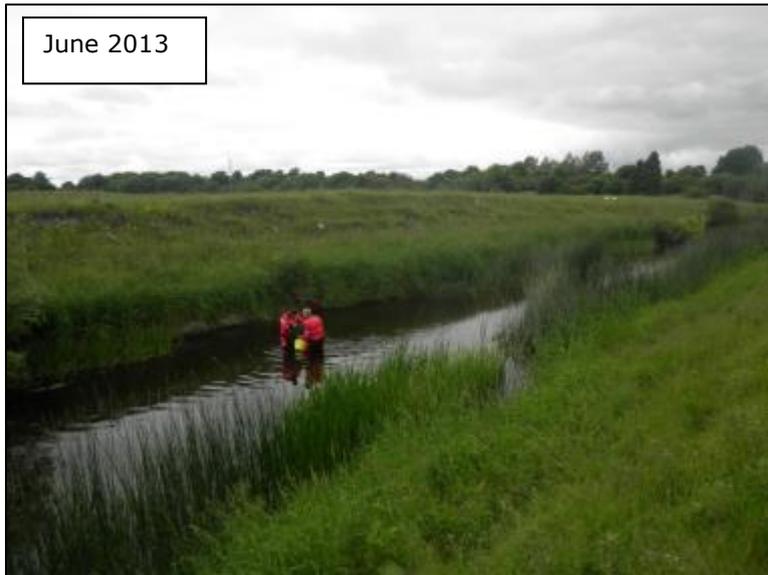
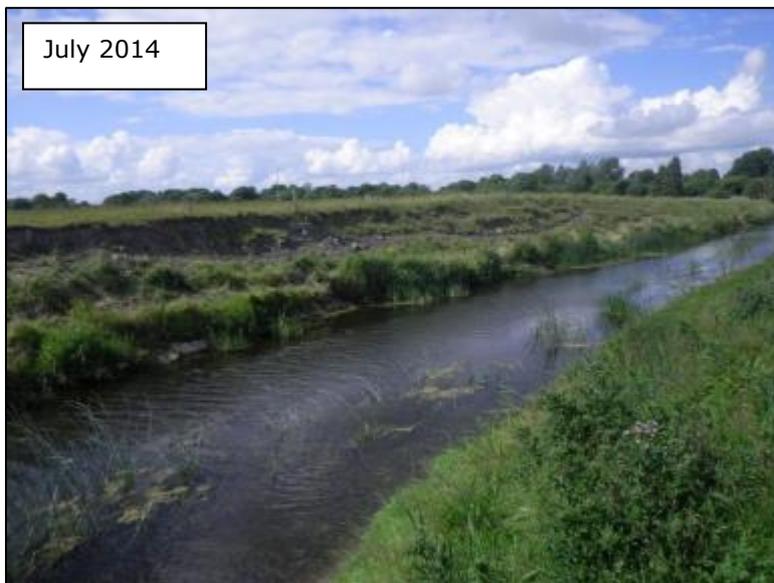
Plate 3.2: Robe control site pre works in 2013 (top) and post works in 2014 (bottom).

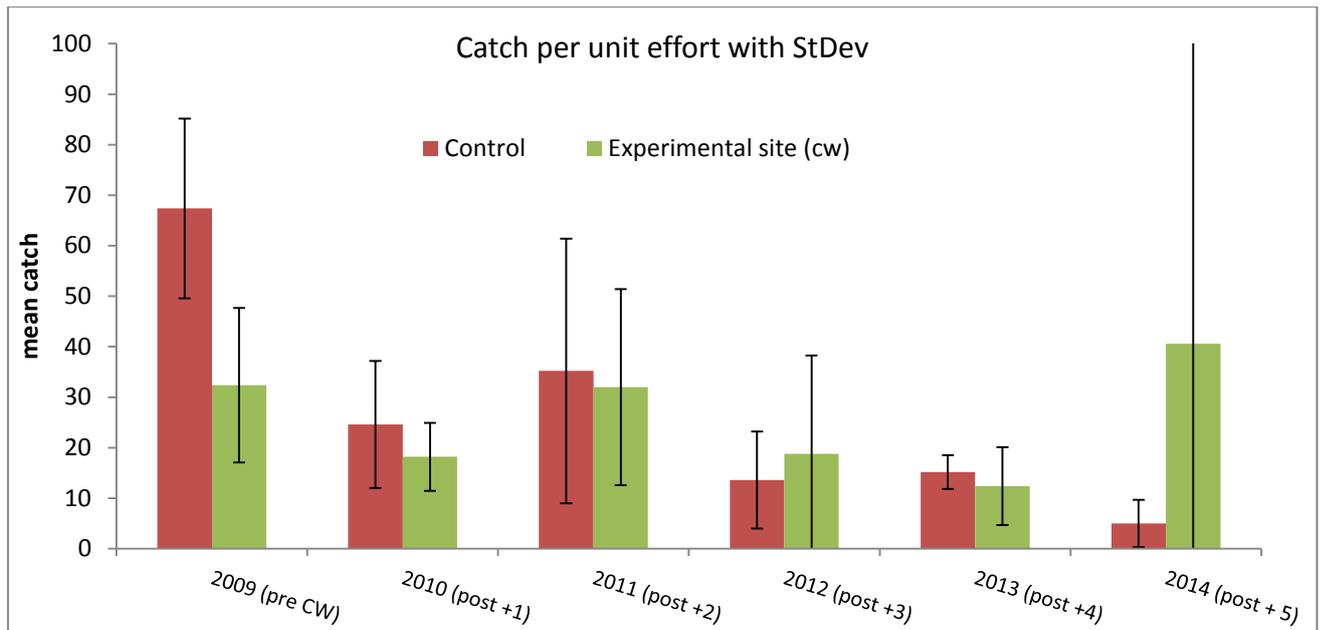
Figure 3.3: Mean crayfish catch per unit effort, 2009 -2014. Maintenance by the private contractor in 2013 occurred post the 2013 survey work. The experimental site was not maintained by the private contractor.

Following capital works in 2009, crayfish numbers in the experimental site showed no significant change in any subsequent years (Table 3.1 and Figure 3.3). In contrast, the control site experienced a significant decline (Table 3.1) in crayfish numbers one year post capital works in 2009 and post maintenance works in 2014. It is not clear why crayfish numbers declined so severely in the control site after works carried out within the experimental site in 2009. One possibility is from additional silt deposits that might have occurred during the instream work phase carried out within the experimental site which was immediately upstream of the control site. Some literature suggests that excessive siltation can have a negative impact on crayfish populations (Holdich, 2003). The increased

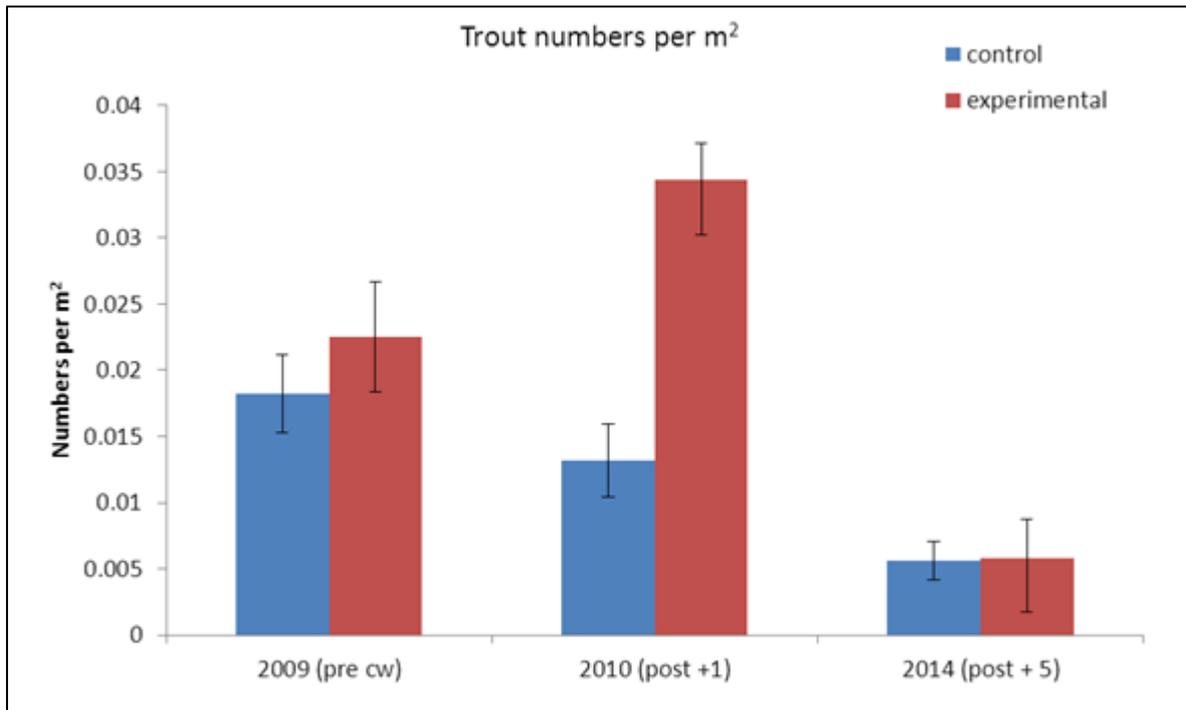
Figure 3.4. Brown trout numbers per m² in the Robe R. experimental and control sites in 2009, 2010 and 2014. Maintenance by the private contractor occurred in 2013. The experimental site was not maintained by the private contractor.

In common with crayfish in the control site, brown trout numbers were substantially reduced post maintenance works in 2014. This was also the case in the experimental site which experienced a more pronounced decrease (Figure 3.4). Similar to the crayfish results, habitat loss is the most likely explanation for the decrease in trout. The 2013 maintenance works consisted of maintaining 9km of the Robe main channel and 6km of a major tributary. Trout use aquatic vegetation for cover and as feeding areas. The removal of significant lengths of tall emergent vegetation over an extended area (approx. 16km) represents a severe degradation of riverine habitat and a very visible and serious departure from enhanced maintenance protocols.

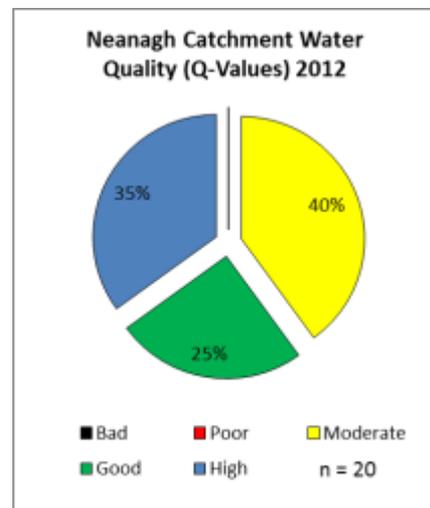
Figure 3.5. Results from EPA Q-Value macro-invertebrate monitoring sites in the Nenagh Catchment.

60% of the EPA (Q-Value) water monitoring sites in the Nenagh catchment are meeting WFD requirements (Figure 3.5). There are no poor/bad Q-value sites in this catchment. The “moderate” sites recorded in this catchment are scoring Q3-4 which is still within the biological limits for salmonid enhancement. However, if this “moderate” water quality decreases from Q3-4 to Q3 water quality will threaten the salmon population. No salmon were recorded in the upper reaches of the Ollatrim River where water quality has only recently improved from a Q3 to a Q3-4.

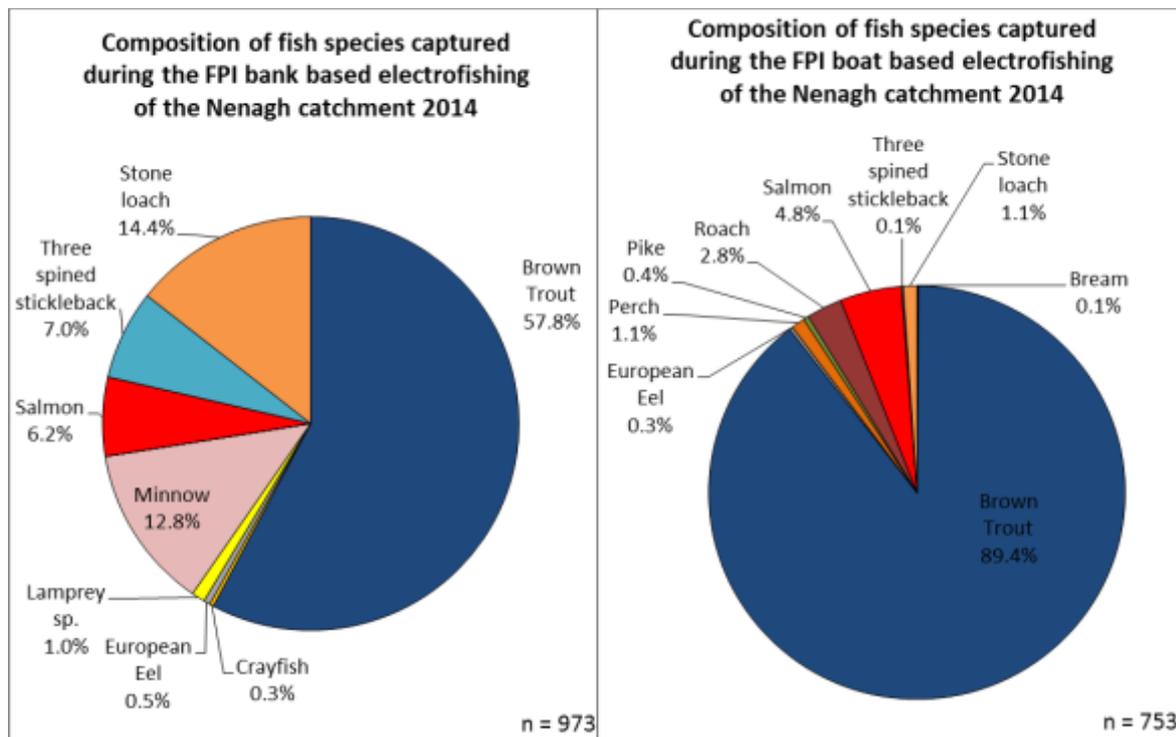
Figure 3.6. Composition of fish species captured in the Nenagh Catchment FPI survey using boat and bank electrofishing equipment.

The fish community in the Nenagh catchment is dominated by trout (Figure 3.6). Trout were present at all sites surveyed (Figure 3.7). Salmon (*Salmo salar*) were only present in the Nenagh, Ollatrim and

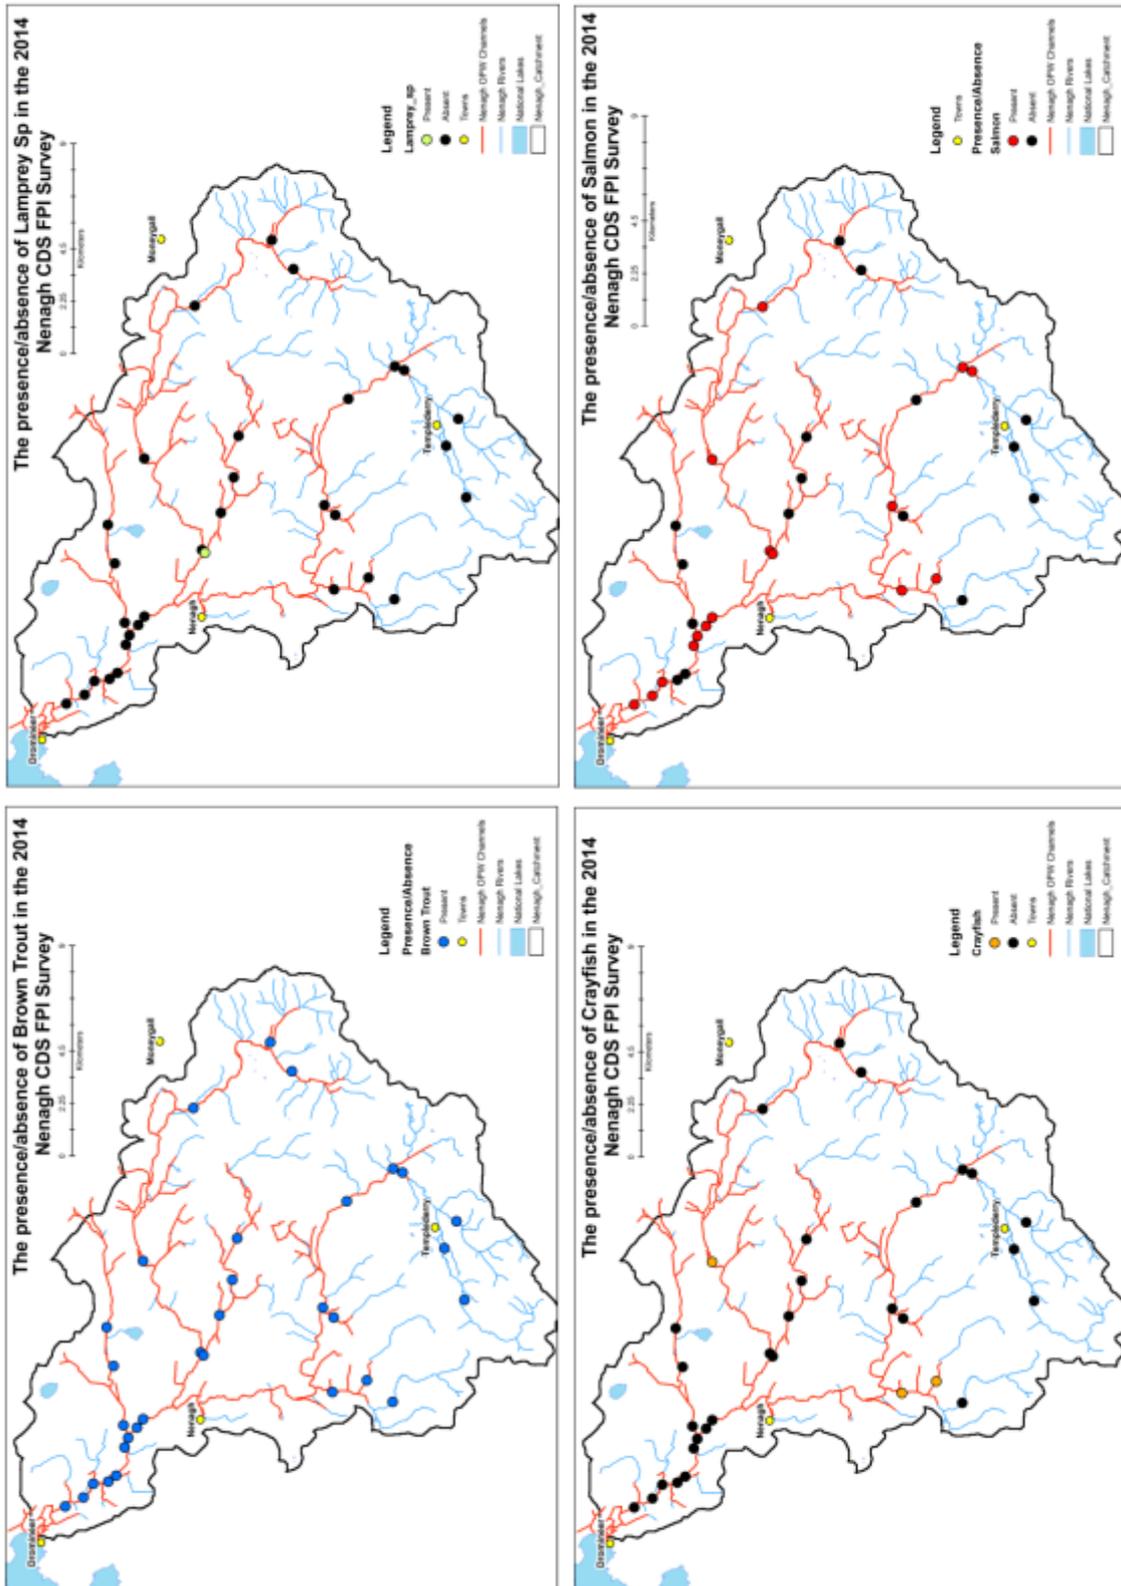
Figure 3.7. Presence / absence of brown trout, salmon, crayfish and lamprey sp. captured during the 2014 Nenagh FPI survey.

Dolla rivers and not in large numbers (Figure 3.7). Total number of salmon captured in the FPI Nenagh Survey from both boat and bank was 96, compared to the trout total of 1235.

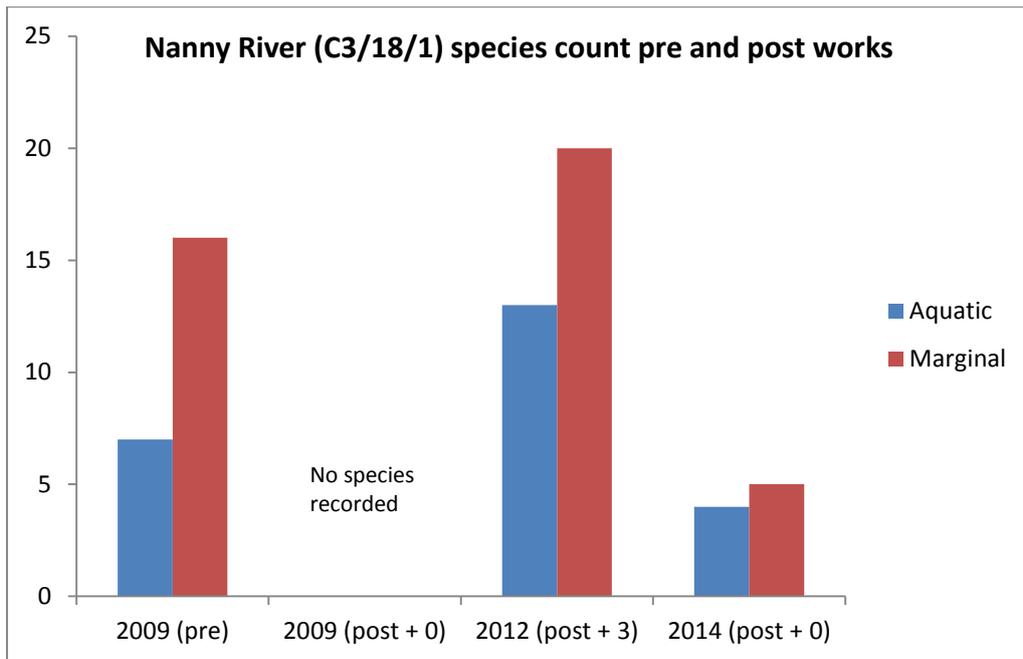
Figure 3.8: Channel species diversity pre and post works.

The 2012 botanical survey results indicated that the marginal and instream flora was recovering 3 years post maintenance (2009) (Figure 3.8) and channel flow/form was improving as a result. Vegetation removal and de-silting was undertaken again between 2013 and 2014. In 2014, a follow up survey of the channel flora demonstrated a substantial decline in plant diversity post works. Furthermore, survey results indicate that spoil spreading on the banktop is changing the plant assemblages from wet grassland species to dry grassland species, by raising the local topography along the machine access corridor at the top of the bank.

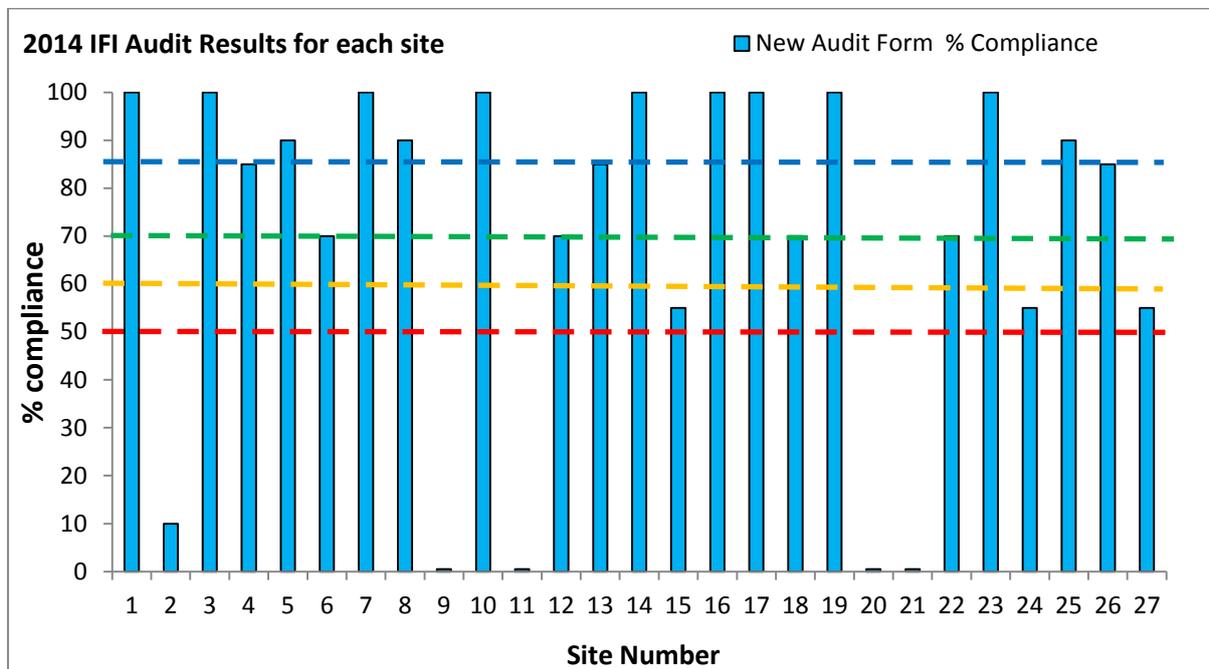
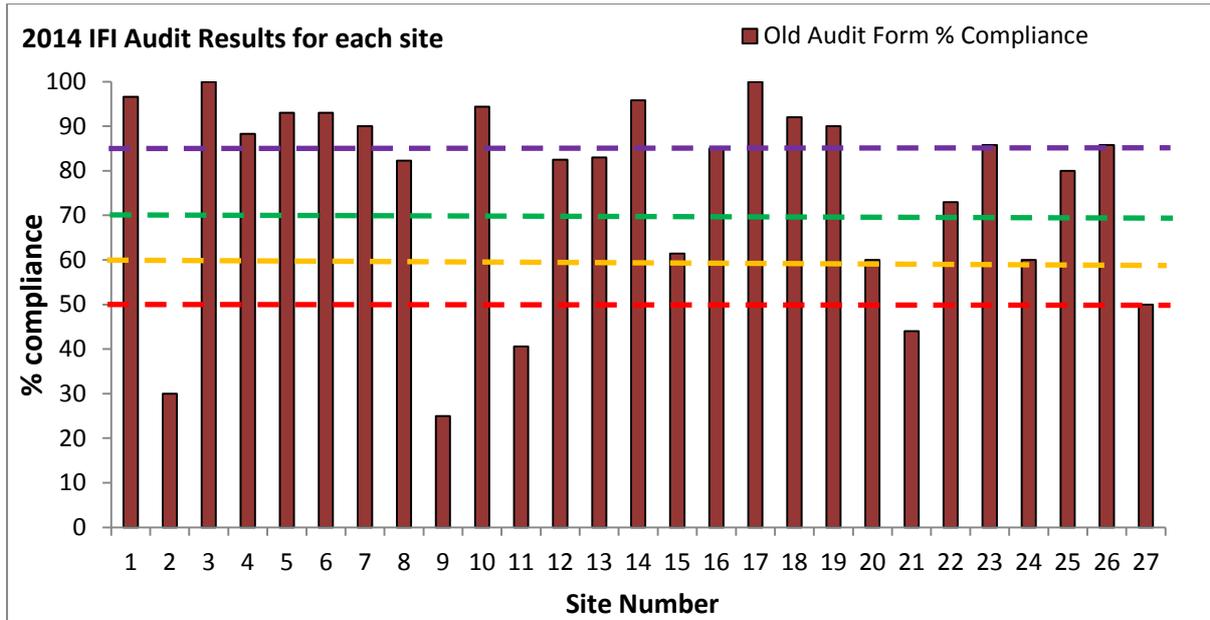
Figure 4.1. IFI 2014 Audit Results (based on both old form and new form).

For comparison, both the new and old audit form were completed during each audit visit in 2014. The old and new form proved to be very comparable, with 76% and 68% of drivers falling into the acceptable /or higher scoring categories respectively (Tables 4.4 & 4.5 and Figure 4.1). Similarly, 24% and 32% of drivers failed to achieve a score of acceptable or higher based on the old and new form respectively (Tables 4.4 & 4.5 and Figure 4.1).

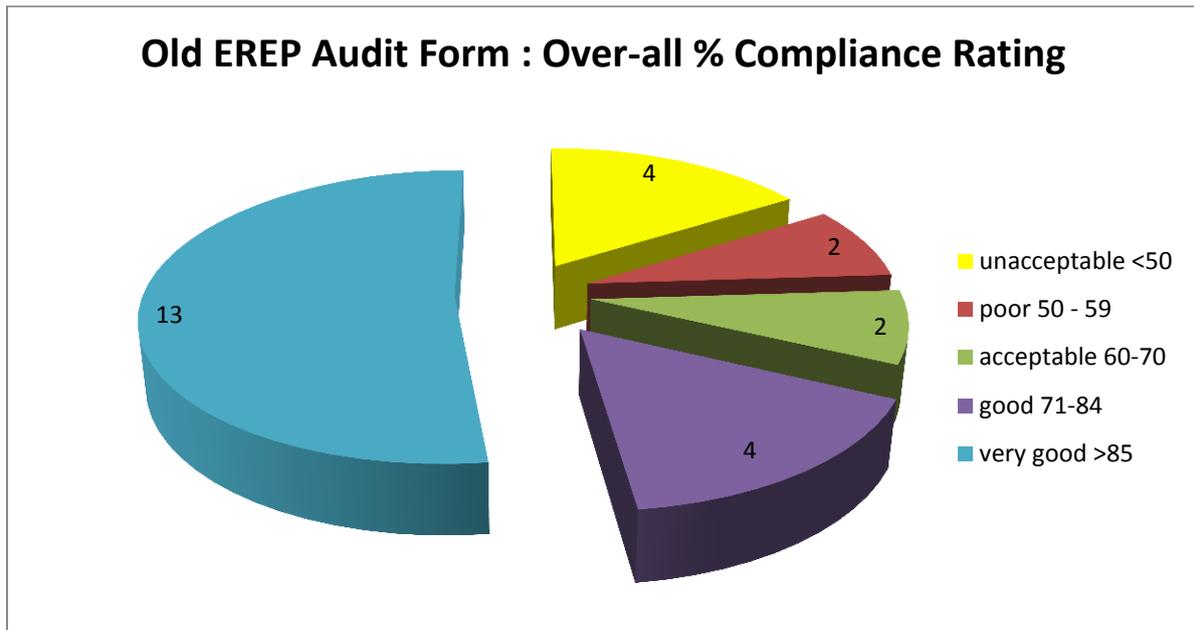
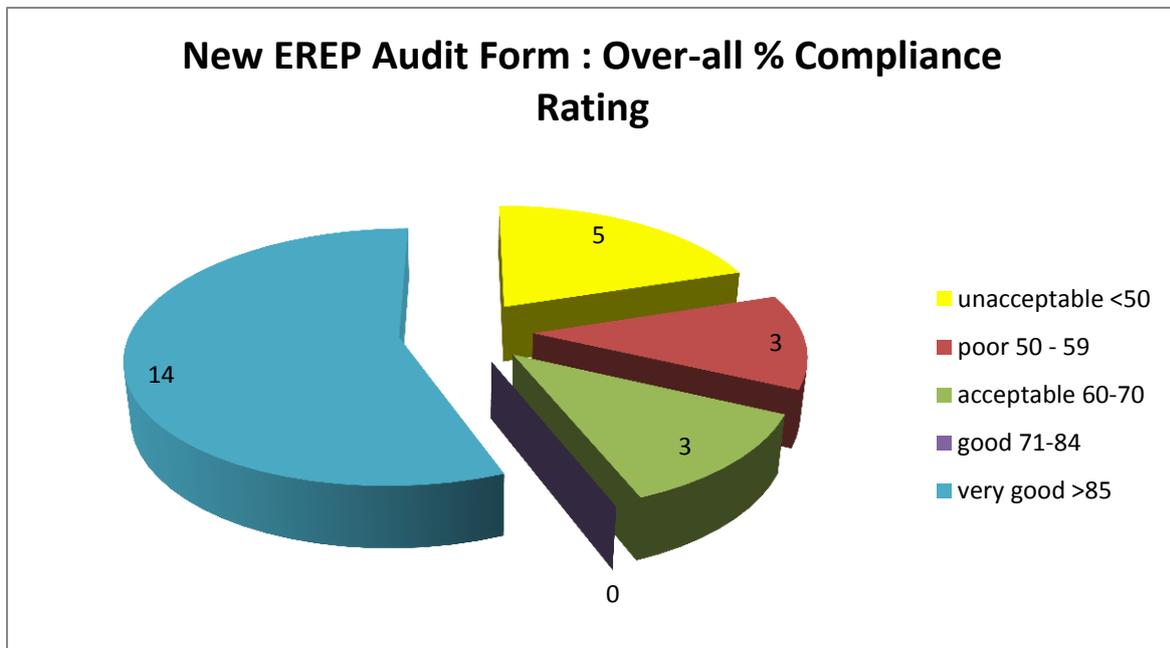
Figure 4.2. Comparison of EREP audit results based on the old and new form % compliance.

A comparison of the over-all % compliance rating from all audits is presented below (Figure 4.2). These results indicate a good similarity between the two scoring system. However the new form elaborates out each of the 10 steps in more detail which provides more useful information back to OPW on the performance of their drivers to in relation to environmental maintenance. It should help identify areas for improvement as well as promote areas where OPW are doing well.

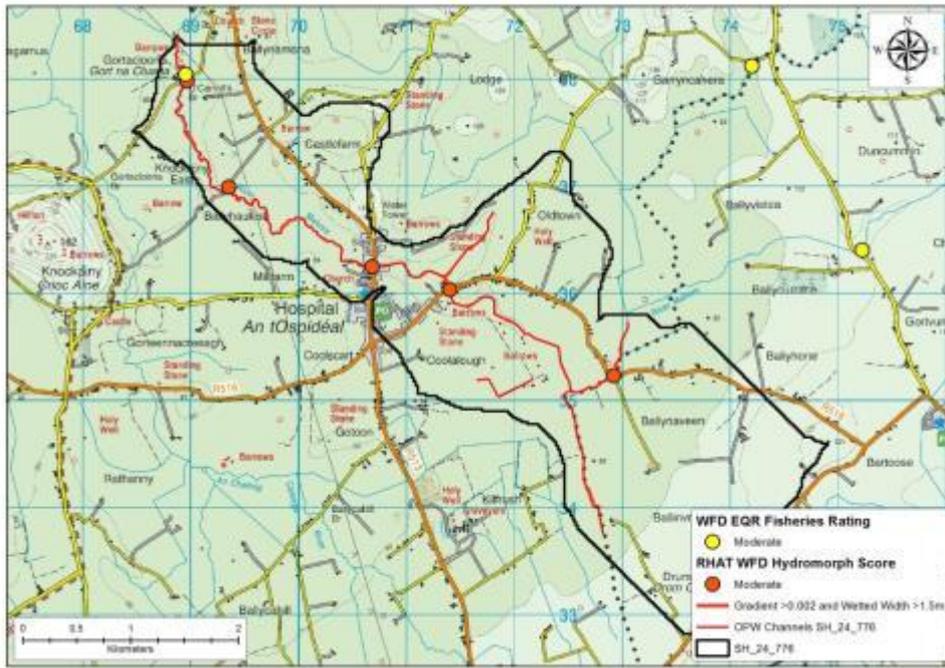
Figure 1. WFD EQR Fish rating and RHAT Scores for sub basin SH_24_776

5 River Hydromorphology Assessment Technique (RHAT) scores were taken in SH_24_776 (Figure 1) all were classed as moderate.

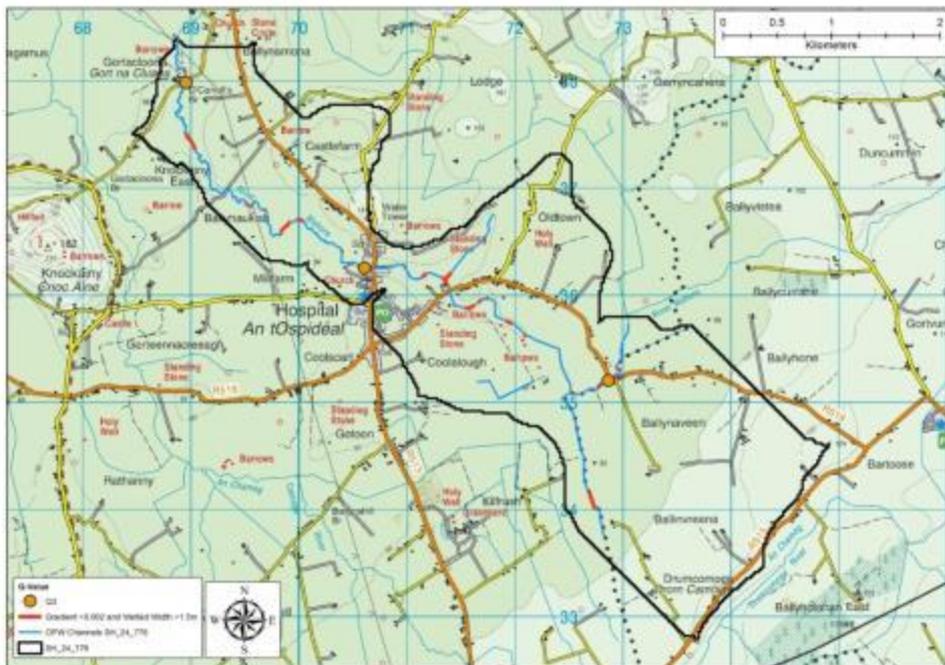
Figure 2. EPA Q-Values for sub basin SH_24_776

Possible Capital works locations (Gradient > 0.002 and wetted width >1.5m) are isolated and scattered throughout the waterbody. Poor water quality would not give value for money in terms of capital works investment for salmon (Figure 2, EPA Q-Value Q3). This water body would be more suited to enhanced maintenance works.

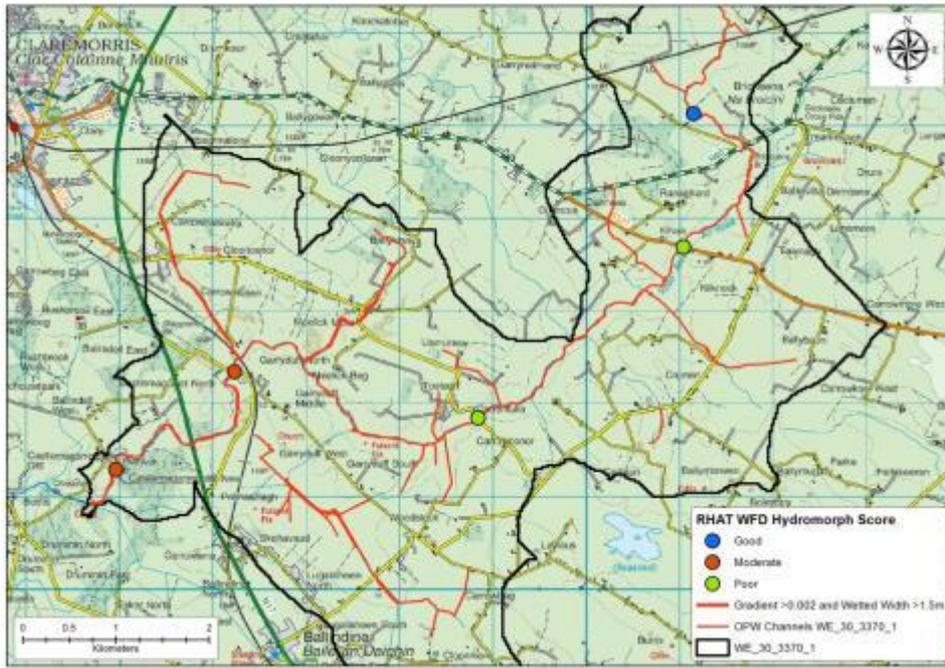
Figure3. RHAT Scores for sub basin WE_30_3370_1

5 River Hydromorphology Assessment Technique (RHAT) scores were taken in WE_30_3370_1 (Figure 3) one was good, two were moderate and two were poor. The site classified as good had river enhancement works done under the Tourist Angling Measure (TAM) in the mid 90's.

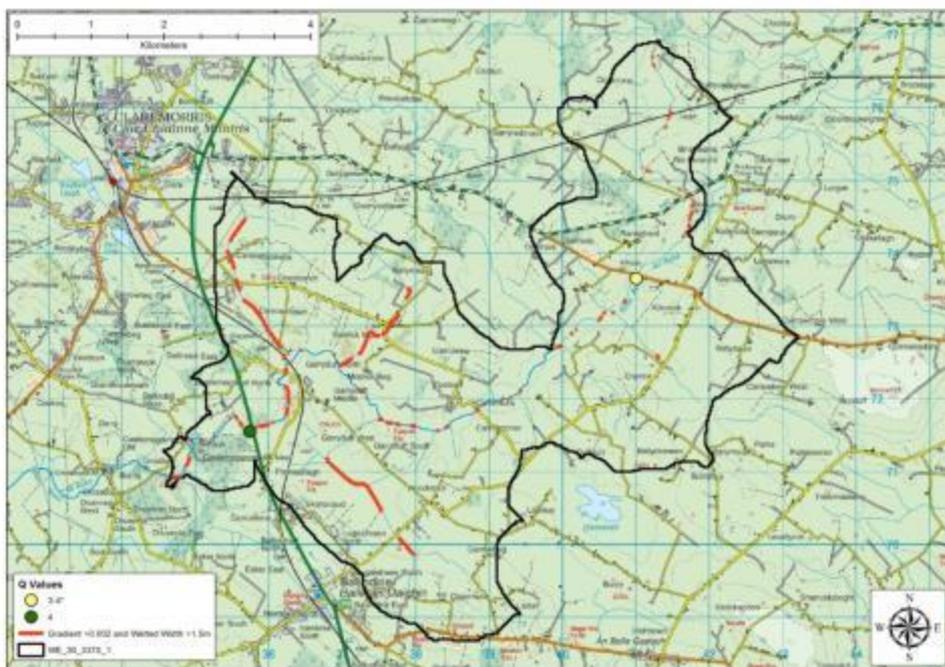
Figure 4. EPA Q-Value Ratings for sub basin WE_30_3370_1

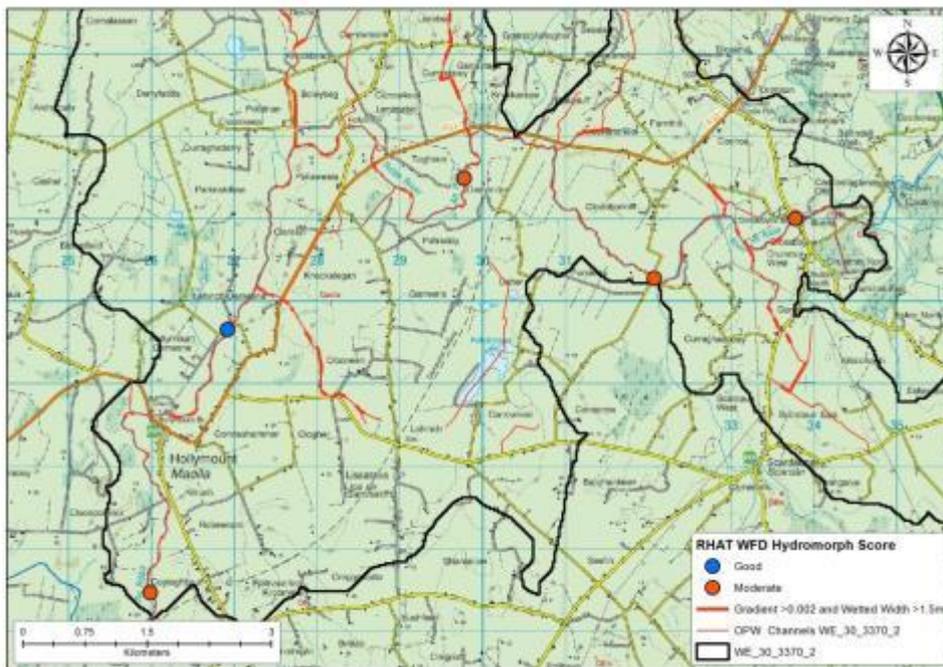
Figure 5. RHAT Scores for sub basin WE_30_3370_2

5 River Hydromorphology Assessment Technique (RHAT) scores were taken in WE_30_3370_2 (Figure 5) four were classed as moderate one as good. The site classified as good had river enhancement works done under TAM in the mid 90's and in 2014 had fresh gravels added.

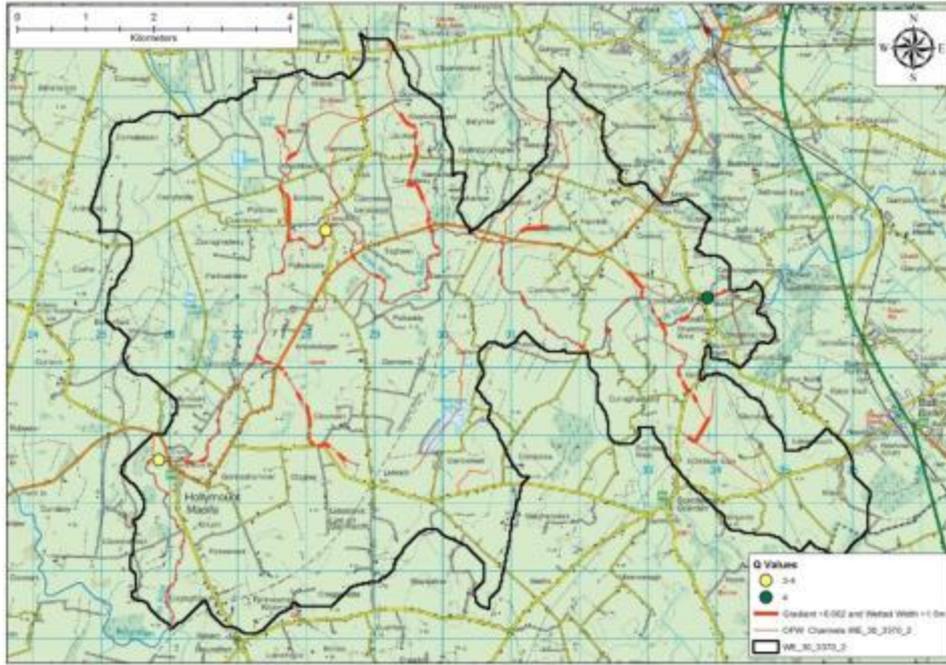
Figure 6. EPA Q-Value Ratings for sub basin WE_30_3370_2

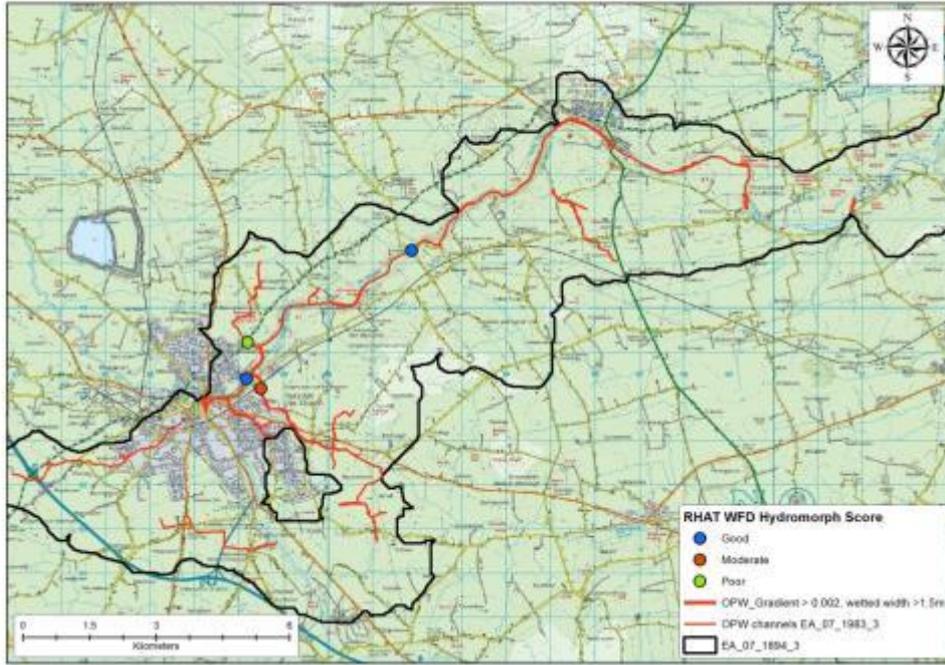
Figure 7. RHAT Scores for sub basin EA_07_1894_3

4 River Hydromorphology Assessment Technique (RHAT) scores were taken in EA_07_1894_3 (Figure 7) two were good, one was moderate and one was poor.

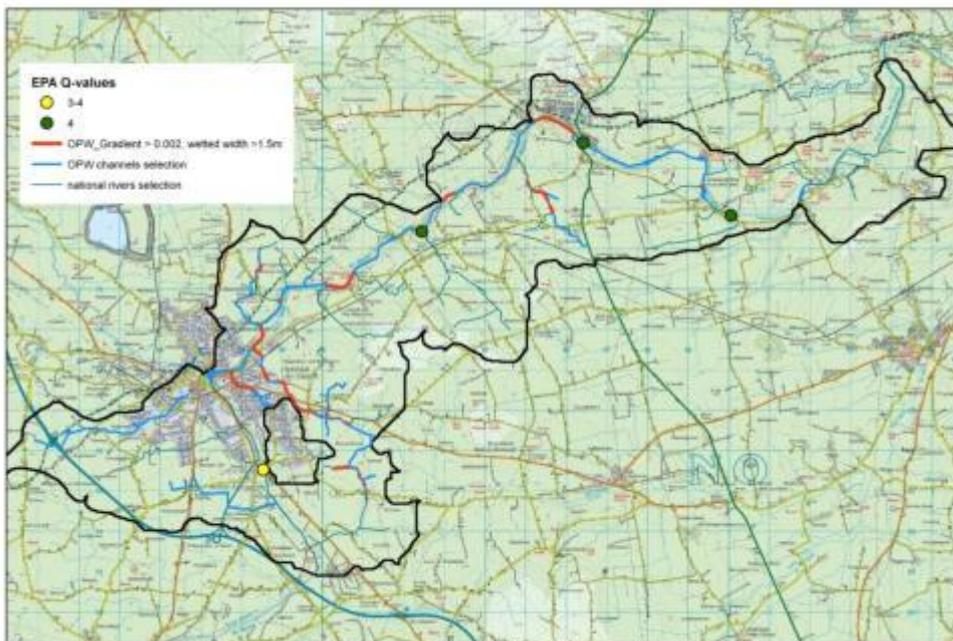
Figure 8. EPA Q-Value Ratings for sub basin EA_07_1894_3

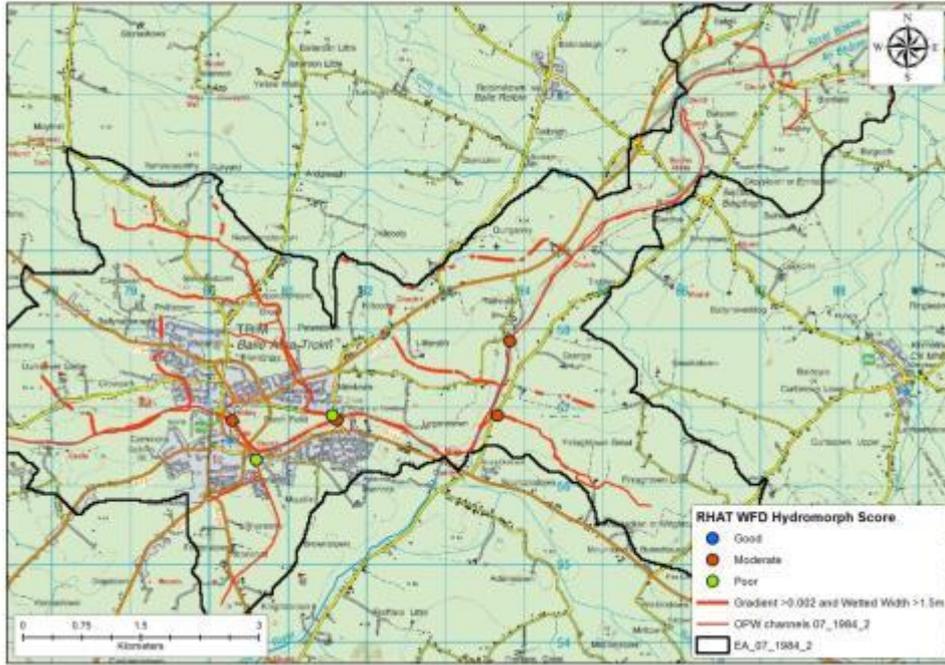
Figure 9. RHAT Scores for sub basin EA_07_1894_2

6 River Hydromorphology Assessment Technique (RHAT) scores were taken in EA_07_1894_2 (Figure 9) four were moderate and two were poor.

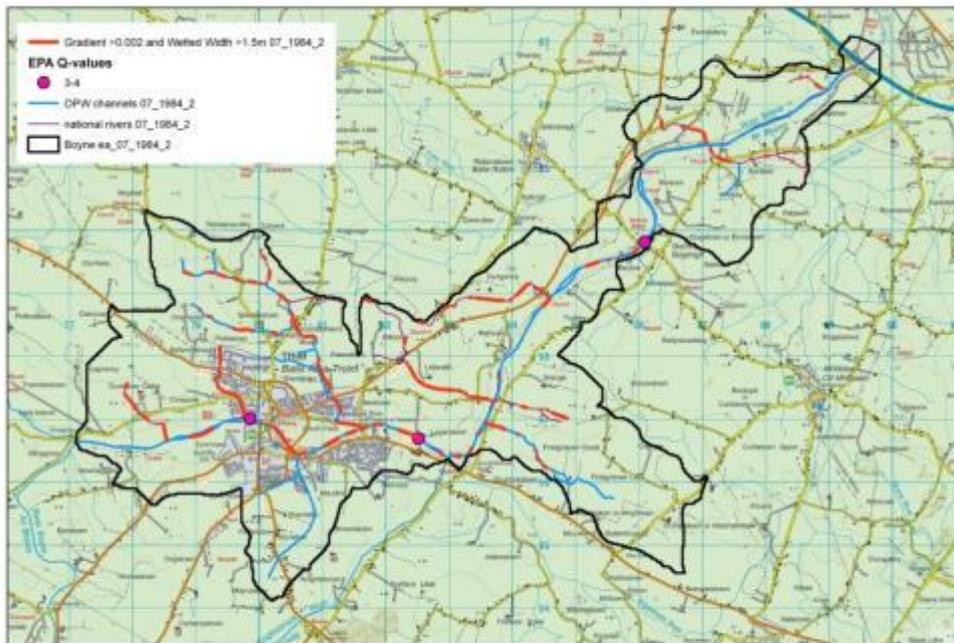
Figure 10. EPA Q-Value Ratings for sub basin EA_07_1894_2

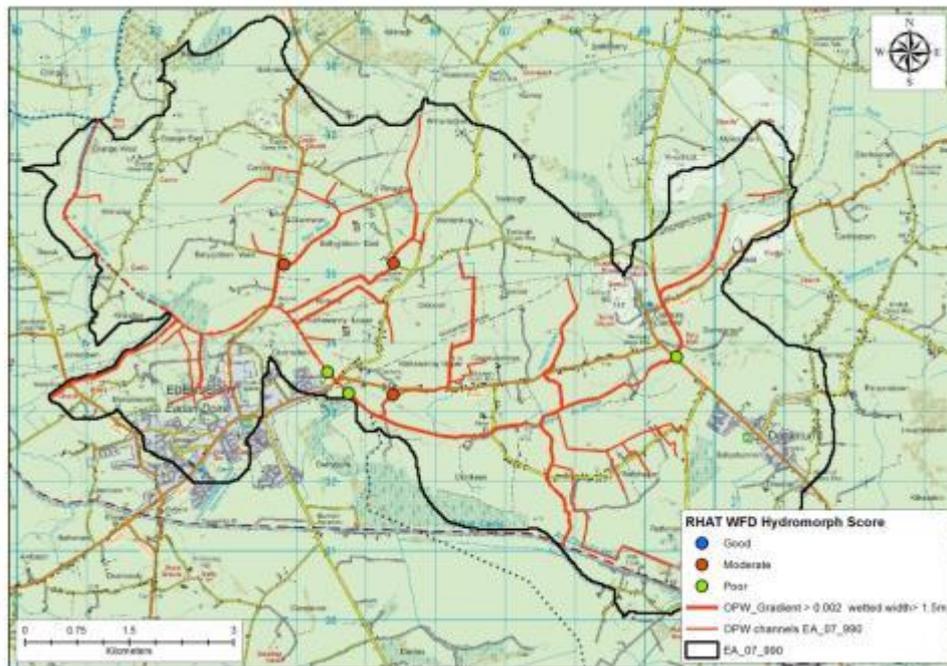
Figure 11. RHAT Scores for sub basin EA_07_990

5 River Hydromorphology Assessment Technique (RHAT) scores were taken in EA_07_990 (Figure 11) three were moderate and two were poor.

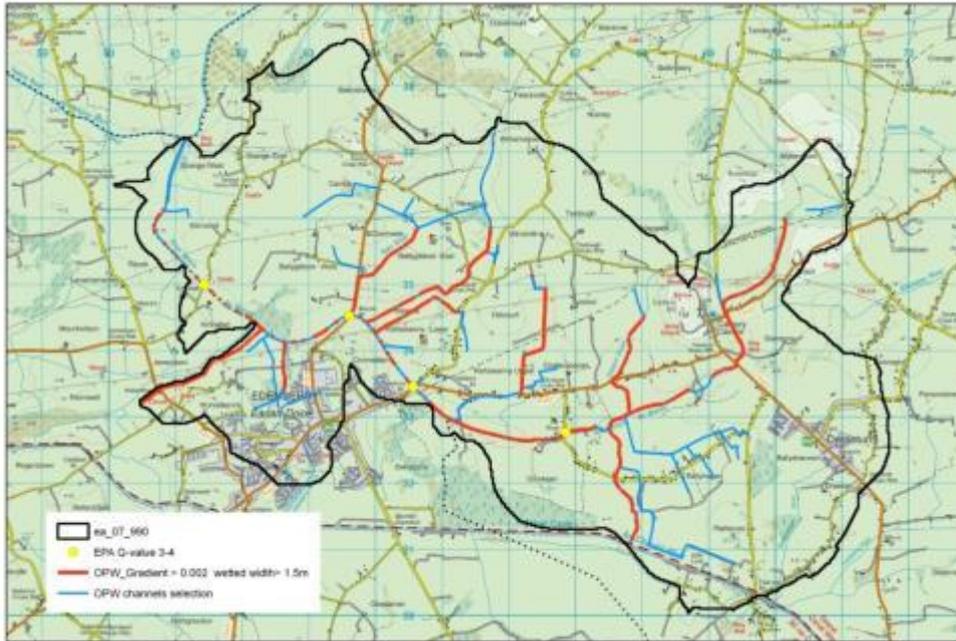
Figure 12. EPA Q-Value Ratings for sub basin EA_07_990
