IFI/2015/1-4261

Post-Trial Dredge Report Hot-water Section Lanesborough August 2015

Asian Clam abundance survey (post dredging) Lanesborough, Co. Longford On Behalf of Inland Fisheries Ireland

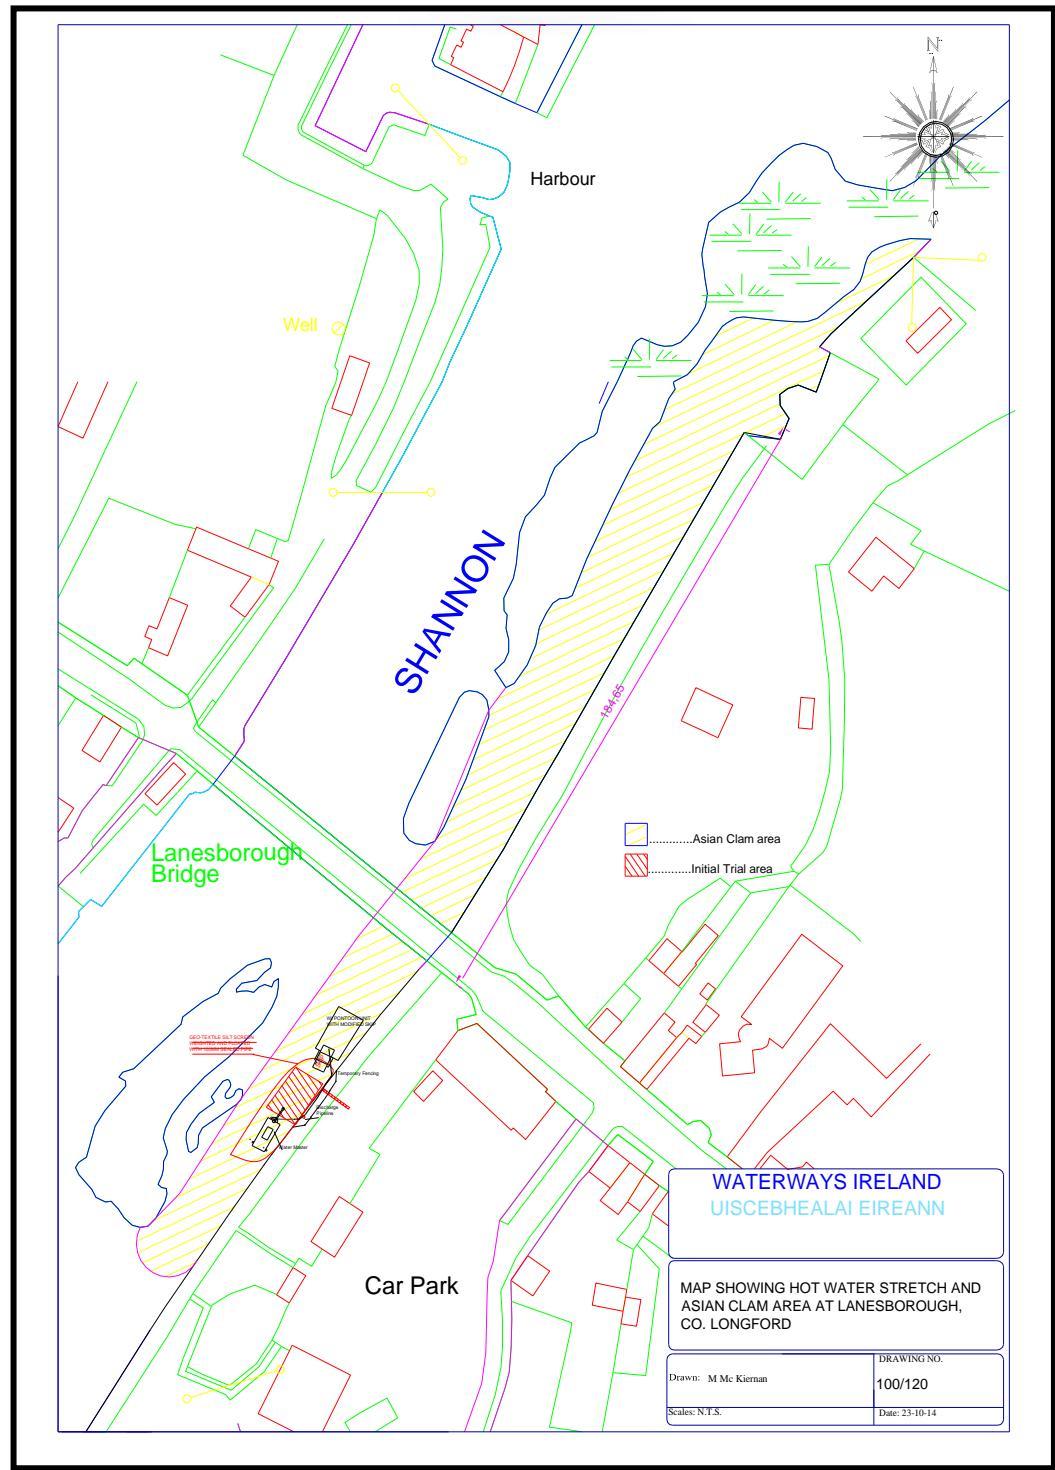
The method proposed was to suction dredge the clams at the location shown hatched in red in Figure 1. A silt screen (Geotextile curtain) was placed around the area. The screen was weighted on the bed of the river by re-bars attached to the screen and was buoyant on the surface of the water. The individual units of the silt curtain were overlapped and stitched together with cable ties. The Watermaster dredger (Figure 2) operated inside the silt curtain. The Watermaster dredger consists of a cutter head attached to a hydraulic arm that rotates on the bed of the river. The dredger is retained in position by spud legs that are attached to the dredger and hydraulically sunk into the river bed. From the cutter head the material is pumped through a flexible pipe system to a discharge point, in this case a skip that allowed the settlement and retention of the dredged material but also allowed the water to drain away.

Figure 1: Trial Area downstream of Lanesborough Bridge marked in red.

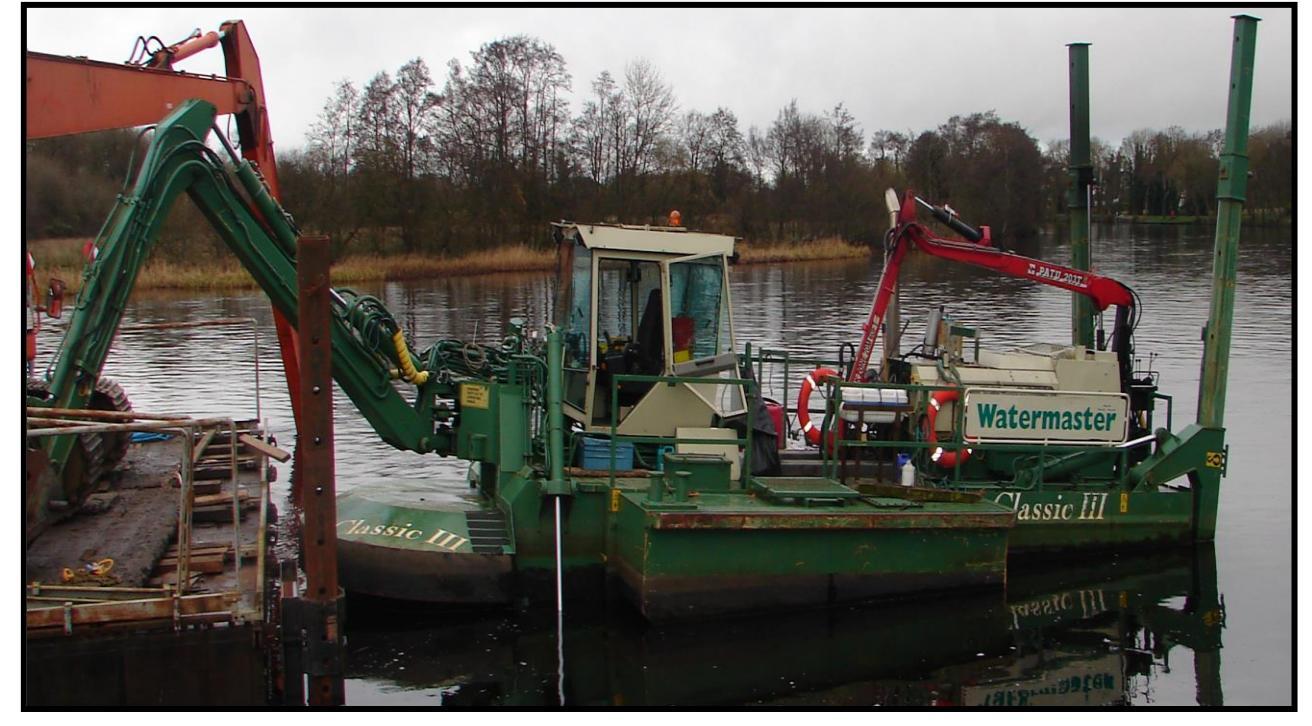
Figure 2: Watermaster suction dredge machinery used during the trial.

- The cutting head of the suction dredger would require alterations to reduce the stone and pebble content of the samples. The bars at the cutting head are currently spaced at 40mm and WI would reduce this to 30mm. The suction area at the cutting head is currently set at 180 degrees and to improve suction WI would amend this area to 360 degrees. This could improve the efficiency of dredging this type of material and reduce the costs.
- 2) The holding tank would have to be modified to allow removal of the sample from the tank. Due to the restrictions of the existing tank this process was carried out manually and the sample removed to cubic metre bags.

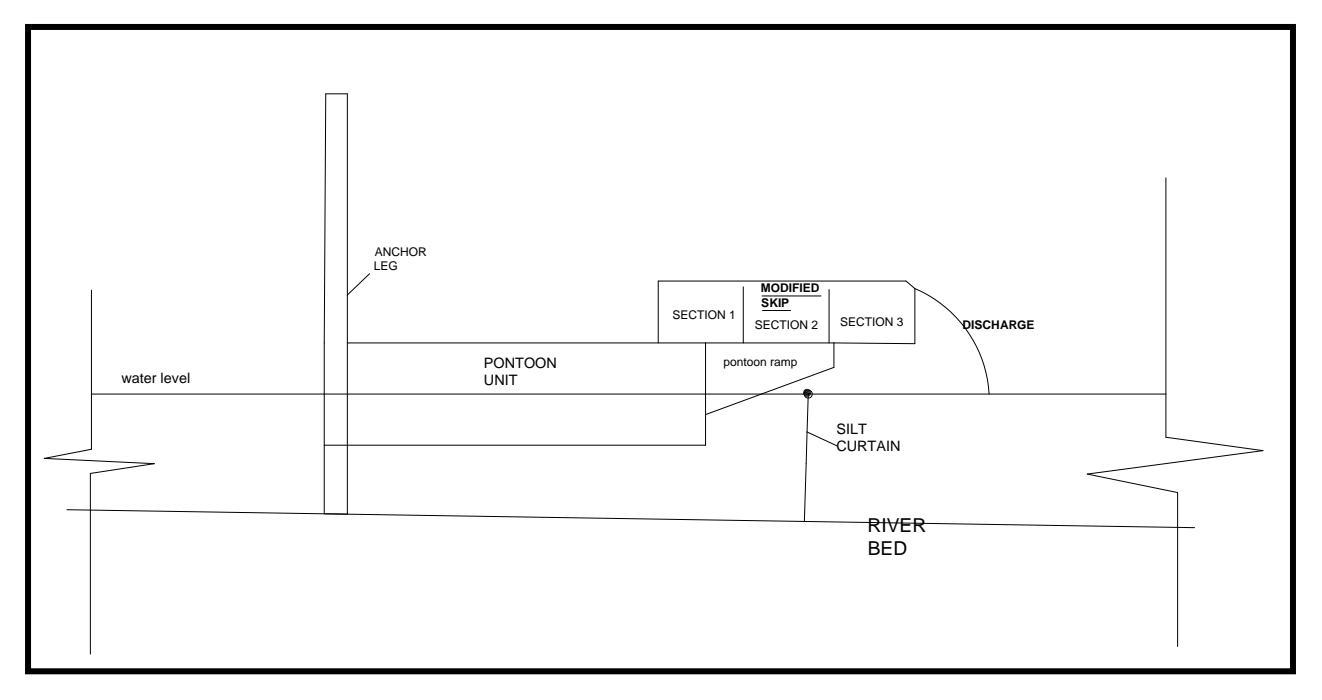
The skip was placed on a set of pontoons overlapping the silt curtain (Figure 3) and any residual liquid returned directly inside the silt curtain area. The operation took 2 days to set up and 1 day operating in the area.

Figure 3: Skip placement on pontoons within the silt curtain area for discharge.

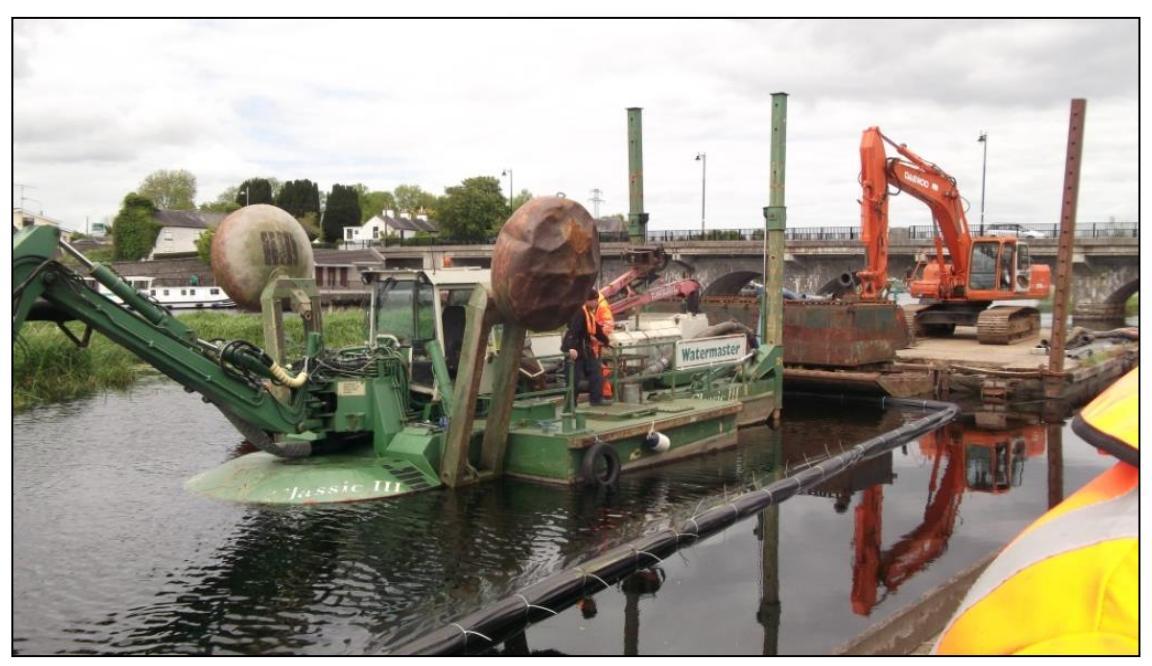
Figure 4: Full set up for trial operation.

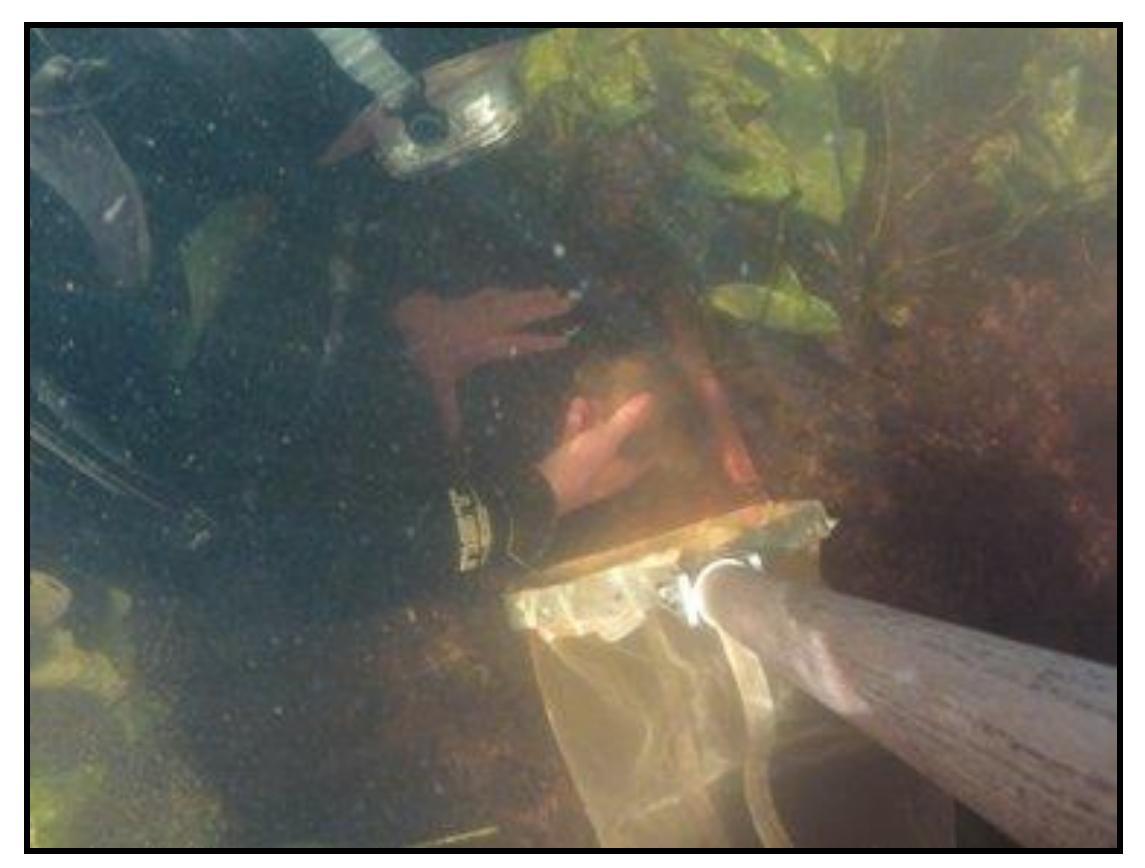
Figure 5: Sample collection technique

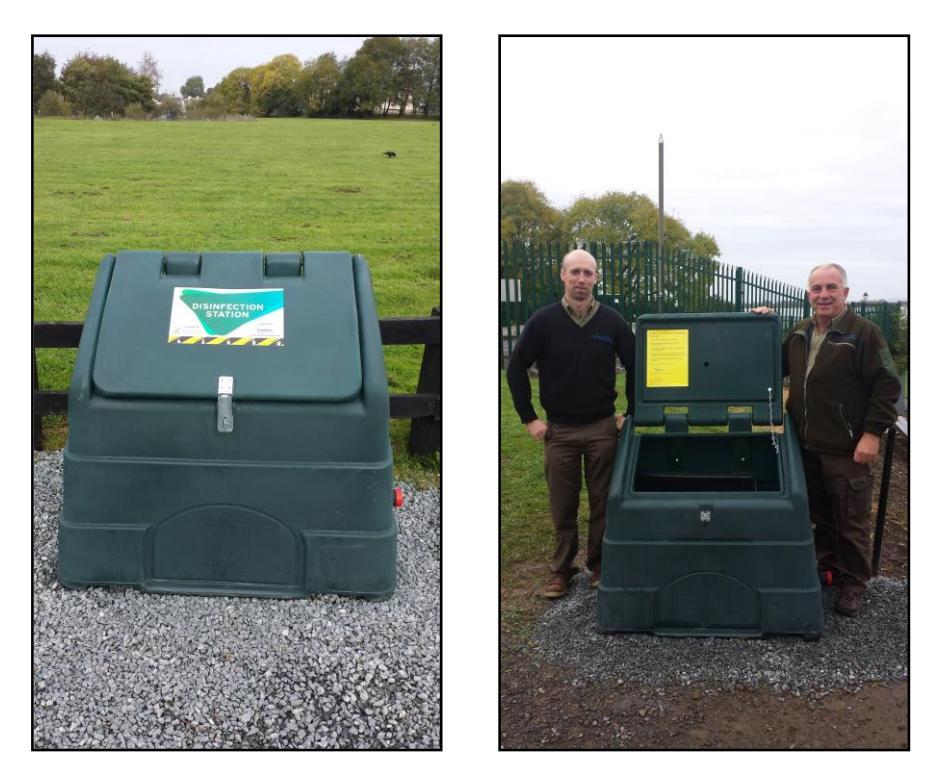
Inland Fisheries Ireland, with funding support from the ESB, installed four disinfection stations for the area in key angling and boating locations. A disinfection unit was placed upstream and downstream of the Lanesborough Bridge, one at the boat slip on the Lanesborough access point and one unit placed on the angling section of the Ballyleague river bank. Appropriate signage was erected on the use of the units which were managed by local representatives and IFI staff.

Figure 6 and 7: Disinfection Units installed in Lanesborough and Ballyleague.

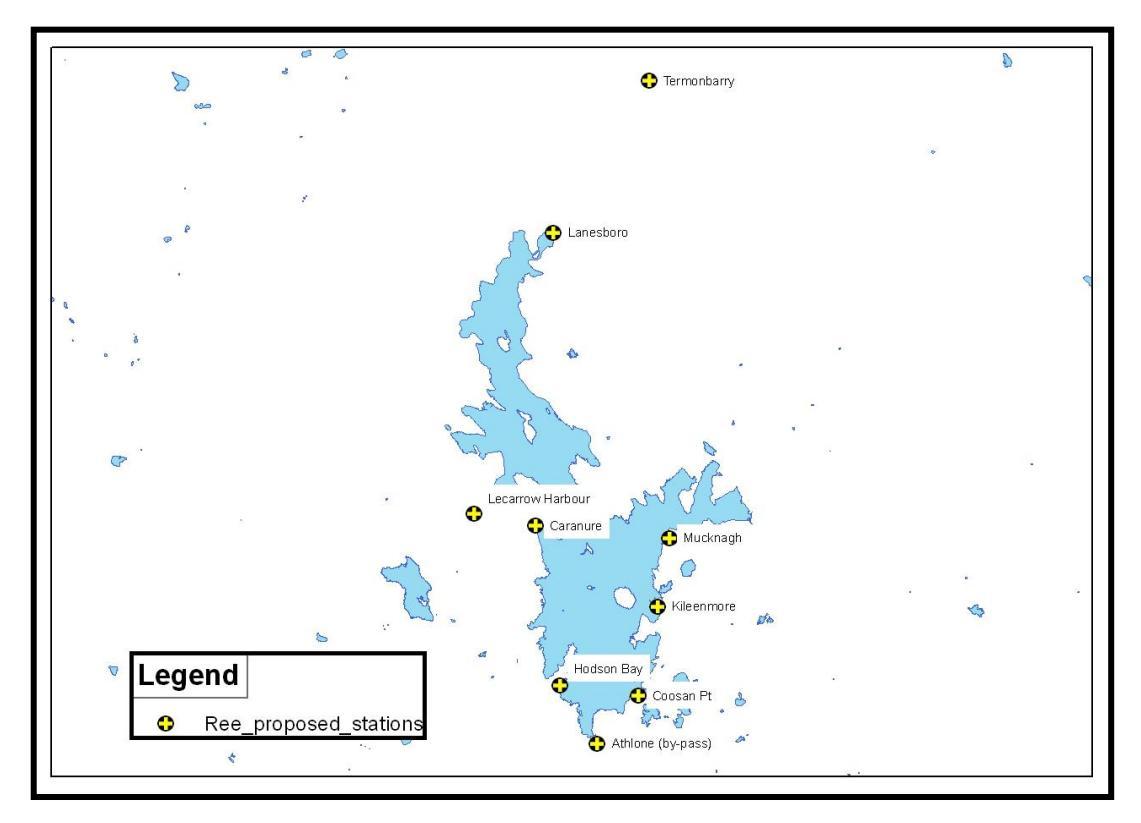
A plan was developed, in conjunction with various angling clubs around Lough Ree and the catchment, identifying key potential sites for the installation of disinfection station locations at angling club boat access points. These measures are primarily to prevent anglers and other boat users from spreading the clam from the Shannon to other catchments. These disinfection units would ideally be purchased by angling clubs and all anglers would be required to disinfect their angling equipment, trailers and engines on departure from the Shannon catchment. Angling clubs were also keen to appoint members as 'invasive officers' to ensure that biosecurity protocols were being implemented rigidly.

Figure 8: Proposed disinfection station locations around Lough Ree.

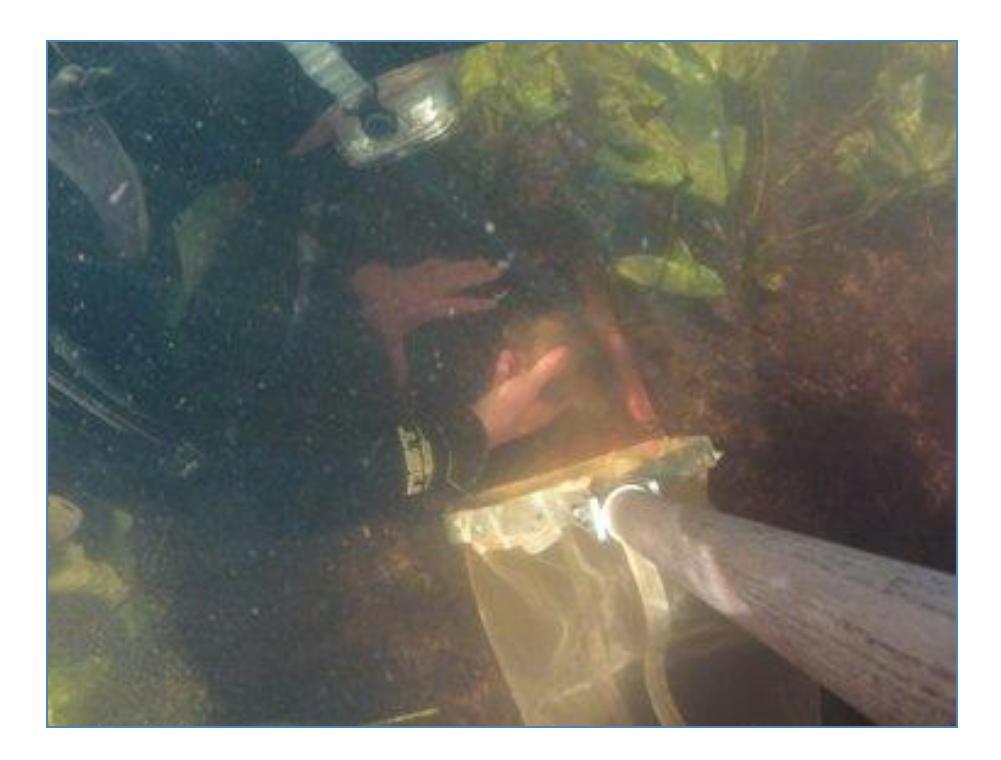
Surber samples enabled the quantitative assessment of Asian clam density (per m^2) in the trial dredged zone and adjacent un-dredged zone. 10 no. random $0.25m^2$ quadrate samples were collected using environmental divers. A $0.25m^2$ quadrat was placed on the surface, a mesh net was placed beside the quadrat, surface and subsurface sediment was collected from the quadrate and stored in the mesh bag for subsequent analysis (Fig 1.). Each sample was labelled and placed in individual bags, washed through 16 mm² sieve and the remaining contents were carefully examined for the presence of clams. Counts were made of the number of Asian clams present in each sample and these were averaged.

Plate 1. Sample collection technique

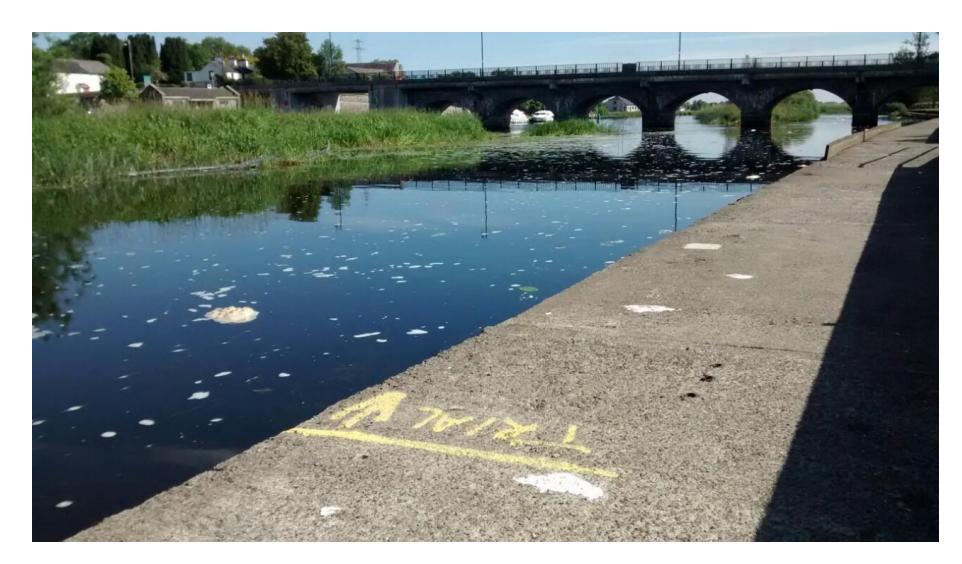
The trial dredged area measured approximately of 15 metres x 15 metres. The trial zone was demarcated in yellow at the start and finish point on the pier wall (Fig 2.).

Plate 2. Demarcated trial area.

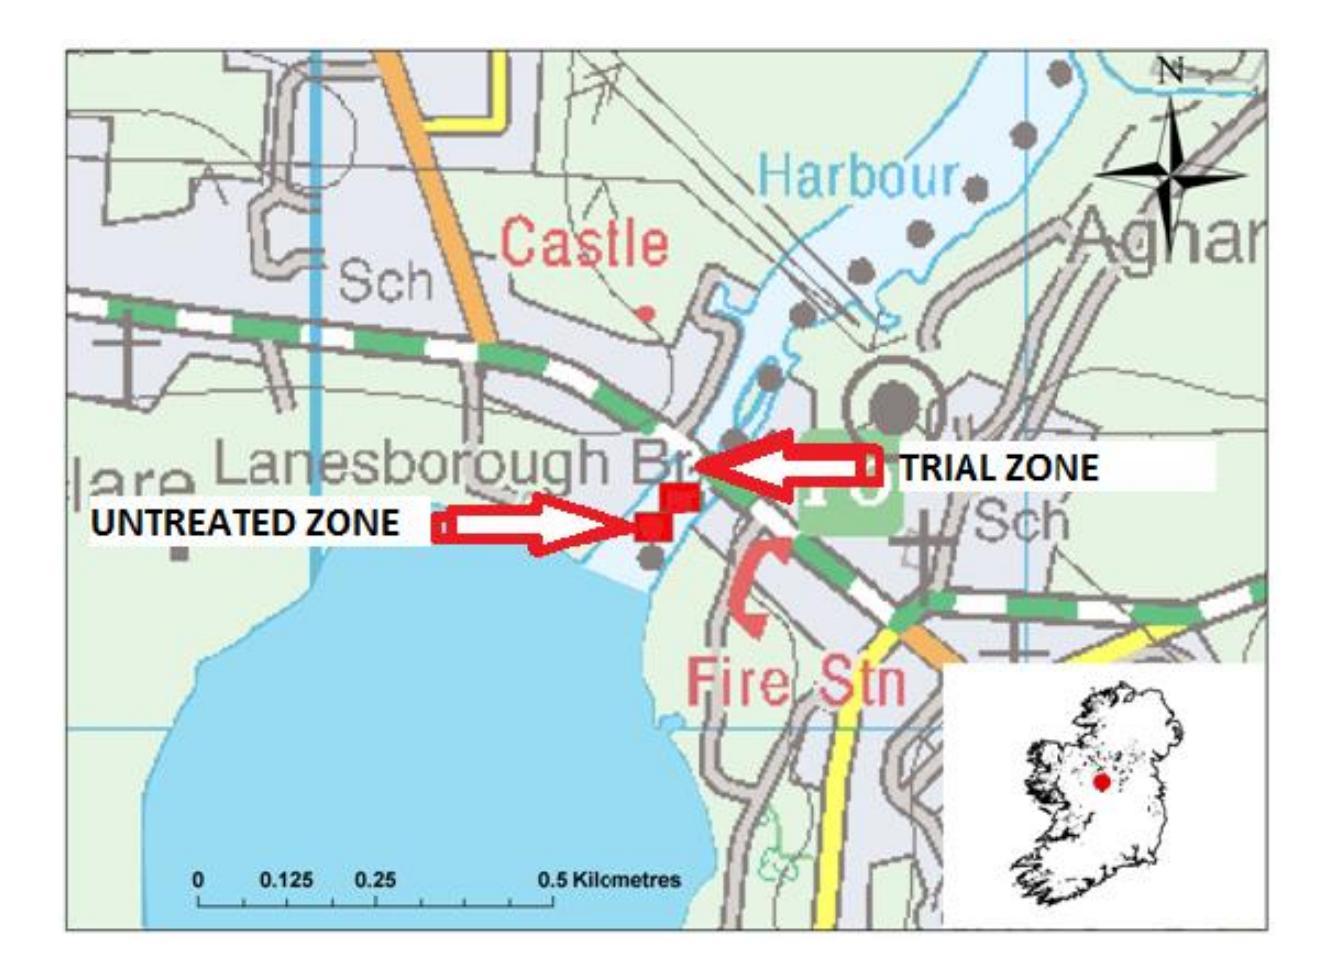
The Environmental dive team worked within the trial area, and 10 metres downstream in the adjacent un-treated zone. These areas lay in the hotwater stretch where large abundances of Asian clams were detected in the 2014 survey.

Figure 1.Survey area, Lanesborough, Co. Longford

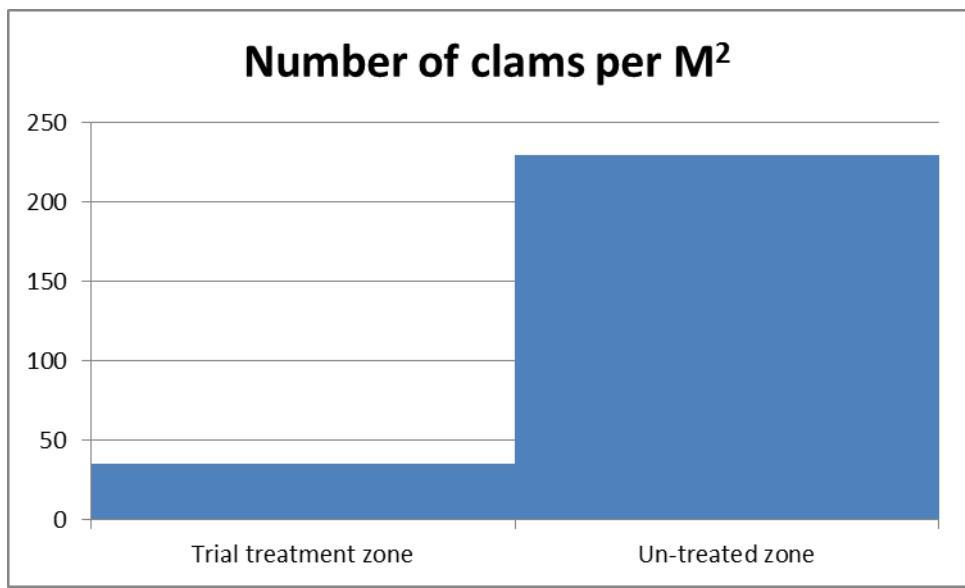
The clams were significantly more abundant in the untreated zone. A mean clam count of 229 individuals (per m^2) was retrieved in the un-treated zone and a mean of 35 (per m^2) in the trial treatment zone.

The sampling indicated that the mean density of the Asian clam population per square metre was greater in the un-treated zone than in the adjacent trial treatment zone (Table 1). The figures reveal more than six time abundance of clams in the un-treated area.

Table 1. Mean density of clams per m² in survey zone

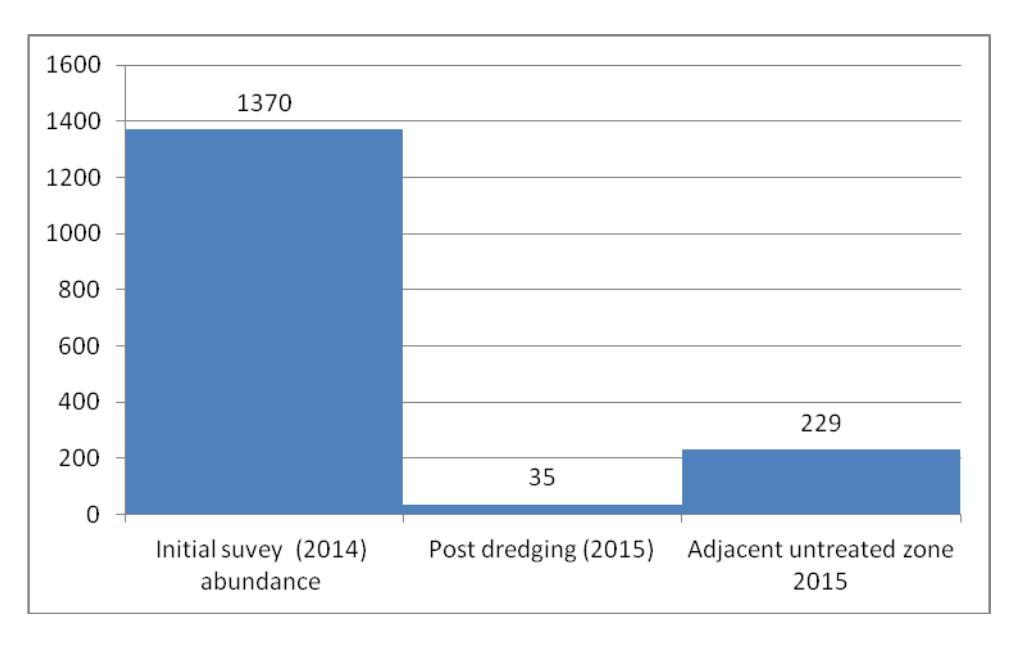
In 2014, the number of clams present in the Suber samples collected in the general area of the hotwater section (Hot Water-2) downstream of the bridge averaged 1370 per m^2 . The survey results reveal a large reduction in the abundance of Asian clam, where an average of 35 clams per m^2 was detected in the trial dredged zone.

Table 3: comparison of clams in pre and post dredge survey

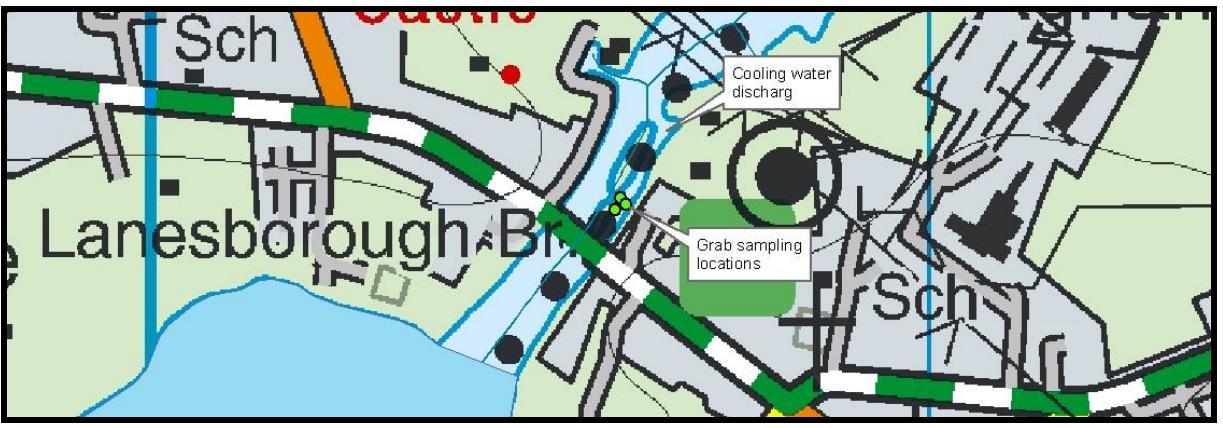
Date Samples Taken:10th November 2014No. of Samples taken:3 samples takenLocation of Samples:Upstream of the vehicle bridge, on the Lanesborough Hot-water stretch. Thislocation was chosen as it contains the highest density of Asian Clams per metre squared.

Figure 1: Sample Sites

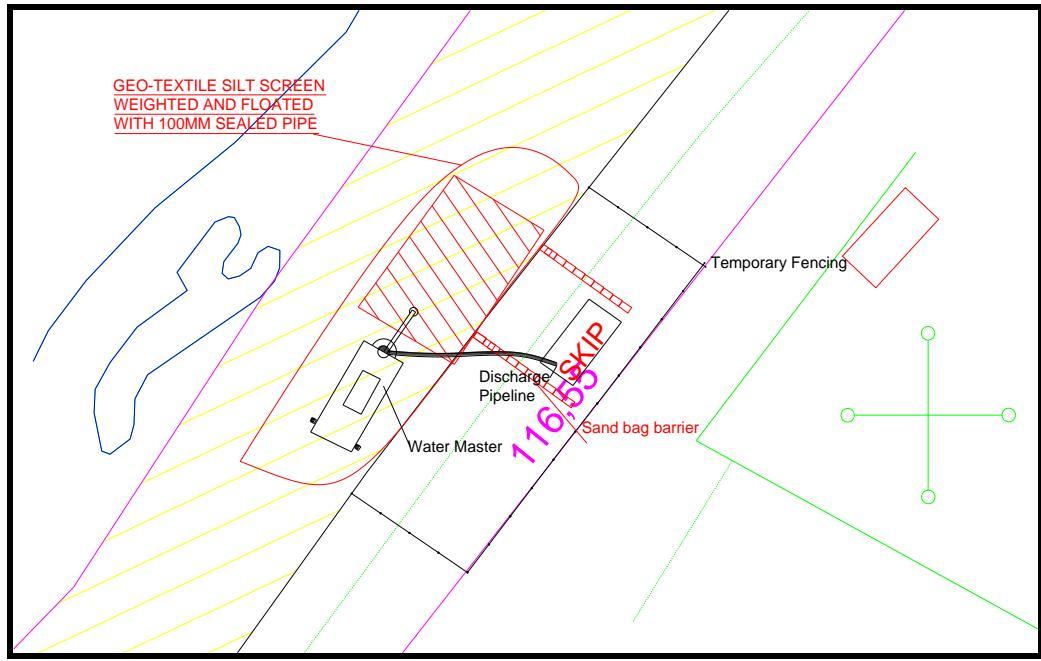
Figure 2: Trial Dredge Schematic.

The Trial Dredge Method statement is contained within the Appropriate Assessment Screening Report. Waterways Ireland is prepared to carry out this trial using a suction method and monitoring of this method will be continually assessed throughout the operation. The estimated volume of dredged material from this operation is 80 tonnes.

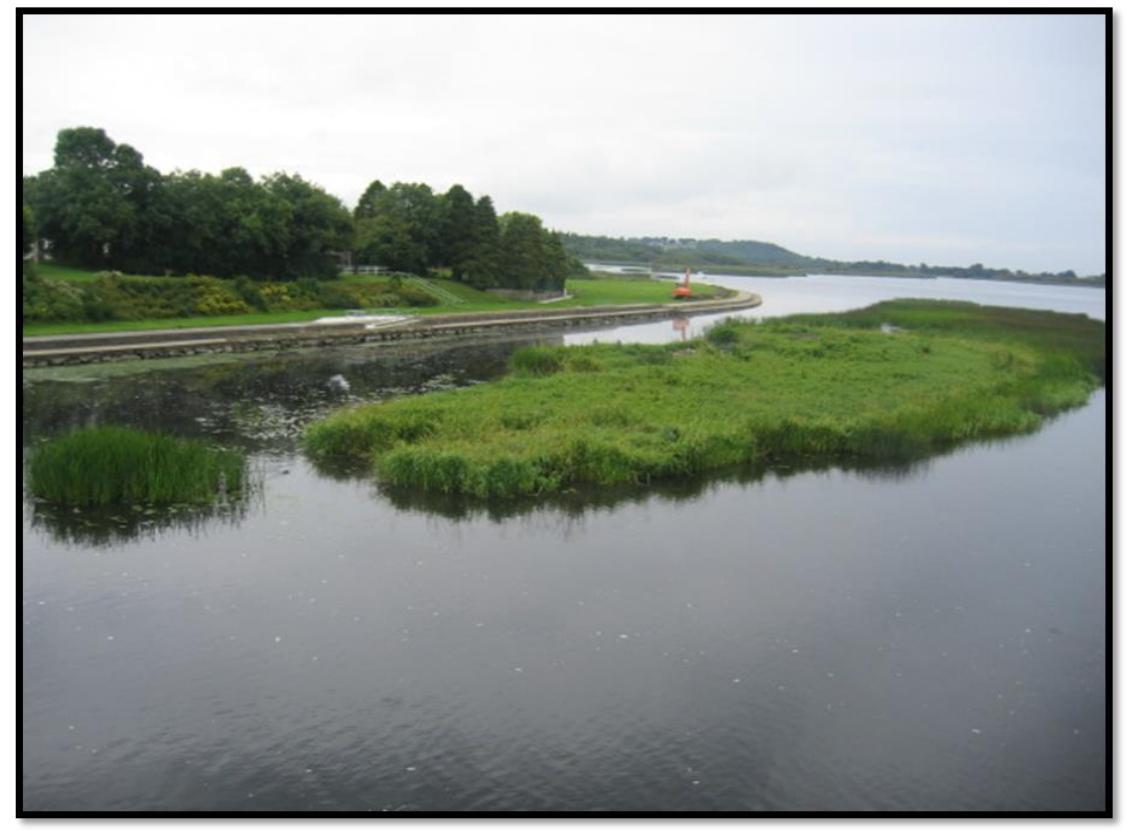
Figure 2: Picture of Downstream Trial Dredge
