Research article

A novel approach to aquatic weed control and habitat restoration using biodegradable jute matting

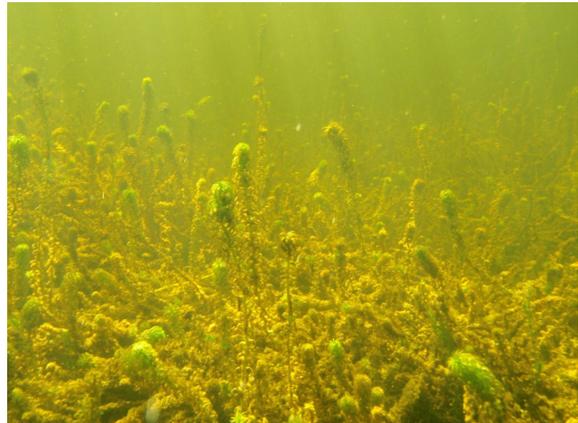
Figure 2. Typical *Lagarosiphon major*-dominated habitat prior to jute application (photograph by Joe Caffrey).

Seven *L. major* dominated sites were treated with jute matting between August 2008 and October 2009 (Figures 1, 2 and Table 1). The areas of lake bed covered varied between 100 and 5000 m². The length of time the jute matting was in place ranged from 4 to 17 months. Before placing the jute matting the extent of the infestation with *L. major* at each sampling location was recorded as follows: total cover = 1 (where the plant occupied *circa* 100% and no other macrophyte species were present) and extensive dense patches = 2 (where *L. major* was the dominant plant but small stands of native species or areas of exposed lake bed were present). At the end of the trial period a series of measurements were recorded at each site. These included: a) status of *L. major* having been covered for a specific duration (live and intact = 1, decaying = 2, fully decomposed = 3); b) condition of jute matting (intact = 1, intact but easily torn = 2, intact but disintegrates on contact = 3); c) extent of sedimentation on jute matting (none = 1, partially covered = 2, jute not visible

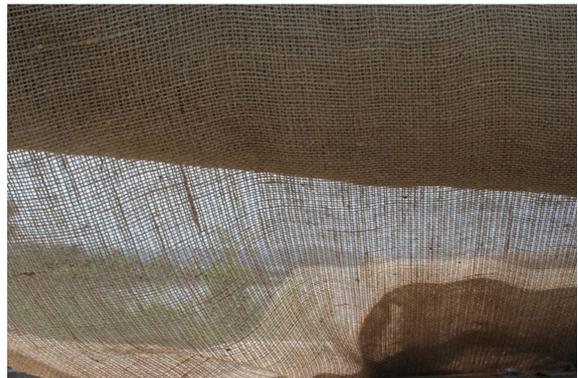
Figure 3. A view through the open-weave jute matting used to kill *Lagarosiphon major* in Lough Corrib (photograph by Joe Caffrey).

A natural and biodegradable material was sought to replace plastic or polyethylene sheeting commonly used for light exclusion in aquatic weed control programmes. Rolls of jute matting (5 m wide × 900 m long, *circa* 200 gm⁻²) were sourced and trialled on *L. major* in Lough Corrib. Jute is a natural vegetable fibre and the matting used is loose-woven (Figure 3) and durable. Another beneficial characteristic of the product for application in large lake situations is the fact that it saturates on contact with water and rapidly sinks, thus limiting the impact that wind can have on its accurate placement.

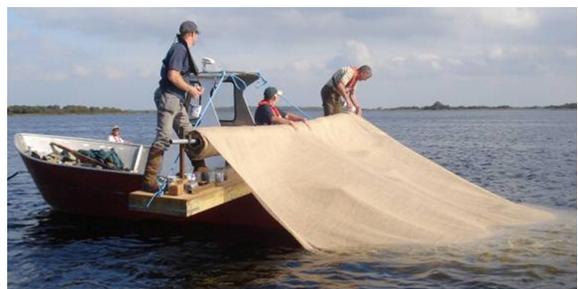
Figure 4. Jute matting application using a purpose modified boat (photograph by Joe Caffrey).

Depending on the size of the area to be treated, two methods for applying the jute matting have been developed. Where *L. major* occupies an area in excess of 200 m², a purpose-modified boat is utilised. The matting is deployed from a boat-mounted dispenser directly onto the water surface (Figure 4). The site to be treated is demarcated by divers using buoys. An estimate of the area to be treated is made and sufficient material to complete the operation is

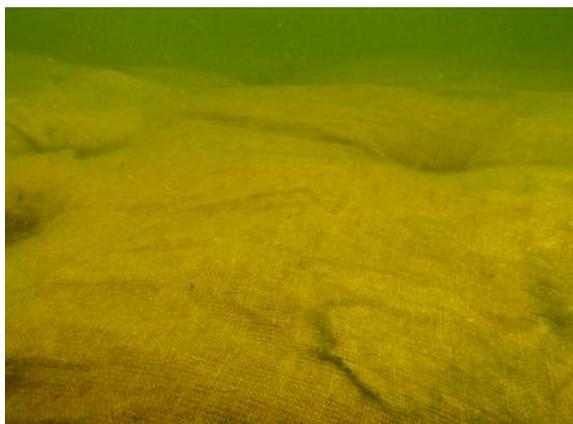
Figure 5. Jute matting secured *in situ* on the lake bed (photograph by Joe Caffrey).

prepared onshore. The jute is commonly laid in 100 m-long strips. Divers are present in the water to oversee the accurate placement of the material and to ensure that strips overlap properly, where this is required. Small weights are attached along each side of the matting, at roughly 5 m intervals, as the material is being laid on the water. This aids in its proper placement on the target weed bed. The matting is secured on the lake bed by the divers using additional weights or pins (Figure 5). Alternatively, where smaller beds of *L. major* (< 200 m²) are the primary target, pre-cut sheets of the jute (each ≤ 5 m × 15 m) are manually laid over the target weed bed from a boat or are brought into position by divers from the shore. As before, the material is secured in place by divers.

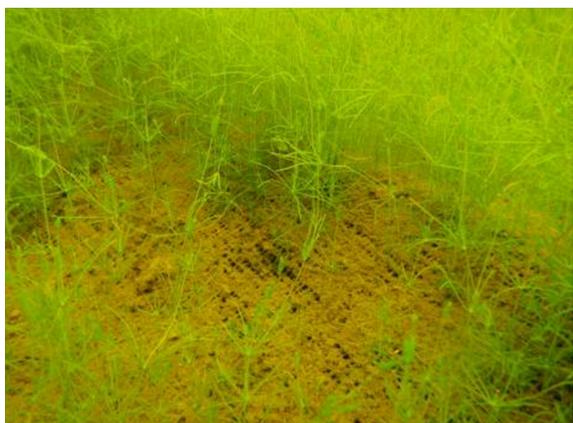
Figure 6. *Nitella flexilis* growth on the jute matting 8 months after application at site Ard Point (photograph by Joe Caffrey).

communities. Within seven months of placing the matting over dense *L. major* beds, relatively dense beds of native macrophyte species were observed growing through the material (Figure 6). Moreover, the presence of *C. virgata* at Gortdrishagh Bay and *N. flexilis* at Kid Island suggests that this regeneration process can commence in as short a time period as four to five months after the matting is applied. The emergence of *C. rudis* through the matting, at Kilbeg South, was somewhat unexpected as this is one of the physically larger charophyte species present in the lake. It was thought that its large size might preclude it from growing through the weave in the matting.
