River Nenagh Walkover Survey Report

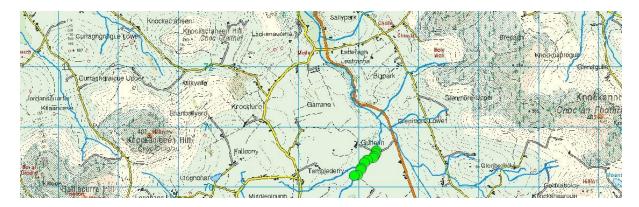
Figure 1: Overview map of proposed rehabilitation area on the River Nenagh.

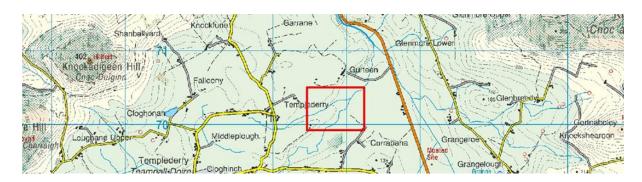
Figure 2: Survey area on the River Nenagh, showing precise locations of proposed works from sites 1 to 27. These sites all involve in-stream restoration works and bank protection. Grid Reference R 973 705
